Façade Collapse Report

201-211 Harrison Street, Oak Park, Illinois

Executive Summary

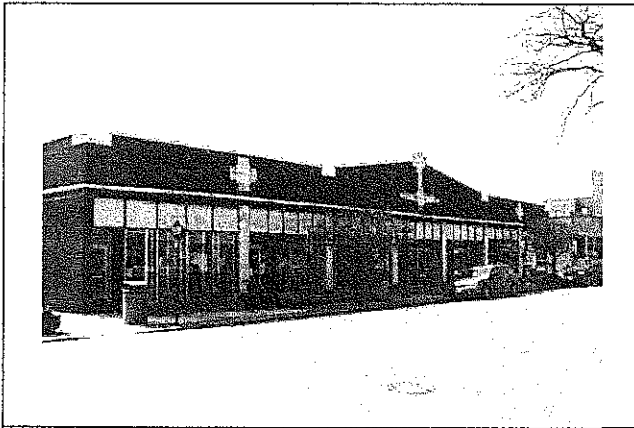
Picture 1 – 2010 VOP Planning Dept Survey Photo

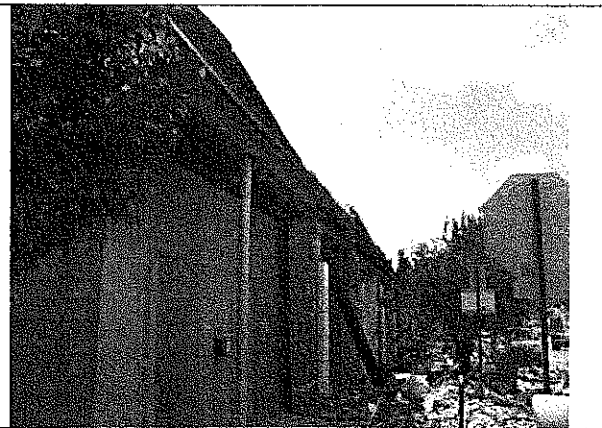
On Wednesday, August 10, 2011, major portions of the north façade of the building at 201-211 Harrison Street collapsed, exposing brick piers, wood framing members and steel I-beams from the northeast corner of the building through approximately two-thirds of the total north façade. This building sits at the southeast corner of Harrison Street and South Lombard Avenue. This façade collapse caused damage to a vehicle parked on the street, the sidewalk and associated landscaping and more importantly, in minor injury to a passerby. Fortunately there were no serious injuries.

Picture 2 – 2011 Photo after collapse

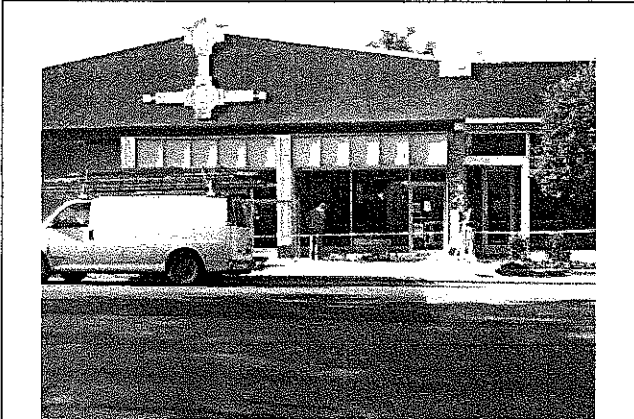
6. A picture acquired by the commission from a local newspaper reporter, taken July 7, 2011 at 8:15 PM (after normal BPS work and inspection hours), clearly shows the supporting terra cotta removed below the beam on the north façade of the building as well as the terra cotta trim and soldier brick course at the lintel.

- a. This work was never permitted.
 - b. Review at the site shows pencil numbering of the individual terra cotta pieces, which is typically done so that the pieces are reinstalled in the correct location – which is further evidence that this terra cotta was removed and partially reinstalled.

- c. Removal of the terra cotta trim and soldier brick course at the lintel made the parapet less stable to resist vertical (self dead load) and lateral loads such as wind.

Picture 3 – 2011.07.07 Photo showing un-permitted work underway – removal of terra cotta at pier, terra cotta trim & soldier brick course at lintel. Note there is no electrical junction box at surface of exposed brick near top of pier

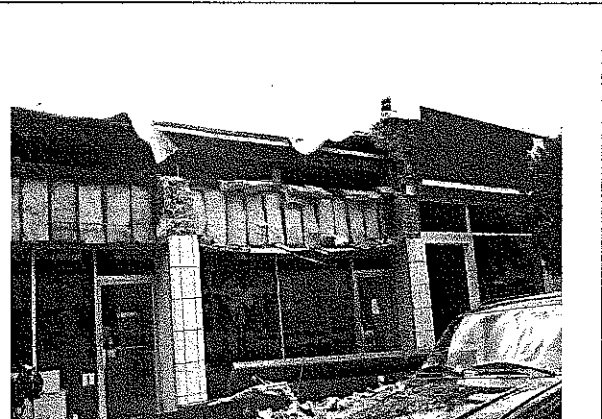
- d. The electrical work and terra cotta removal that was performed at the building façade was clearly outside the scope of permitted work. If that work had not been performed the collapse would not have occurred.

Picture 4 – 2011.08.10 Photo after collapse showing same pier as Picture 3 - terra cotta replaced up to unpermitted electrical junction box installation

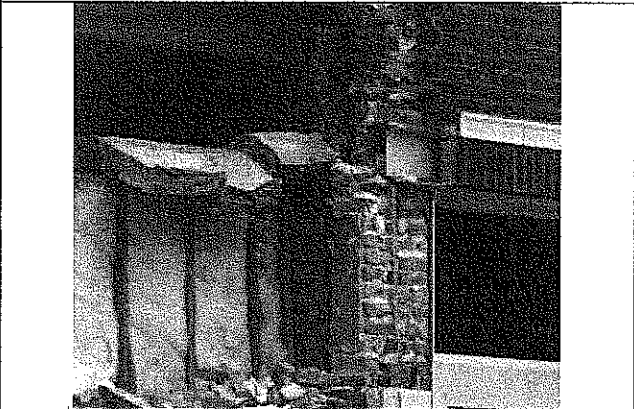
- b. Specifically, the likely cause of the collapse was the removal of the terra cotta under the lintel beam bearing points and the poor condition of the masonry piers (loose and missing mortar in the joints).

Picture 5 – 2011.08.10 Close-up of top of pier showing unpermitted electrical work after unpermitted terra cotta removal and replacement & loss of bearing for beam due to removal of terra cotta

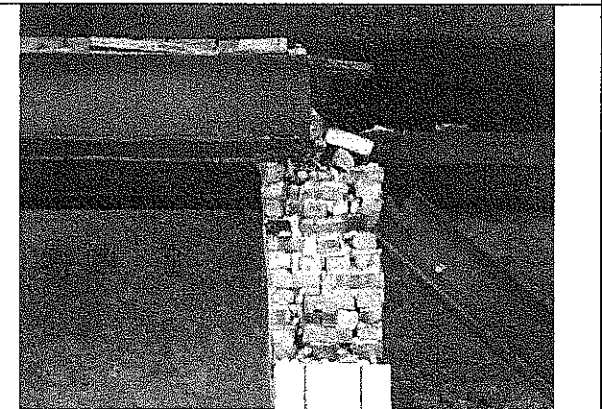
3. The commission agrees in part with the 8/23/11 Papadopoulos report that the failure appears to have occurred due to a loss of bearing surface at the column. However in the commission's view, had the supporting terra cotta not been removed under the outer 1/3 of the beam plate, the beam would have remained much more stable and the likelihood of collapse would have been greatly reduced.

Picture 6 – 2011.08.10 Photo showing terra cotta missing under beam flange resulting in loss of bearing surface for beam
