**PHASE I
ENVIRONMENTAL ASSESSMENT
REPORT**

**700-728 West Madison Avenue
Oak Park, Illinois**

Project #924.004

**SUBJECT: PHASE I ENVIRONMENTAL ASSESSMENT
700-728 WEST MADISON AVENUE
OAK PARK, ILLINOIS**

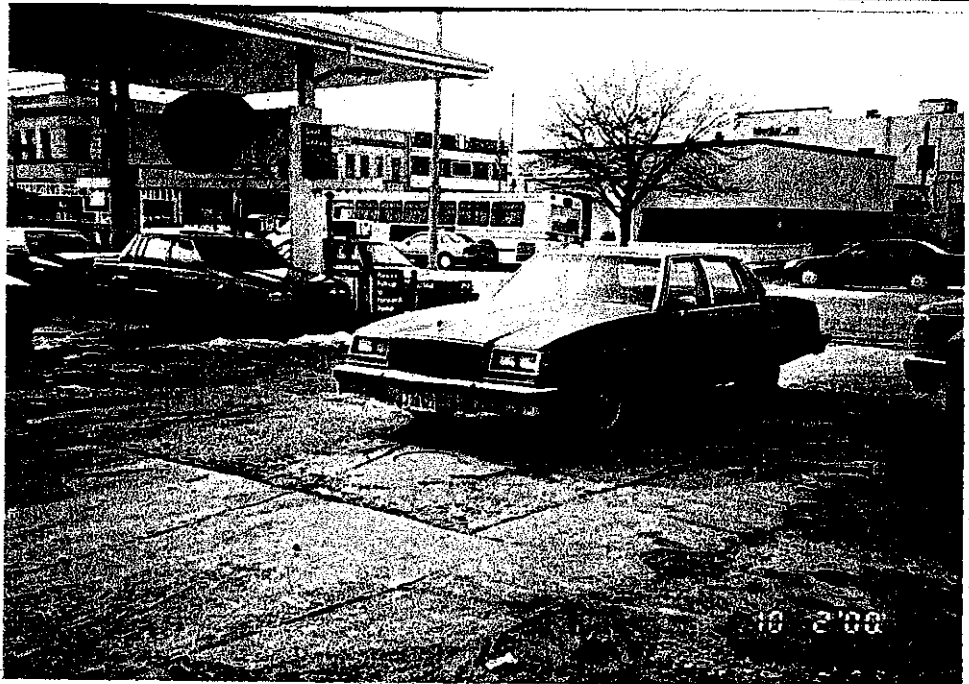
PHOTO #1

Drilling at 728 W. Madison Avenue in Oak Park, Illinois. The gas tanks were located north of the dispensers. Borings were installed north, west and east of these tanks.

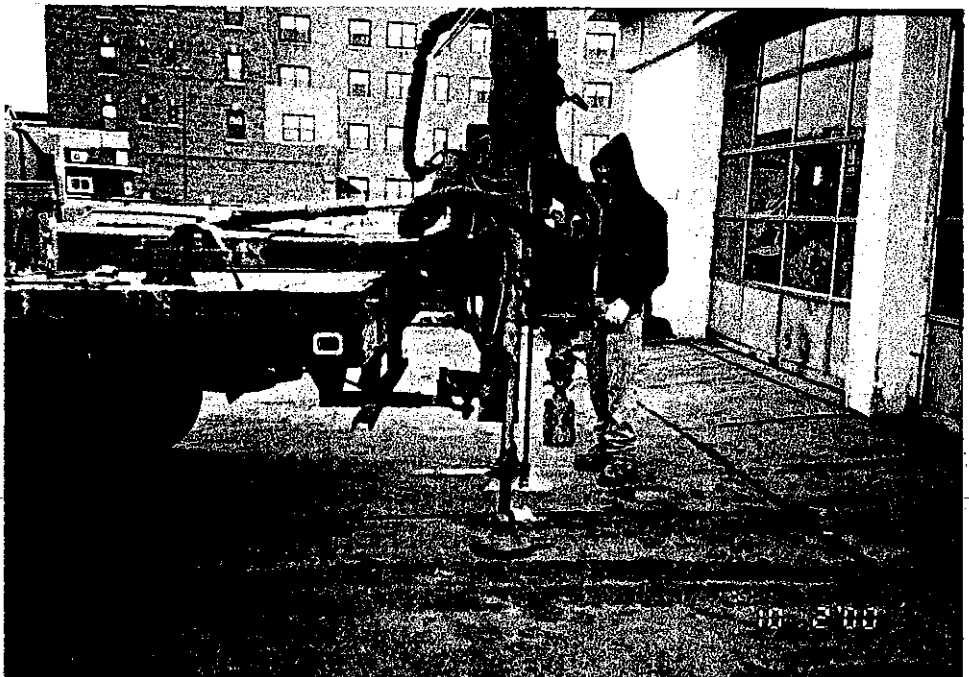
PHOTO #2

Boring B-2 was installed south of the waste oil UST. This boring was abandoned as the Geoprobe could not penetrate the concrete.

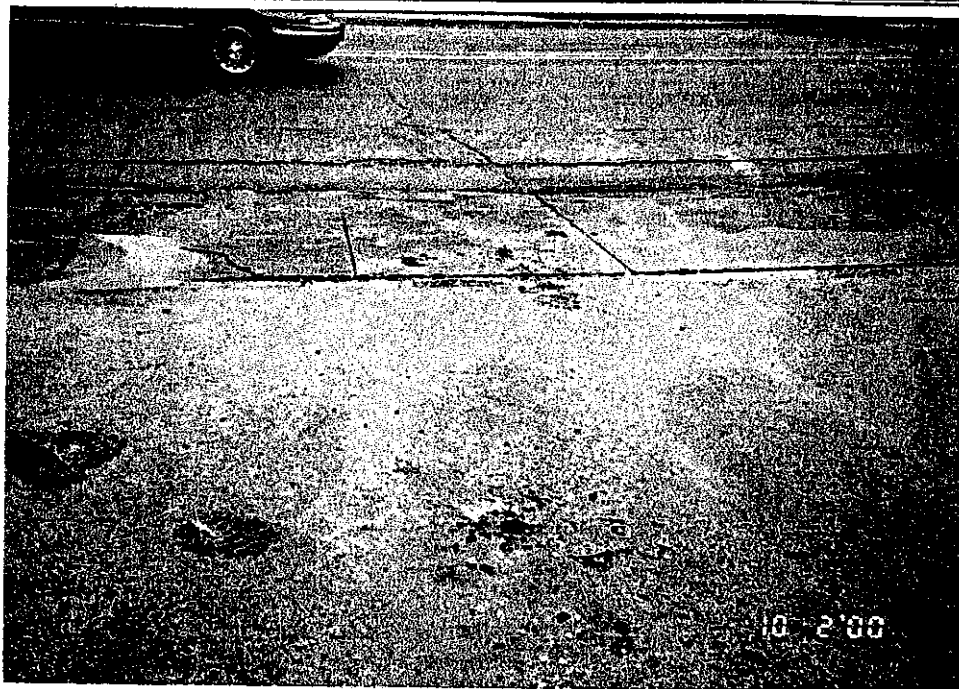
PHOTO #3

Boring B-3 was installed west of the gasoline USTs along the western property boundary.

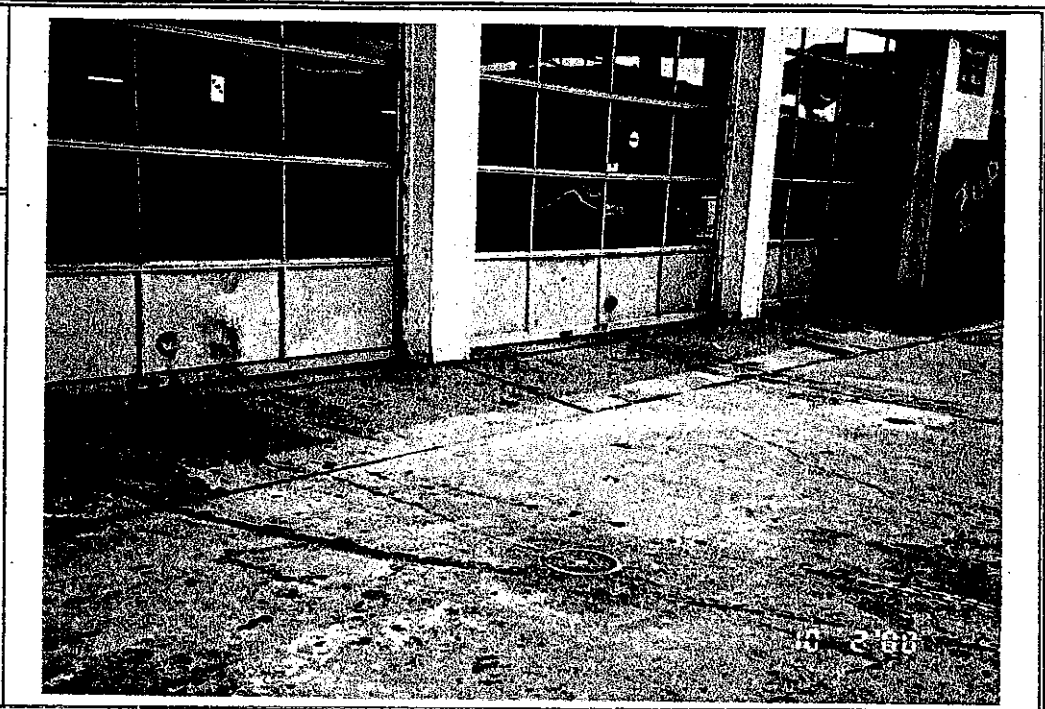
PHOTO #5

Description:
The waste oil UST was located near the building.

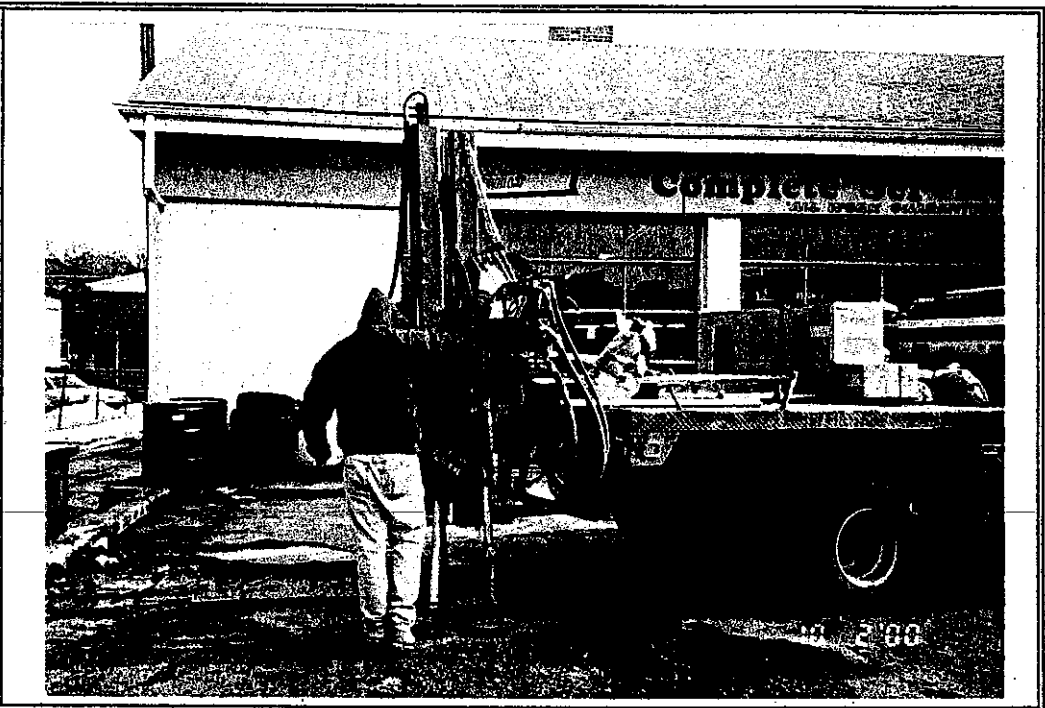
PHOTO # 6

Description:
Boring B-8 was installed west of the waste oil UST.
