OAK PARK VILLAGE HALL Property Condition Assessment

Oak Park, Illinois 60304

Final Report

November 9, 2015

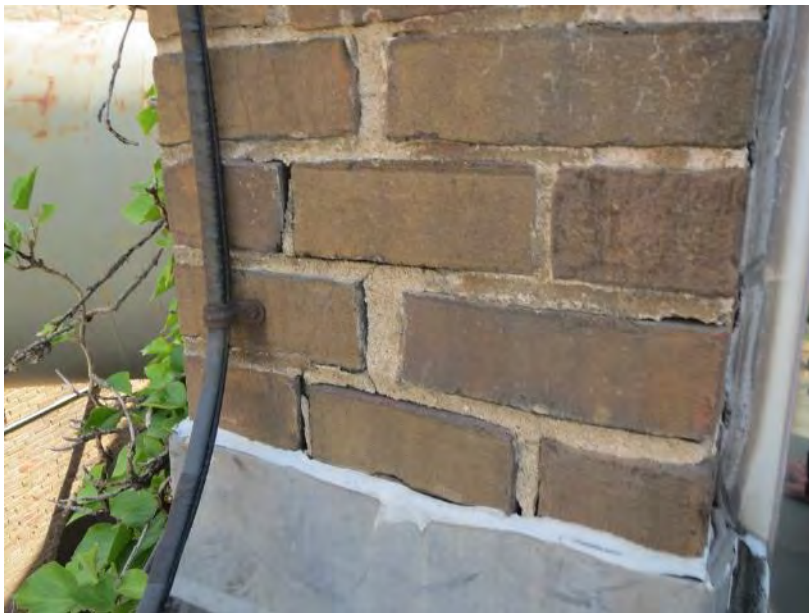
3. Cracked and open mortar joints exist at the return ends of the brick wall at the clerestory at the north and east facades (Figure 25 and Figure 26). The open mortar joints by-pass the deteriorated sealant at the leading edge of the metal counterflashing.

Figure 25. View of cracked and debonded mortar joints at the masonry piers at the north and east ends of the clerestory windows

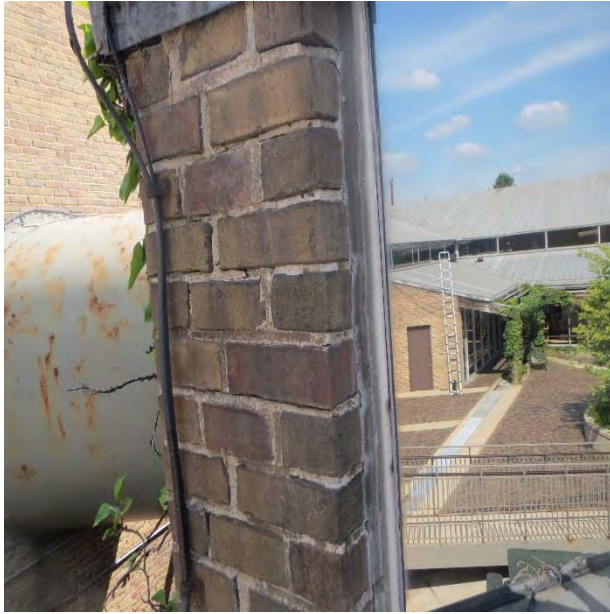
Figure 26. View of cracked and debonded mortar joints at the masonry piers at the north and east ends of the clerestory windows

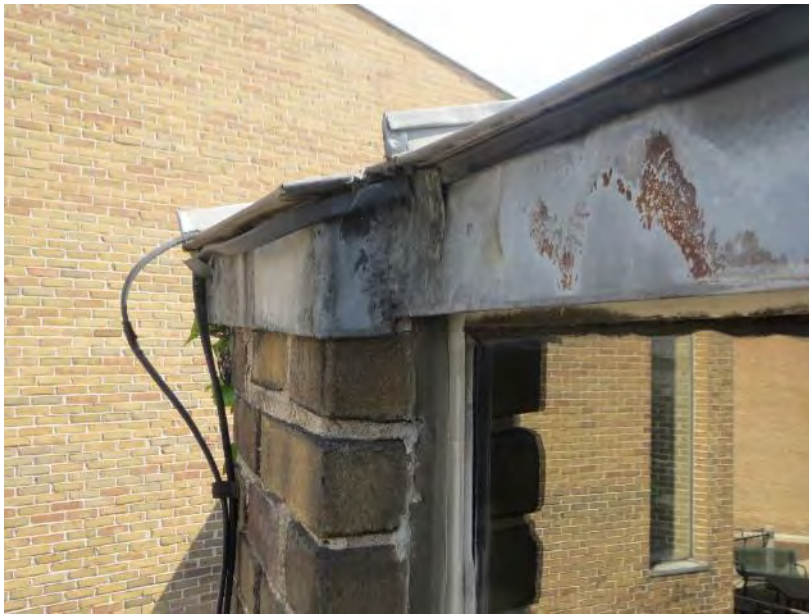
4. The top of the brick cavity wall at the return ends of the north and east facades is open under the roof edge condition (Figure 27 and Figure 28).
5. Isolated cracked and debonded mortar and open joints exist throughout the brick masonry (Figure 29 through Figure 31).

Figure 27. Counterflashing/ roof termination at the masonry piers and the top of the clerestory windows

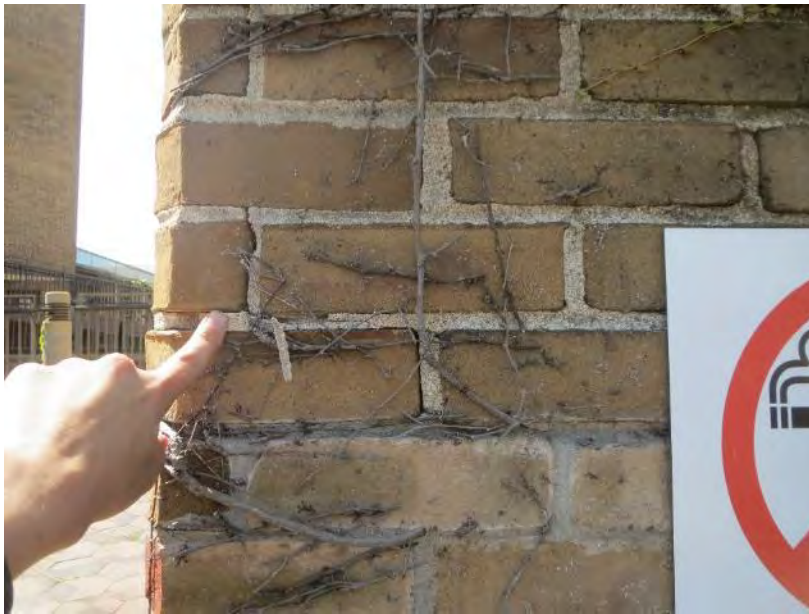
Figure 29. Typical cracked and debonded mortar joints

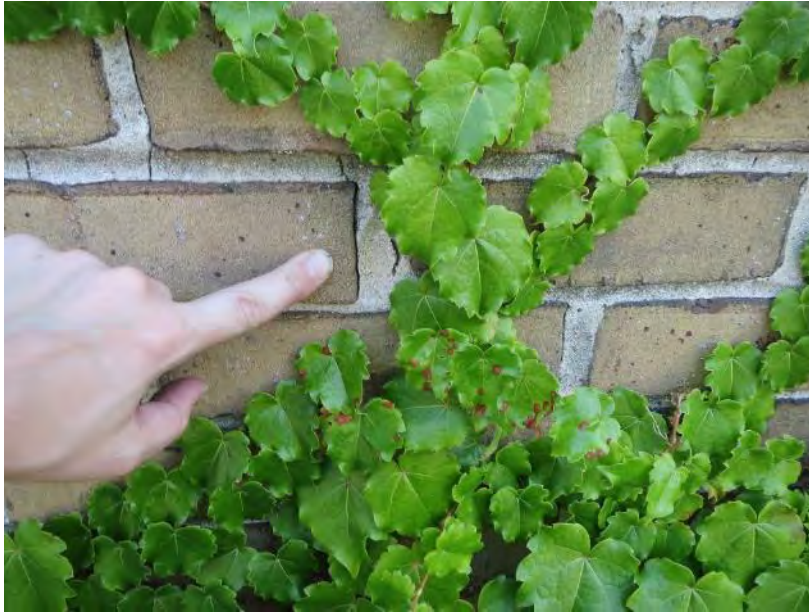
Figure 30. Typical cracked and debonded mortar joints

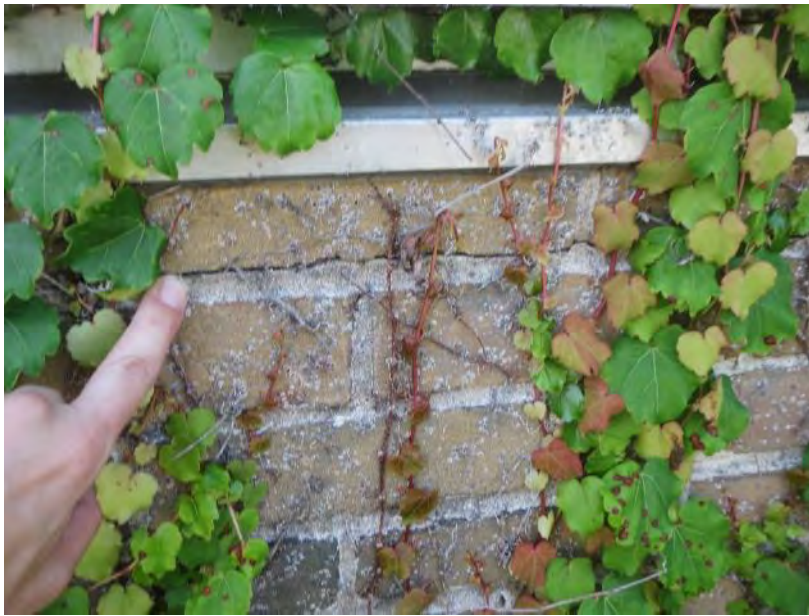
Figure 31. Typical cracked and debonded mortar joints

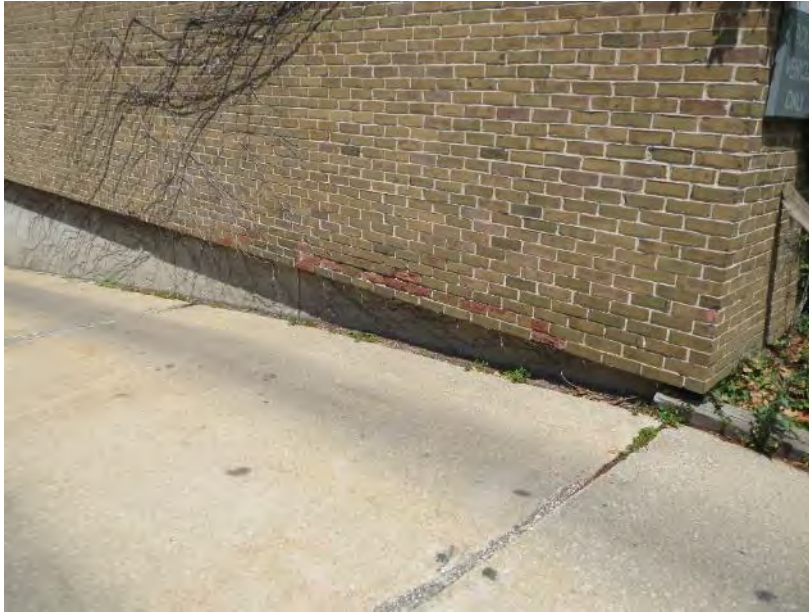
6. Isolated bricks at the base of the east corner above the galvanized shelf angle of the south facade are spalled (Figure 32).
7. A 3/8 inch wide crack exists in the concrete beam at the base of the cavity wall at the intersection of the building with the ramped walkway to the plaza level. Efflorescence, organic growth, and moisture were visible adjacent to the crack (Figure 33 through Figure 35).

Figure 32. Face spalling of brick masonry above the shelf angle at the east end of the south facade

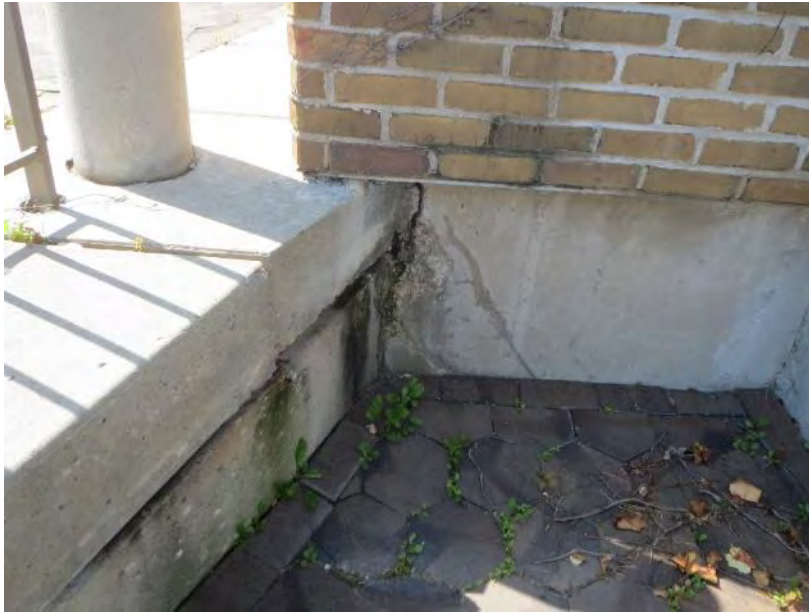
Figure 33. Crack at concrete foundation wall at the intersection of the base of the ramp

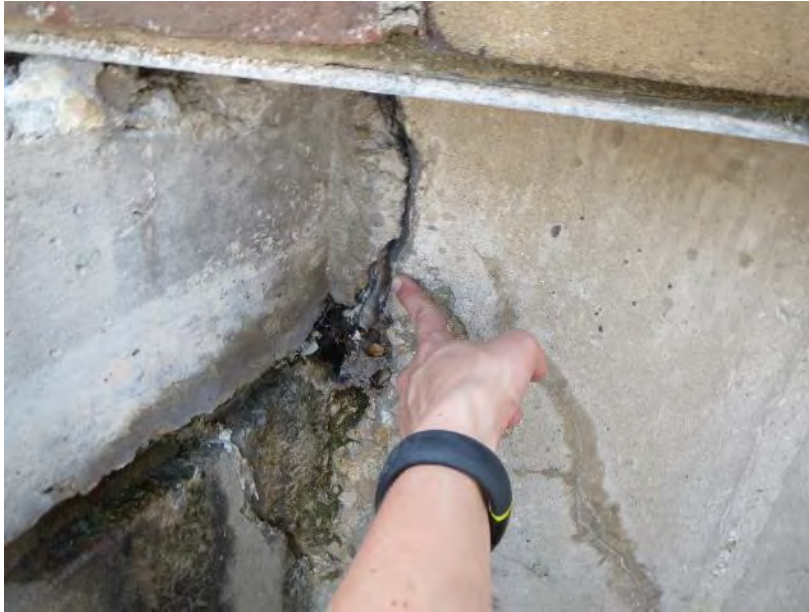
Figure 34. Moisture, biological growth and efflorescence at the crack at the concrete foundation wall

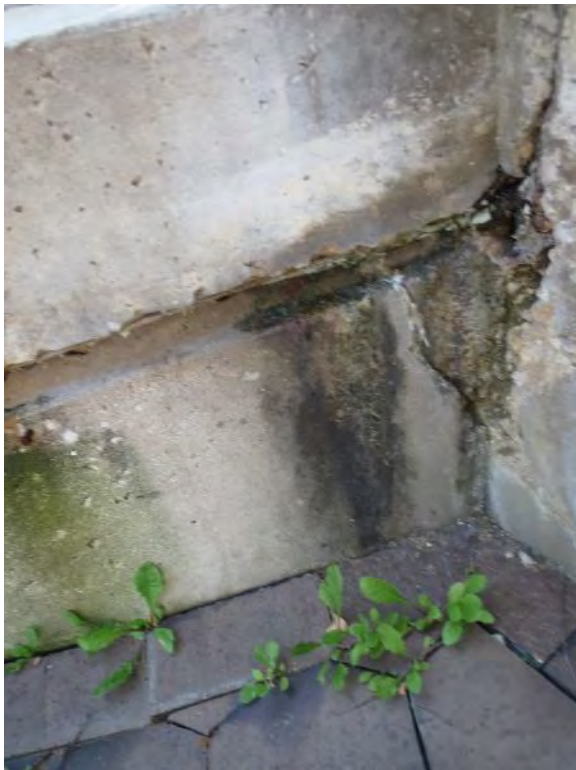
Figure 35. Moisture, biological growth and efflorescence at the crack at the concrete foundation wall

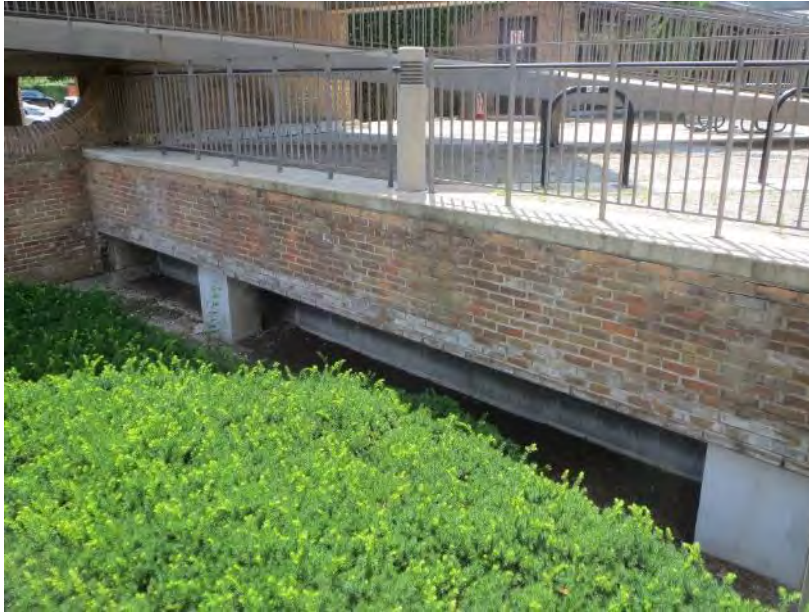
8. Significant efflorescence and water staining were visible on brick and concrete at the north wall of the elevated plaza. The brick is supported on a galvanized steel shelf angle (Figure 36 and Figure 37).

Figure 36. View of efflorescence at the brick cladding at the edge of the elevated plaza level

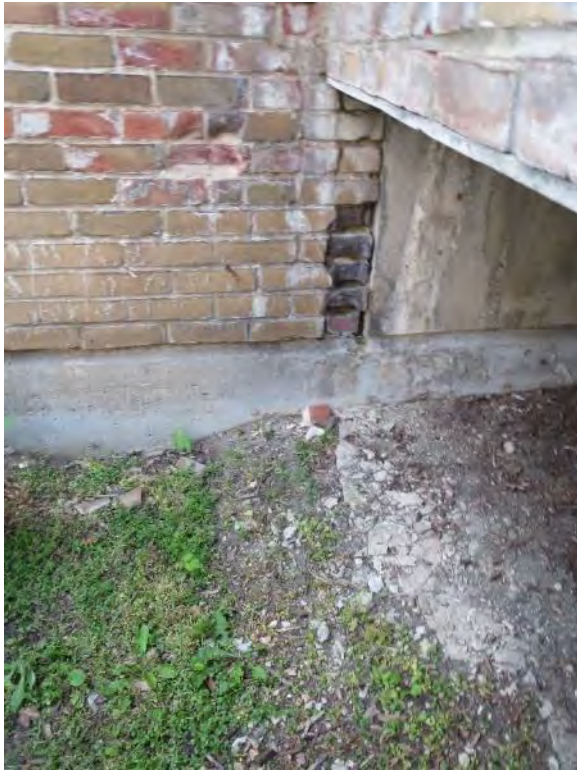
9. A portion of the brick cladding at the raised edge of the plaza level at the intersection with the ramped walk way is cracked and spalled (Figure 38).

Figure 38. Spalled brick at base of masonry pier near elevated plaza level

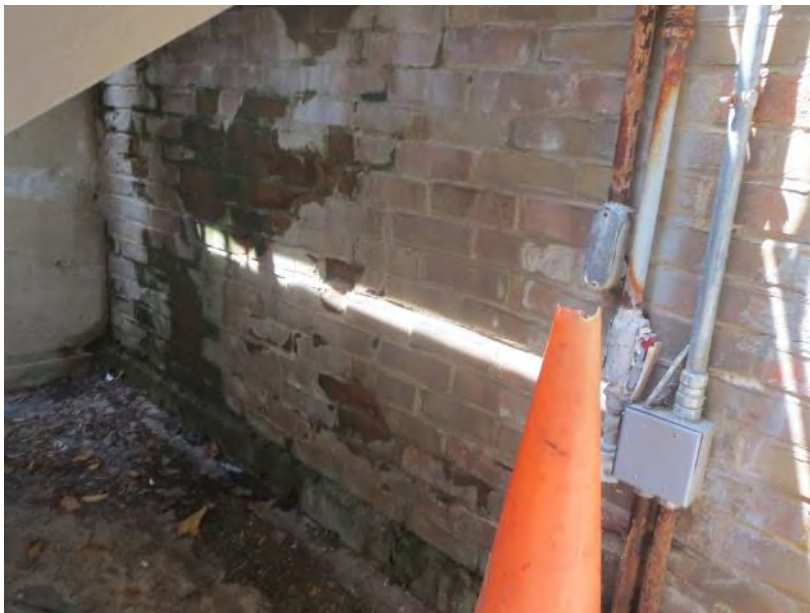
10. Moisture and efflorescence were observed on the brick at the east wall of the elevated plaza beneath the metal and concrete framed stairs extending between the elevated plaza level and the plaza infilled reflecting pool below the Council Chambers (Figure 39).

Figure 39. Moisture and efflorescence at the masonry cladding of the elevated plaza below the concrete stairs

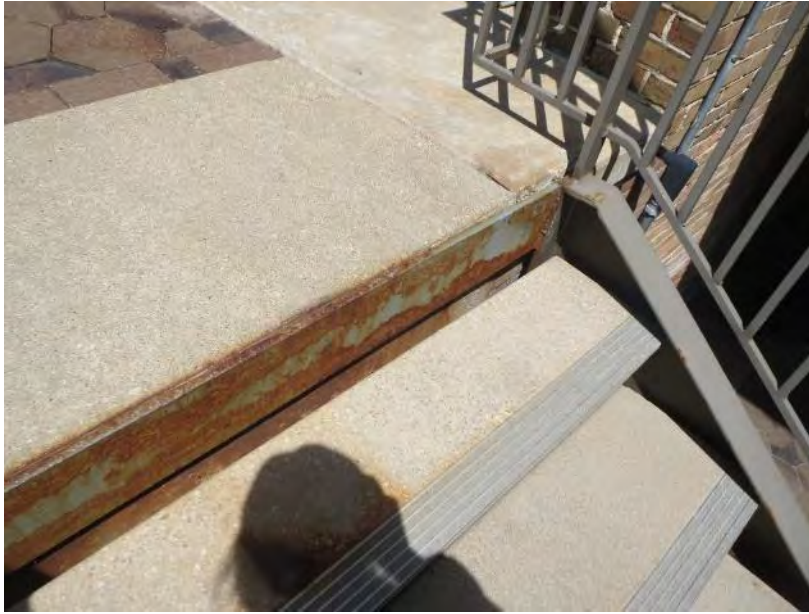
13. A 1/4 inch wide vertical crack exists at the southwest corner of the main building.
14. Surface corrosion exists at the metal riser at the top of the brick masonry clad plaza wall (Figure 40).

Figure 40. Corrosion scaling at the metal panning of the stairs between the elevated plaza level and the original reflecting pool plaza area

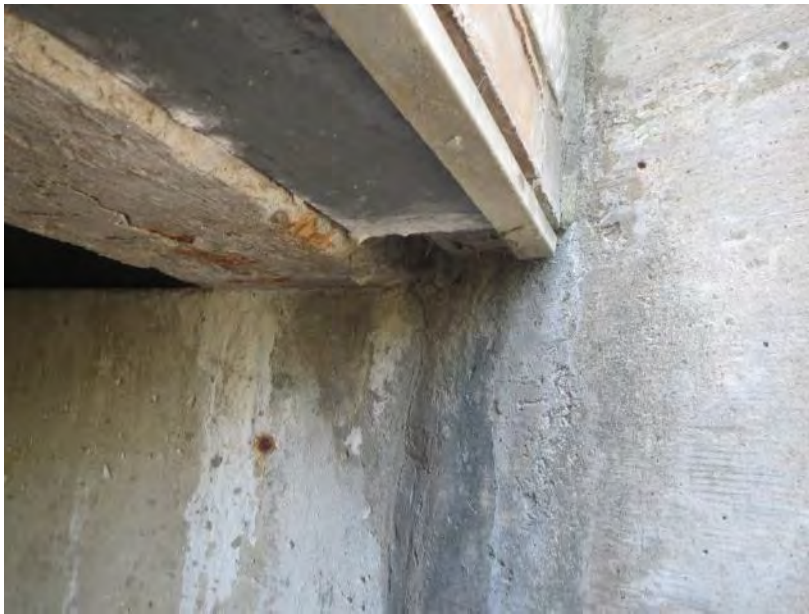
18. Incipient spalls are present at the edge near the steel angle supports on the underside of the concrete deck of the ramped walkway leading from the plaza level to the Council Chambers' entrance (Figure 41).

Figure 41. Spalling and efflorescence at steel angle at concrete beam at the ramped walkway

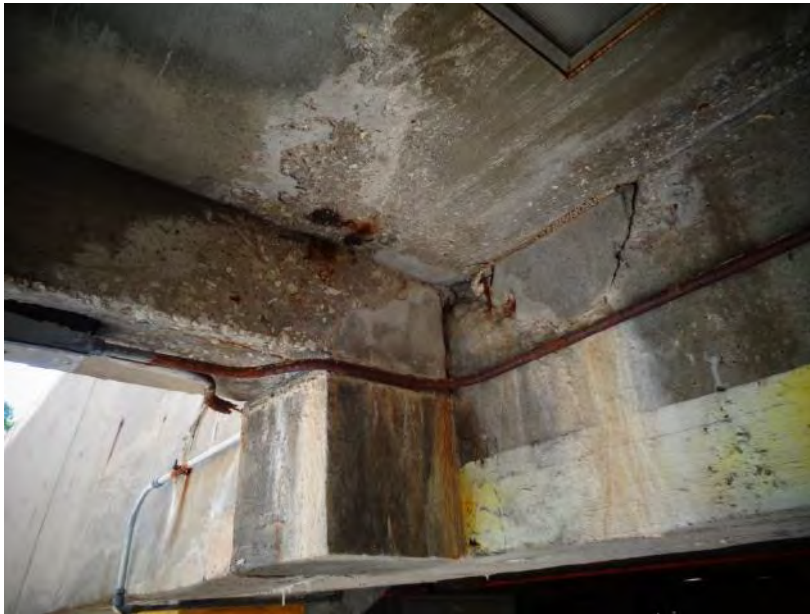
19. Cracking, spalling, corrosion staining, and visible corroded reinforcing bars were noted at the underside of the concrete elevated walkway at the south entrance above the garage ramp entrance (Figure 42 and Figure 43). Additionally, the traffic coating on the top side of the slab at the elevated walkway is bubbling, peeling, and delaminated (Figure 44).

Figure 43. View of incipient spalls and corrosion of steel reinforcing bars at underside of the slab elevated entrance bridge at south facade

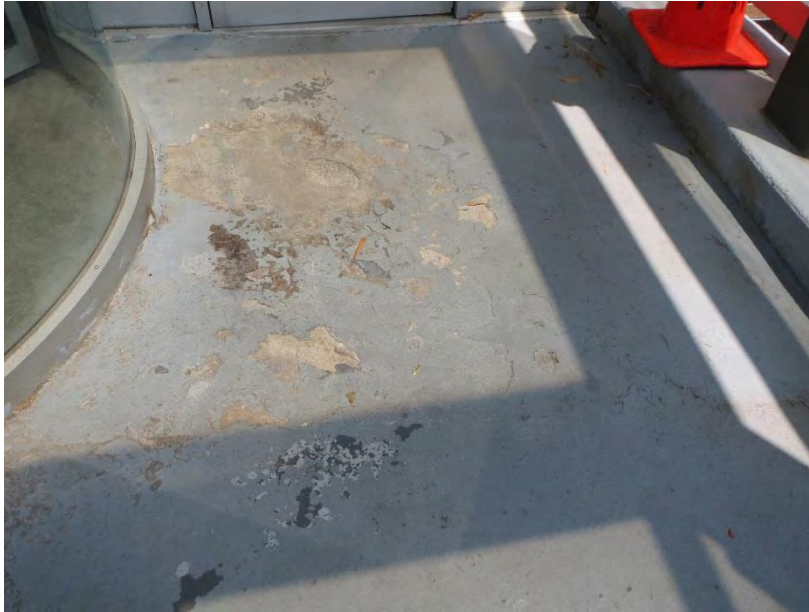
Figure 44. View of deteriorated traffic coating at the top side of the slab at the entrance bridge

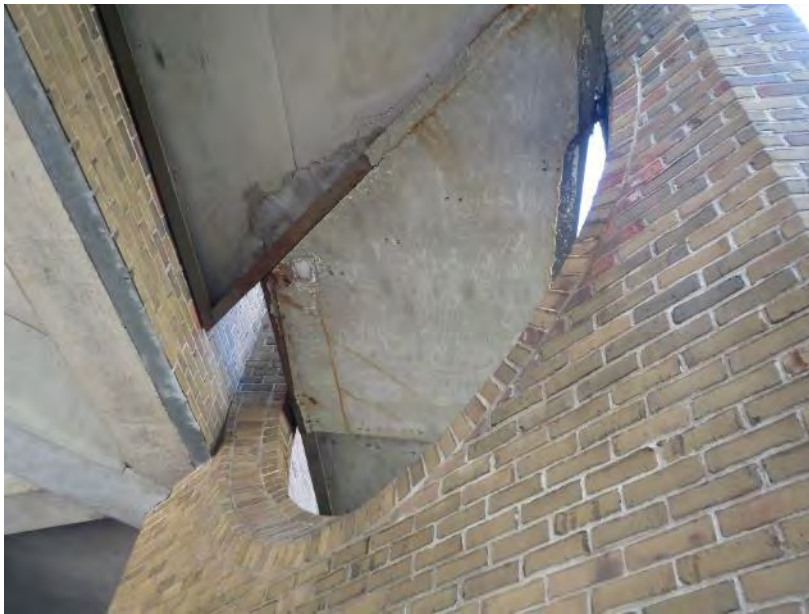
20. Surface corrosion exists on the underside of the painted metal frame supporting the concrete deck at the ramped walkway. Additionally, some surface corrosion was visible at the exposed steel reinforcing bars (Figure 45).

Figure 45. View of incipient spalls and corrosion of steel support at underside of the slab elevated ramped walkway at the Council Chambers Annex

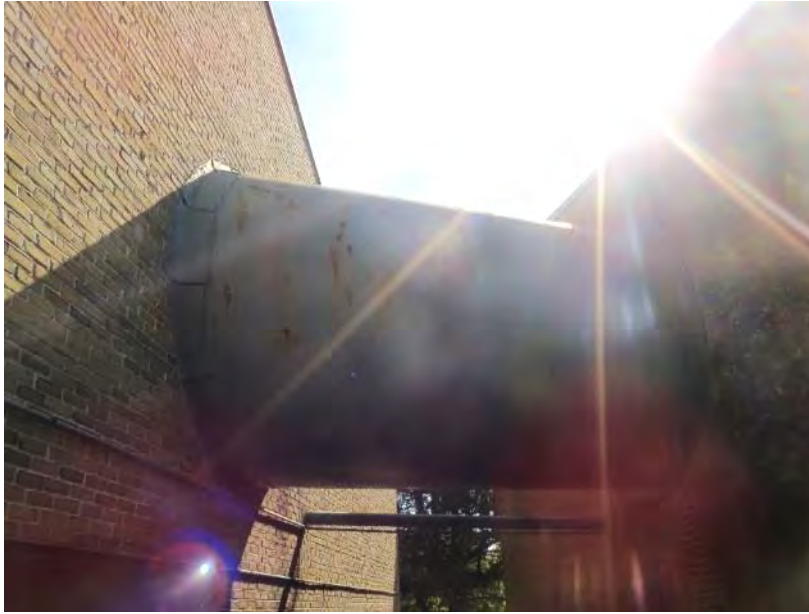
21. Surface corrosion was noted at the painted metal tube hallway connection between the main building and the Council Chambers annex (Figure 46).

Figure 46. Surface corrosion at the painted steel tube connecting link between the council chambers annex and the main Village Hall building

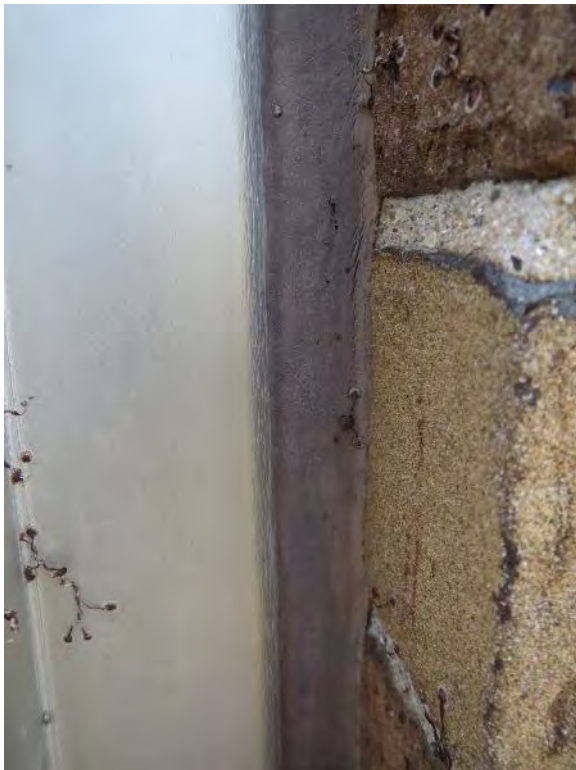
1. Crazeing is noticeable at the exterior window sealant at all facades (Figure 47).
2. The sealant is missing from portions of the joint between the steel door frame and the brick masonry on the north portion of the east facade (Figure 48).

Figure 47. View of typical crazed sealant at window and door perimeters

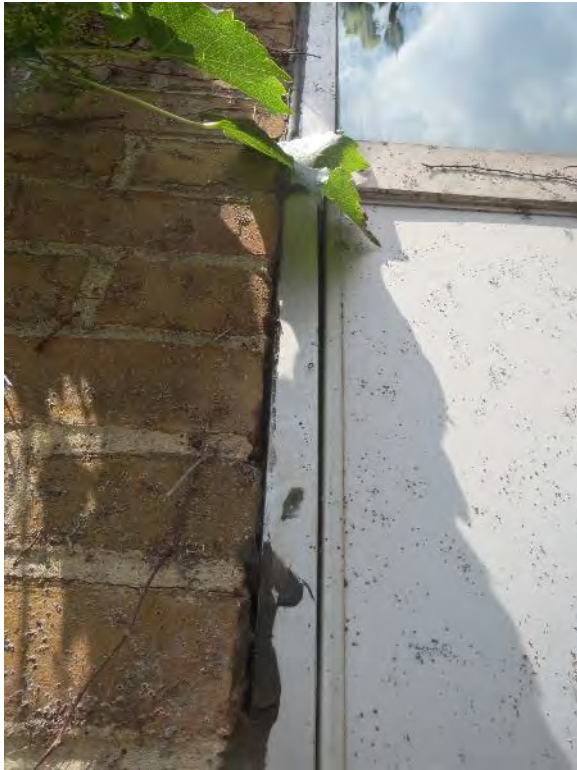
Figure 48. View of missing sealant at door perimeter on east facade

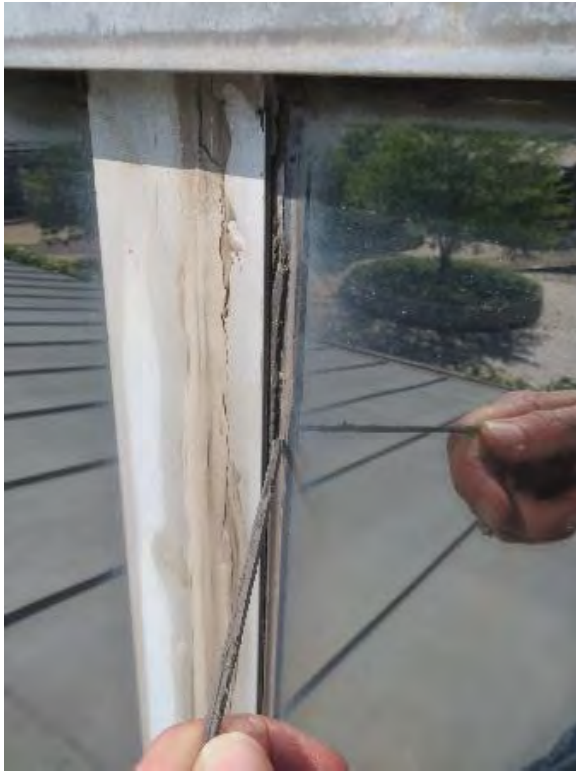
Figure 51. Deteriorated and debonded gaskets at the clerestory windows

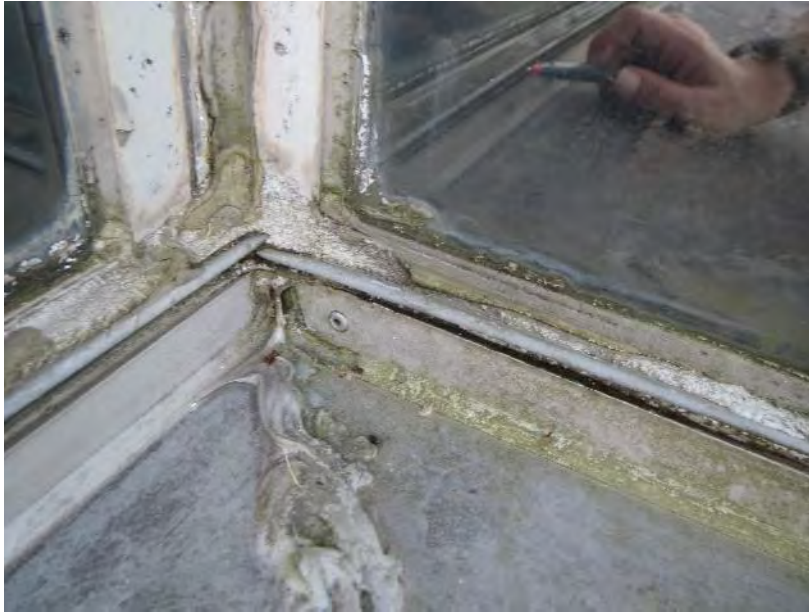
Figure 52. Crazed sealant at counterflashing at the base of the clerestory windows and deteriorated gaskets/wet seals at the metal to glass joints at the clerestory windows at a valley location

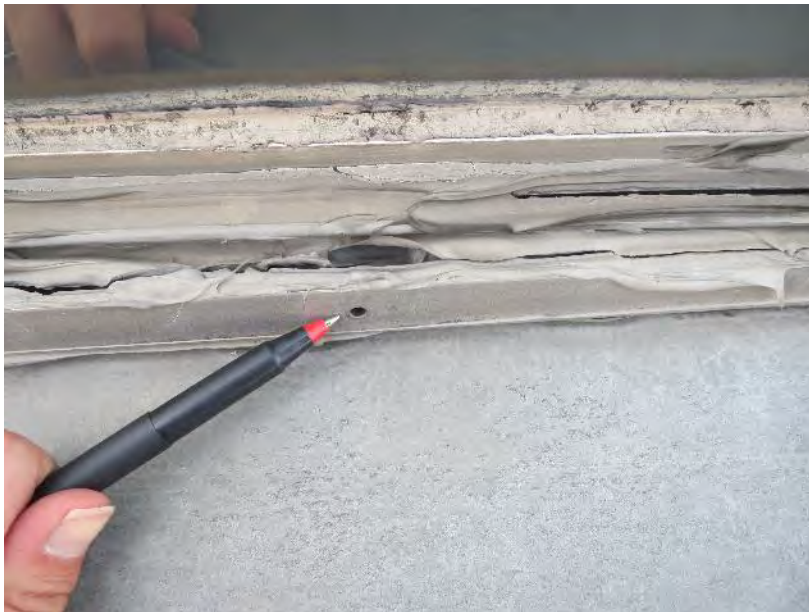
Figure 53. Missing fasteners and severely debonded sealant at the counterflashing at the base of the clerestory windows

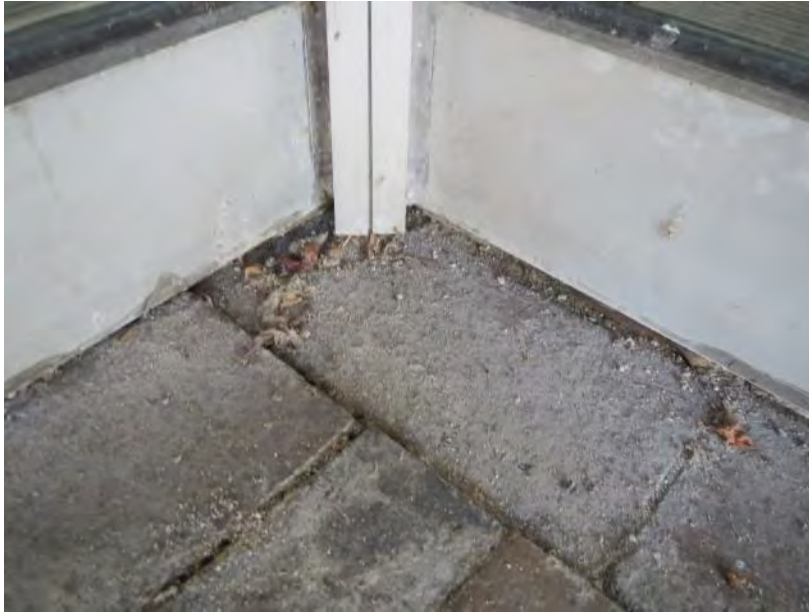
Figure 54. Missing sealant in the joint between base of window wall and pavers

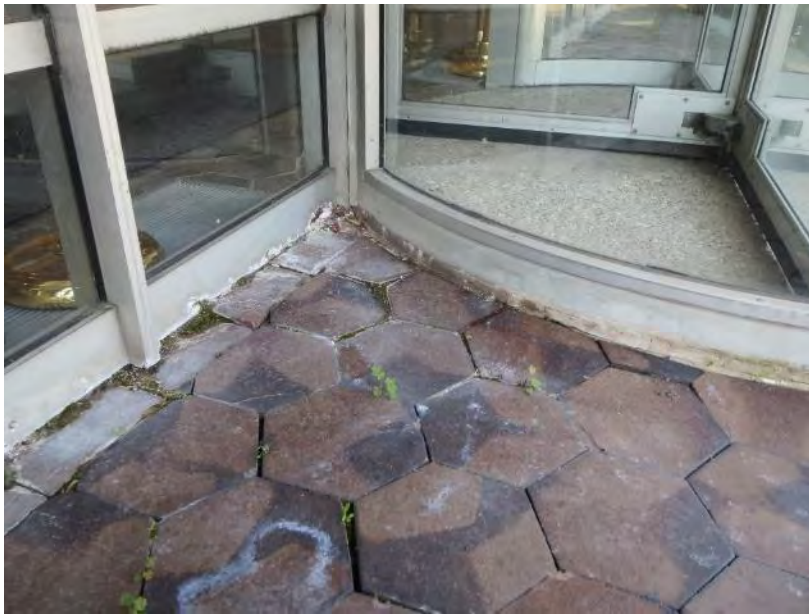
Figure 55. Missing fillet sealant in the joint between base of window wall and pavers. Note the significant organic growth and efflorescence.

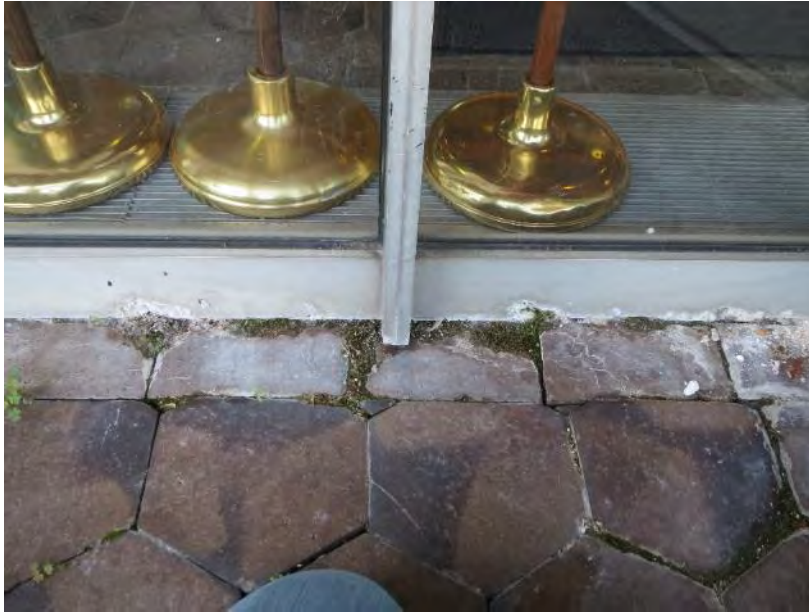
Figure 56. Missing fillet sealant in the joint between base of window wall and pavers. Note the significant organic growth and efflorescence.

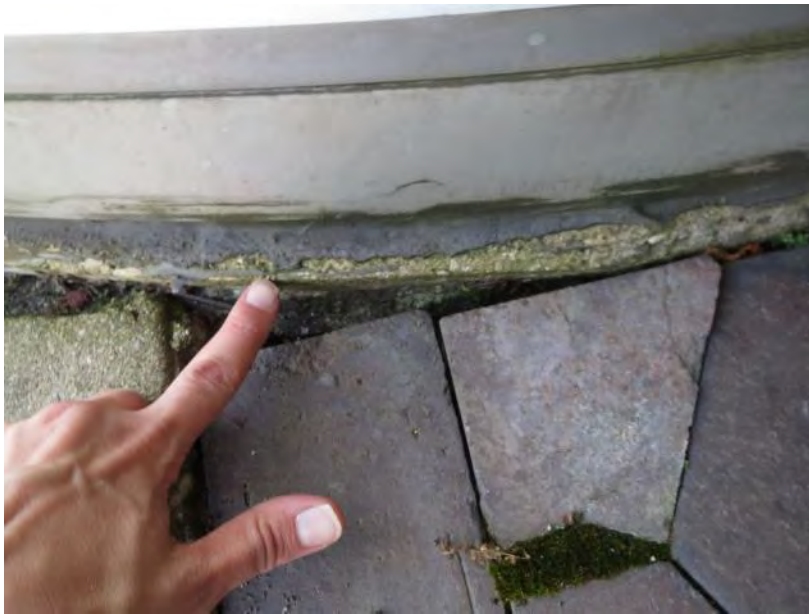
Figure 57. Deteriorated sealant at the joint between the concrete curb and the base of revolving door. Note displacement of pavers and organic growth at pavers at revolving door curb.

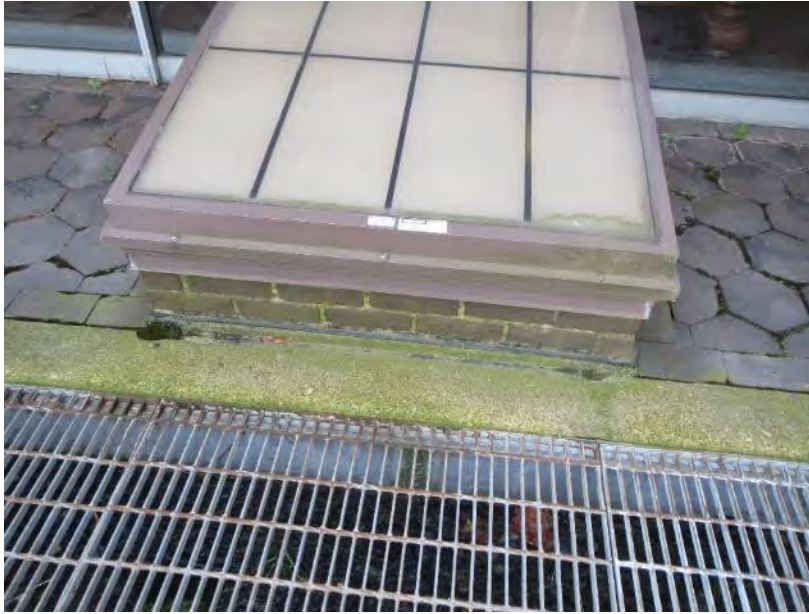
6. Sealant has been smeared over the face of the skylights at the courtyard level (Figure 58 and Figure 59).
7. Corrosion staining, surface corrosion, and efflorescence are present at the base of the aluminum frame storefront with the revolving door at the south facade (Figure 60).

Figure 58. Sealant has been smeared over the face of the skylight. Debonded sealant in the joint between the concrete curb and the base of the skylight. Note displacement of pavers and organic growth at pavers at skylight.

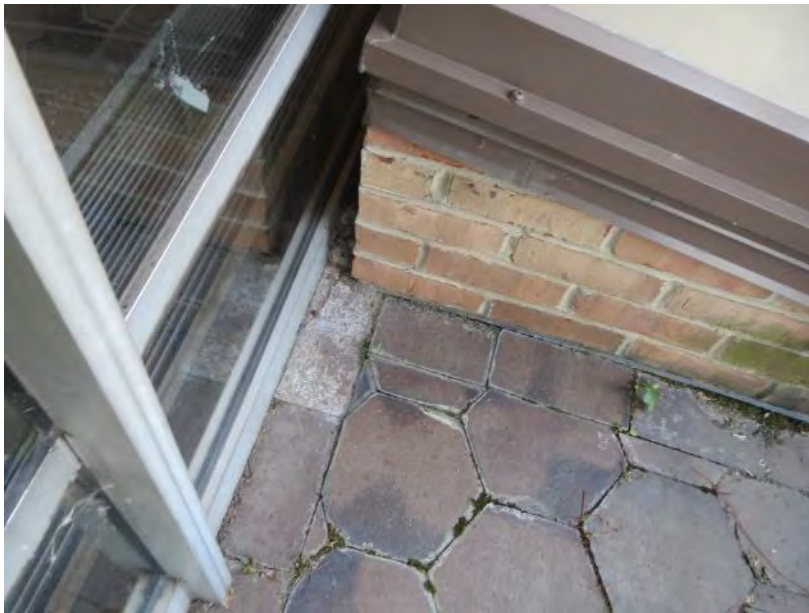
Figure 59. Deteriorated sealant at the joint between the concrete curb and the base of skylight. Note displacement of pavers and organic growth at pavers at skylight.

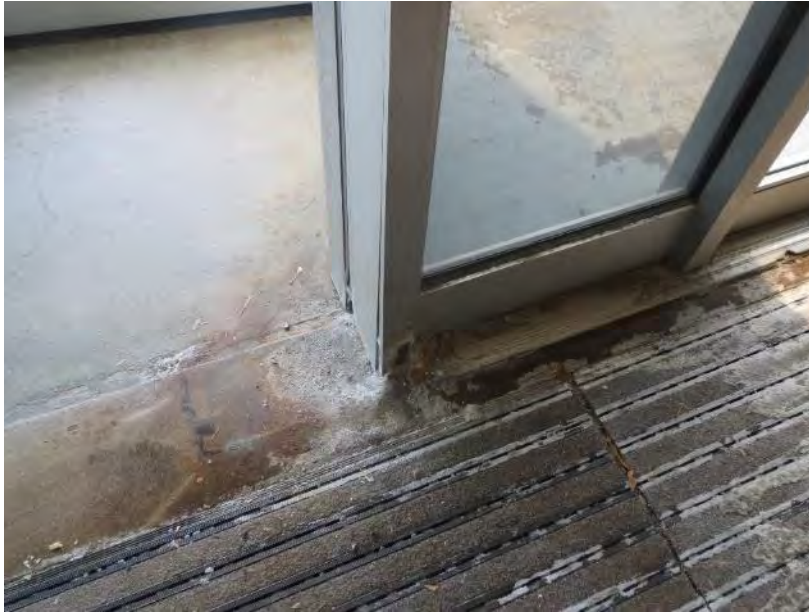
Figure 60. Efflorescence, surface corrosion and staining at base of storefront at south entrance

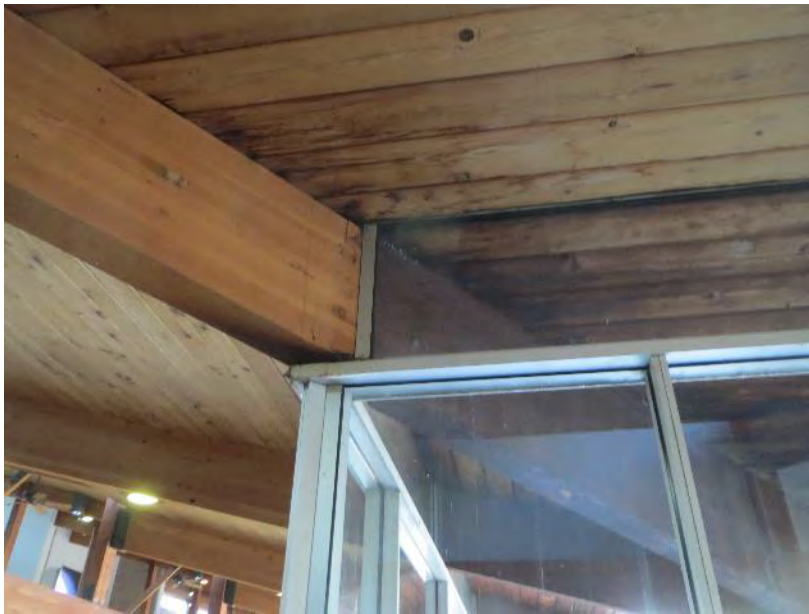
1. Isolated water staining was noted at the underside of the wood deck at the interface of the valley rafter, the wood decking, and the aluminum frame window wall system (Figure 61 and Figure 63).

Figure 61. Water staining at underside of wood deck at the valley member above the window wall

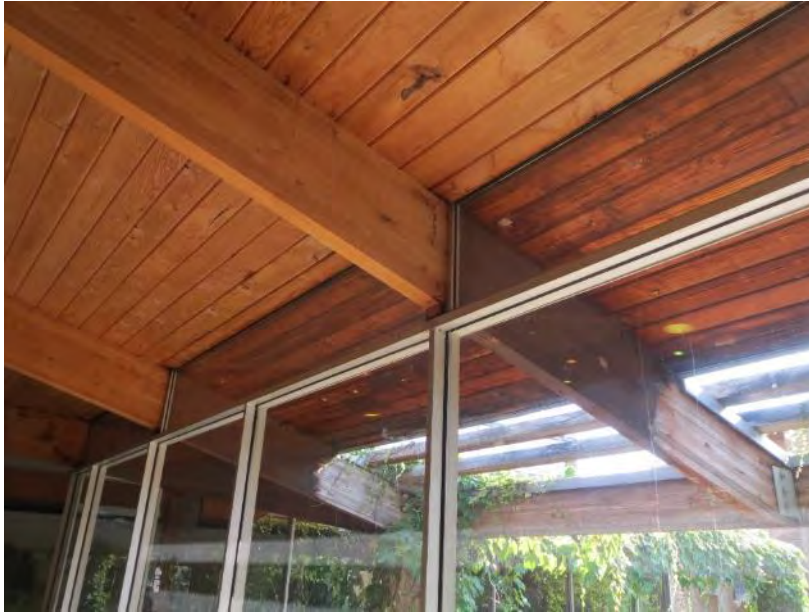
Figure 62. Water staining at underside of wood deck at typical rafters above the window wall

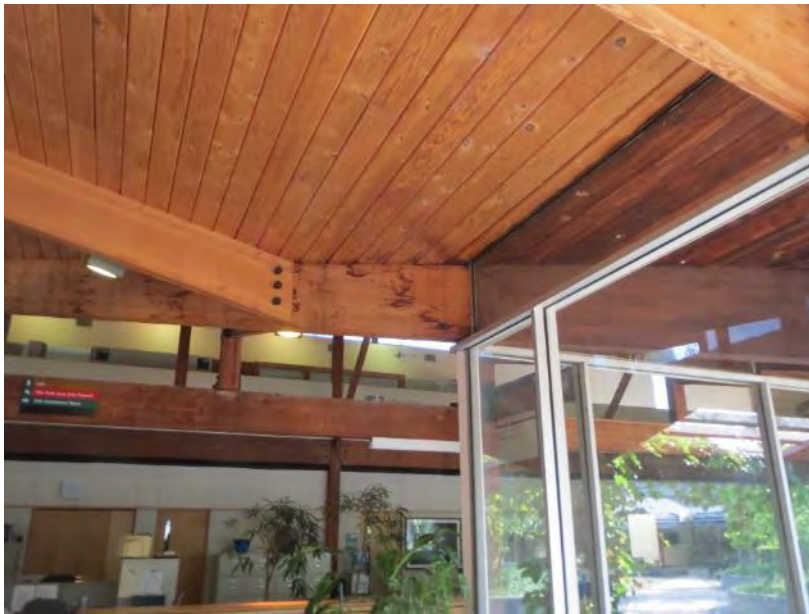
Figure 63. Water staining at the valley member above the window wall. Previous water infiltration has been reported at the valley members.

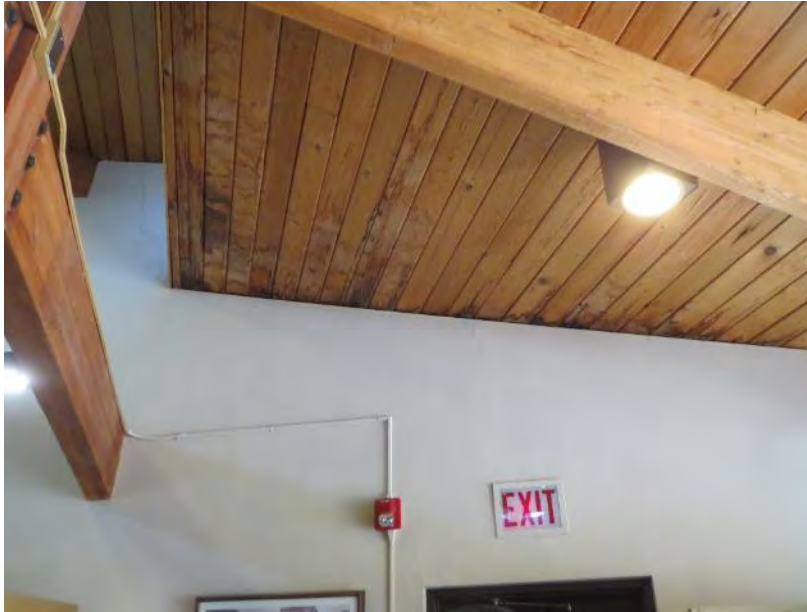
3. Isolated water staining exists at the underside of the wood decking at the interface of the east end wall and the lower roof (Figure 64).
4. Water staining exists at the underside of the wood deck, below the clerestory windows at the west face of the east wing (Figure 65).

Figure 64. Water staining at the wood deck above the drywall at the east wall at the north portion of the building. This is coincident with a location of previous leaks.

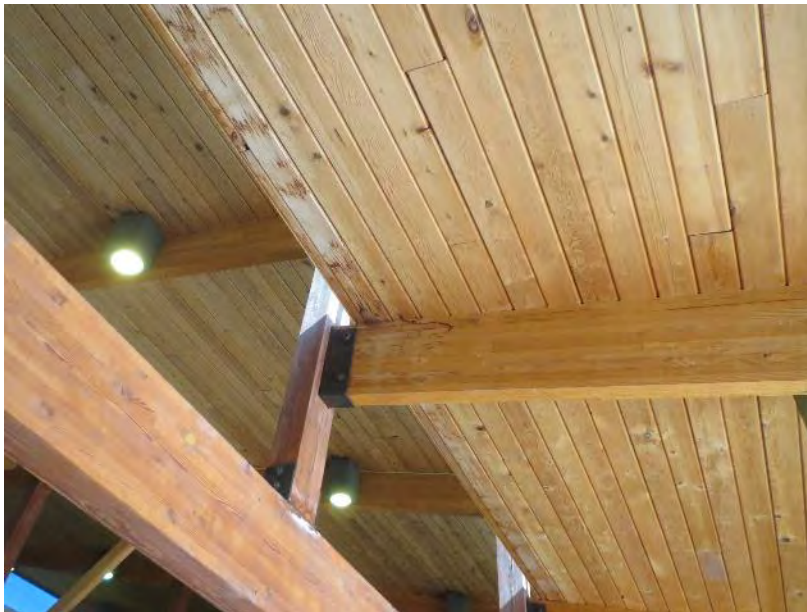
Figure 65. Water staining at the wood decking under the clerestory windows at the east side of the plaza

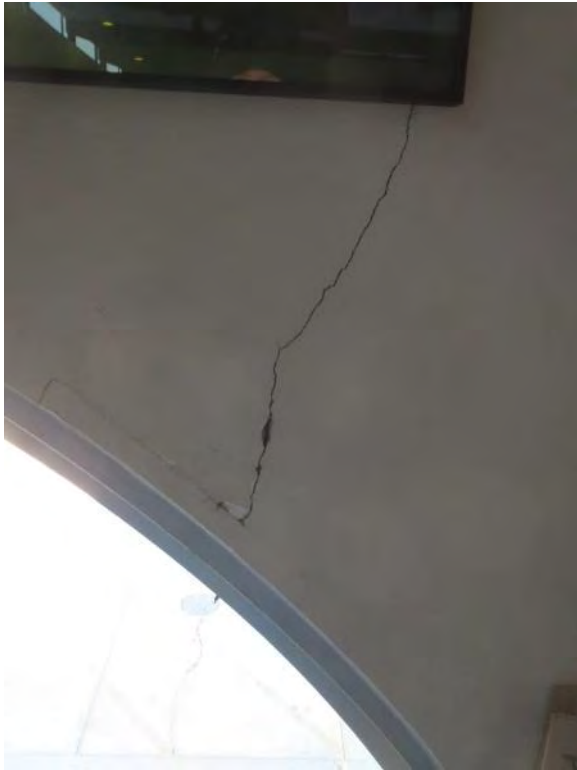
5. There is cracked drywall adjacent to the clerestory windows at the east end wall of the north facade (Figure 66).
6. Water staining exists on the underside of the wood decking below the flat roof area on the south facade and at the interface of the canopy edge (Figure 67).

Figure 66. Cracked drywall finishes at the southwest corner of the building

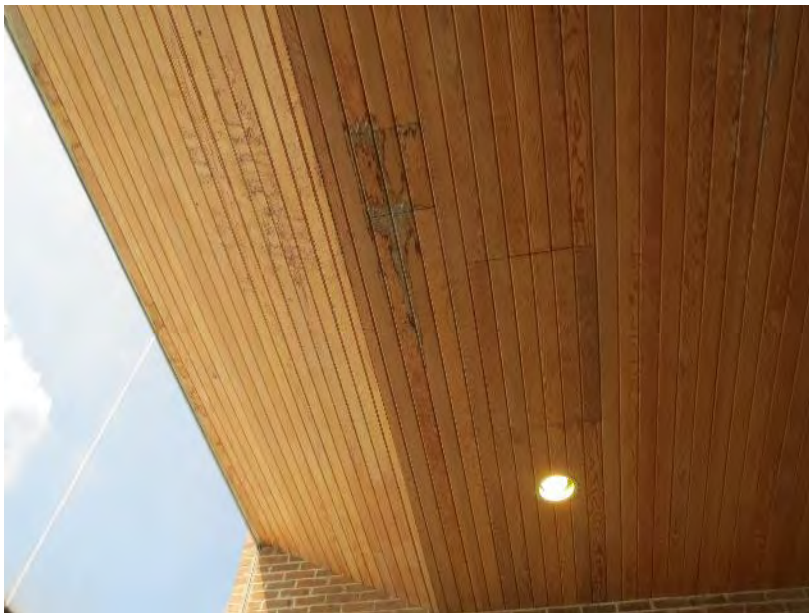
Figure 67. Water staining at the underside of wood decking below the flat roof portion of the building above the south entrance

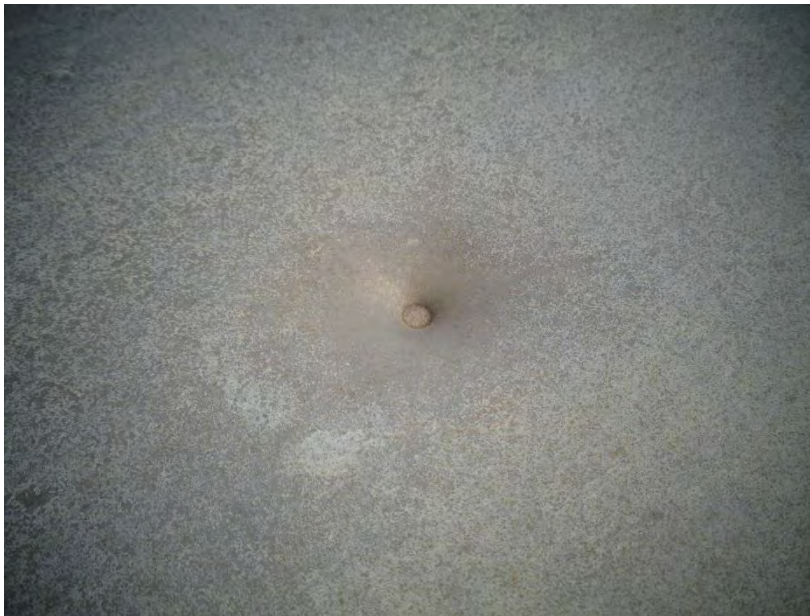
Figure 75. Typical impact damage at sheet metal roofing

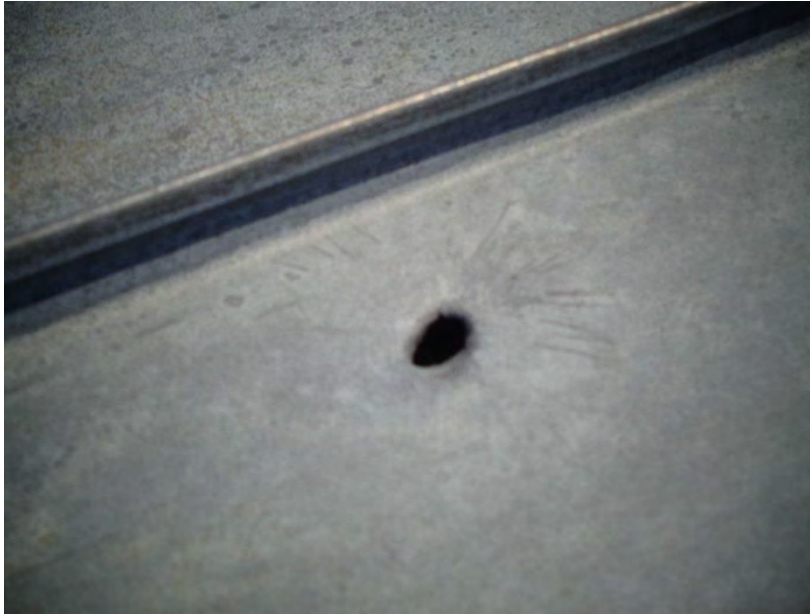
Figure 76. Small hole (approximately 1/2 inch) diameter at the west portion of the sheet metal roofing

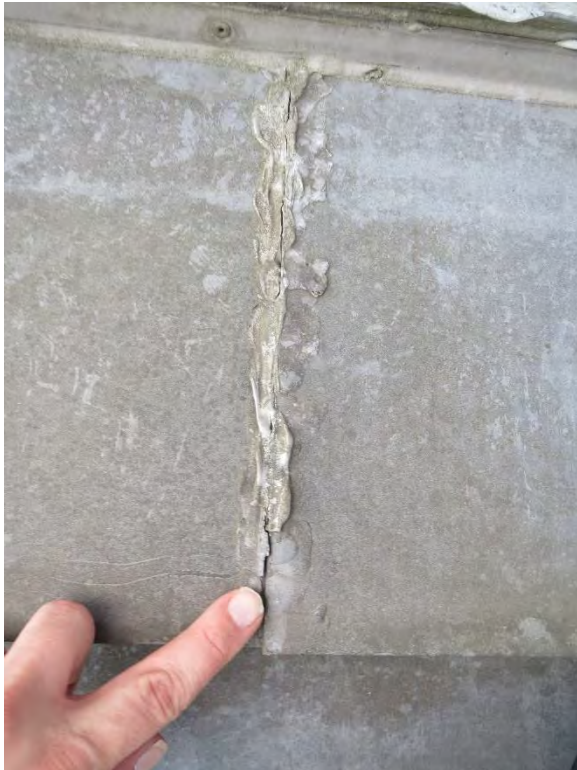
1. At the top of the lower roof level, the top ends of the standing seam panels are covered by roof-to-wall style sheet metal flashings. The flashings are riveted to the clerestory window frames and include a pocket for sealant (Figure 85). The sealant is typically crazed. The flashings lock into Z-shaped closures soldered to the standing seam panels. The roof-to-wall closure flashings were lapped and soldered. Many of the solder seams in the flashings are split. Some of the joints have been previously repaired with sealant, but in many instances the sealant is also split (Figure 86).

Figure 86. Cracked/split solder seam at roof-to-wall flashing which has been previously sealed

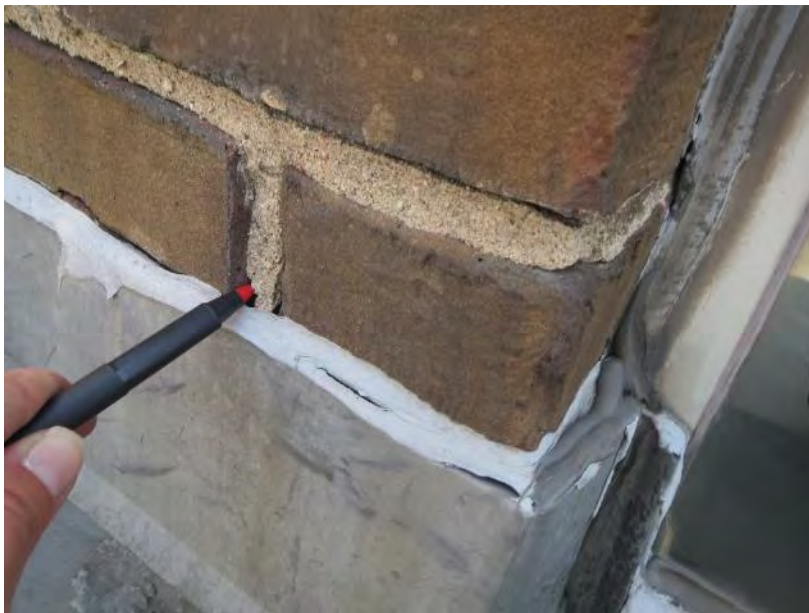
Figure 87. Debonded, crazed and split sealant at the roof counterflashing at the base of the masonry pier
