OAK PARK VILLAGE HALL Property Condition Assessment

Oak Park, Illinois 60304

Final Report

November 9, 2015

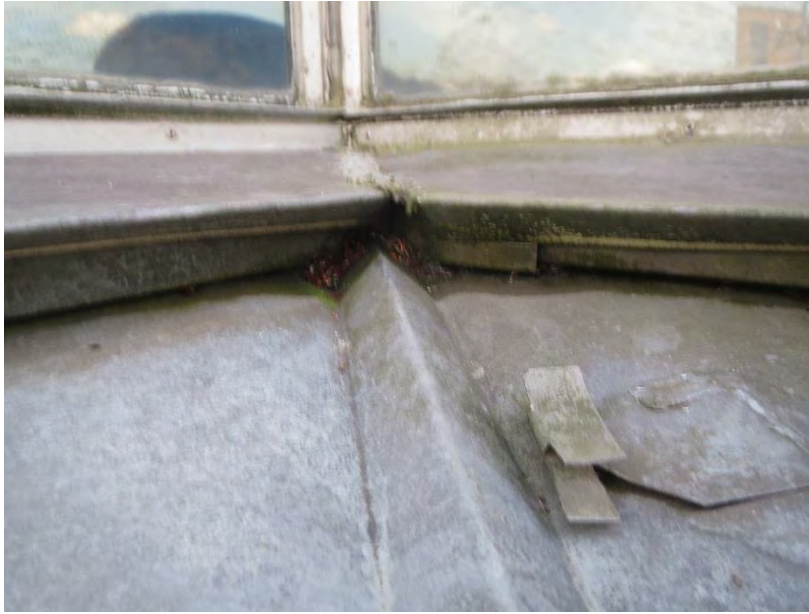
3. Water and debris were typically observed under the roof-to-wall closer at the top of the valleys (Figure 88).
4. The ends of the valleys extend into sheet metal pans to carry the runoff water past the wood trellis (Figure 89). The standing seam panels are slit around the perimeter of the pan. The solder over these slits is typically cracked (Figure 90).

Figure 88. Water and debris were typically observed under the roof-to-wall closer at the top of the valleys

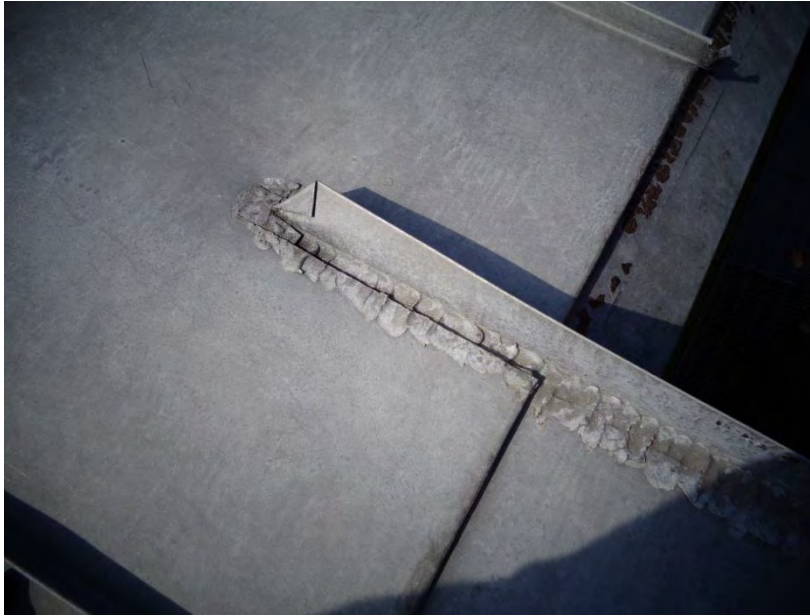
Figure 90. Soldered slits in standing seam panels around the pans at the ends of the valleys are typically cracked

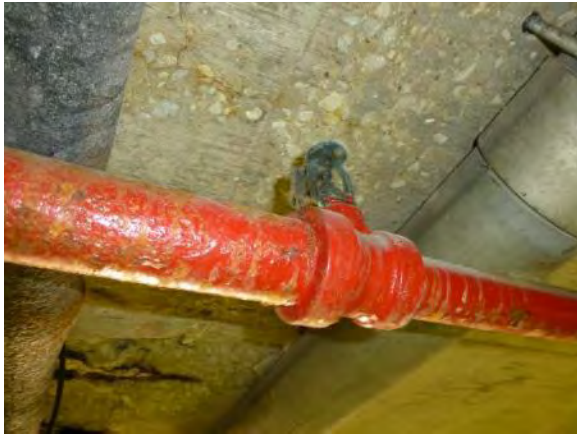
Figure 124. Sprinkler and piping with corrosion in south garage dry-pipe sprinkler system

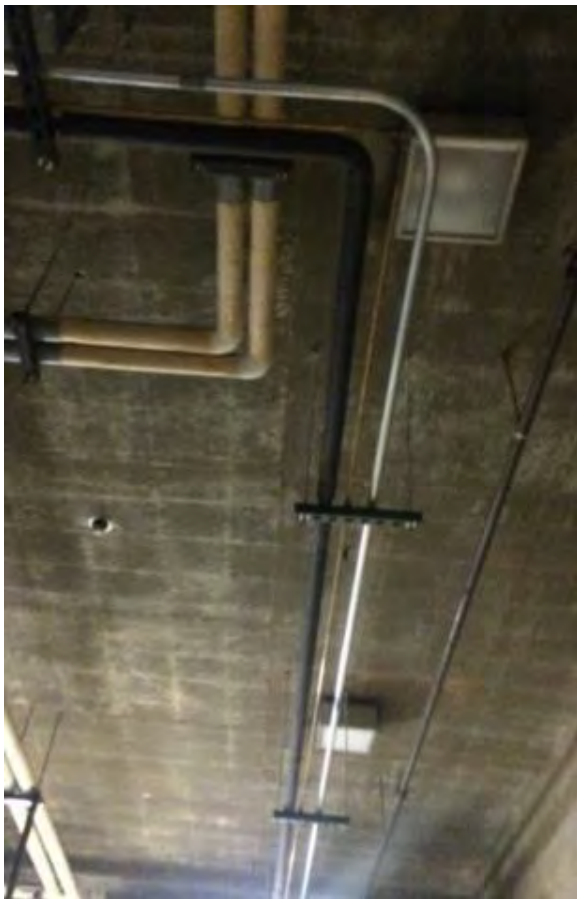
Figure 132. Motorcycle storage lighting (not functioning)

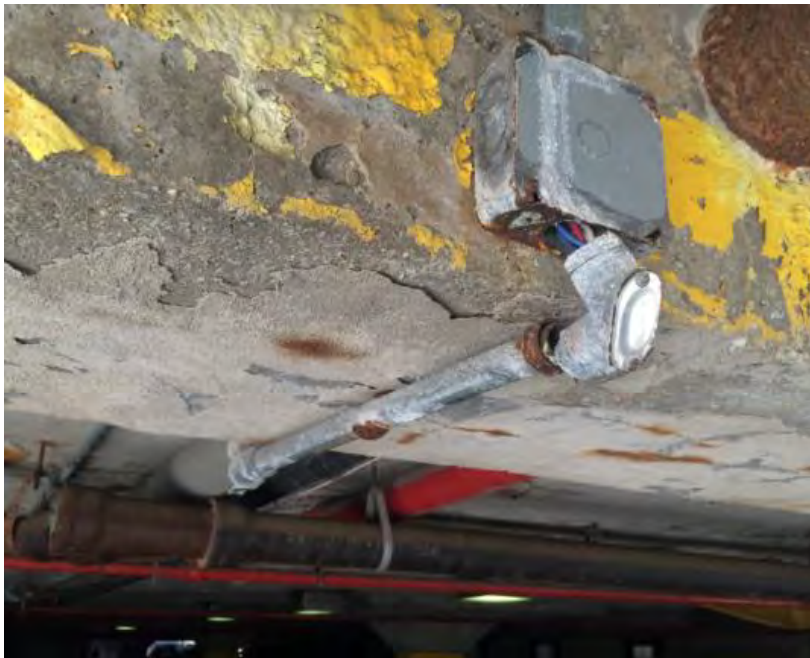
Figure 134. Underground parking structure lighting conduits (damaged)

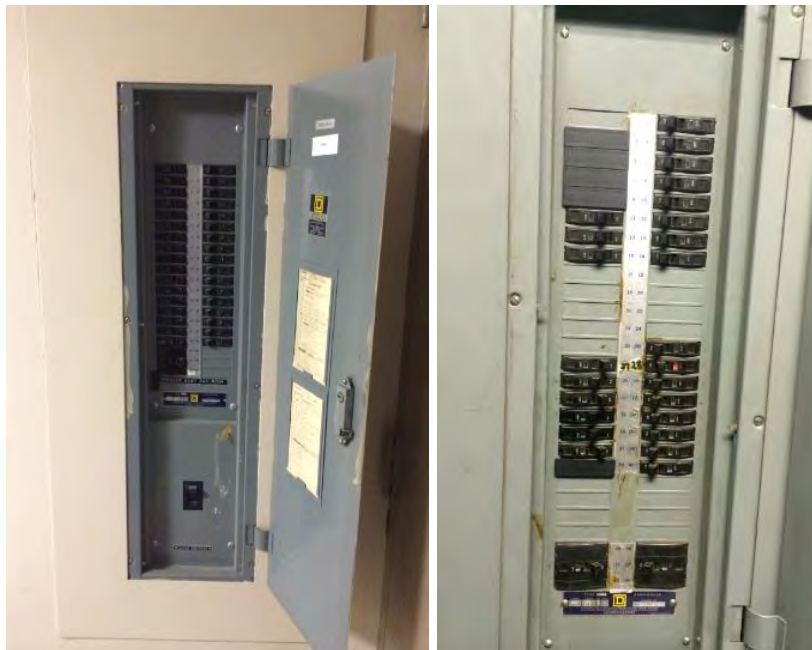
Figure 136. Branch panel boards (reaching limit of serviceable lifetime)

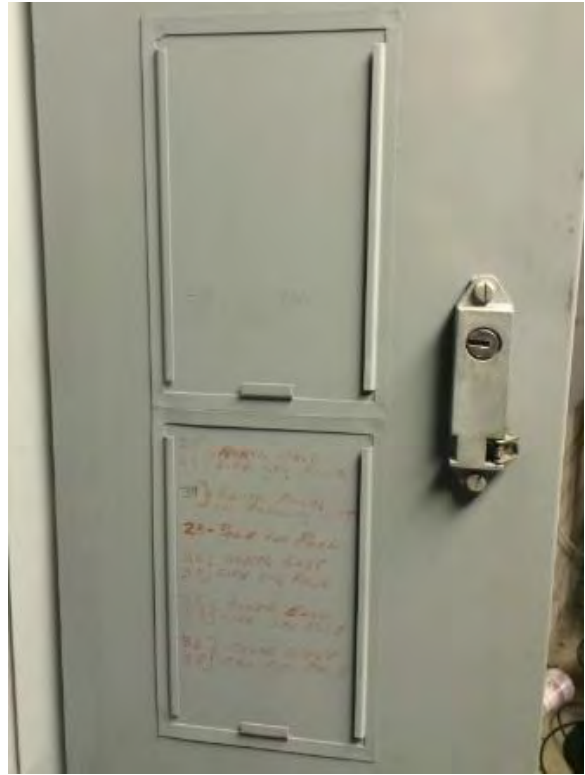
Figure 138. Panel schedules missing

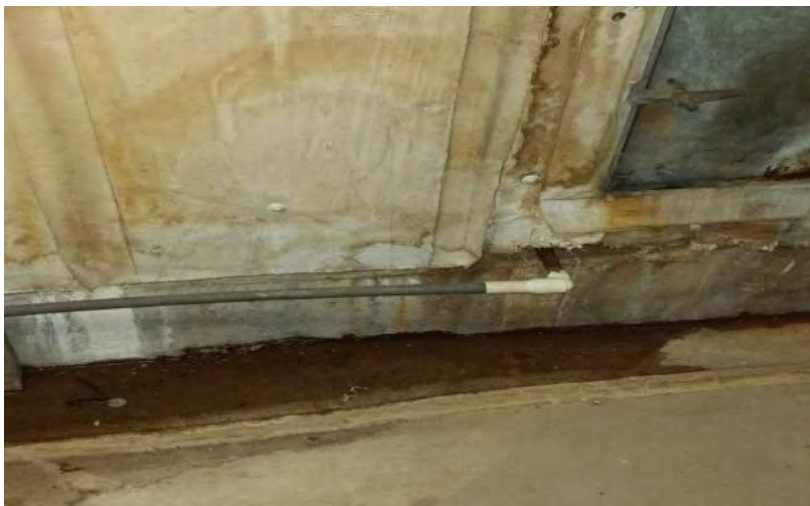
Figure 139. S-1 chilled water coil section and condensate drain (untrapped)

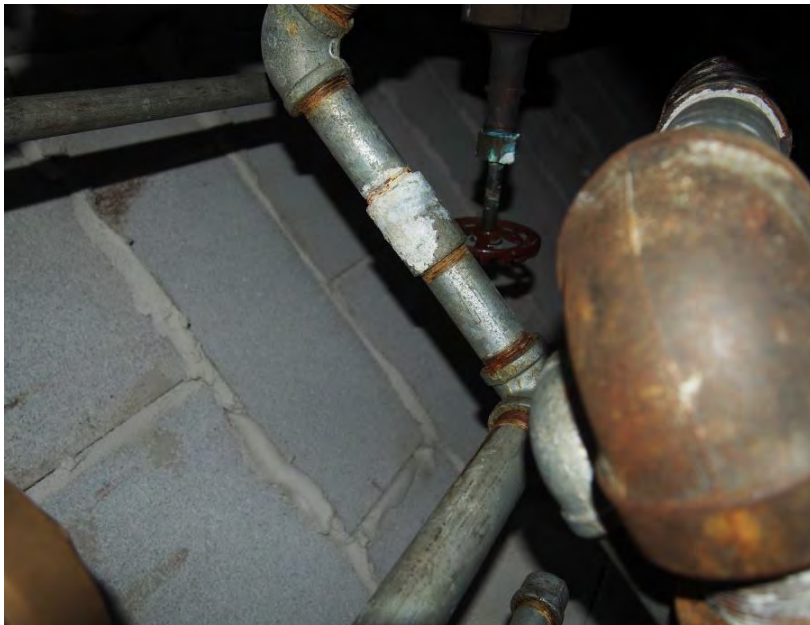
Figure 148. Pipe corrosion

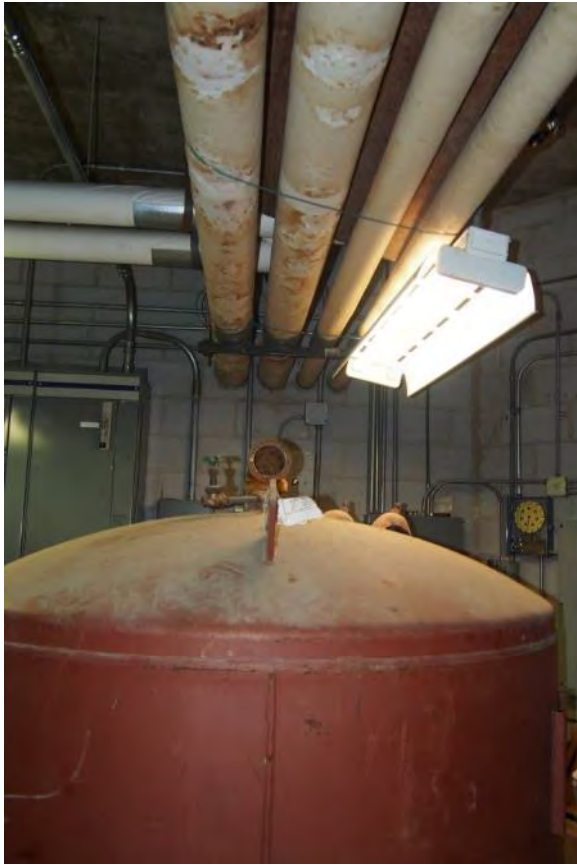
Figure 149. Pipe corrosion and deterioration of insulation

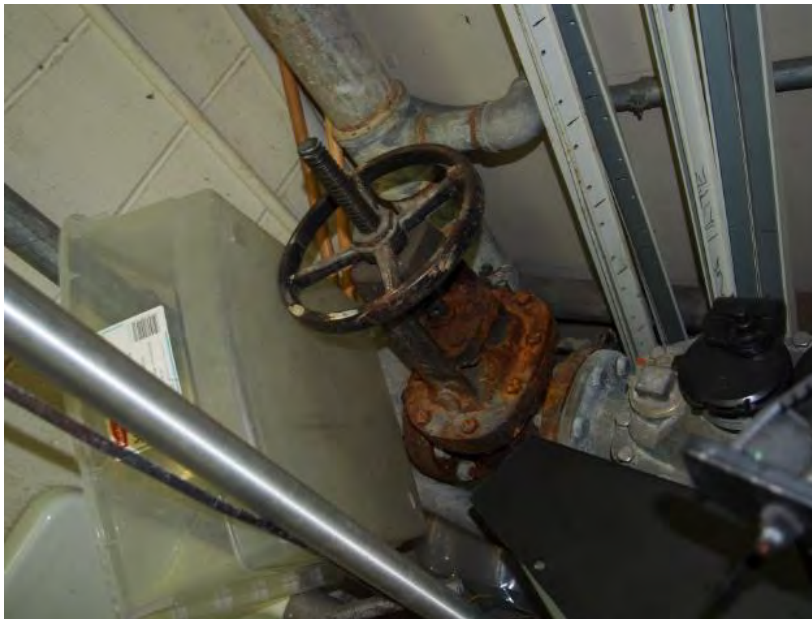
Figure 150. Pipe corrosion at incoming service

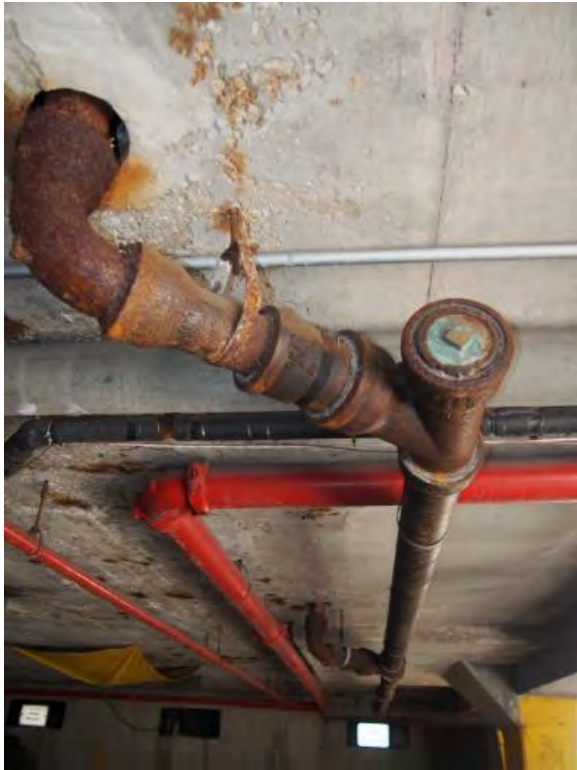
Figure 151. Corrosion of waste piping at garage ceiling
