## OAK PARK POLICE DEPARTMENT

SPACE NEEDS ASSESSMENT

August 30, 2019  
FGM # 19-2639.01

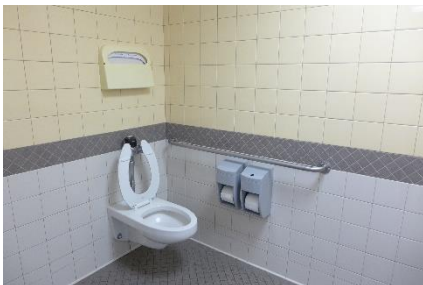
*Non-compliant ADA grab bars***Accessibility**

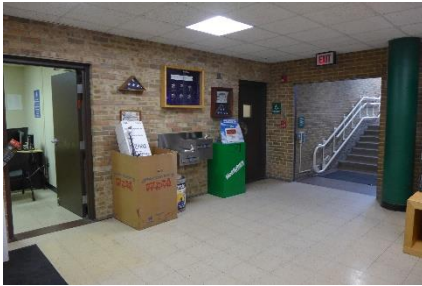
Missing fire doors at stairway

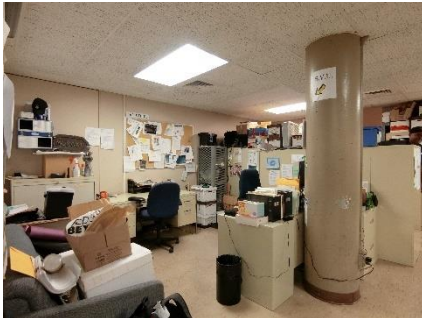
*Cords dropped over furniture within Investigation Department*

- Due to age of building there is a lack of electrical and data outlets, cords are draped over furniture and across cabinets throughout the building.
- Within the Administration Department extension cords are lying across walkways creating a tripping hazard.
- Within the lobby conference room, temporary partition walls have been added to the west and south walls creating mechanical and electrical closets. These closets lack the required signage and fire ratings.
- A mechanical closet is located within the Crime Analyst's Office. This equipment should be accessible from the main corridor and not require access through a private office.
- Files and boxes being stored within 24" of ceiling
- Lighting levels within the Building Maintenance Department are too low.
- There is no free exit from the Mechanical Room. This door requires free egress.

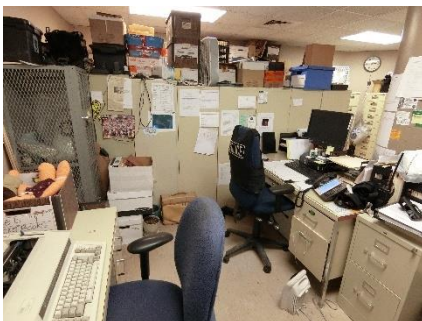
*Boxes being stored too close to the ceiling*

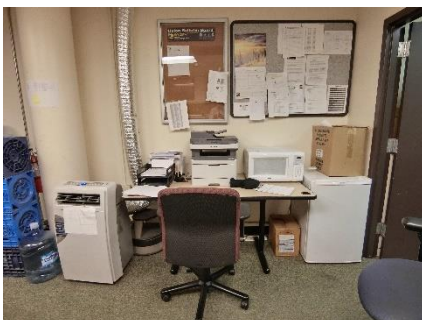
Air conditioner overloading the circuit

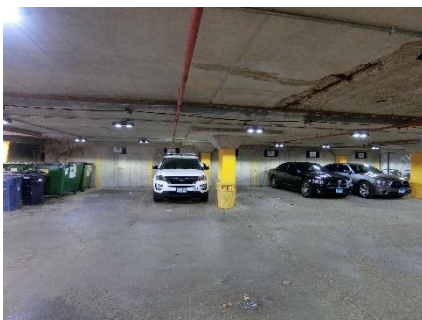
*Spalled concrete within parking garage*

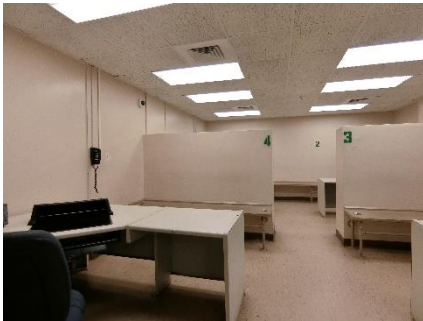
- The prisoner processing area is not secure and is remote from booking.
- The security glazing on the lock-up cell is damaged and cloudy making it difficult to monitor prisoners within.
- There is a water leak above the report room as witnessed by damaged ceiling tiles.

*Unsecured prisoner processing area*

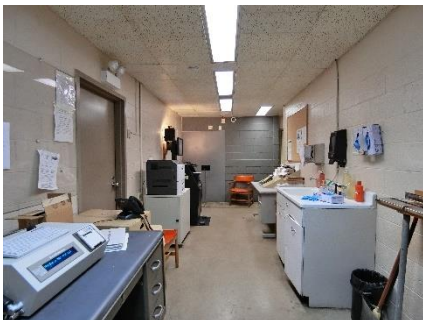
*Insufficient space within Booking Area*

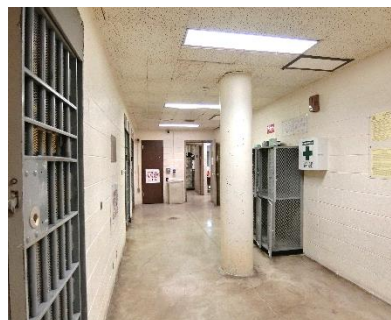
*Damaged ceiling tiles within detention area*

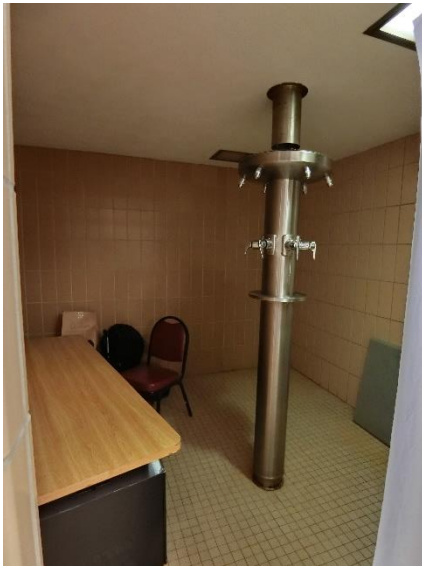
*Women's Shower being used for storage*

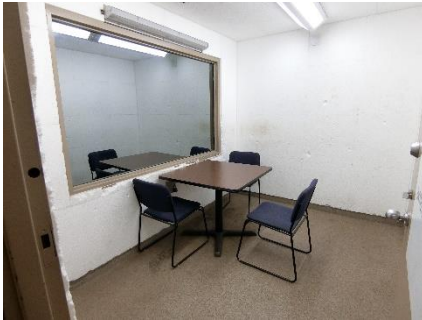
*Damaged acoustical walls within interview rooms*

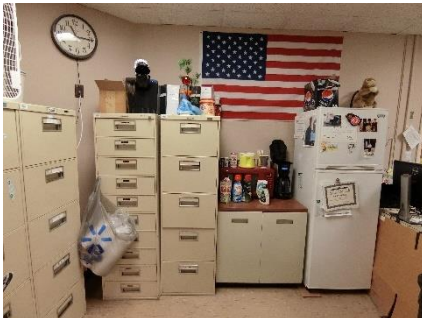
*Lack of storage and break areas*

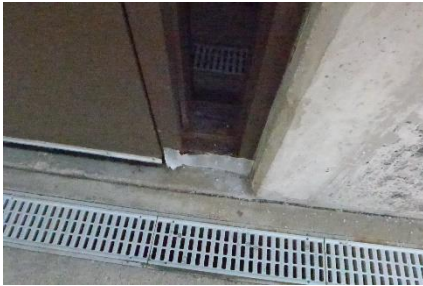
*Steel door frame is corroding*

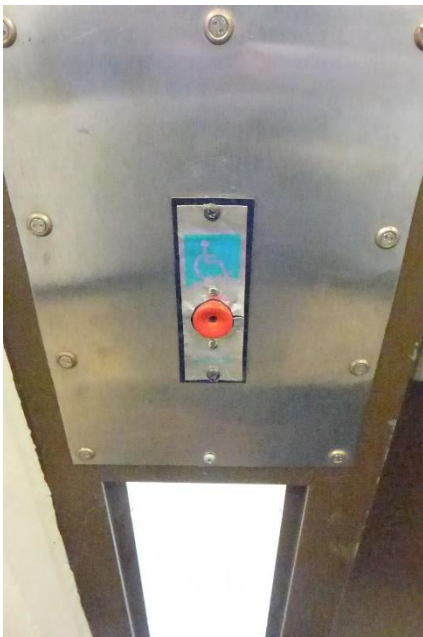
- The exterior elevator buttons are damaged.
- The elevator serving the police station is not designed for gurneys (stretcher size). While not a code requirement in Oak Park, a stretcher size elevator is recommended as they are safer for emergency response staff for moving the injured or sick and allow a person on a gurney to be moved without unnecessary trauma, for example, being shaken when carried up a stairway.

*Damaged buttons at elevator*

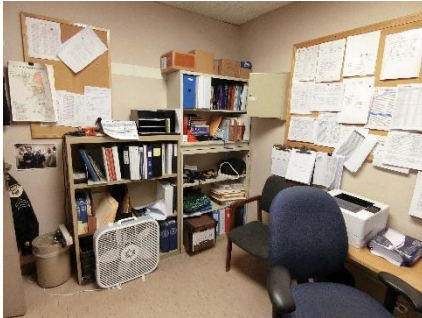
3. The mechanical systems have had some major equipment upgrades, but the overall design of the system is not energy efficient by today's standards. It was noted that several parts of the Police Department were noticeably devoid of air movement resulting in uncomfortable spaces. This is a common issue within basement spaces. Without external cooling or heat gain sources, such as exterior walls in winter, or windows in summer, the spaces tend to be neutral in temperature and there is little need for the HVAC system to heat or cool. Therefore, the ventilation system does not operate, and the air becomes stagnant. Modern systems maintain a fixed amount of air circulation regardless of heating or cooling need and provide air movement without the use of space mounted oscillating fans.

*Supplemental fans  
located throughout  
building to help circulate air*

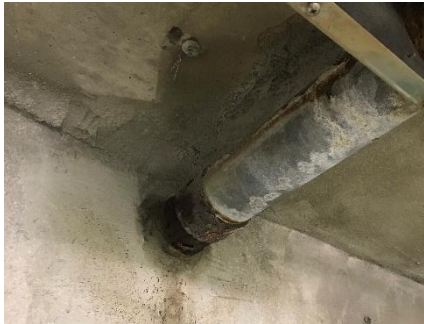
*Repaired conduit within garage*

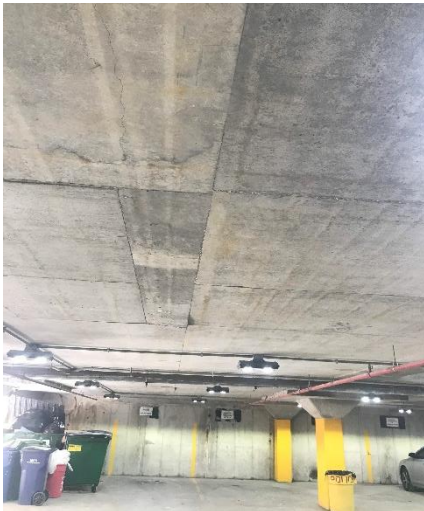
*Repaired concrete deck at garage*

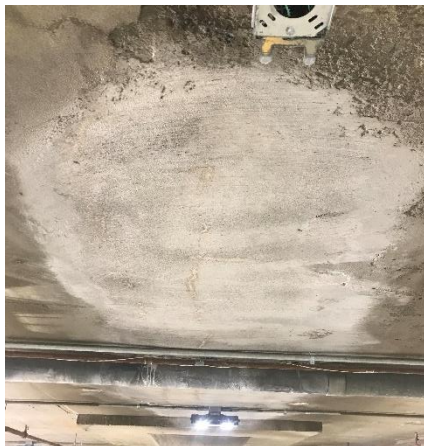
*Area of patched concrete deck at garage*

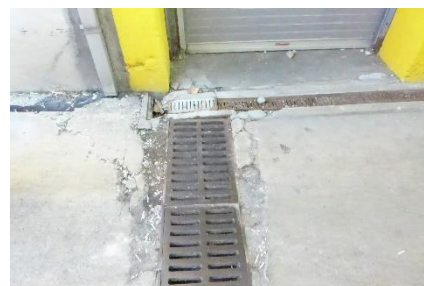
*Broken concrete at trench drain***Structural Conditions**

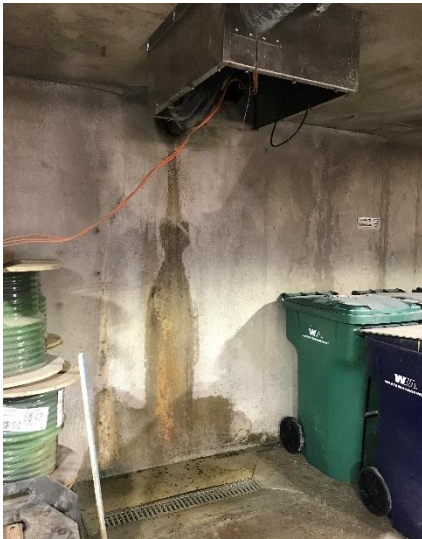
*Water infiltration at pipe penetration*

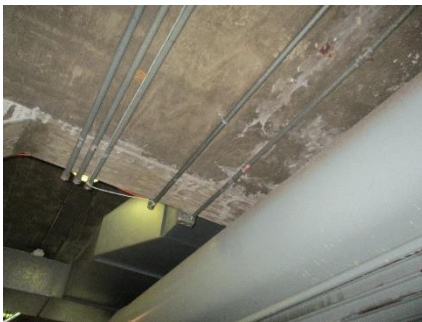
- The floors and ceilings within the sally port are showing signs of damage. There is a large area of efflorescence/moisture visible in the concrete ceiling slab. The concrete slab near the floor drain is cracking and spalling
- Two of the walls within the sally port are lined with storage units creating a dangerous situation when moving prisoners in and out. Some of the storage units hold evidence and hazardous materials that should not in the same area as prisoners.
- The east section of the sally port is caged off for evidence storage. Evidence should not be stored within the unconditioned space of the sally port as it can be subjected to water damage and is not thermally protected.
- There is a lack of security vestibules at all the exits.
- There is no secure separation between the mechanical spaces to the west and the sally port.

*Efflorescence in hall at Sally port*

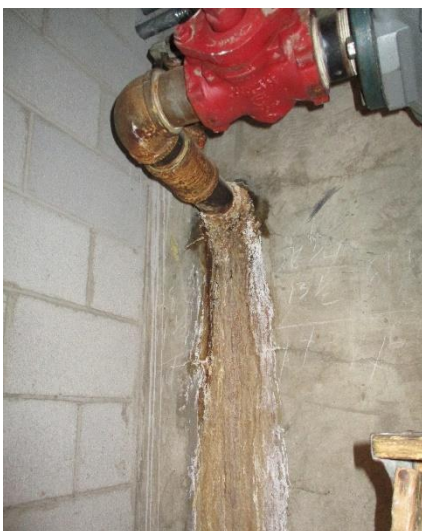
Within the building basement area utilized by the Police Department, the extent of visible structural concrete was limited. The areas with accessible concrete include building maintenance, storage, the sally port, the firing range, and the mechanical and generator rooms. Overall, the structure in these areas was in good condition. There is a small area of efflorescence visible in the slab above the sally port and a pipe penetration in the HVAC mechanical room shows significant leakage of ground water.

*Water infiltration and corrosion  
at pipe in mechanical room*
