**OAK PARK VILLAGE HALL
123 Madison Street, Oak Park IL. 60302**

**PROPERTY CONDITION ASSESSMENT REPORT
07.08.23**

Property Condition Assessment Report

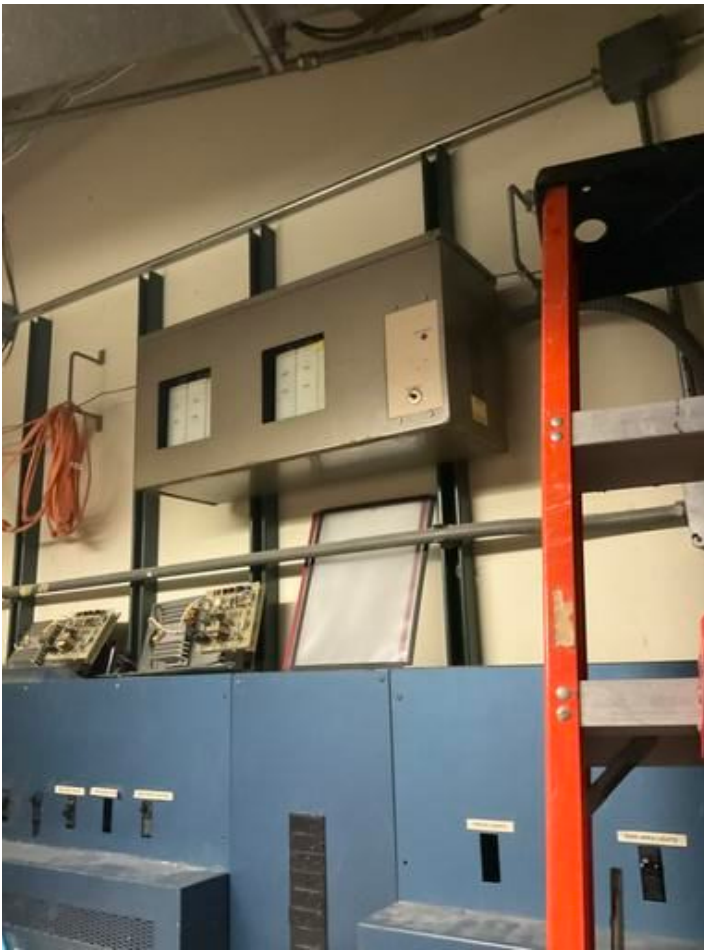
[20230608_101544_photo](#)

Description	Blocked electrical panels.
Assigned to	—
Created by	Gabriel David (Cordogan Clark)
Created on	Jun 21, 2023
Location	Village Hall - First Floor
Location details	—
Due date	—
Start date	—
Placement	05 (Village Hall - First Floor Plan)
Root cause	—

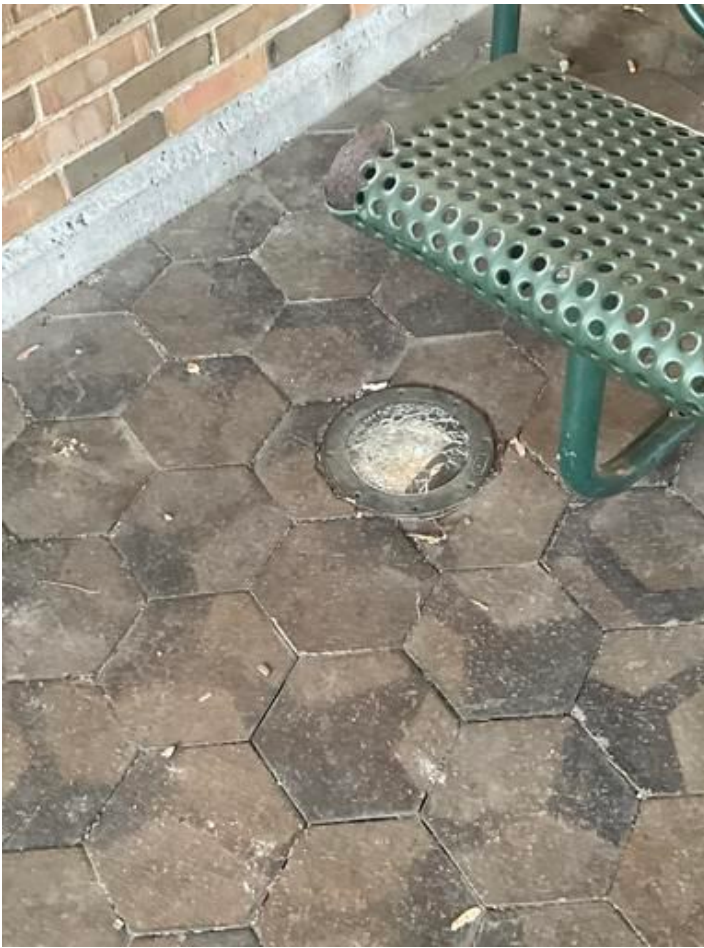
[20230608_155459043_iOS](#)

3. Lighting: Exterior – Fixtures: The lighting fixtures are in fair condition. There is moisture buildup and cracked glass within the circular up-lights in the area below the Council Chambers. (Issue #360).

Description	Overall image of exterior uplights below Council Chamber. Note moisture build up and cracked glass.
Assigned to	—
Created by	Gabriel David (Cordogan Clark)
Created on	Jun 30, 2023
Location	Village Hall - First Floor
Location details	—
Due date	—
Start date	—
Placement	05 (Village Hall - First Floor Plan)
Root cause	—

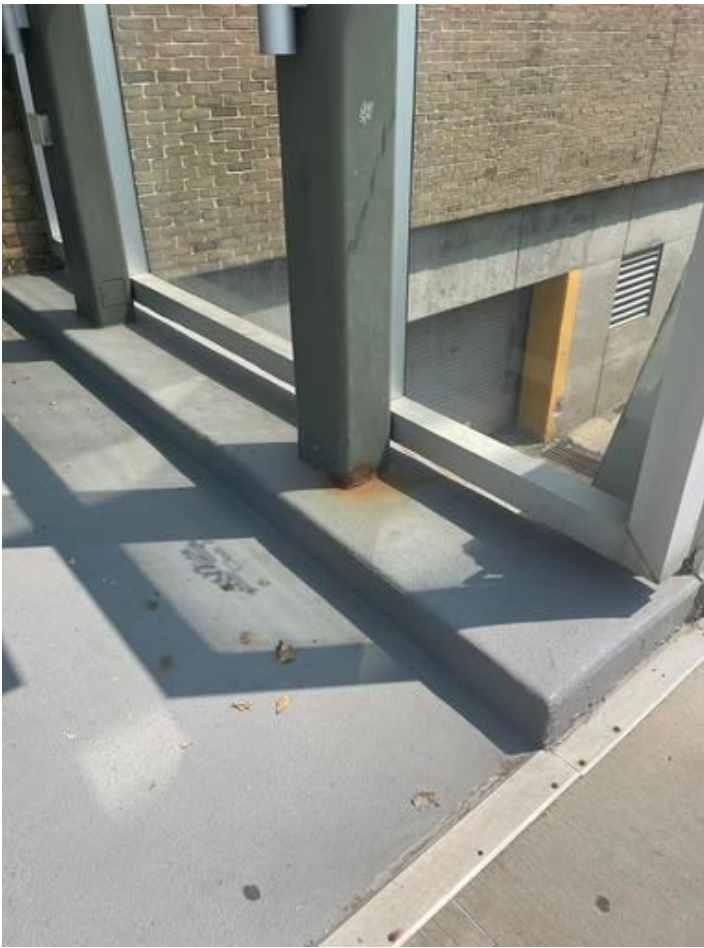
[IMG_3630](#)

1. Southern Canopy Structure – Steel: Metal canopy column at the Southern main entrance has corrosion. (Issue #137).
2. Courtyard Concrete/Railing – Concrete: There is a cracked concrete slab supporting a metal guardrail in the courtyard. The guardrail is very loose and can sway 4-5" when slight force is applied. Concrete columns below guardrail also have exposed rebar. There is exposed rebar in an exterior column in the courtyard. There is exposed rebar in a half wall in front of northeast courtyard stairs. (Issue #153, #142, #146).

Description	Rusting metal column near main entrance.
Assigned to	—
Created by	Gabriel David (Cordogan Clark)
Created on	Jun 21, 2023
Location	Village Hall - First Floor
Location details	—
Due date	—
Start date	—
Placement	05 (Village Hall - First Floor Plan)
Root cause	—

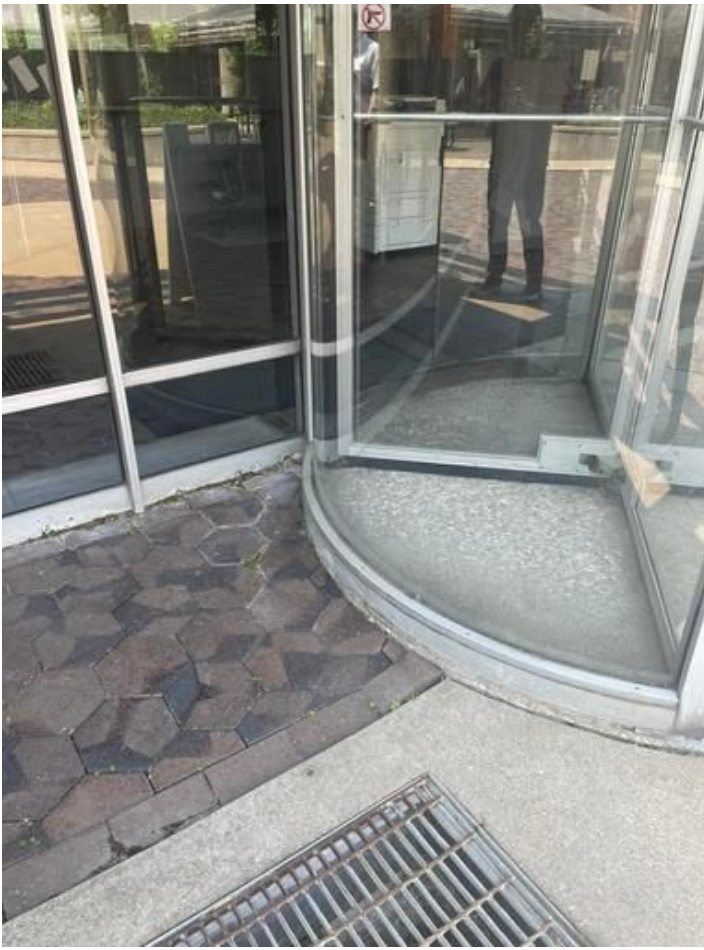
[IMG_3597](#)

Description	Swelling in the concrete next to revolving door entrance. Base of window missing sealant between wall and pavers. Efflorescence and organic growth prevalent.
Assigned to	—
Created by	Gabriel David (Cordogan Clark)
Created on	Jun 21, 2023
Location	Village Hall - First Floor
Location details	—
Due date	—
Start date	—
Placement	05 (Village Hall - First Floor Plan)
Root cause	—

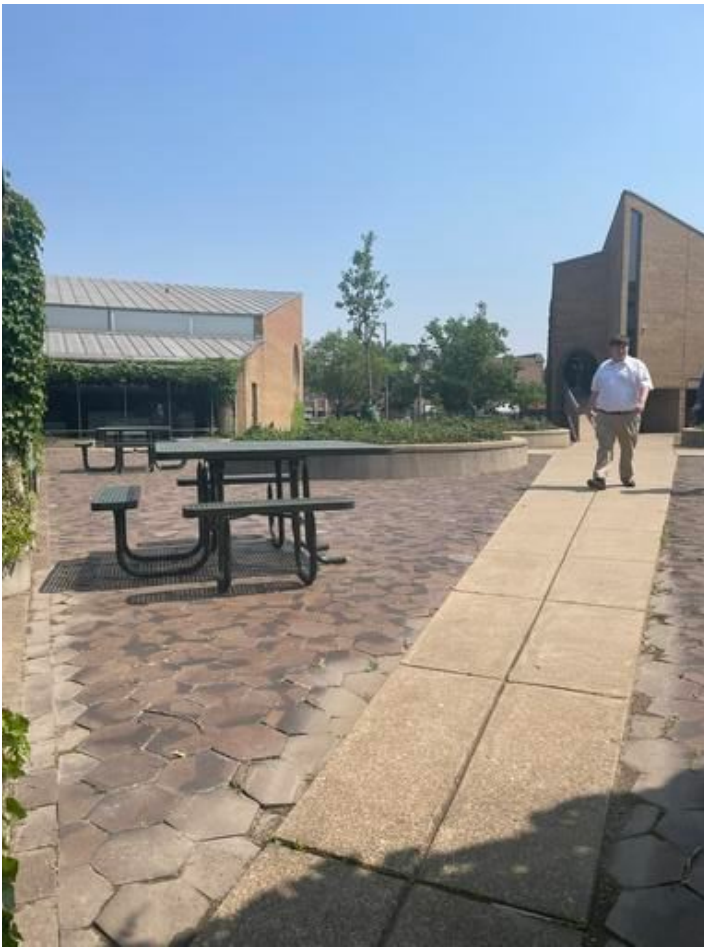
[IMG_3596](#)

Description	Uneven tiling in courtyard.
Assigned to	—
Created by	Gabriel David (Cordogan Clark)
Created on	Jun 21, 2023
Location	Village Hall - First Floor
Location details	—
Due date	—
Start date	—
Placement	05 (Village Hall - First Floor Plan)
Root cause	—

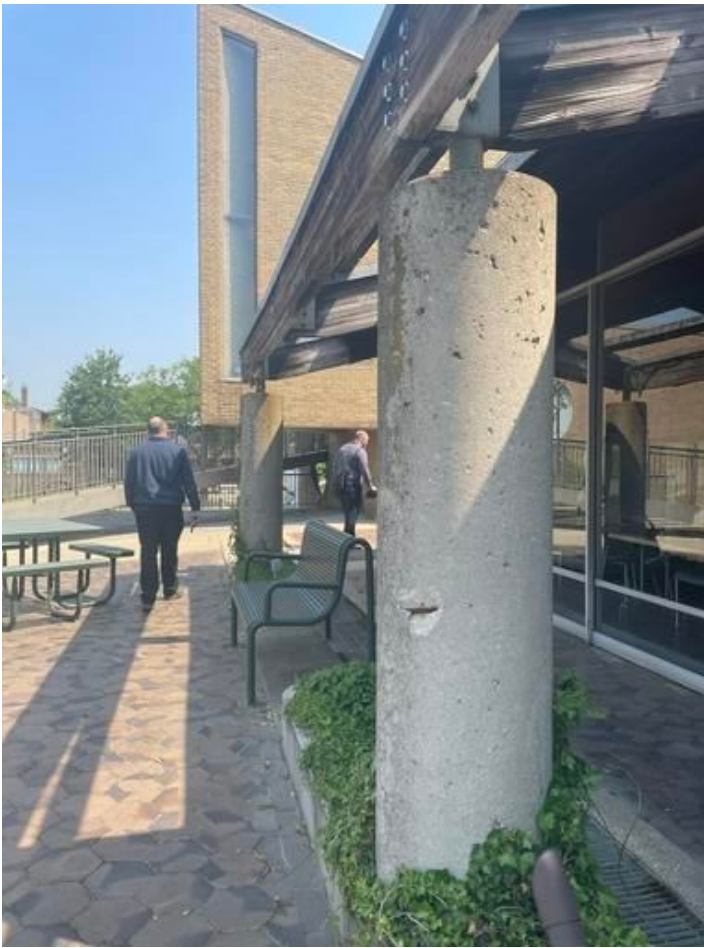
IMG_3601

Description	Exposed rebar in exterior column.
Assigned to	—
Created by	Gabriel David (Cordogan Clark)
Created on	Jun 21, 2023
Location	Village Hall - First Floor
Location details	—
Due date	—
Start date	—
Placement	05 (Village Hall - First Floor Plan)
Root cause	—

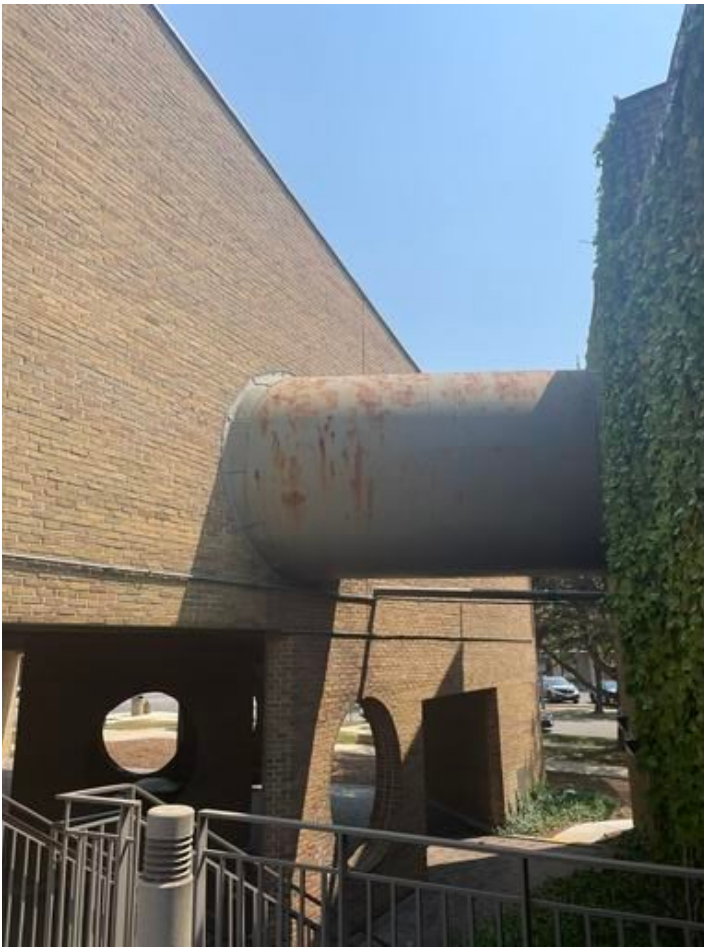
[IMG_3602](#)

5. Council Chamber Connection Tube – Steel: The exterior steel tube passageway connecting the Council Chamber to the main building has surface corrosion. (Issue #144).

Description	Surface corrosion and rusting exterior steel tube passageway.
Assigned to	—
Created by	Gabriel David (Cordogan Clark)
Created on	Jun 21, 2023
Location	Village Hall - First Floor
Location details	—
Due date	—
Start date	—
Placement	05 (Village Hall - First Floor Plan)
Root cause	—

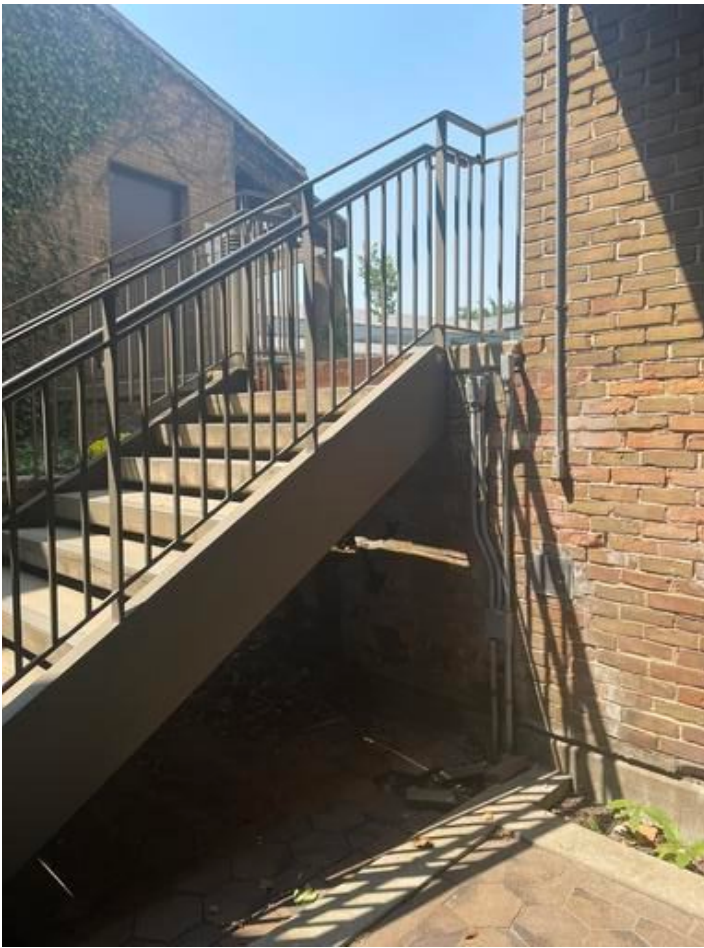
[20230608_105838_photo](#)

Description	Masonry damage underneath exterior stairs. Corrosion at the metal panning at the top of the stairs.
Assigned to	—
Created by	Gabriel David (Cordogan Clark)
Created on	Jun 21, 2023
Location	Village Hall - First Floor
Location details	—
Due date	—
Start date	—
Placement	05 (Village Hall - First Floor Plan)
Root cause	—

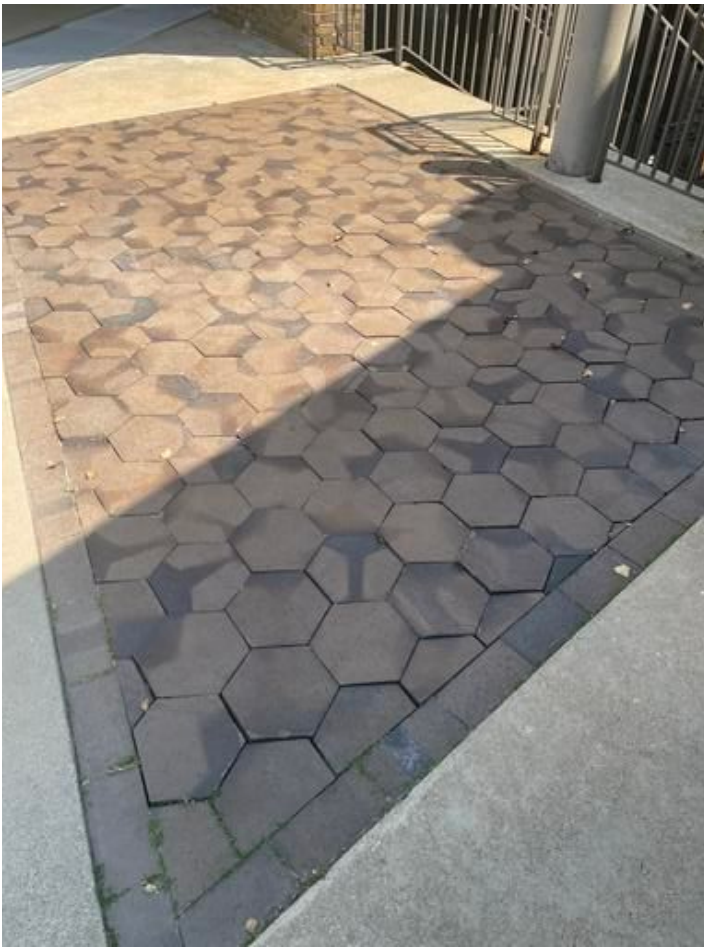
[20230608_105012_photo](#)

Description	Organic growth at the corner and along the edge of the tiled area.
Assigned to	—
Created by	Gabriel David (Cordogan Clark)
Created on	Jun 21, 2023
Location	Village Hall - First Floor
Location details	—
Due date	—
Start date	—
Placement	05 (Village Hall - First Floor Plan)
Root cause	—

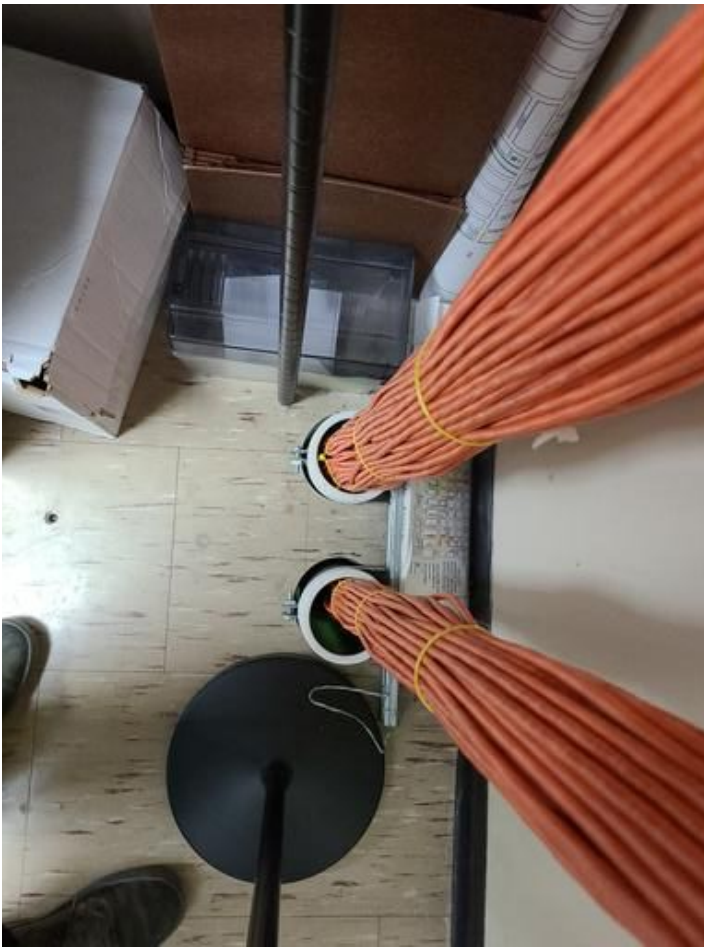
[20230608_145551_photo](#)

Description	Cable penetrations not sealed.
Assigned to	—
Created by	Gabriel David (Cordogan Clark)
Created on	Jun 21, 2023
Location	Village Hall - First Floor
Location details	—
Due date	—
Start date	—
Placement	05 (Village Hall - First Floor Plan)
Root cause	—

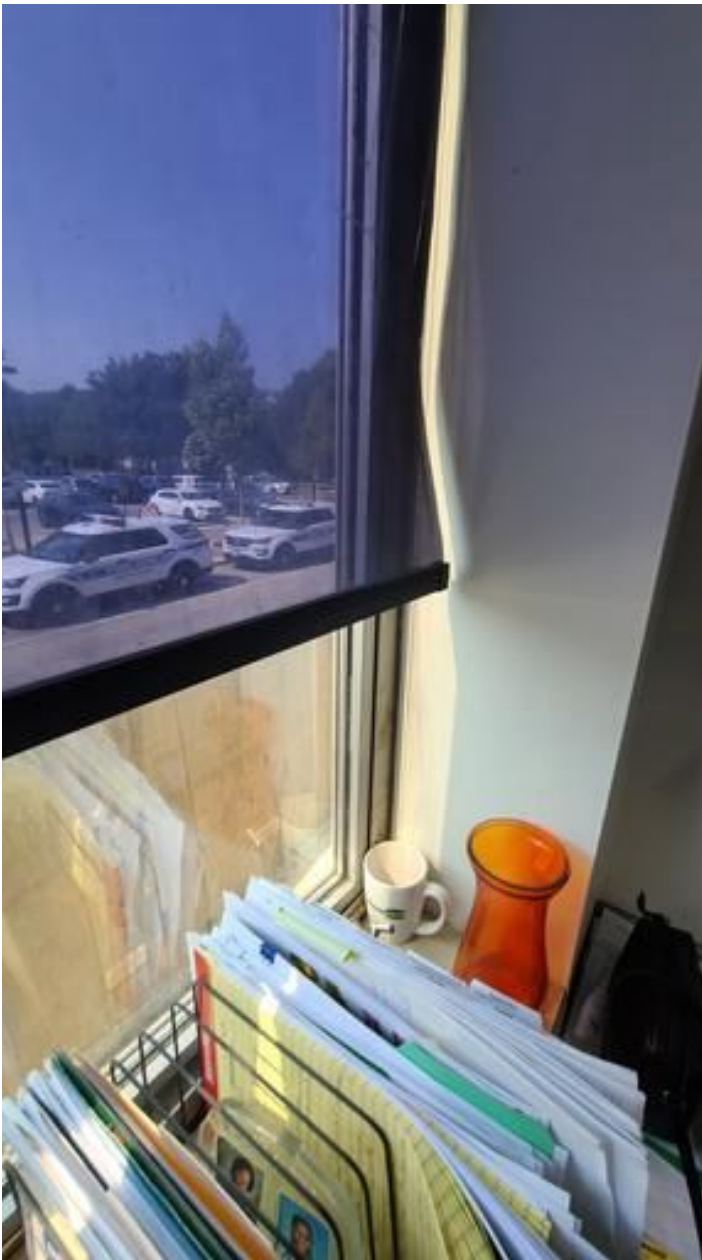
[20230608_095806](#)

Description	Images of window in Adjudication Office. Note corrosion on the frame.
Assigned to	—
Created by	Gabriel David (Cordogan Clark)
Created on	Jun 26, 2023
Location	Village Hall - First Floor
Location details	—
Due date	—
Start date	—
Placement	05 (Village Hall - First Floor Plan)
Root cause	—

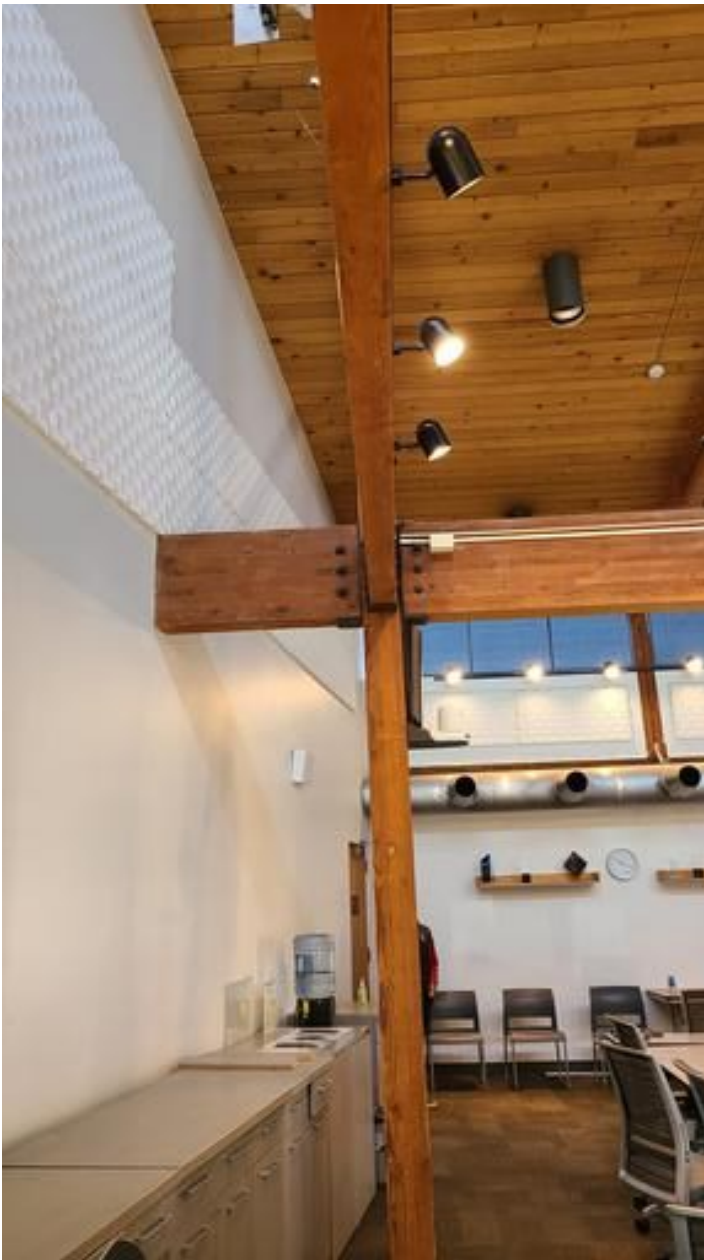
[20230608_101607](#)

Description	Wood supports warping slightly.
Assigned to	—
Created by	Gabriel David (Cordogan Clark)
Created on	Jun 26, 2023
Location	Village Hall - First Floor
Location details	—
Due date	—
Start date	—
Placement	05 (Village Hall - First Floor Plan)
Root cause	—

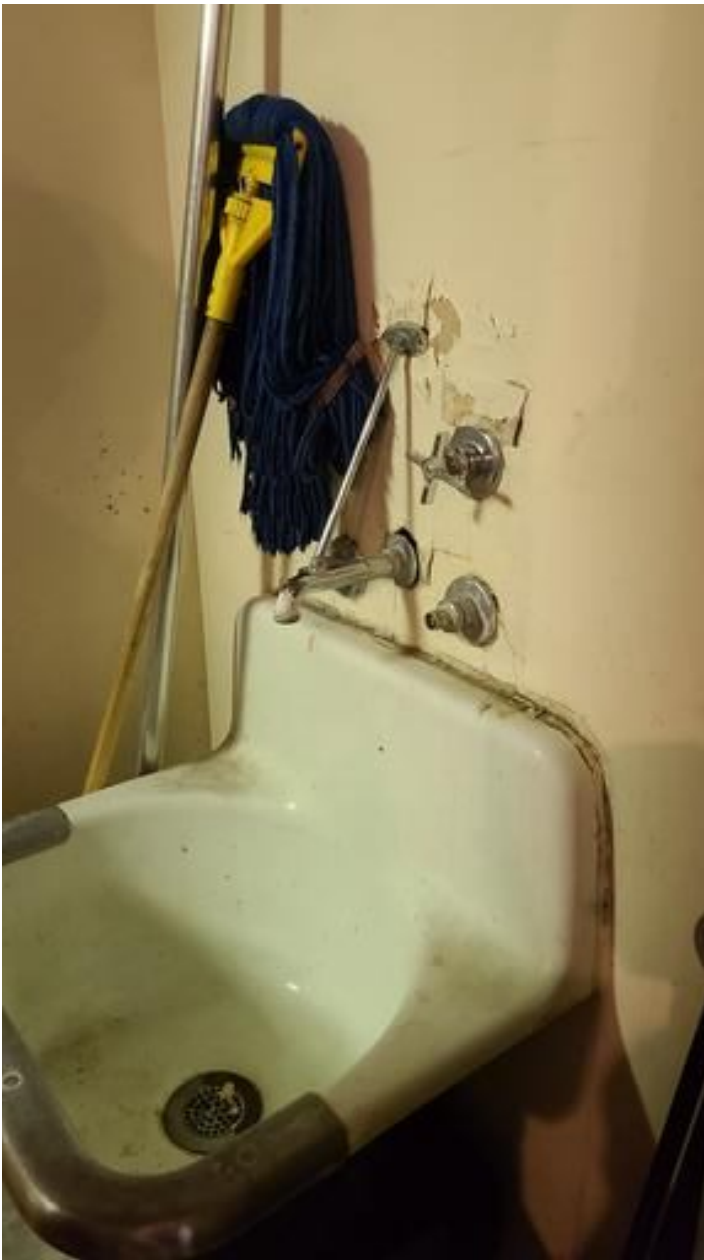
[20230608_101730](#)

4. Wall Finish – Paint: The interior paint finish is in fair condition. There is paint cracking and peeling above and around the sink, near the Conference Room. (Issue #263).

Description	Wall paint cracking and peeling above and around sink.
Assigned to	—
Created by	Gabriel David (Cordogan Clark)
Created on	Jun 26, 2023
Location	Village Hall - First Floor
Location details	—
Due date	—
Start date	—
Placement	05 (Village Hall - First Floor Plan)
Root cause	—

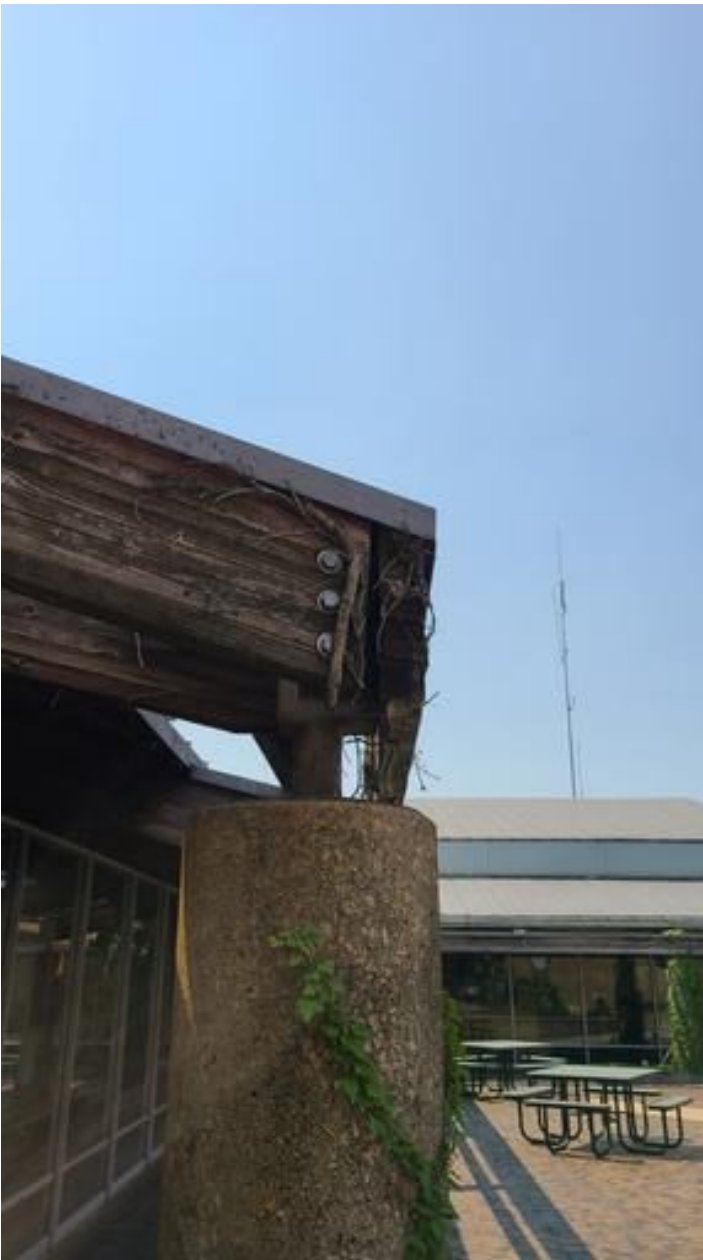
[20230608_104857](#)

Description	Ivy growth at support connections.
Assigned to	—
Created by	Gabriel David (Cordogan Clark)
Created on	Jun 26, 2023
Location	Village Hall - First Floor
Location details	—
Due date	—
Start date	—
Placement	05 (Village Hall - First Floor Plan)
Root cause	—

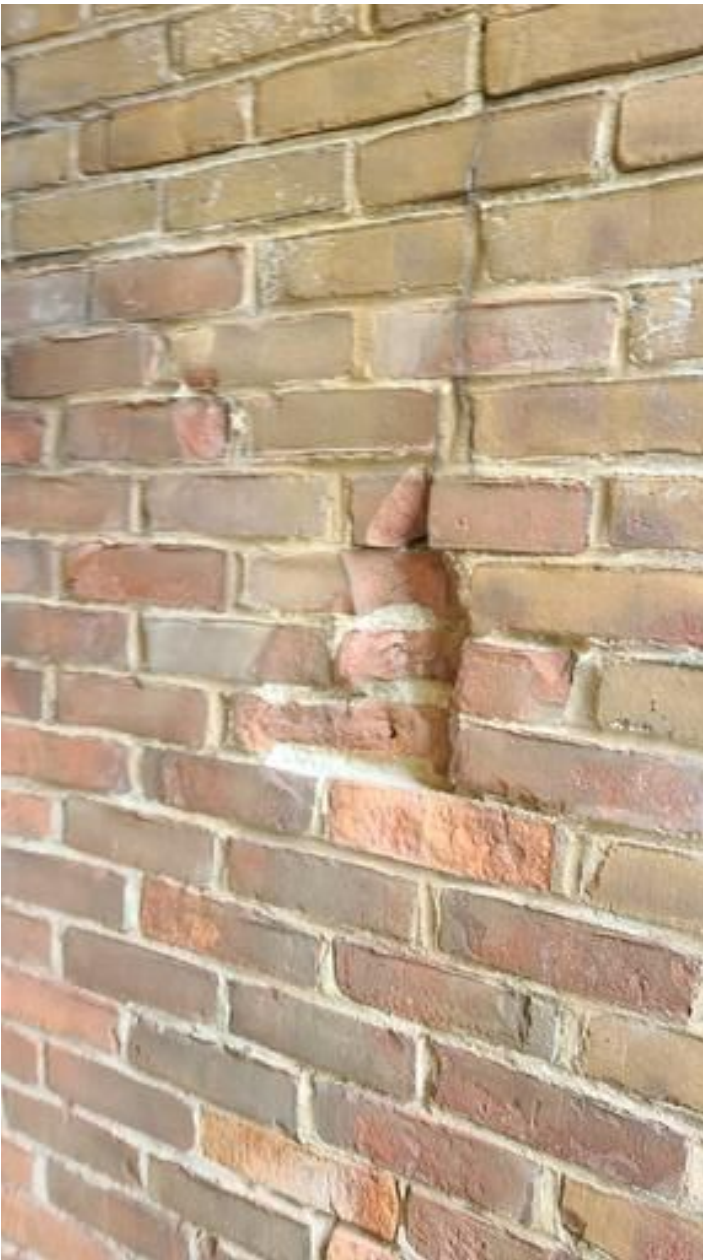
[20230608_105703](#)

Description	Damaged masonry.
Assigned to	—
Created by	Gabriel David (Cordogan Clark)
Created on	Jun 26, 2023
Location	Village Hall - First Floor
Location details	—
Due date	—
Start date	—
Placement	05 (Village Hall - First Floor Plan)
Root cause	—

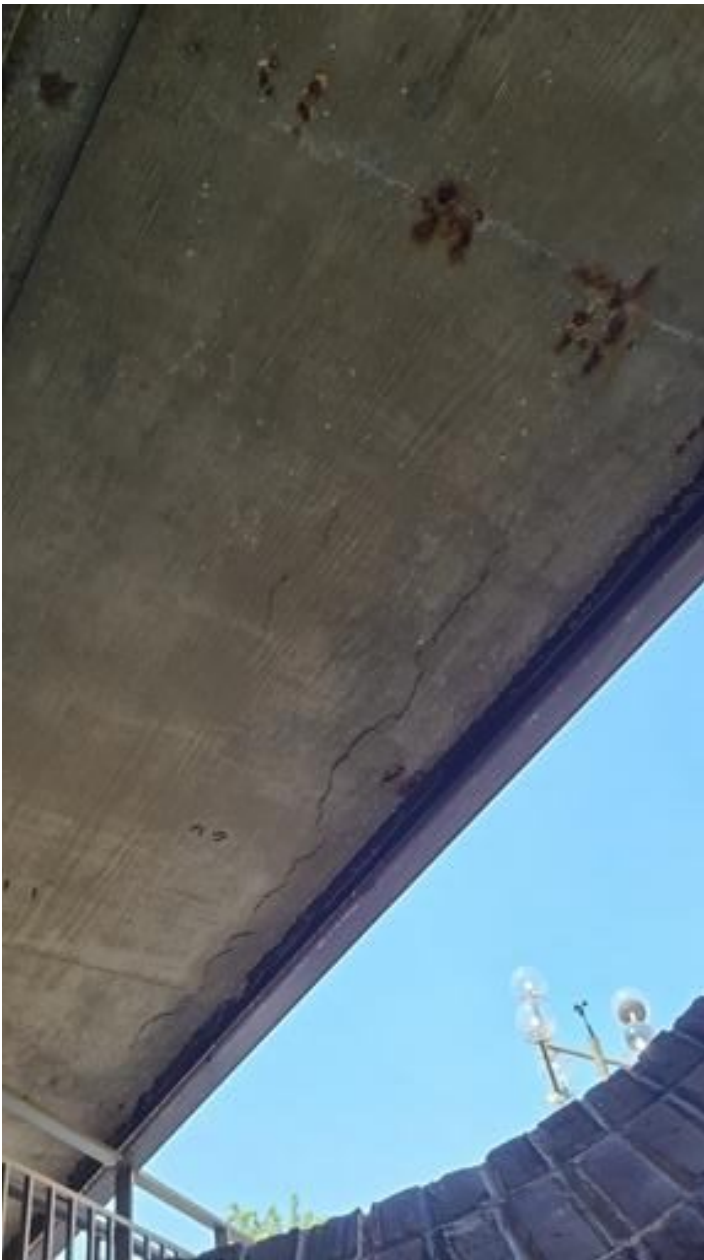
[20230608_105711](#)

Description	Cracked underside.
Assigned to	—
Created by	Gabriel David (Cordogan Clark)
Created on	Jun 26, 2023
Location	Village Hall - First Floor
Location details	—
Due date	—
Start date	—
Placement	05 (Village Hall - First Floor Plan)
Root cause	—

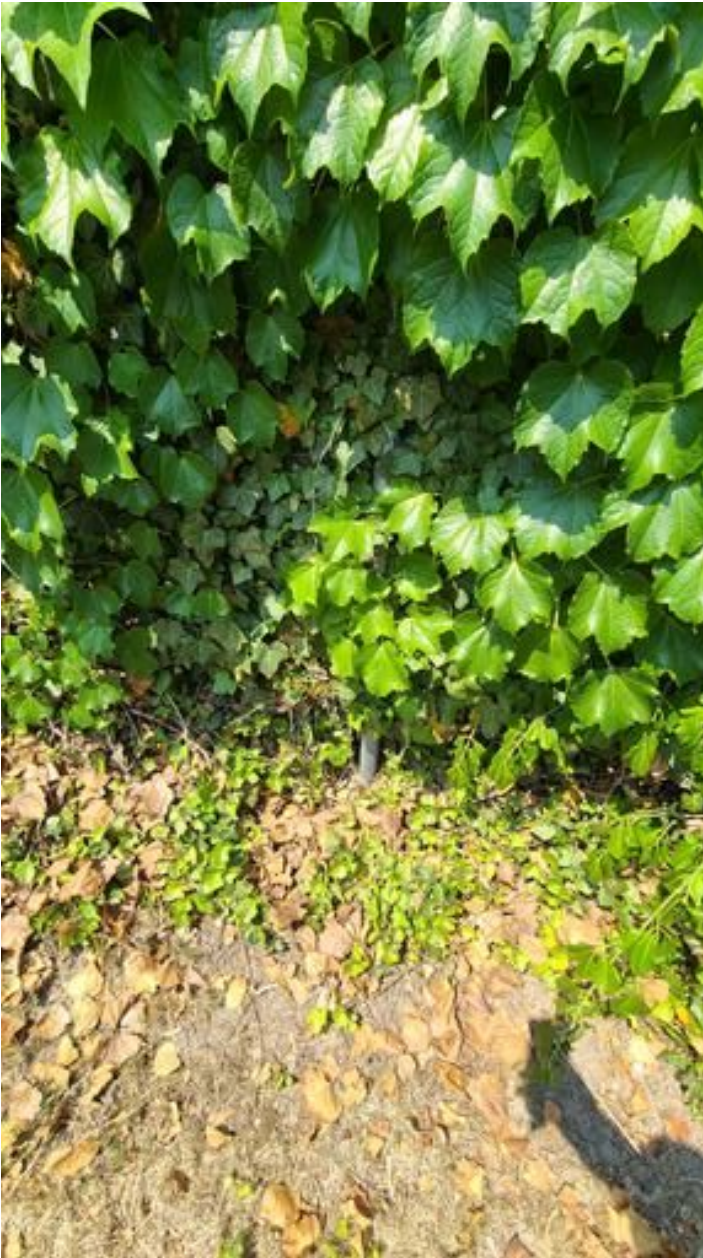
[20230608_112030](#)

Description	Pipe obscured by excess overgrowth.
Assigned to	—
Created by	Gabriel David (Cordogan Clark)
Created on	Jun 26, 2023
Location	Village Hall - First Floor
Location details	—
Due date	—
Start date	—
Placement	05 (Village Hall - First Floor Plan)
Root cause	—

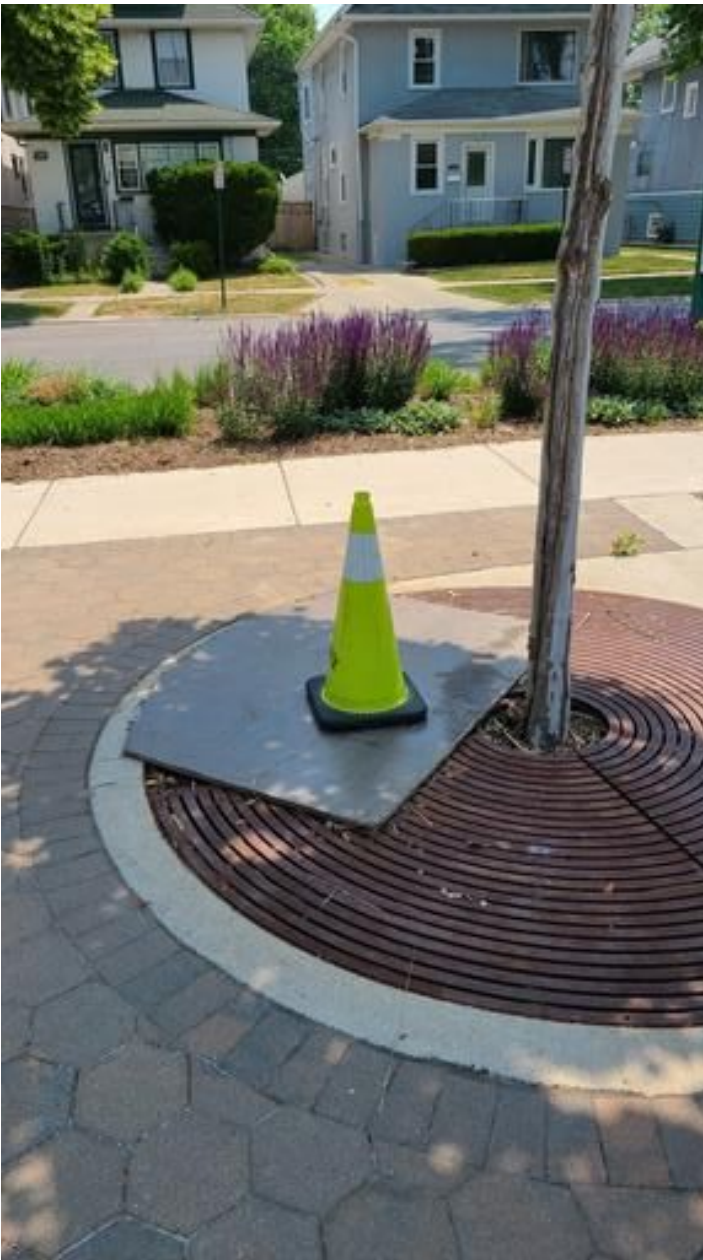
[20230608_112504](#)

Description	Missing portion of tree grate.
Assigned to	—
Created by	Gabriel David (Cordogan Clark)
Created on	Jun 26, 2023
Location	Village Hall - First Floor
Location details	—
Due date	—
Start date	—
Placement	05 (Village Hall - First Floor Plan)
Root cause	—

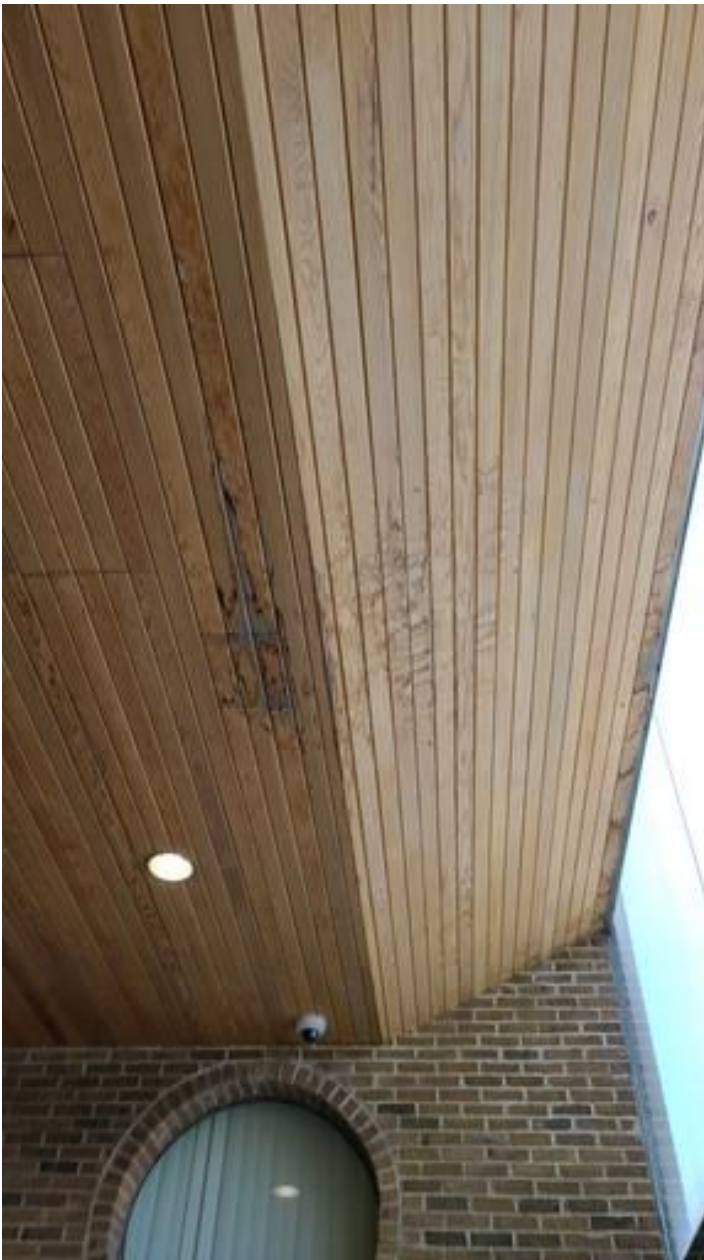
[20230608_111054](#)

2. Ceiling Finish – Wood: The interior wood ceiling finishes are in good condition. The underside of the wood decking in the Southern entrance has water staining. (Issue #313).

Description	Water staining at the underside of wood decking in the South entrance
Assigned to	—
Created by	Gabriel David (Cordogan Clark)
Created on	Jun 26, 2023
Location	Village Hall - First Floor
Location details	—
Due date	—
Start date	—
Placement	05 (Village Hall - First Floor Plan)
Root cause	—

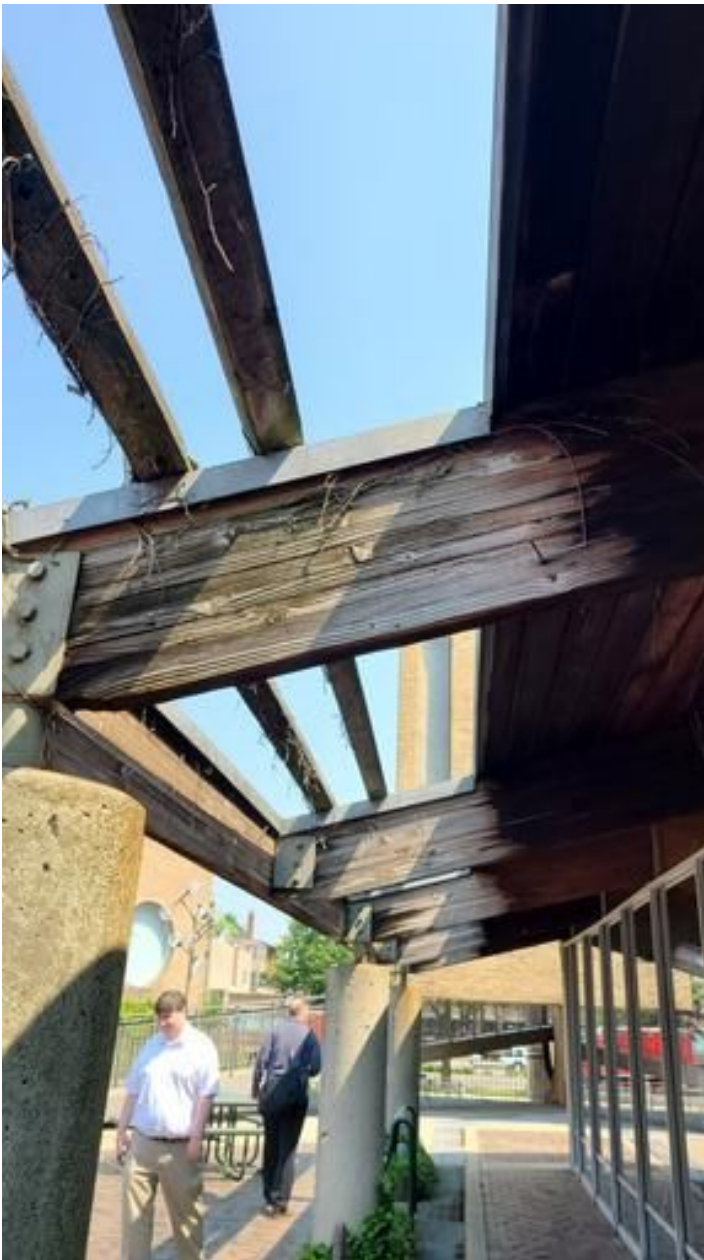
[20230608_104718](#)

Description	Ivy growth along beams.
Assigned to	—
Created by	Gabriel David (Cordogan Clark)
Created on	Jun 26, 2023
Location	Village Hall - First Floor
Location details	—
Due date	—
Start date	—
Placement	05 (Village Hall - First Floor Plan)
Root cause	—

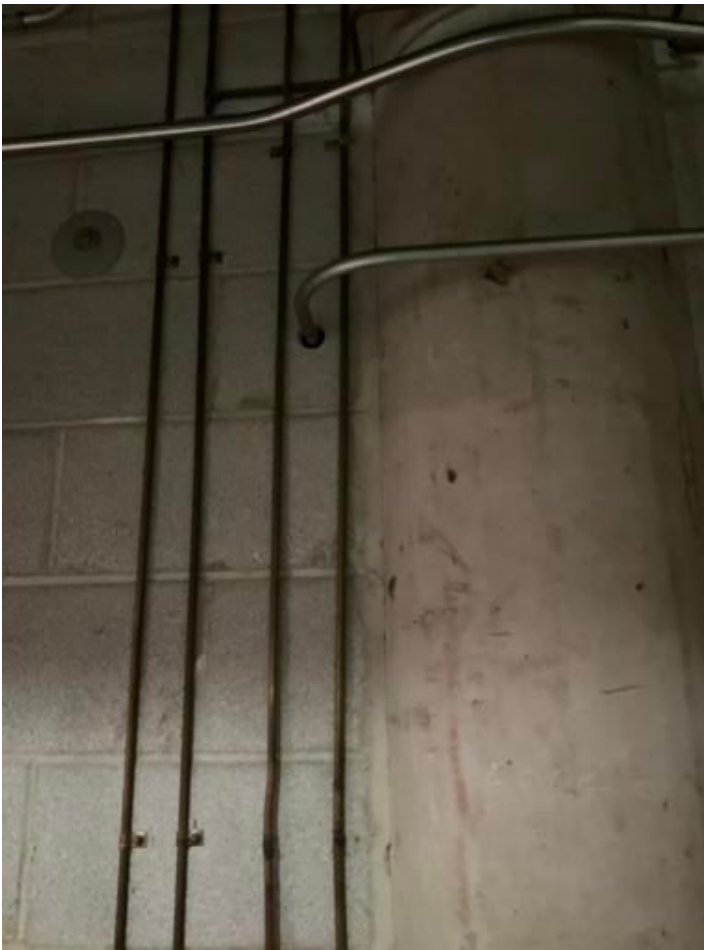
[20230608_090319_photo](#)

Description	Unsealed penetration into boiler room.
Assigned to	—
Created by	Gabriel David (Cordogan Clark)
Created on	Jun 21, 2023
Location	Village Hall - Lower Level
Location details	—
Due date	—
Start date	—
Placement	04 (Village Hall - Lower Level Plan)
Root cause	—

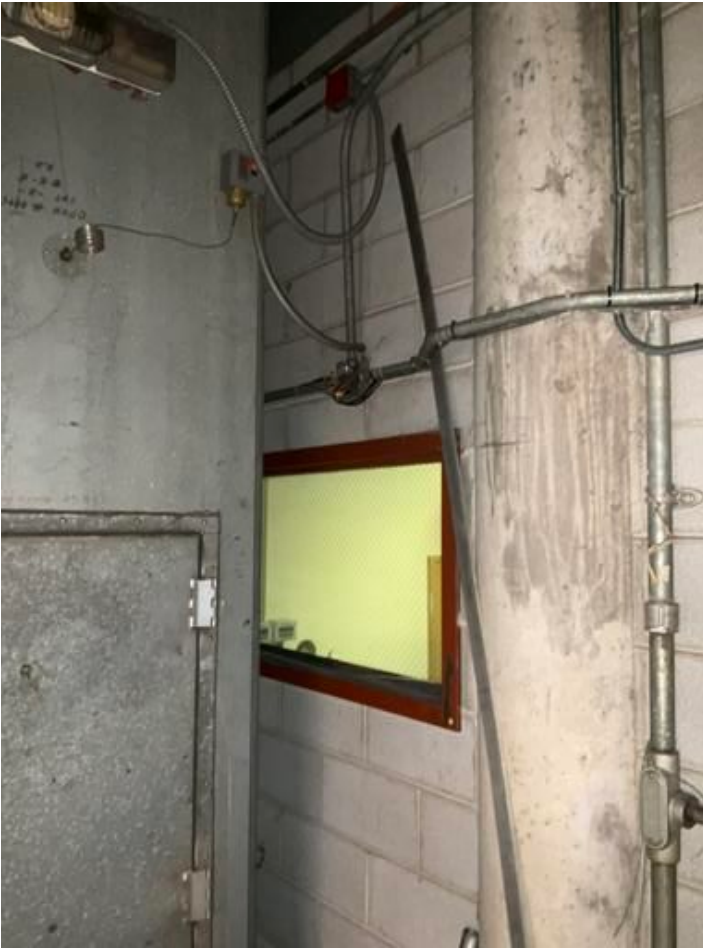
[20230608_085914_photo](#)

Description	Missing junction box cover.
Assigned to	—
Created by	Gabriel David (Cordogan Clark)
Created on	Jun 21, 2023
Location	Village Hall - Lower Level
Location details	—
Due date	—
Start date	—
Placement	04 (Village Hall - Lower Level Plan)
Root cause	—

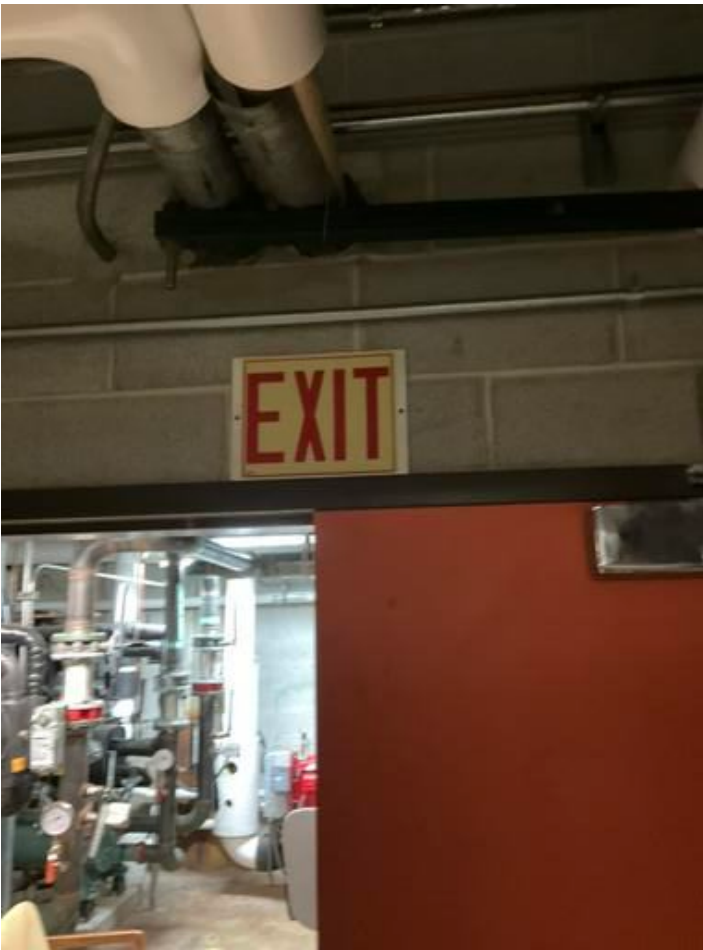
[20230608_083350_photo](#)

Description	Non-illuminated exit for path egress from boiler room.
Assigned to	—
Created by	Gabriel David (Cordogan Clark)
Created on	Jun 21, 2023
Location	Village Hall - Lower Level
Location details	—
Due date	—
Start date	—
Placement	04 (Village Hall - Lower Level Plan)
Root cause	—
