**OAK PARK VILLAGE HALL
123 Madison Street, Oak Park IL. 60302**

**PROPERTY CONDITION ASSESSMENT REPORT
07.08.23**

Property Condition Assessment Report

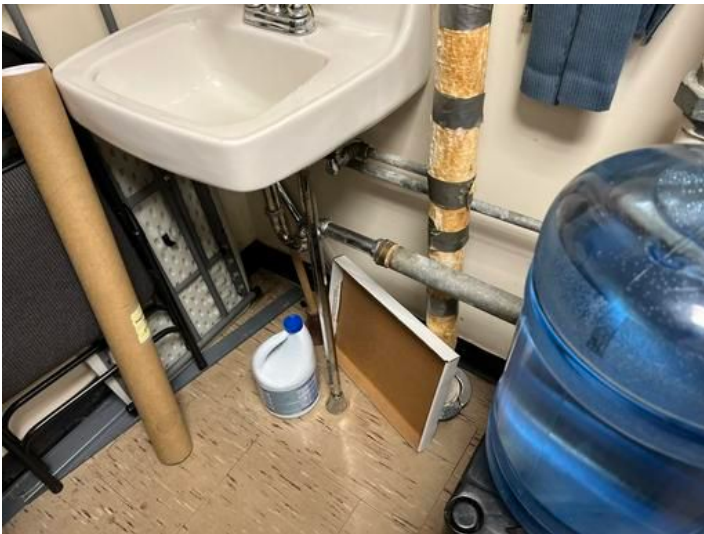
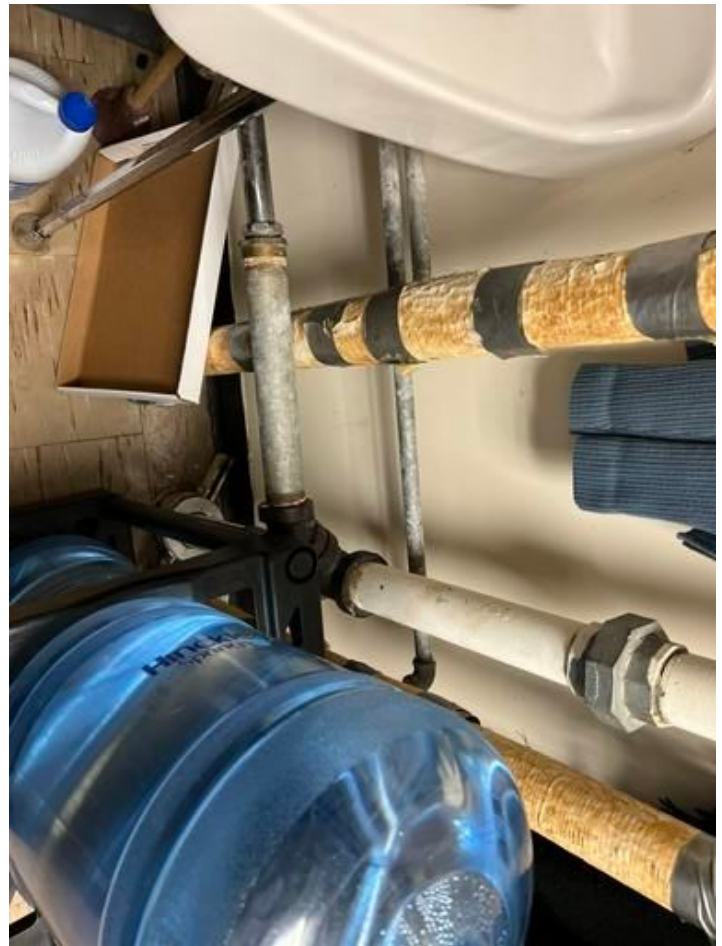
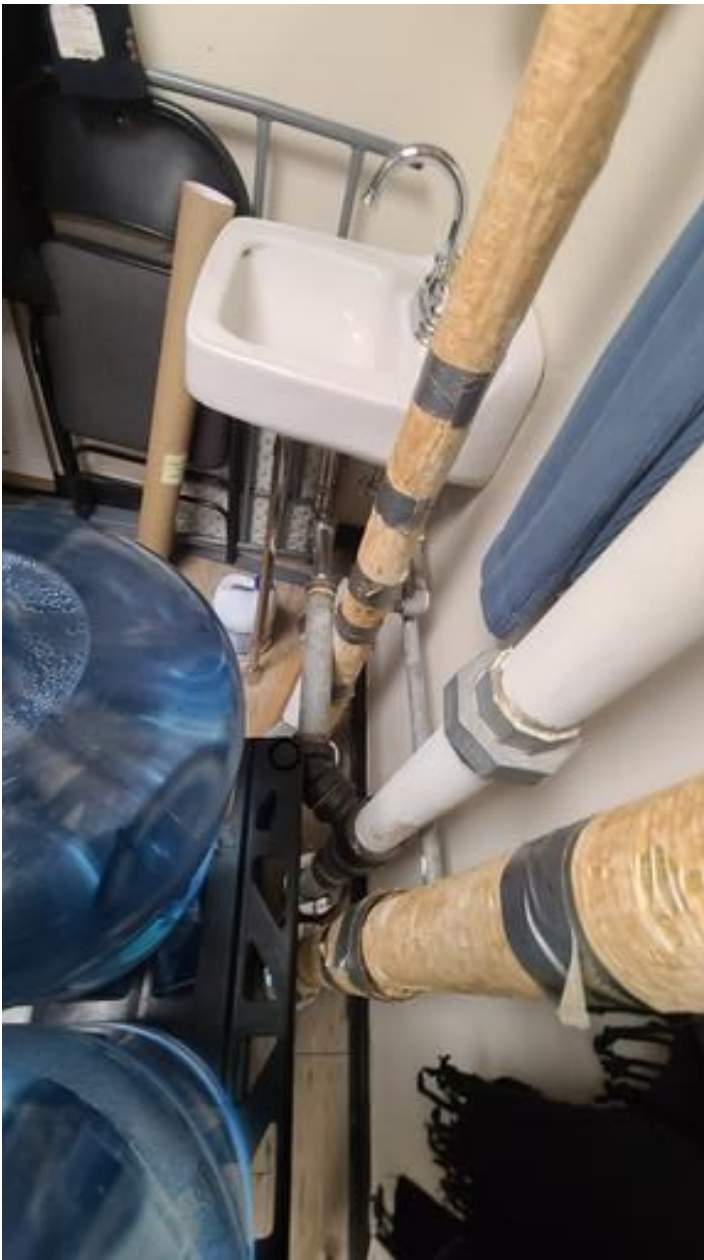
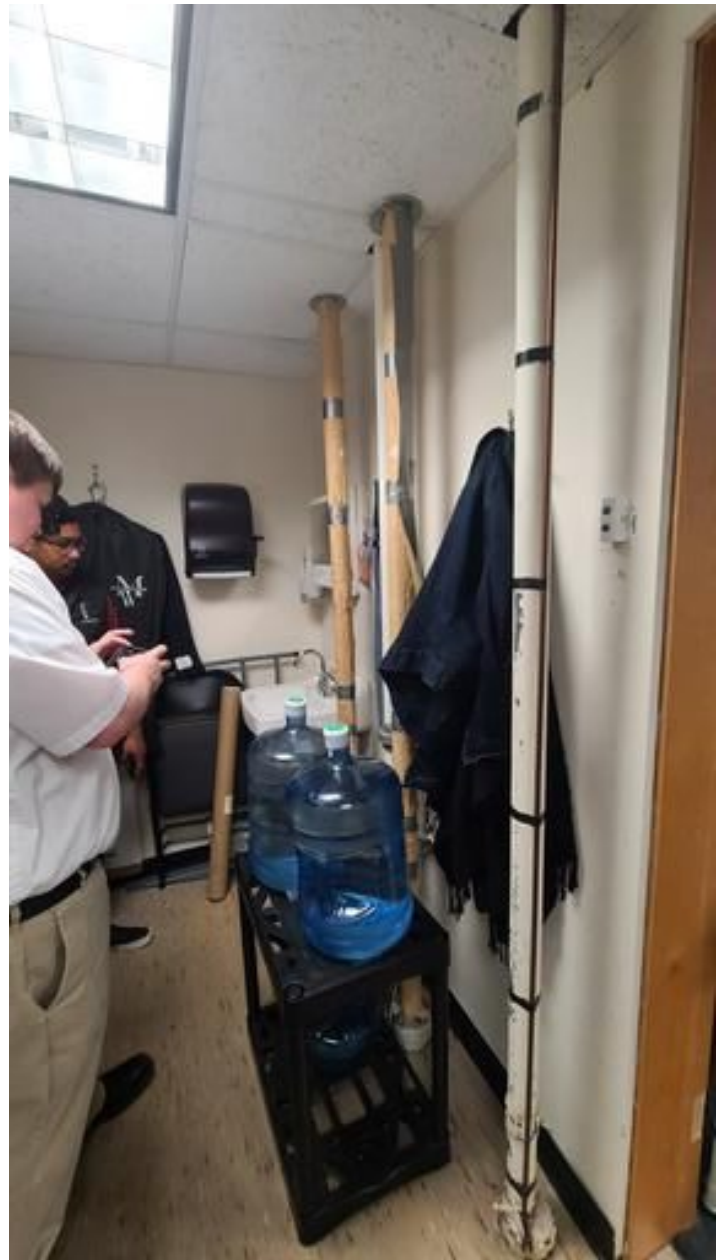
ID	#150
Pin	1
Status	■ Open
Type	PI Plumbing Issues > Plumbing Issues

Description	Overall images of piping near sink in Adjudication Office.
Assigned to	—
Created by	Gabriel David (Cordogan Clark)
Created on	Jun 21, 2023
Location	Village Hall - First Floor
Location details	—
Due date	—
Start date	—
Placement	05 (Village Hall - First Floor Plan)
Root cause	—

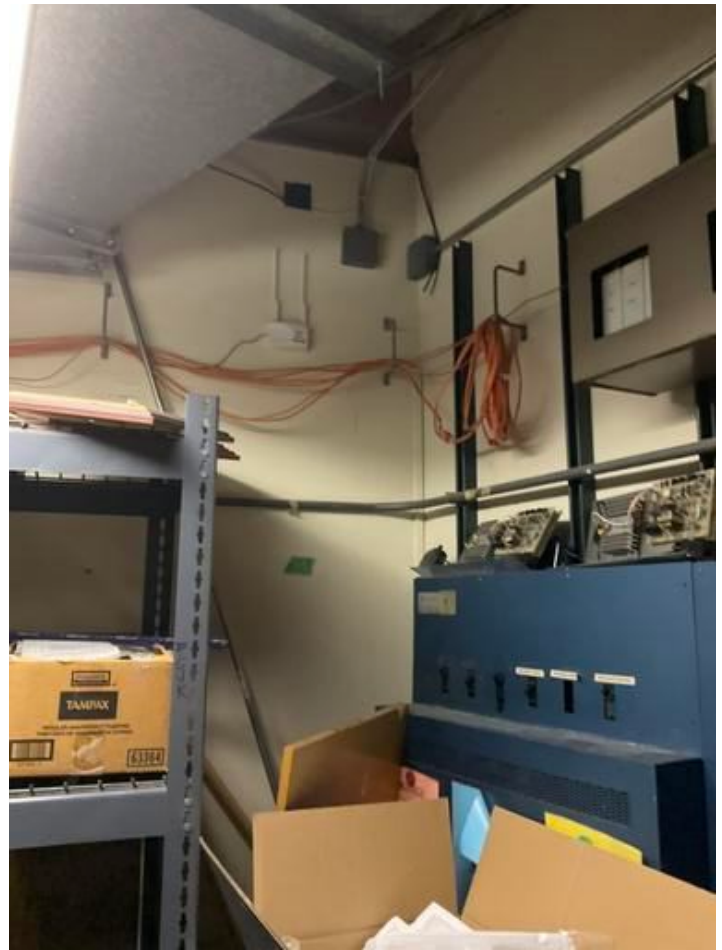
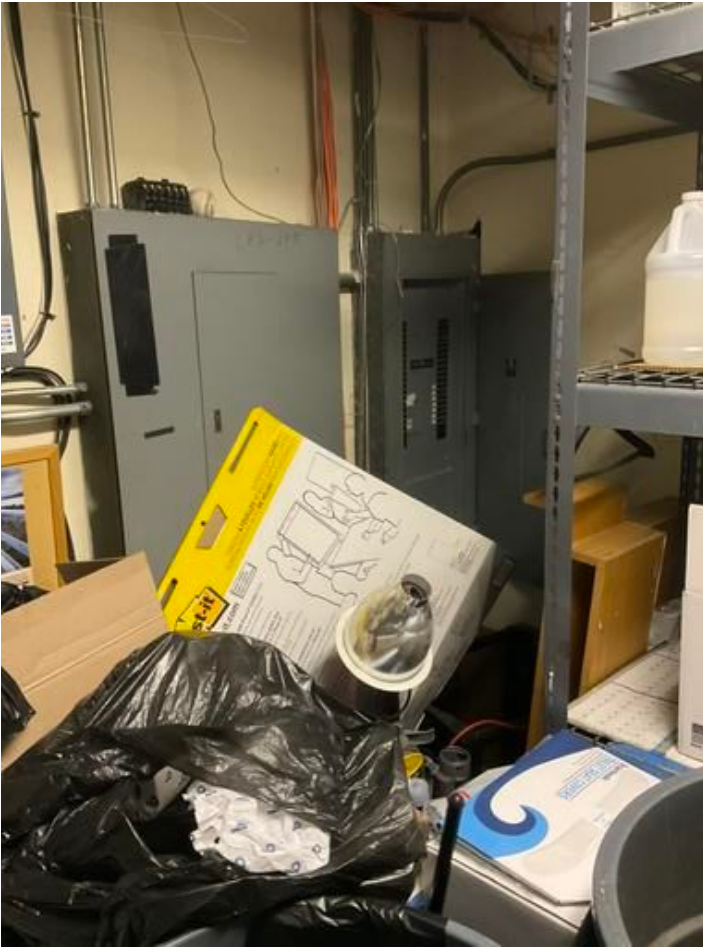
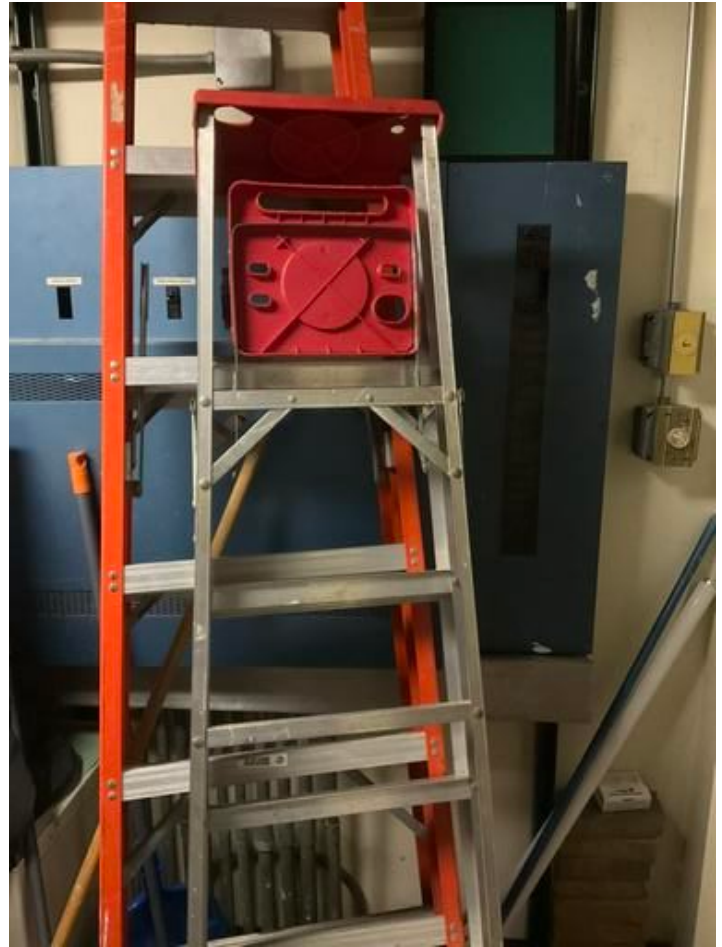
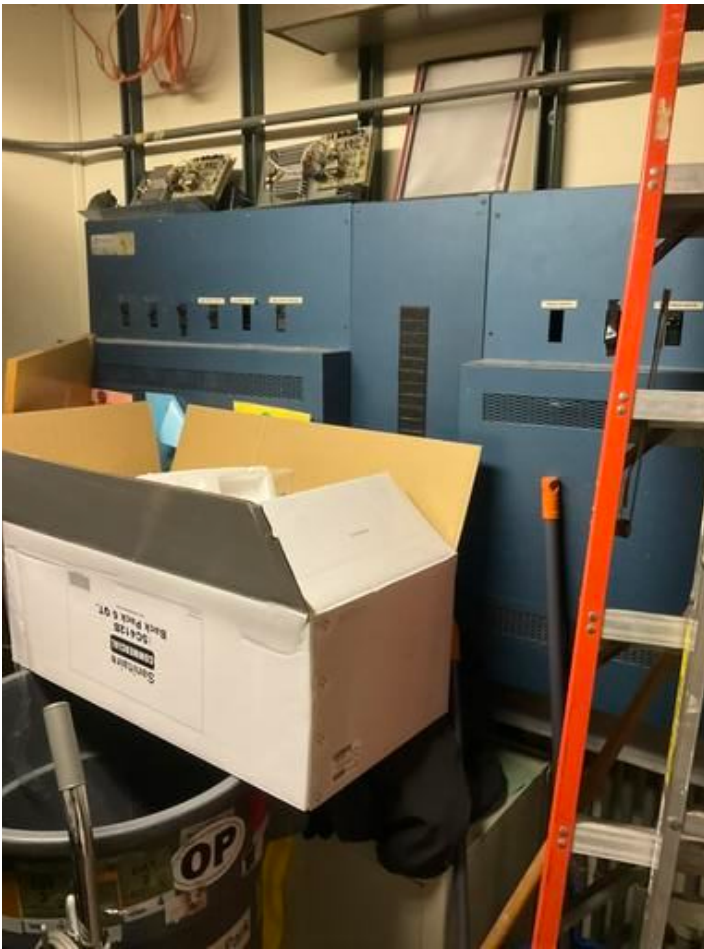
ID	#158
Pin	2
Status	<div>Open</div>
Type	<div>MI</div> Mechanical Issues > Mechanical Issues

Description	Blocked electrical panels.
Assigned to	—
Created by	Gabriel David (Cordogan Clark)
Created on	Jun 21, 2023
Location	Village Hall - First Floor
Location details	—
Due date	—
Start date	—
Placement	05 (Village Hall - First Floor Plan)
Root cause	—

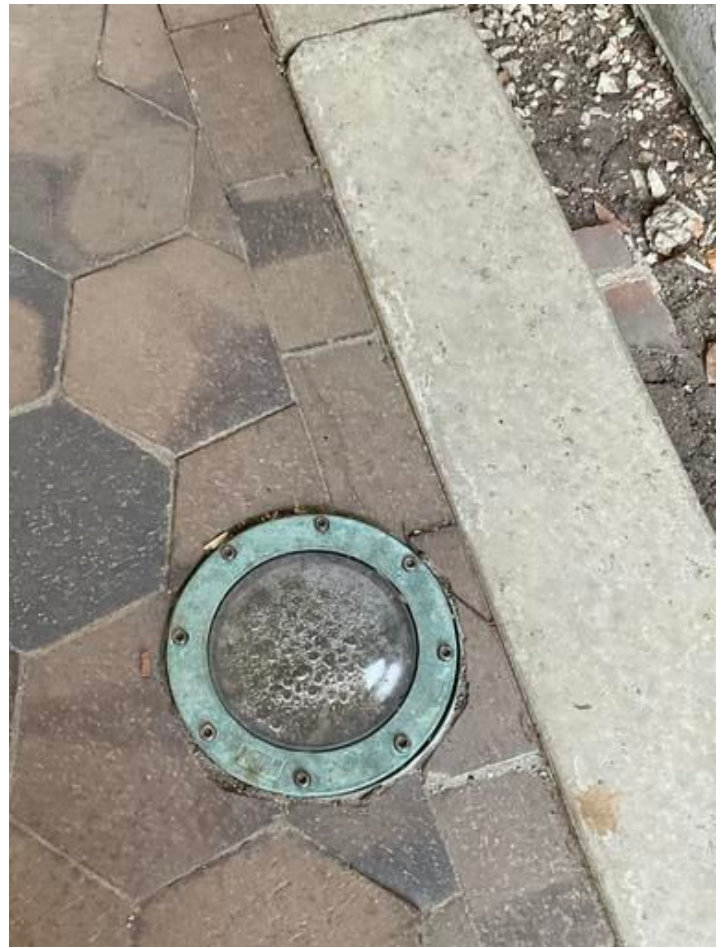
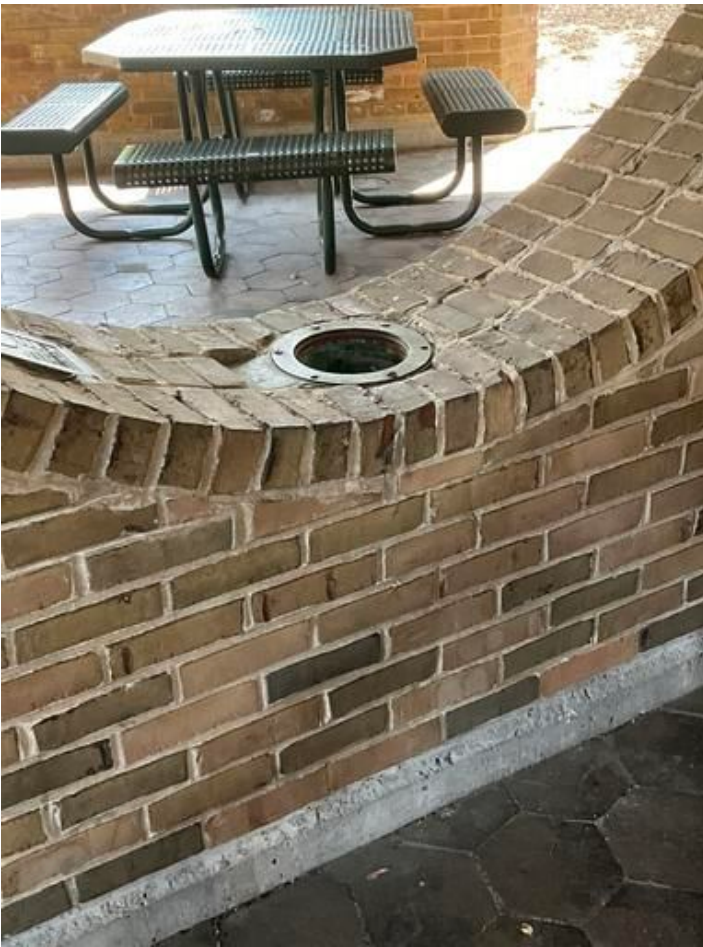
ID	#360
Pin	3
Status	■ Open
Type	EI Electrical Issues > Electrical Issues

3. Lighting: Exterior – Fixtures: The lighting fixtures are in fair condition. There is moisture buildup and cracked glass within the circular up-lights in the area below the Council Chambers. (Issue #360).

Description	Overall image of exterior uplights below Council Chamber. Note moisture build up and cracked glass.
Assigned to	—
Created by	Gabriel David (Cordogan Clark)
Created on	Jun 30, 2023
Location	Village Hall - First Floor
Location details	—
Due date	—
Start date	—
Placement	05 (Village Hall - First Floor Plan)
Root cause	—

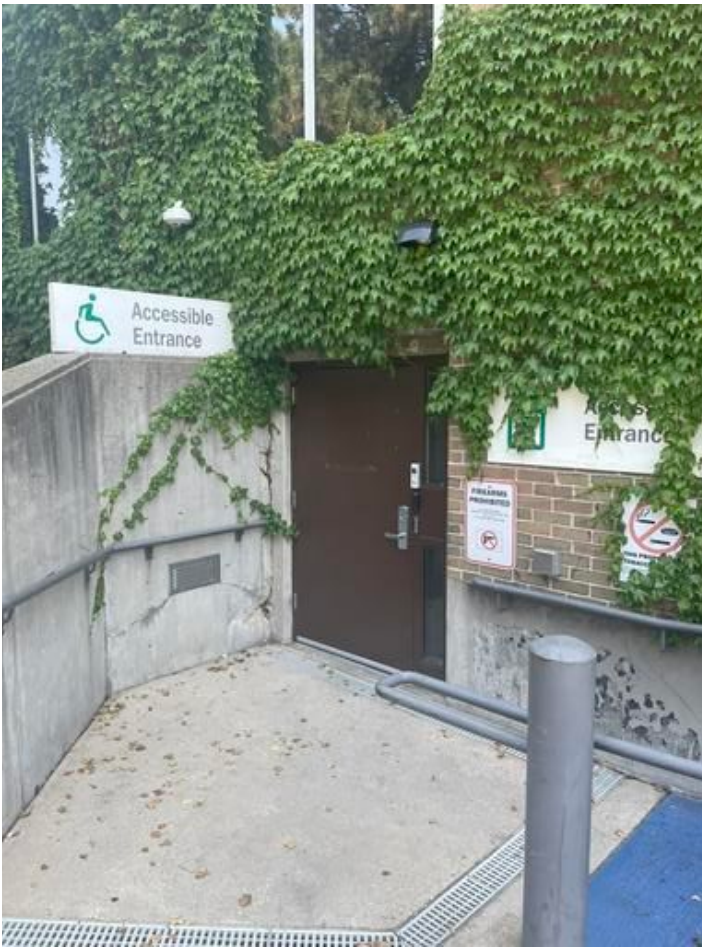
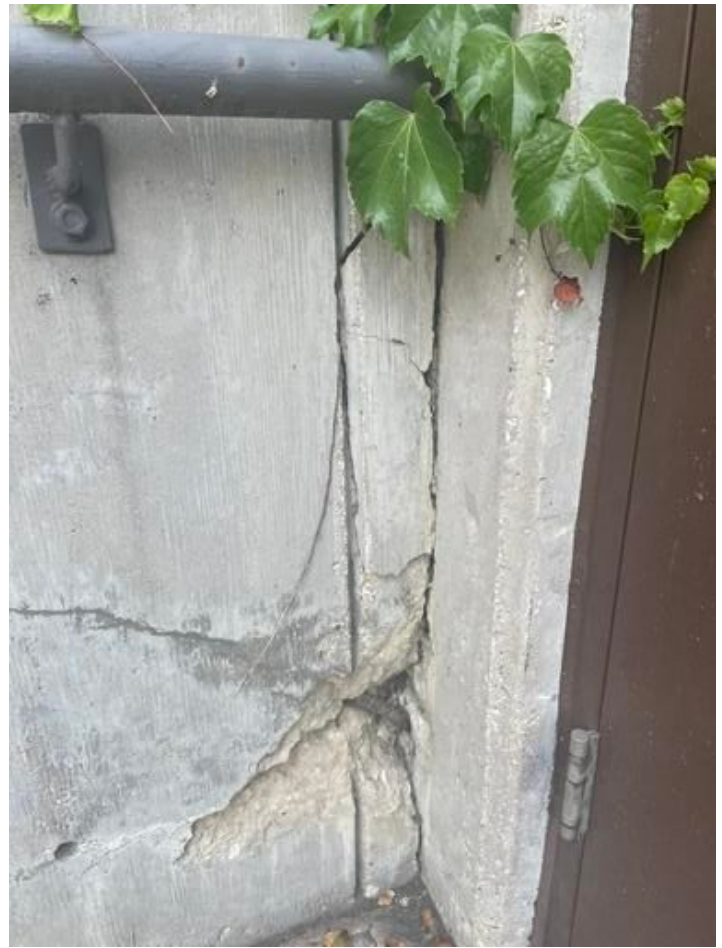
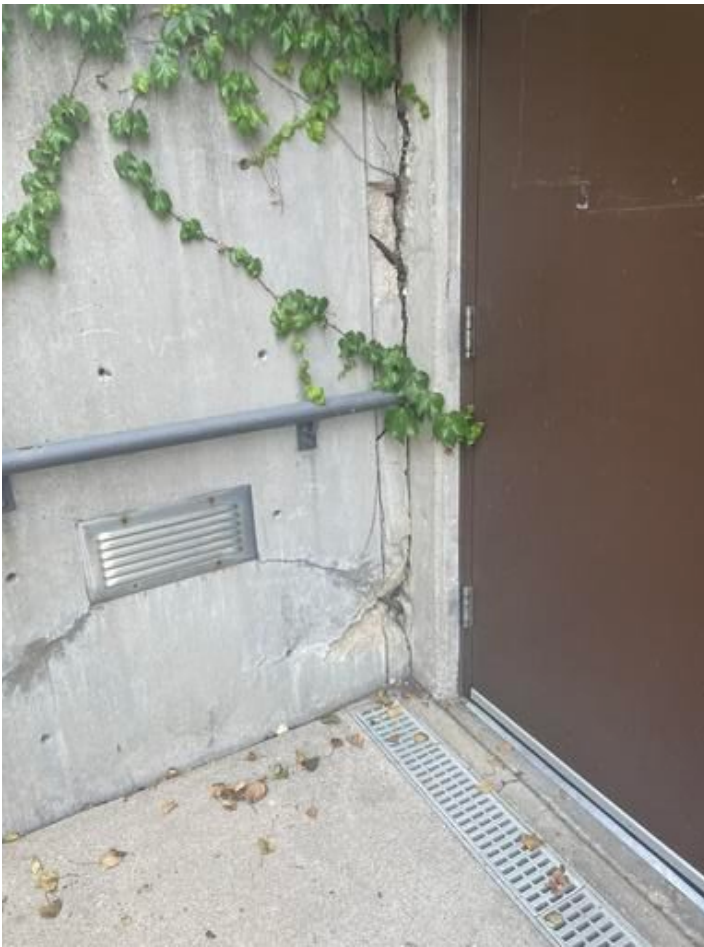
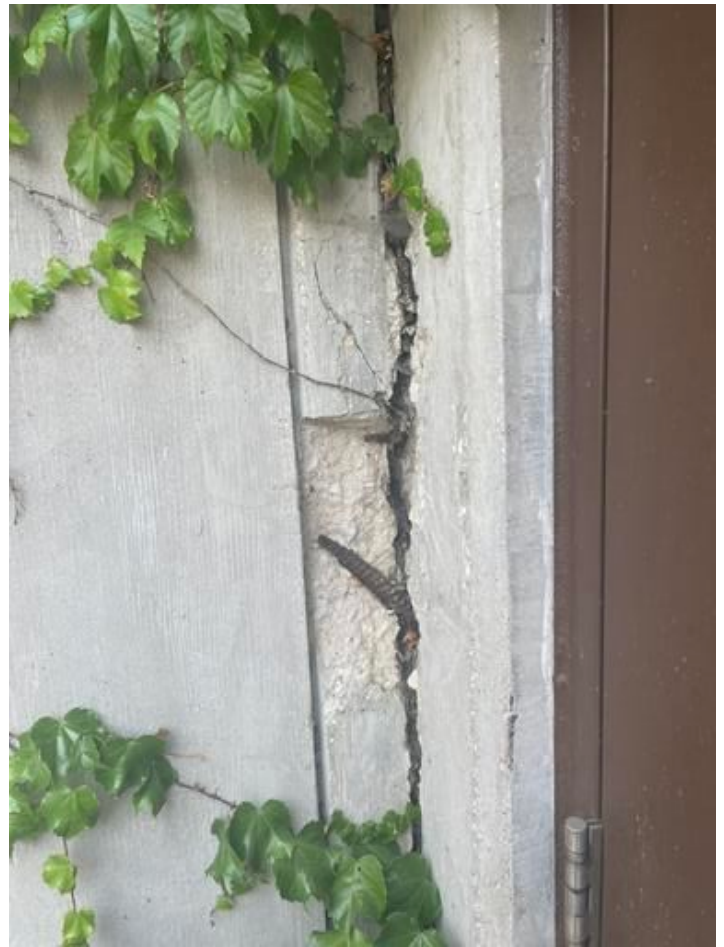
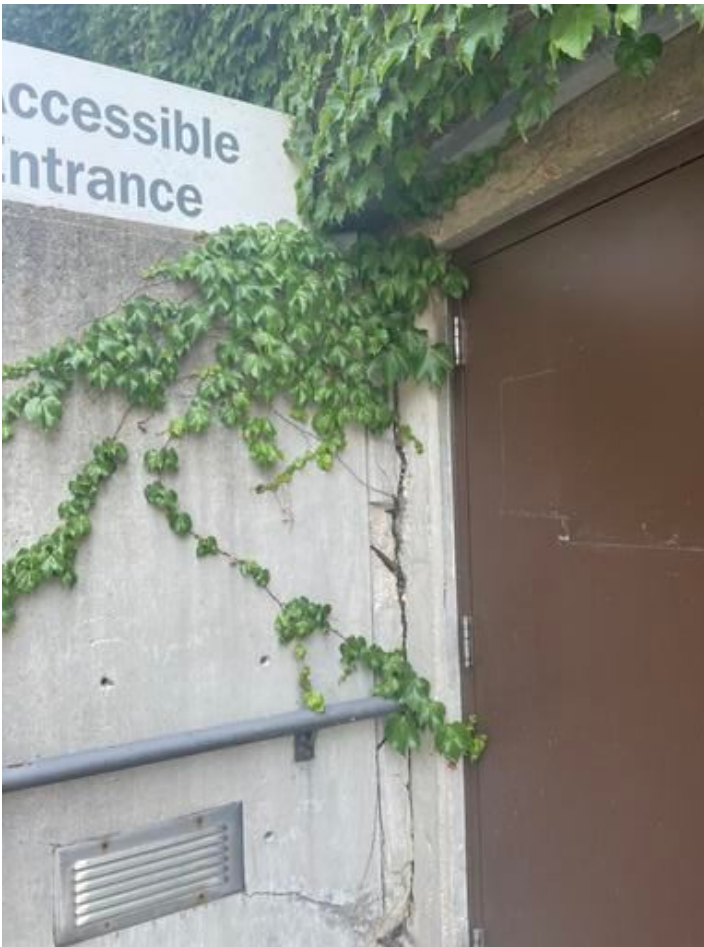
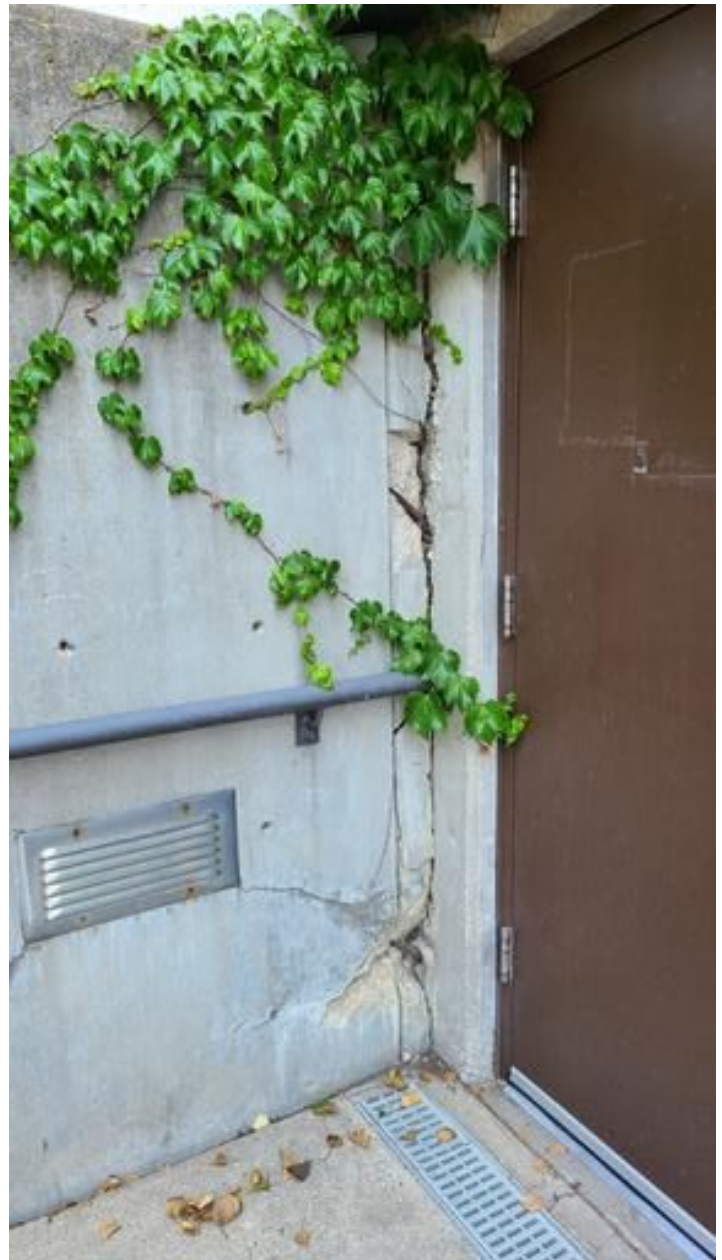
ID	#136
Pin	4
Status	■ Open
Type	AI Architectural Issues > Architectural Issues

4. Police Underground Parking Concrete – Concrete: Foundation wall concrete is spalling at several places along vehicle ramp to underground parking. Concrete is spalling at sallyport entrance and at underground parking structure. Structural slab leaks at parking garage. Also, there is corrosion on sprinkler piping and conduit. The underground parking garage is approximately 7000sf. The foundation wall at the Southwest corner building entrance has crack developing with exposed rebar. (Issue #133, #136).

Description	Exposed rebar in cracking concrete near accessible entrance.
Assigned to	—
Created by	Gabriel David (Cordogan Clark)
Created on	Jun 21, 2023
Location	Village Hall - First Floor
Location details	—
Due date	—
Start date	—
Placement	05 (Village Hall - First Floor Plan)
Root cause	—

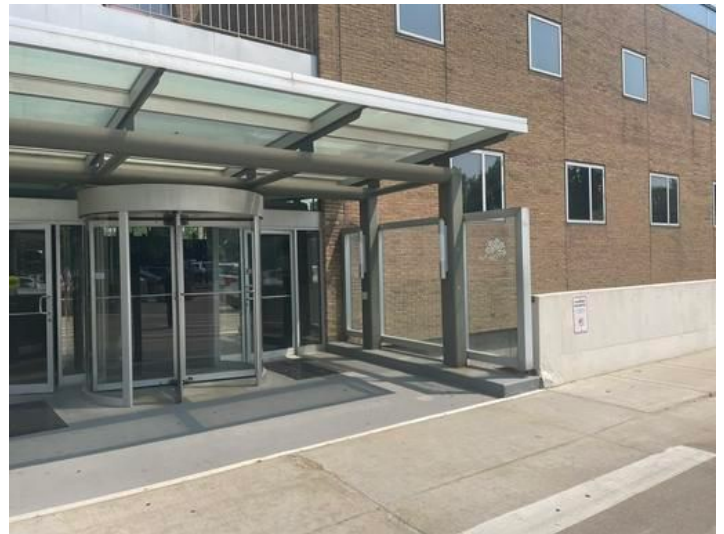
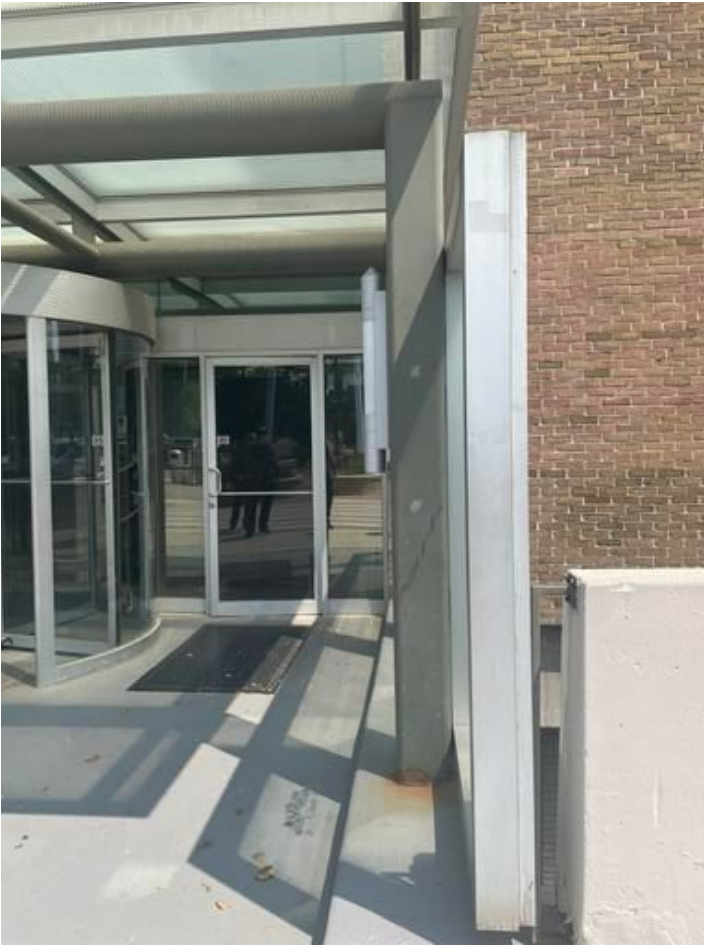
ID	#137
Pin	5
Status	<div>Open</div>
Type	<div>AI</div> Architectural Issues > Architectural Issues

1. Southern Canopy Structure – Steel: Metal canopy column at the Southern main entrance has corrosion. (Issue #137).
2. Courtyard Concrete/Railing – Concrete: There is a cracked concrete slab supporting a metal guardrail in the courtyard. The guardrail is very loose and can sway 4-5" when slight force is applied. Concrete columns below guardrail also have exposed rebar. There is exposed rebar in an exterior column in the courtyard. There is exposed rebar in a half wall in front of northeast courtyard stairs. (Issue #153, #142, #146).

Description	Rusting metal column near main entrance.
Assigned to	—
Created by	Gabriel David (Cordogan Clark)
Created on	Jun 21, 2023
Location	Village Hall - First Floor
Location details	—
Due date	—
Start date	—
Placement	05 (Village Hall - First Floor Plan)
Root cause	—

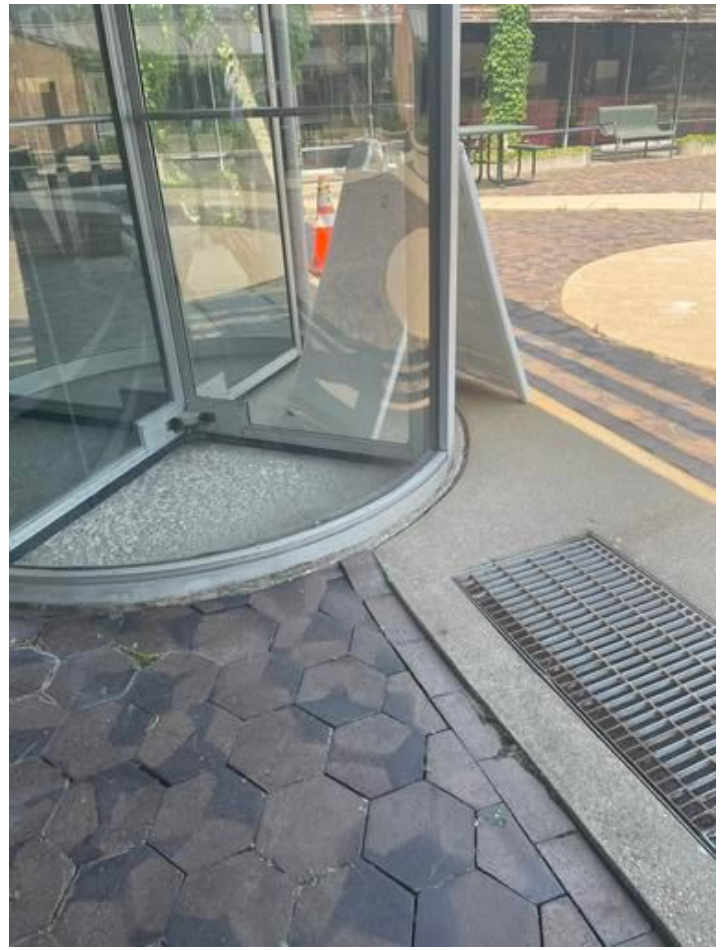
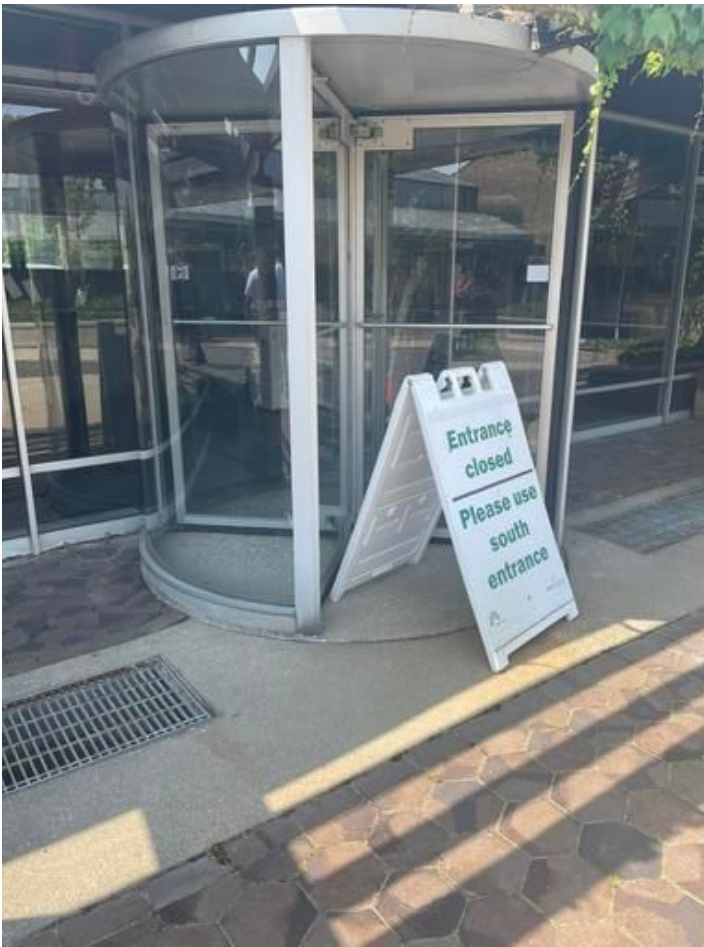
ID	#140
Pin	6
Status	■ Open
Type	AI Architectural Issues > Architectural Issues

Description	Swelling in the concrete next to revolving door entrance. Base of window missing sealant between wall and pavers. Efflorescence and organic growth prevalent.
Assigned to	—
Created by	Gabriel David (Cordogan Clark)
Created on	Jun 21, 2023
Location	Village Hall - First Floor
Location details	—
Due date	—
Start date	—
Placement	05 (Village Hall - First Floor Plan)
Root cause	—

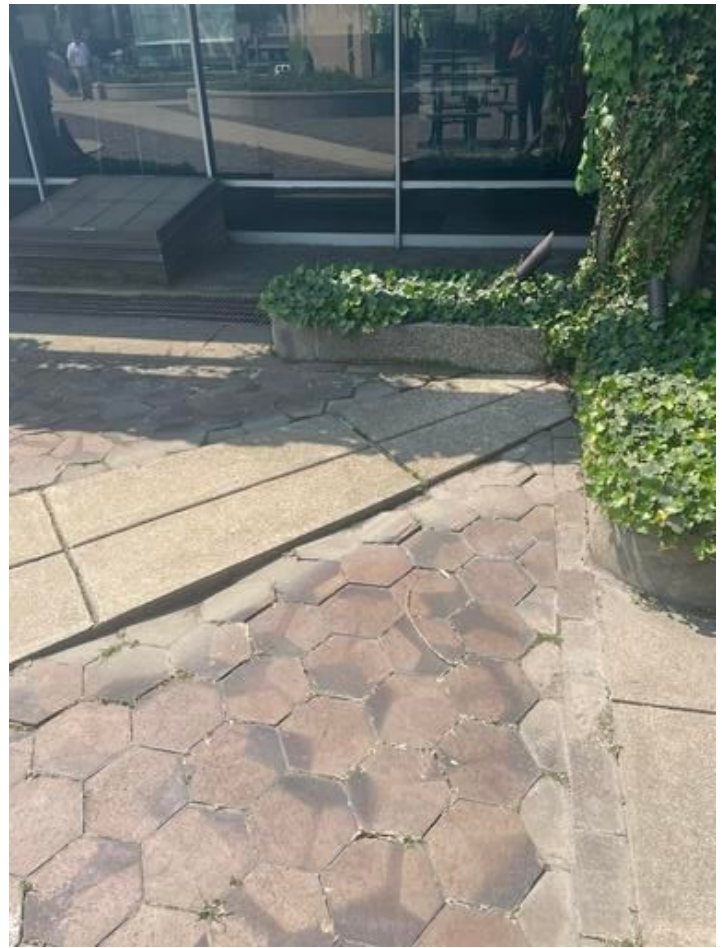
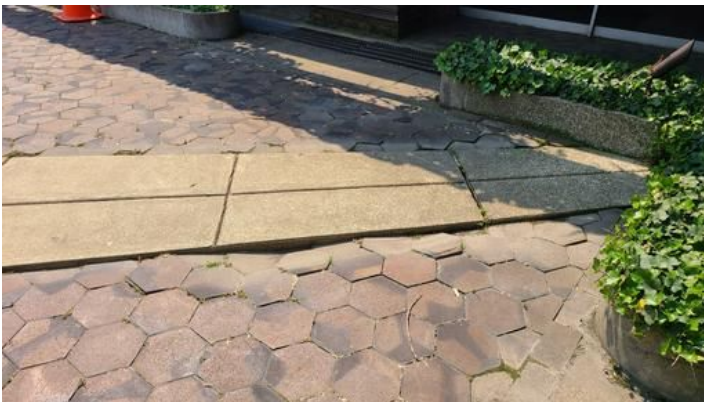
ID	#141
Pin	7
Status	<div>Open</div>
Type	<div>AI</div> Architectural Issues > Architectural Issues

Description	Uneven tiling in courtyard.
Assigned to	—
Created by	Gabriel David (Cordogan Clark)
Created on	Jun 21, 2023
Location	Village Hall - First Floor
Location details	—
Due date	—
Start date	—
Placement	05 (Village Hall - First Floor Plan)
Root cause	—

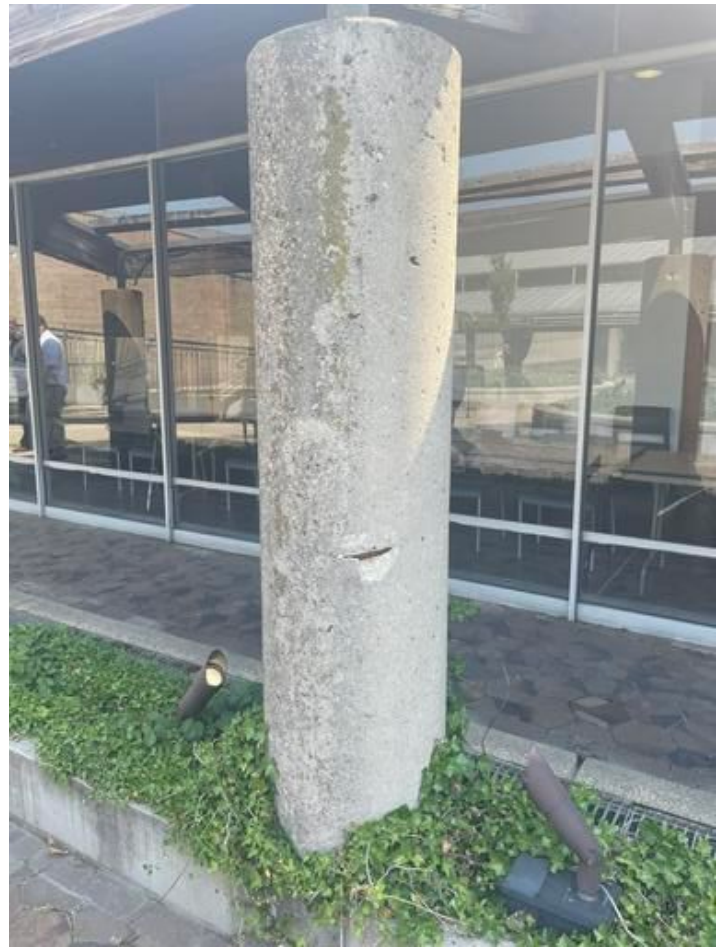
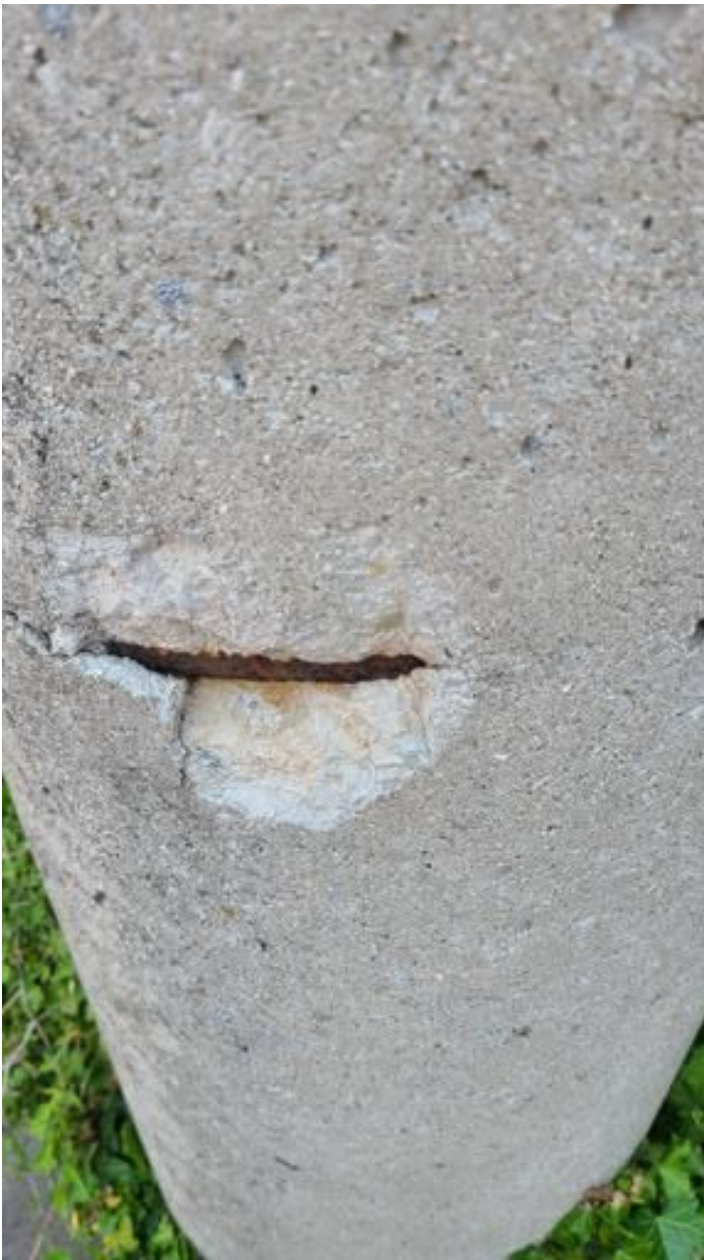
ID	#142
Pin	8
Status	■ Open
Type	AI Architectural Issues > Architectural Issues

Description	Exposed rebar in exterior column.
Assigned to	—
Created by	Gabriel David (Cordogan Clark)
Created on	Jun 21, 2023
Location	Village Hall - First Floor
Location details	—
Due date	—
Start date	—
Placement	05 (Village Hall - First Floor Plan)
Root cause	—

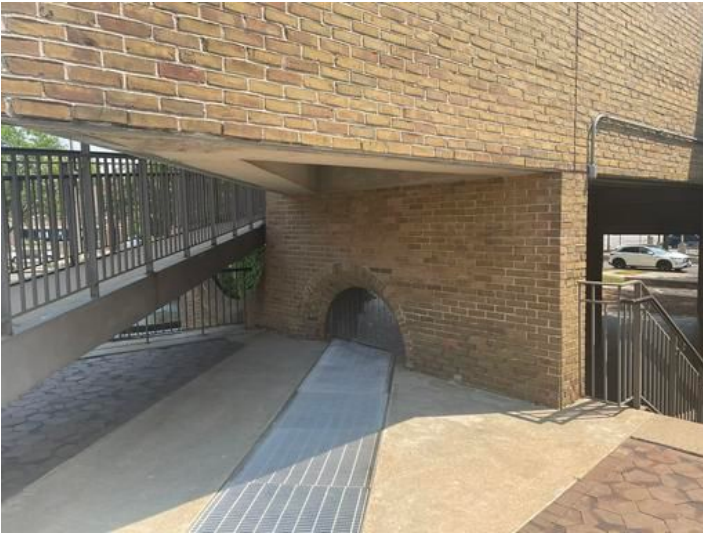
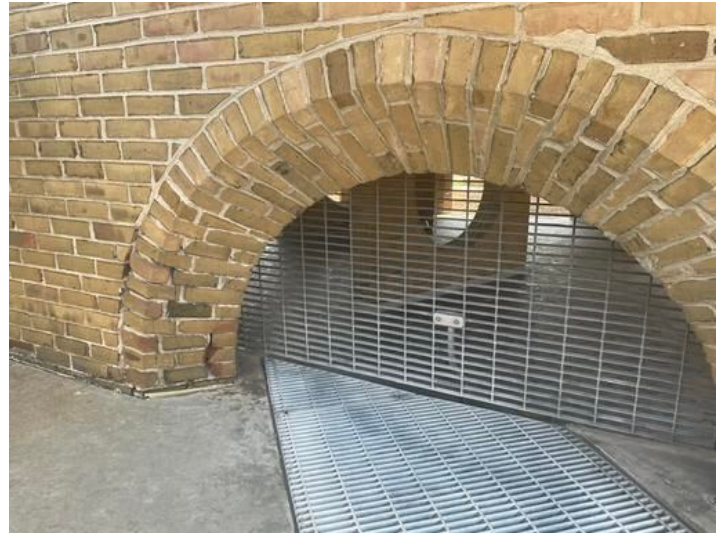
ID	#143
Pin	9
Status	 Open
Type	AI Architectural Issues > Architectural Issues

Description	Cracked masonry in arch.
Assigned to	—
Created by	Gabriel David (Cordogan Clark)
Created on	Jun 21, 2023
Location	Village Hall - First Floor
Location details	—
Due date	—
Start date	—
Placement	05 (Village Hall - First Floor Plan)
Root cause	—

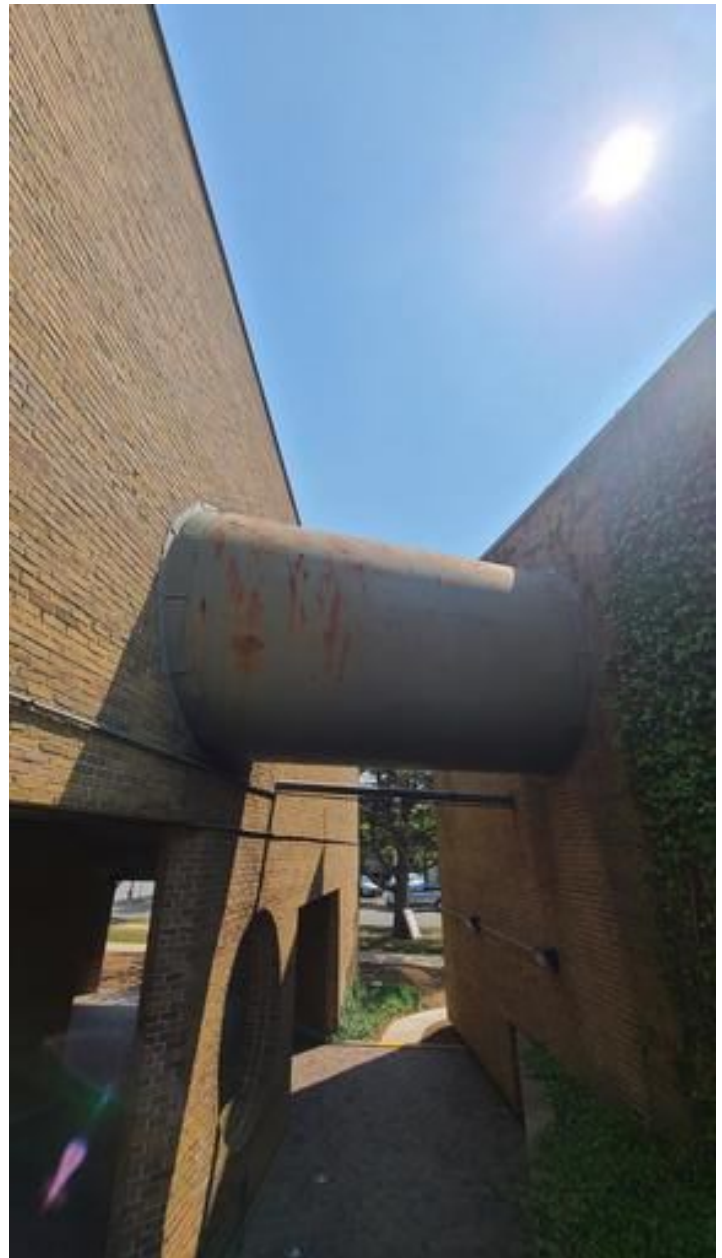
ID	#144
Pin	10
Status	 Open
Type	AI Architectural Issues > Architectural Issues

5. Council Chamber Connection Tube – Steel: The exterior steel tube passageway connecting the Council Chamber to the main building has surface corrosion. (Issue #144).

Description	Surface corrosion and rusting exterior steel tube passageway.
Assigned to	—
Created by	Gabriel David (Cordogan Clark)
Created on	Jun 21, 2023
Location	Village Hall - First Floor
Location details	—
Due date	—
Start date	—
Placement	05 (Village Hall - First Floor Plan)
Root cause	—
