**OAK PARK VILLAGE HALL
123 Madison Street, Oak Park IL. 60302**

**PROPERTY CONDITION ASSESSMENT REPORT
07.08.23**

Property Condition Assessment Report

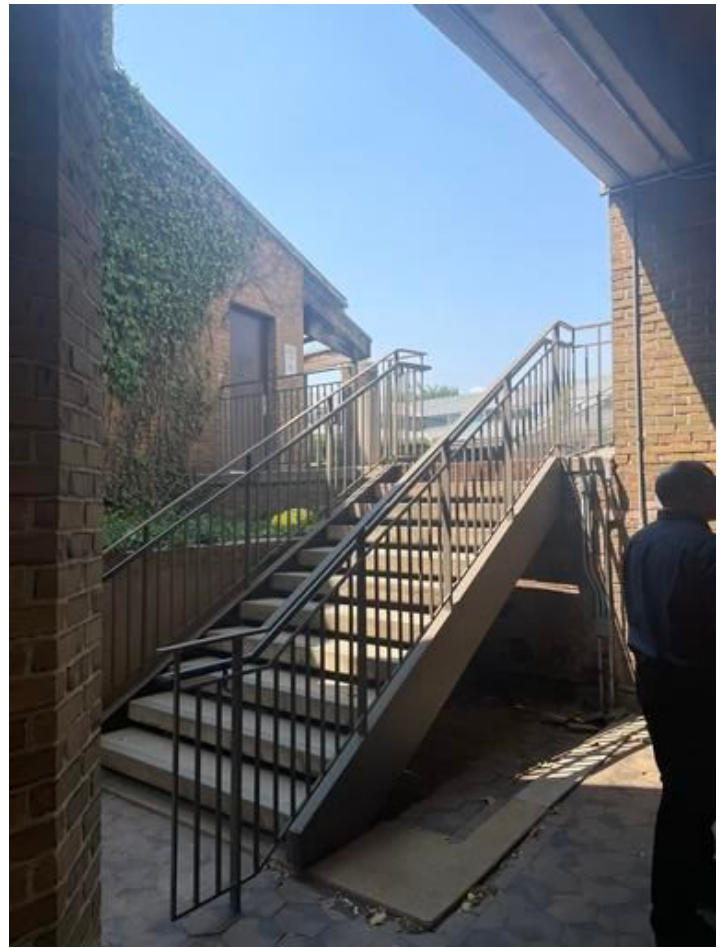
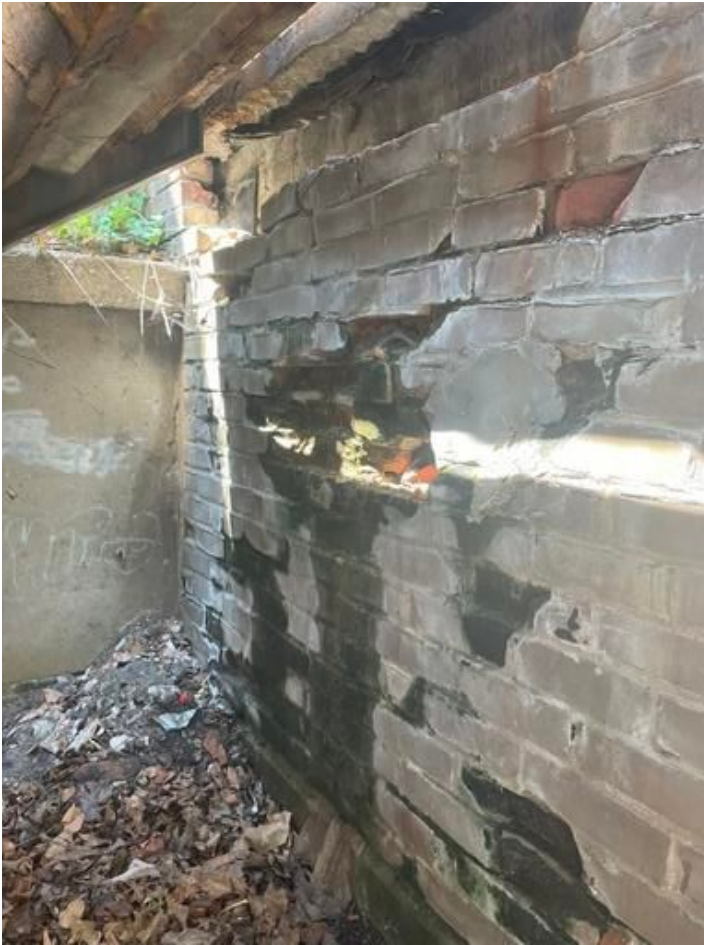
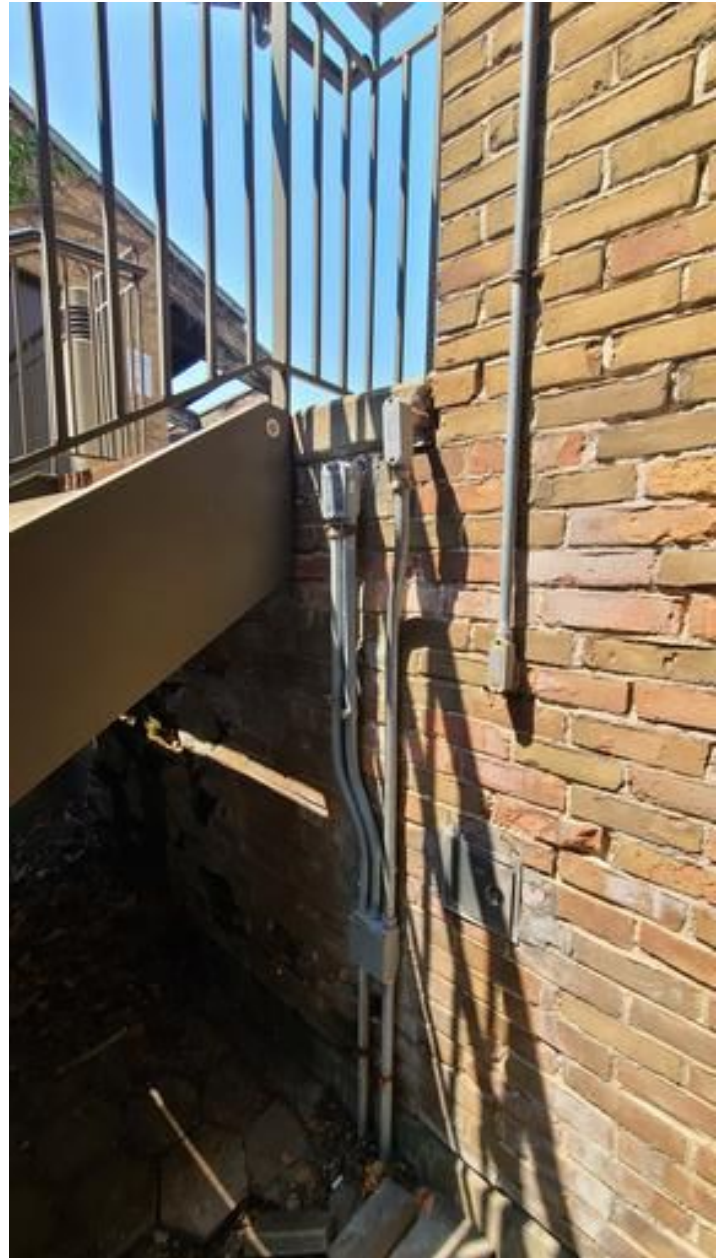
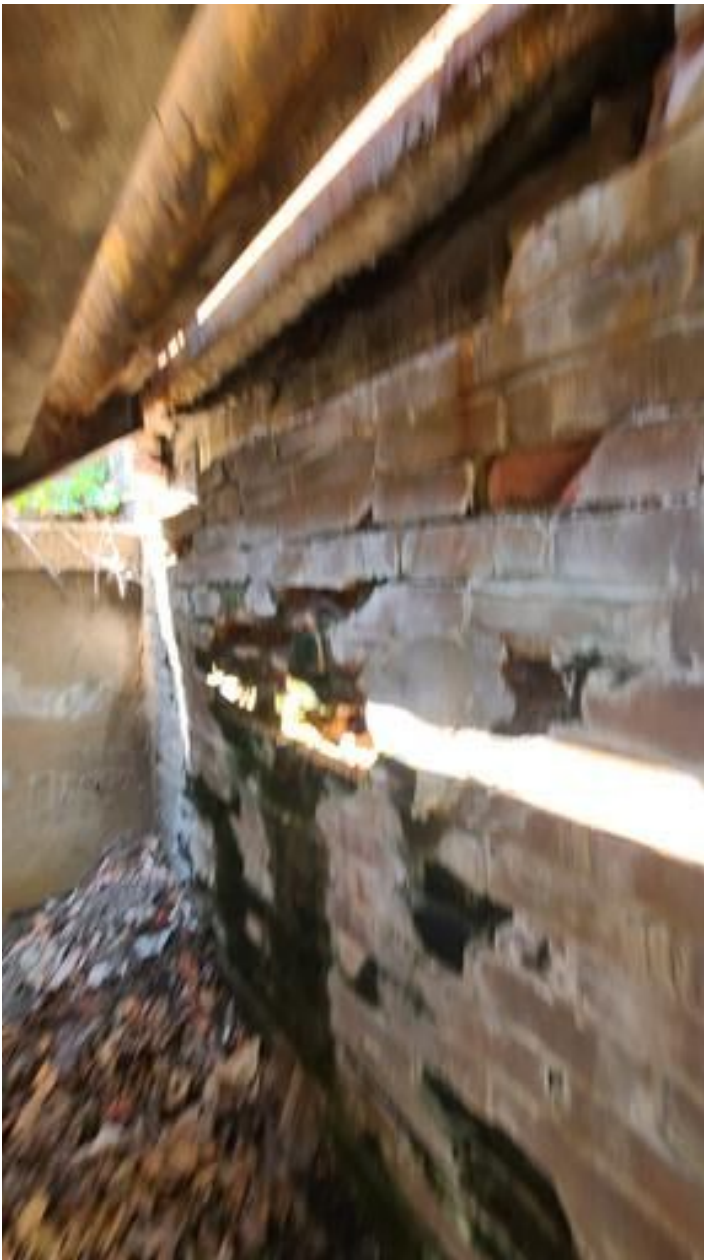
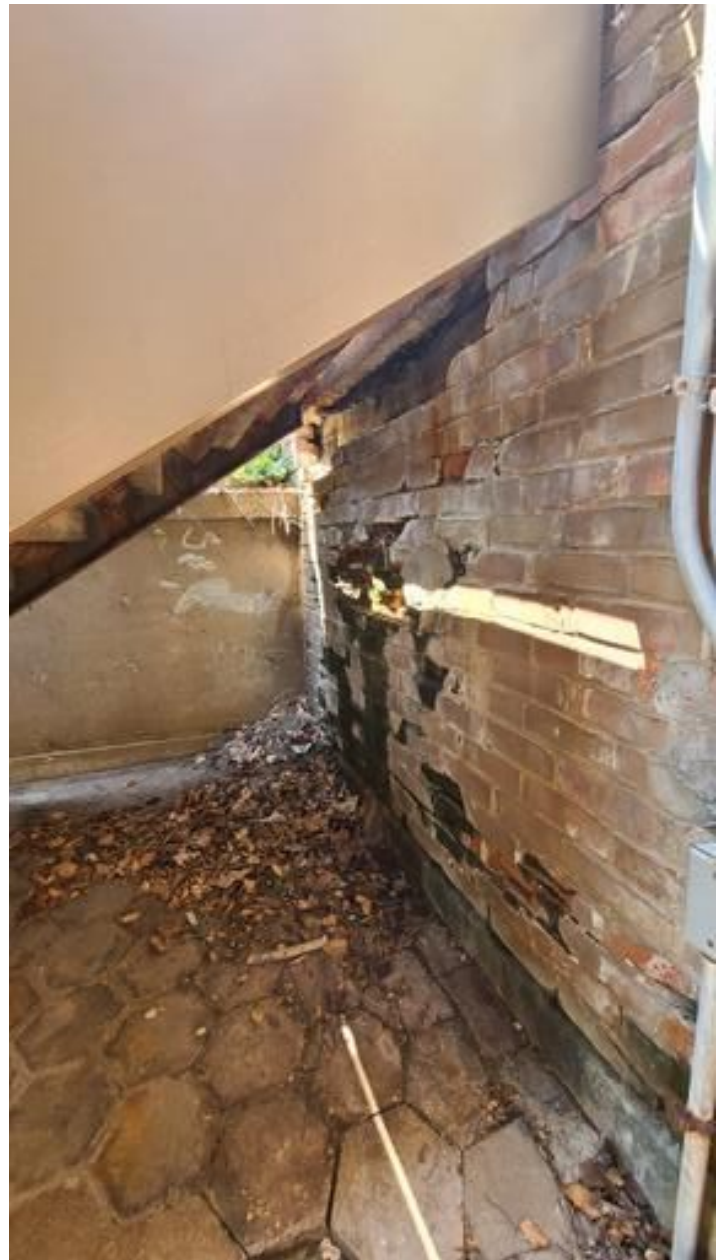
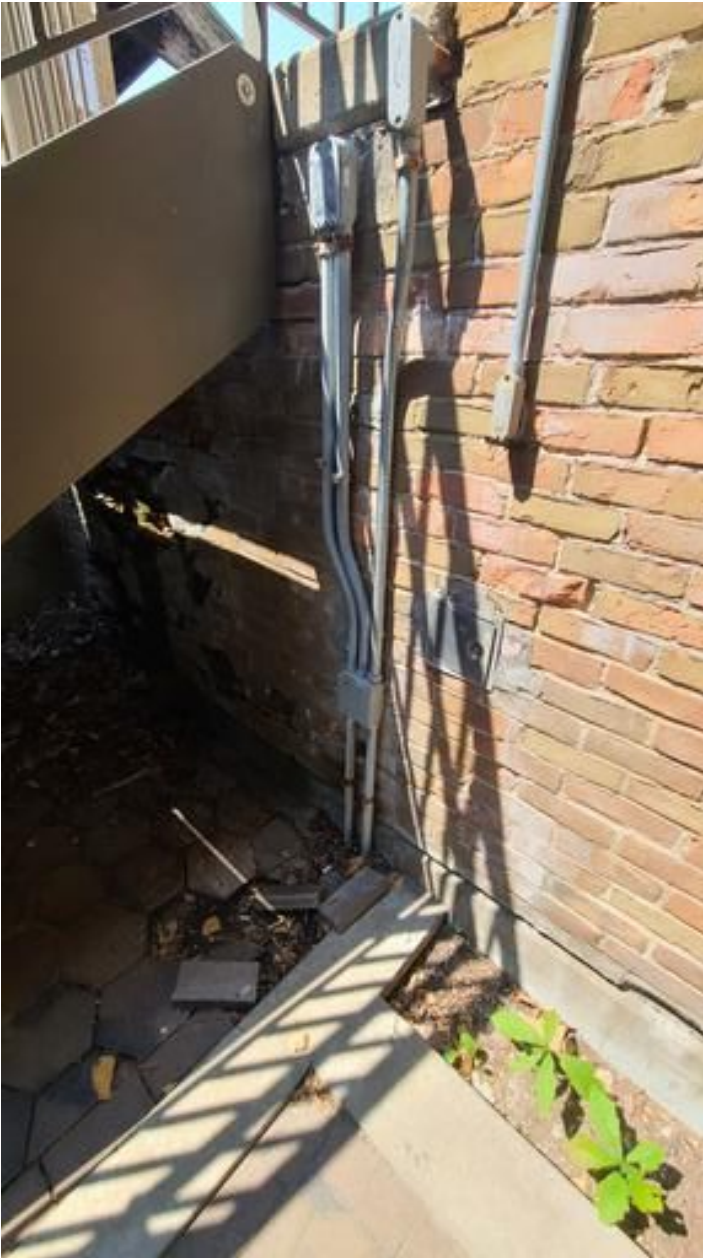
Description	Masonry damage underneath exterior stairs. Corrosion at the metal panning at the top of the stairs.
Assigned to	—
Created by	Gabriel David (Cordogan Clark)
Created on	Jun 21, 2023
Location	Village Hall - First Floor
Location details	—
Due date	—
Start date	—
Placement	05 (Village Hall - First Floor Plan)
Root cause	—

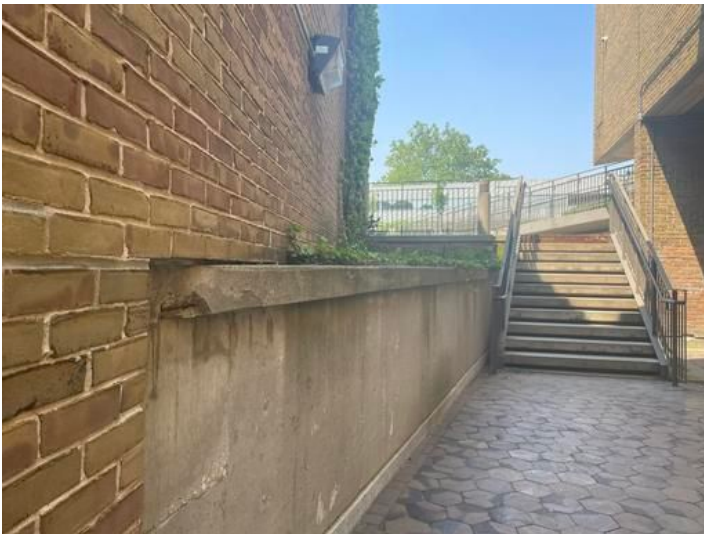
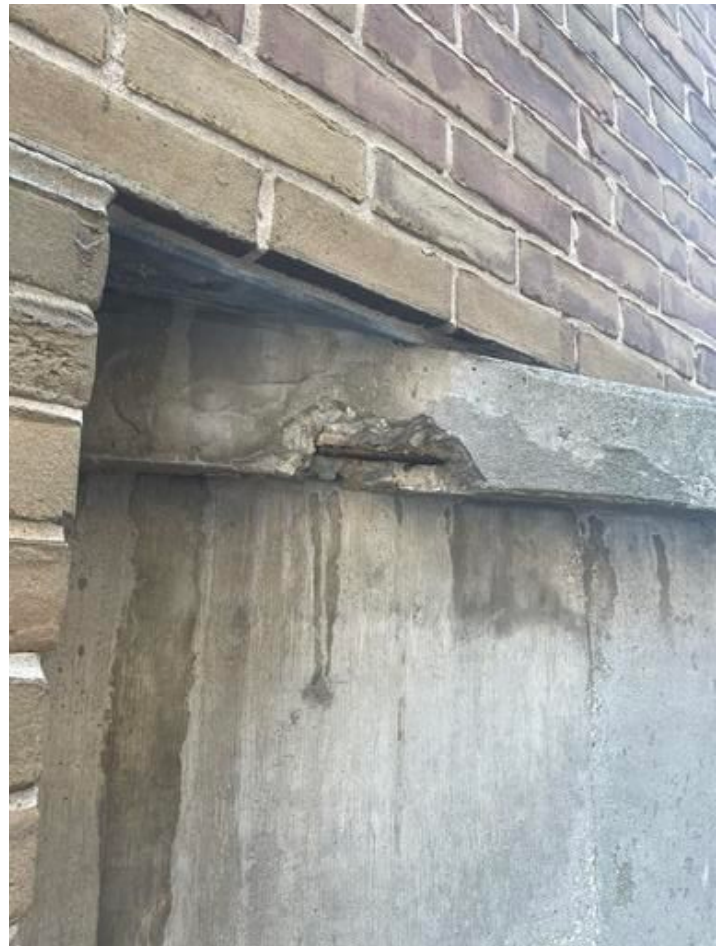
ID	#146
Pin	12
Status	<div></div> Open
Type	<div>AI</div> Architectural Issues > Architectural Issues

Description	Exposed rebar in concrete.
Assigned to	—
Created by	Gabriel David (Cordogan Clark)
Created on	Jun 21, 2023
Location	Village Hall - First Floor
Location details	—
Due date	—
Start date	—
Placement	05 (Village Hall - First Floor Plan)
Root cause	—

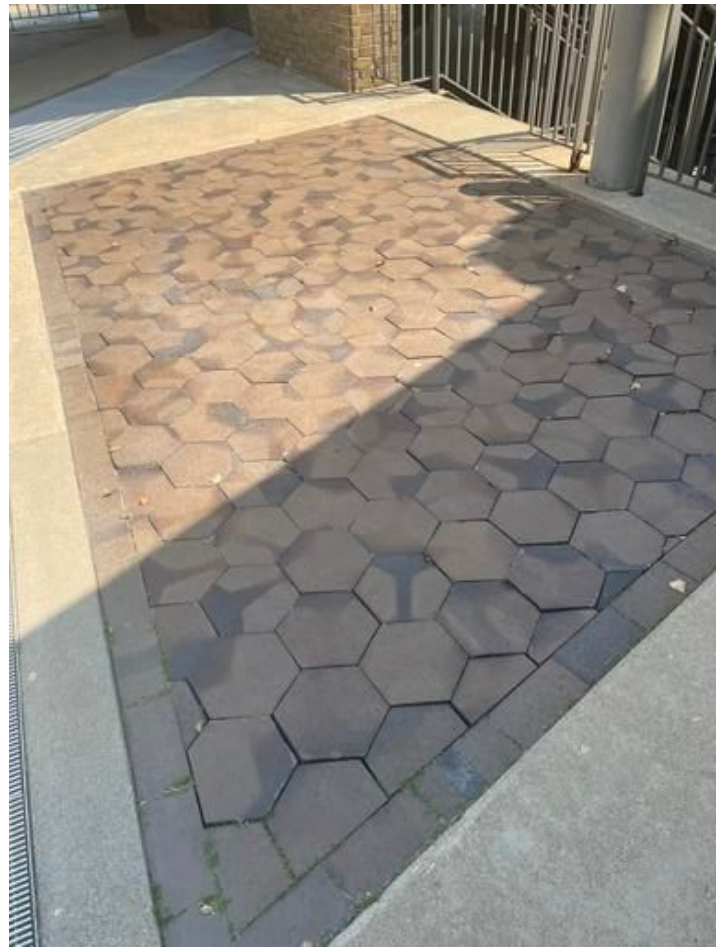
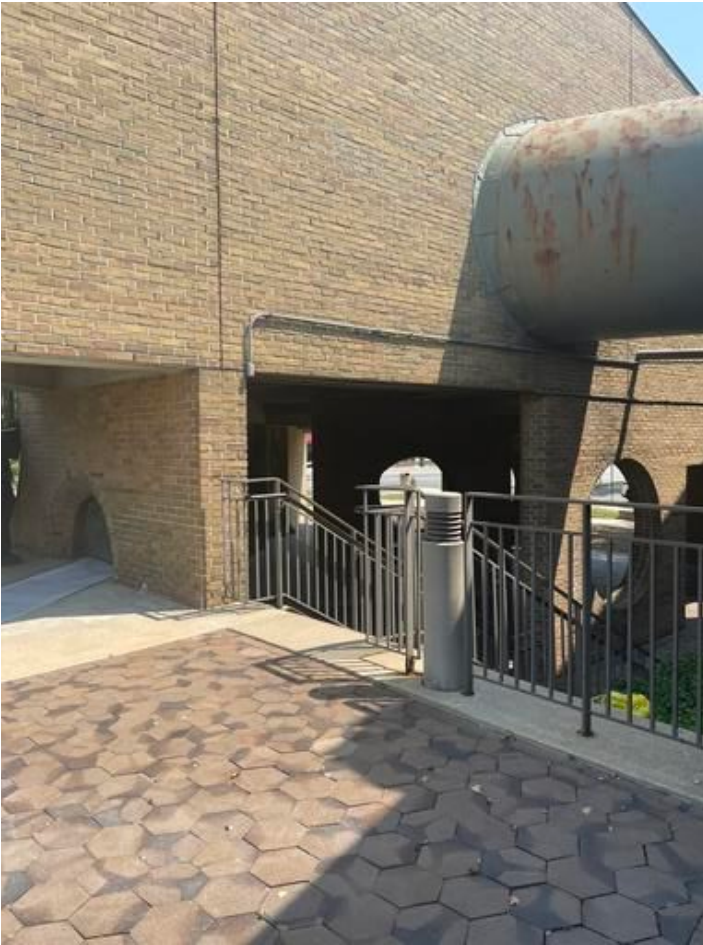
ID	#147
Pin	13
Status	<div>Open</div>
Type	<div>AI</div> Architectural Issues > Architectural Issues

Description	Organic growth at the corner and along the edge of the tiled area.
Assigned to	—
Created by	Gabriel David (Cordogan Clark)
Created on	Jun 21, 2023
Location	Village Hall - First Floor
Location details	—
Due date	—
Start date	—
Placement	05 (Village Hall - First Floor Plan)
Root cause	—

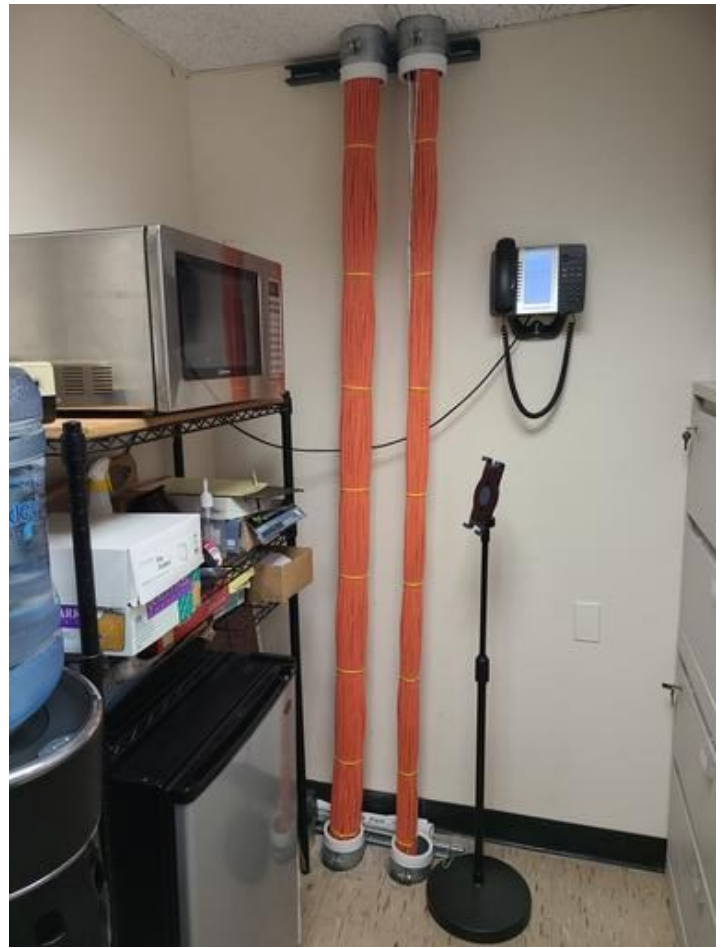
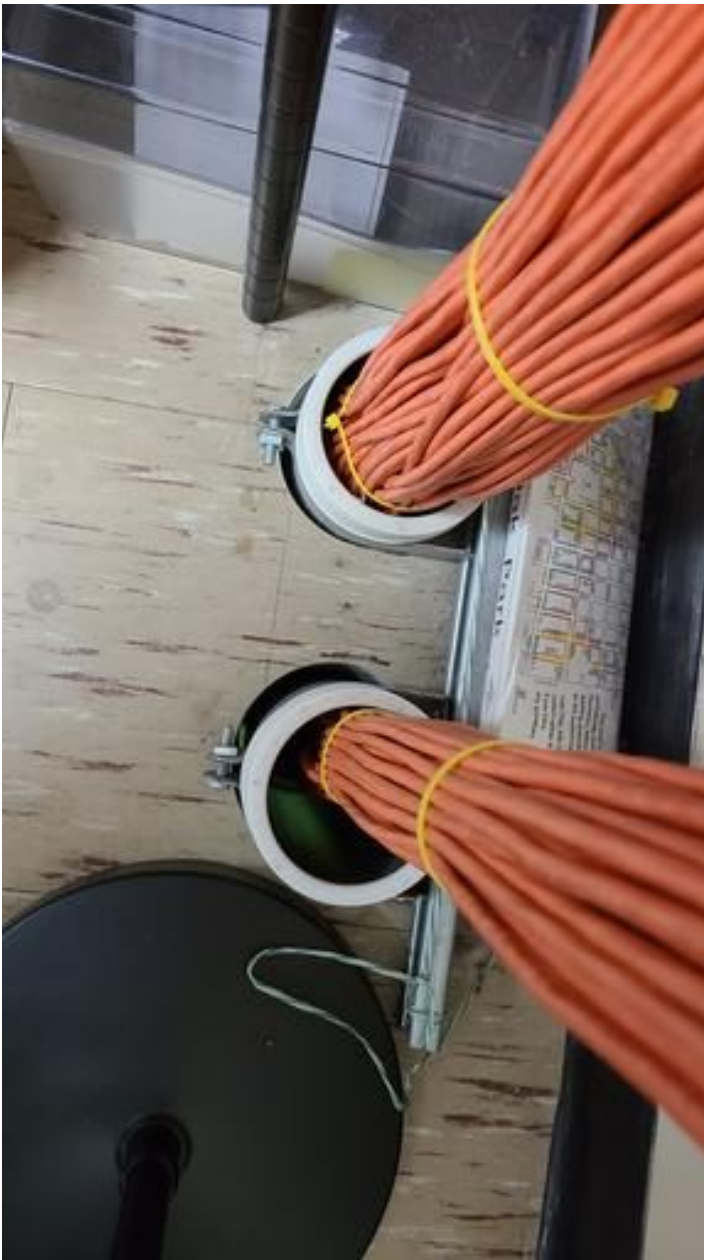
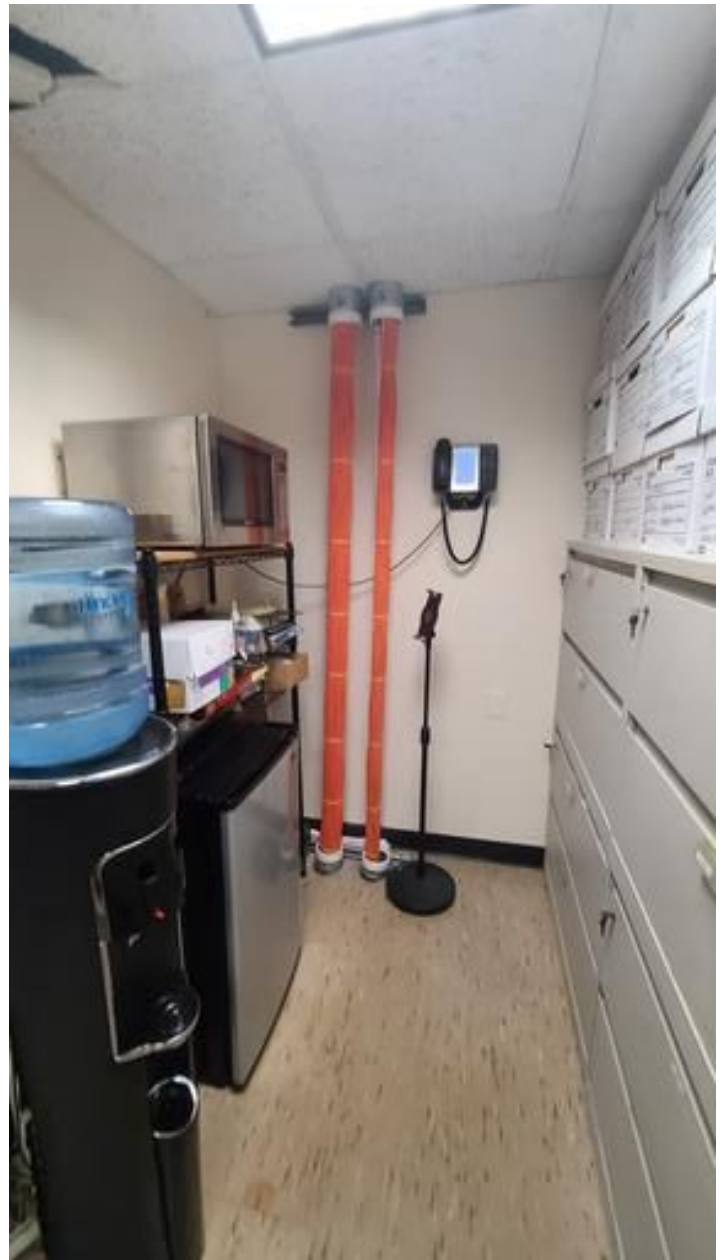
ID	#151
Pin	14
Status	■ Open
Type	AI Architectural Issues > Architectural Issues

Description	Cable penetrations not sealed.
Assigned to	—
Created by	Gabriel David (Cordogan Clark)
Created on	Jun 21, 2023
Location	Village Hall - First Floor
Location details	—
Due date	—
Start date	—
Placement	05 (Village Hall - First Floor Plan)
Root cause	—

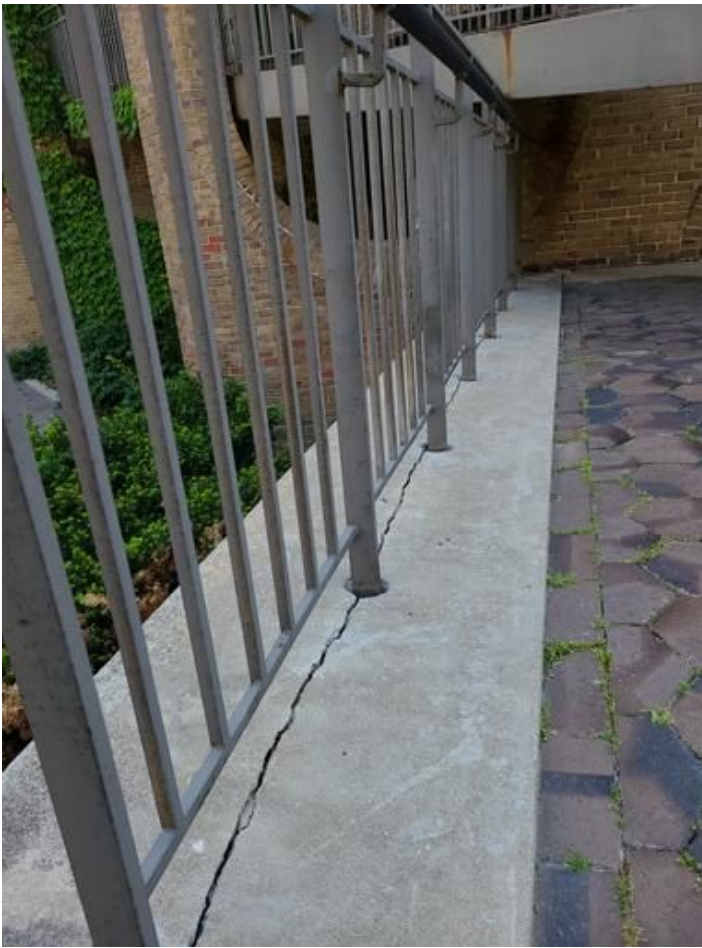
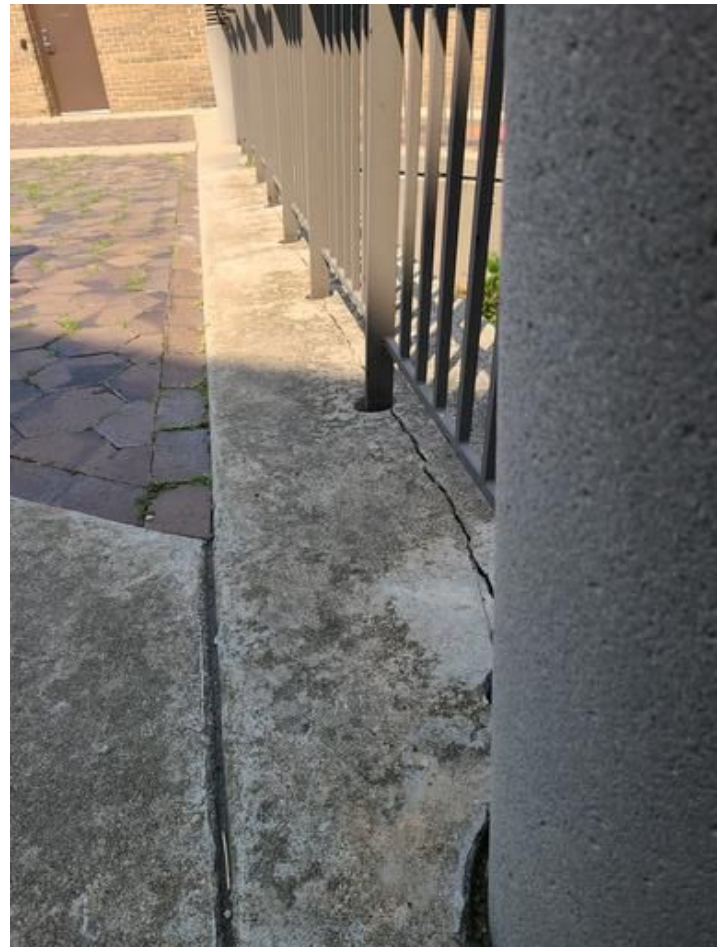
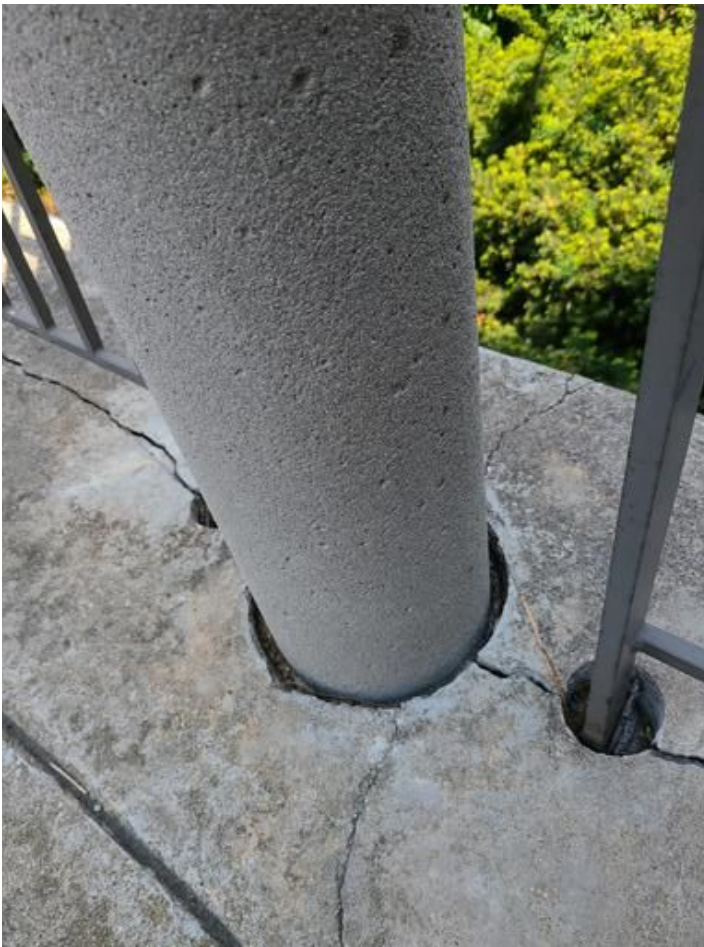
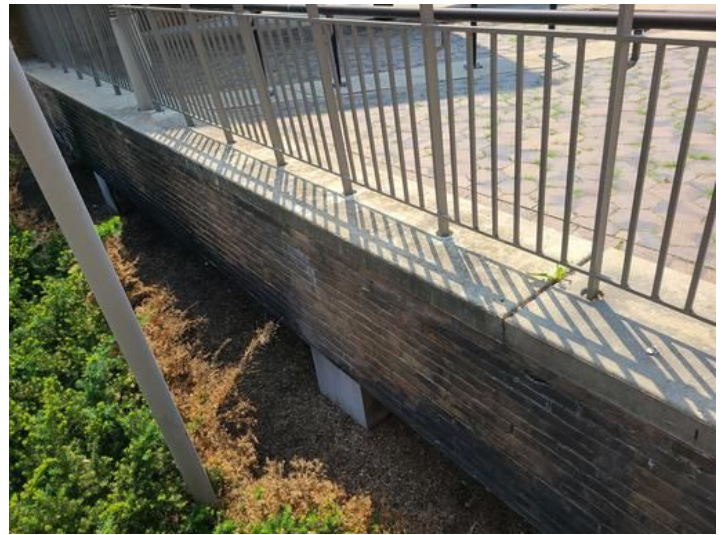
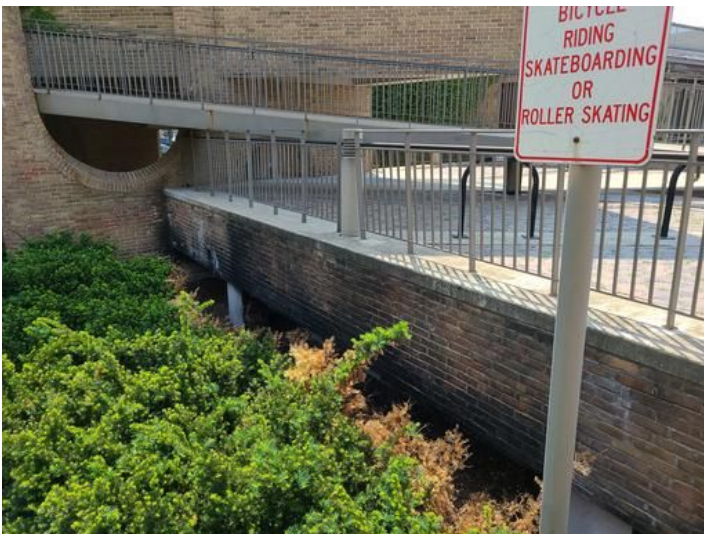
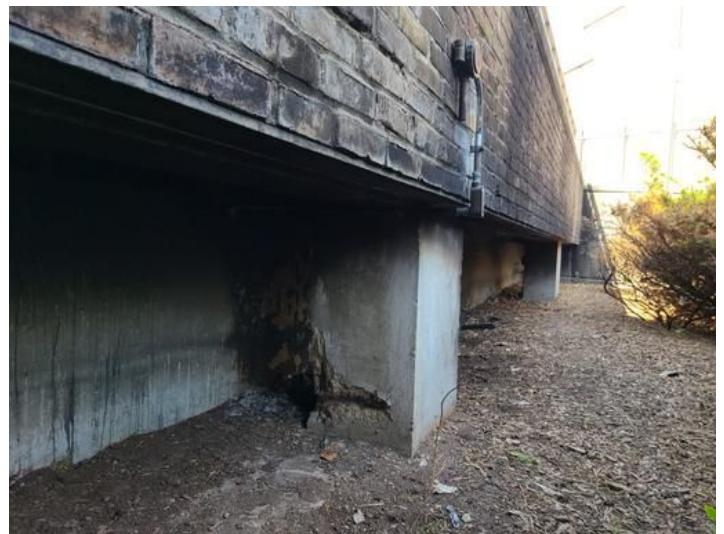
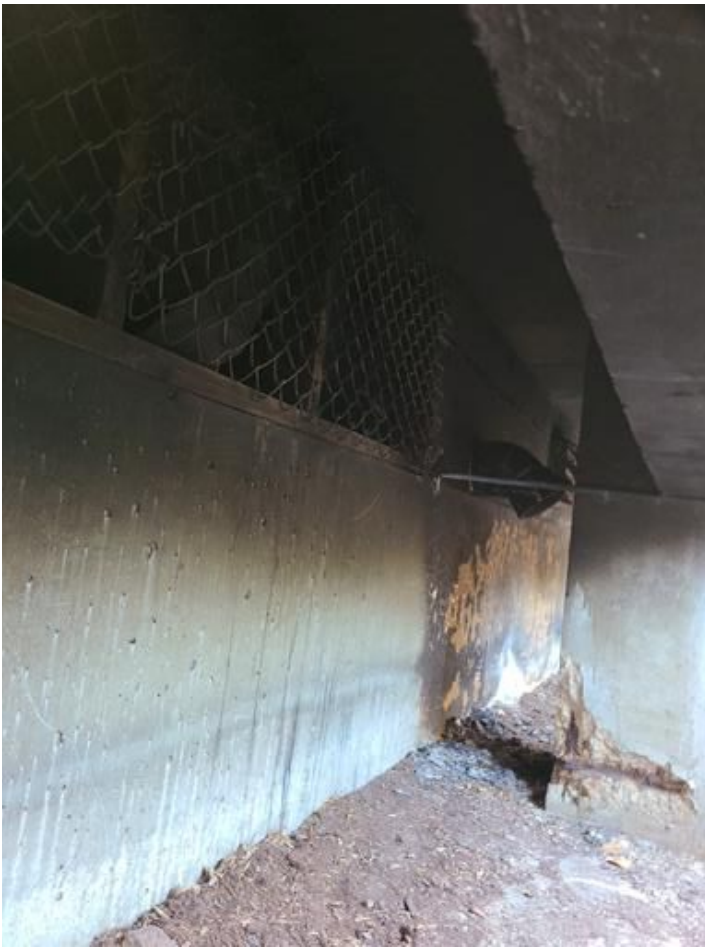
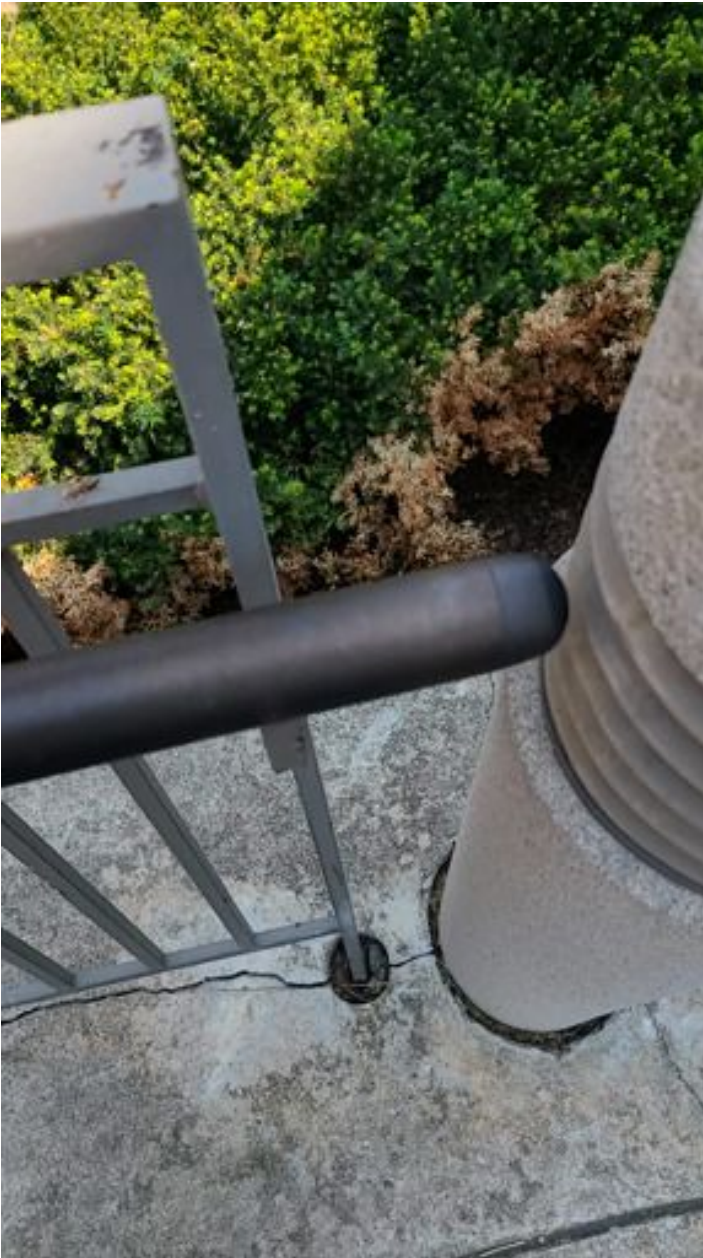
ID	#153
Pin	15
Status	■ Open
Type	AI Architectural Issues > Architectural Issues

Description	Railing loose. Concrete cracked.
Assigned to	—
Created by	Gabriel David (Cordogan Clark)
Created on	Jun 21, 2023
Location	Village Hall - First Floor
Location details	—
Due date	—
Start date	—
Placement	05 (Village Hall - First Floor Plan)
Root cause	—

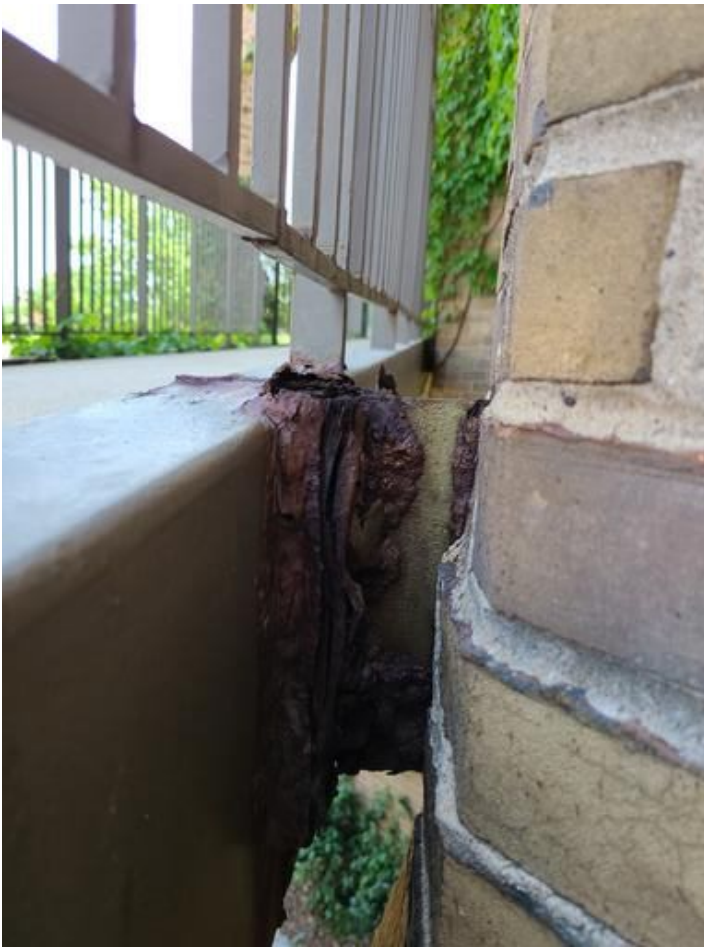
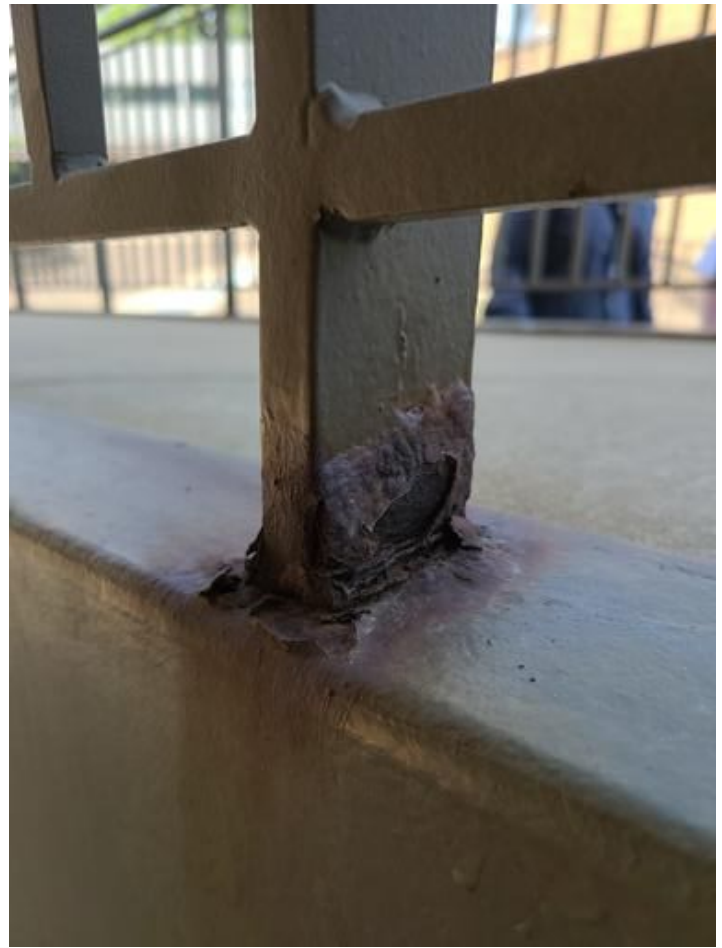
ID	#154
Pin	16
Status	■ Open
Type	AI Architectural Issues > Architectural Issues

Description	Corrosion at steel connections.
Assigned to	—
Created by	Gabriel David (Cordogan Clark)
Created on	Jun 21, 2023
Location	Village Hall - First Floor
Location details	—
Due date	—
Start date	—
Placement	05 (Village Hall - First Floor Plan)
Root cause	—

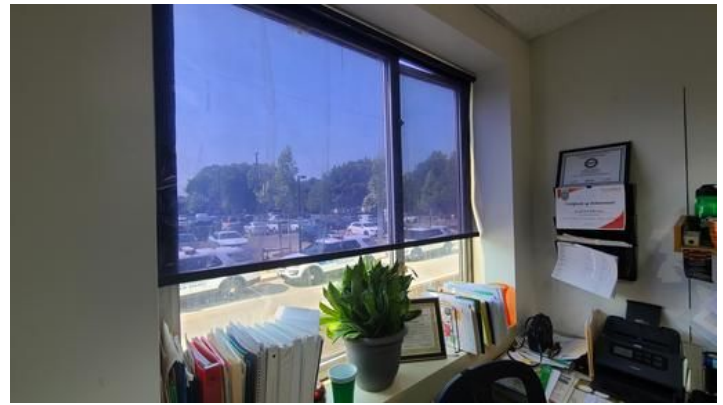
ID	#253
Pin	17
Status	■ Open
Type	AI Architectural Issues > Architectural Issues

Description	Images of window in Adjudication Office. Note corrosion on the frame.
Assigned to	—
Created by	Gabriel David (Cordogan Clark)
Created on	Jun 26, 2023
Location	Village Hall - First Floor
Location details	—
Due date	—
Start date	—
Placement	05 (Village Hall - First Floor Plan)
Root cause	—

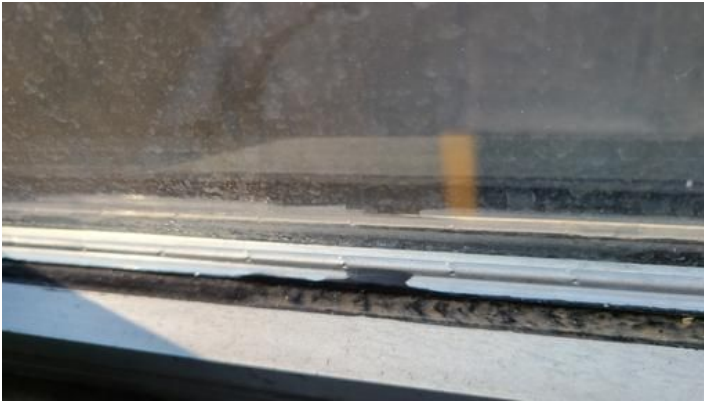
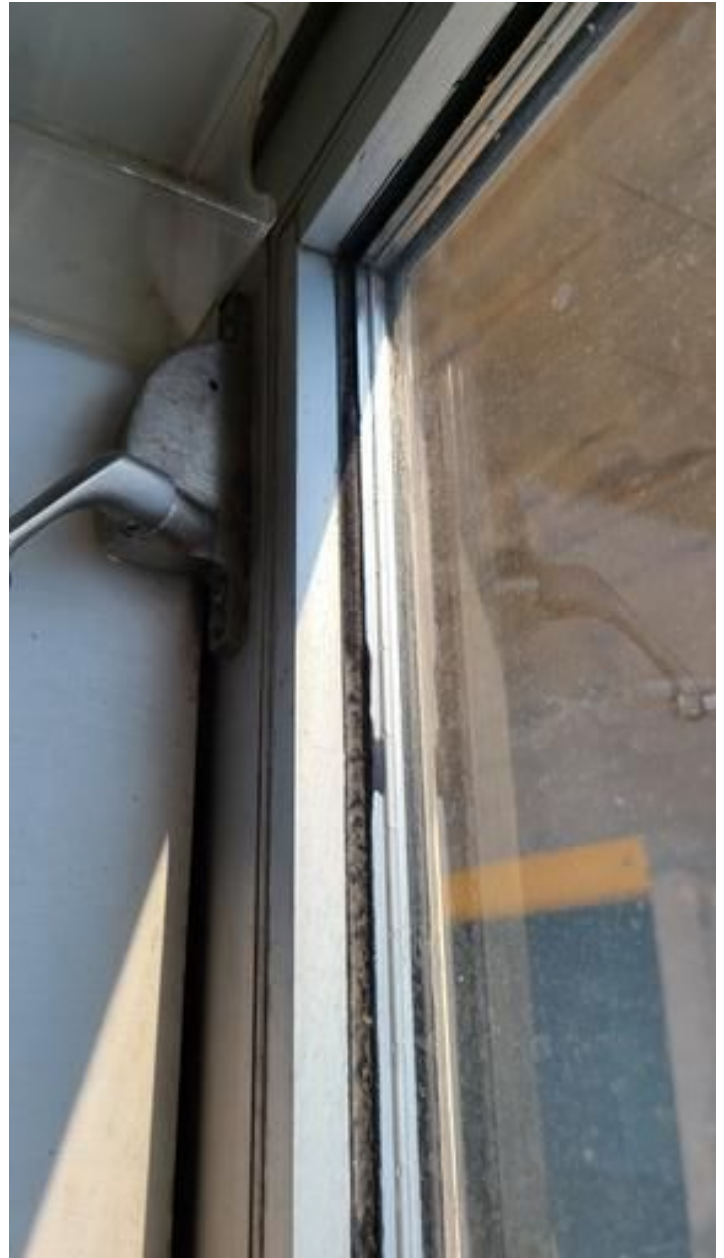
ID	#255
Pin	18
Status	■ Open
Type	AI Architectural Issues > Architectural Issues

Description	Close inspection of window frame damage.
Assigned to	—
Created by	Gabriel David (Cordogan Clark)
Created on	Jun 26, 2023
Location	Village Hall - First Floor
Location details	—
Due date	—
Start date	—
Placement	05 (Village Hall - First Floor Plan)
Root cause	—

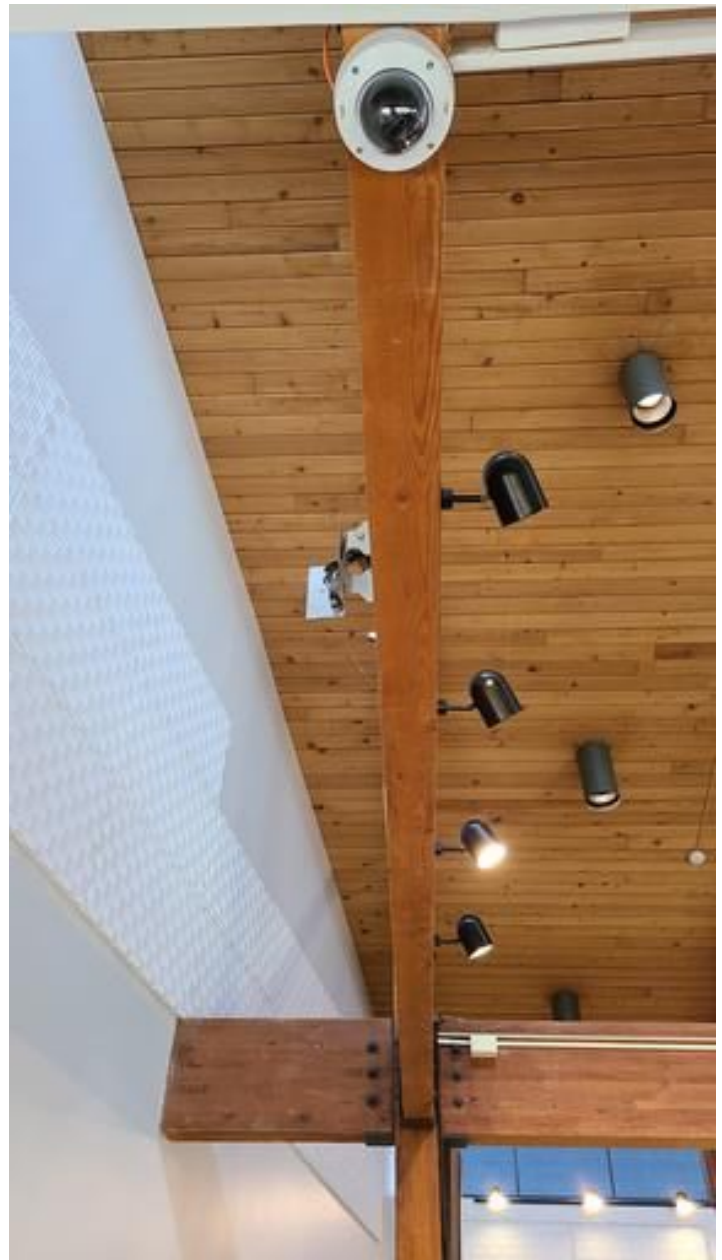
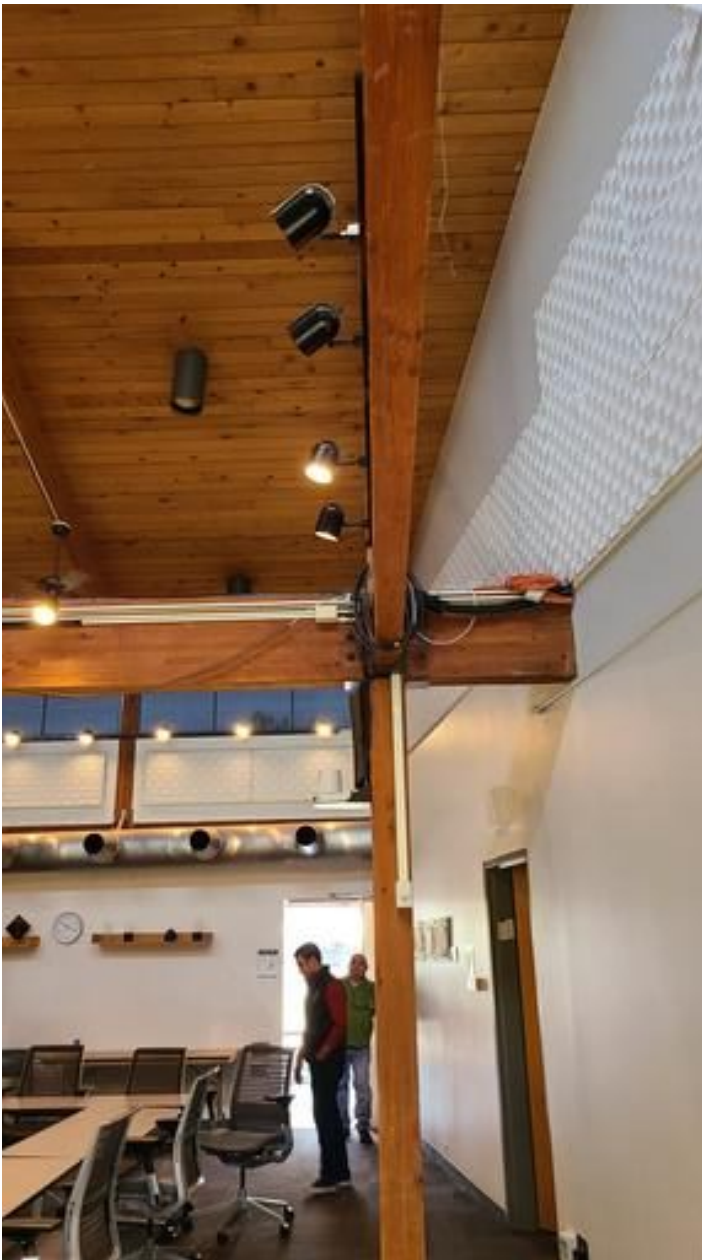
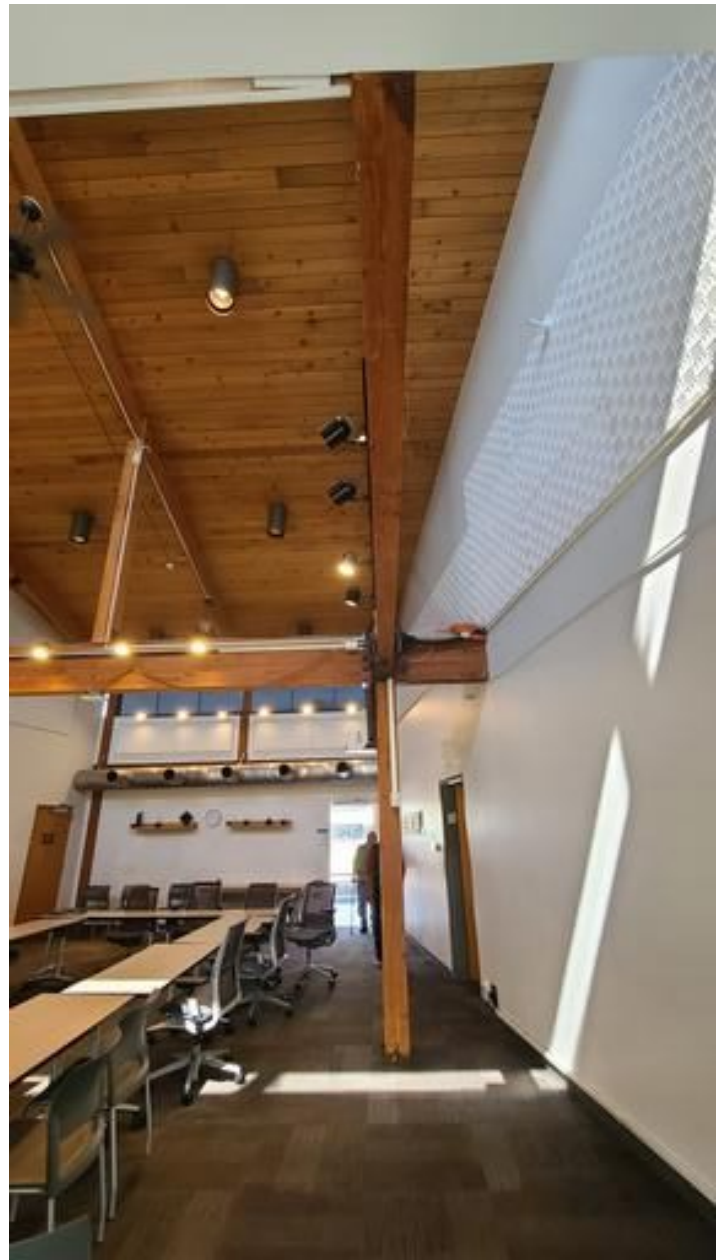
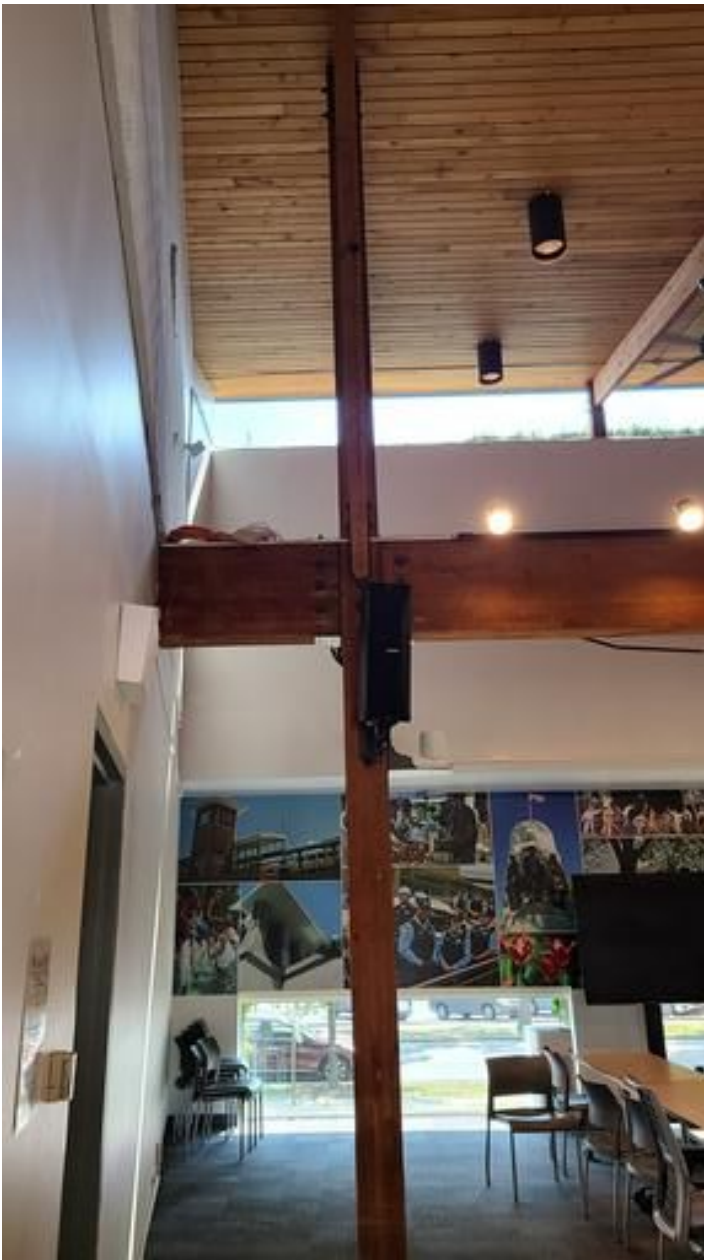
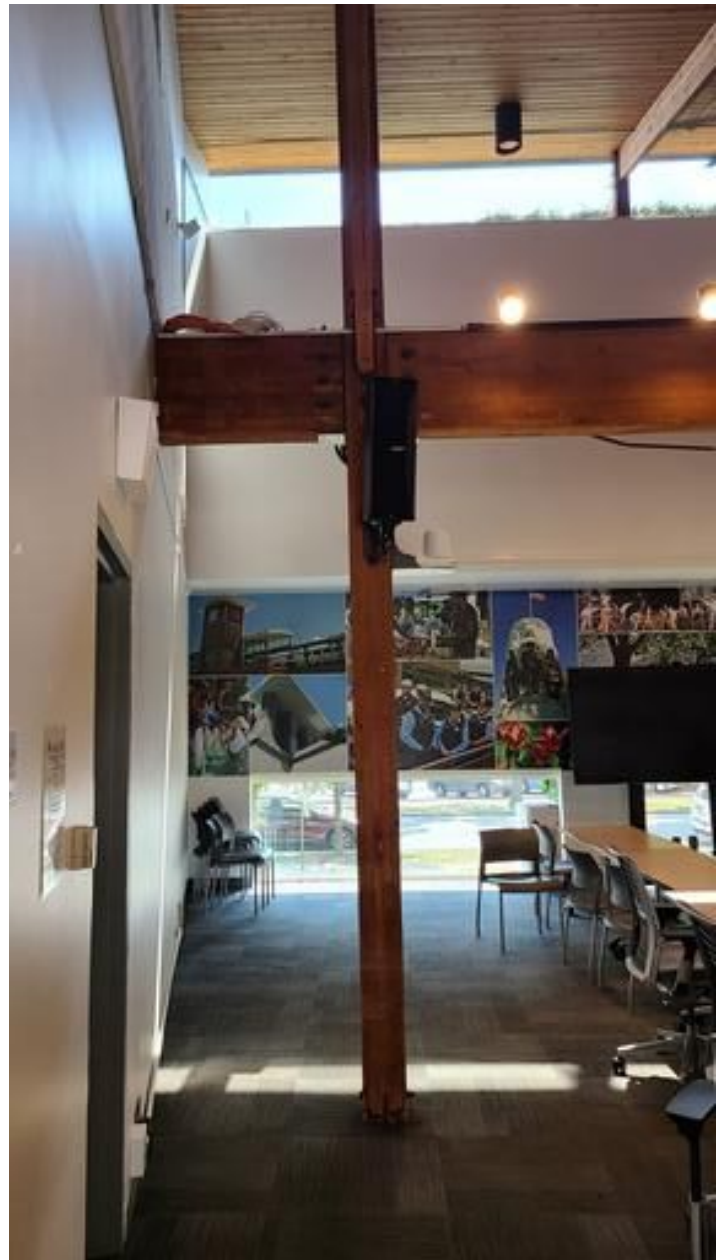
ID	#262
Pin	19
Status	■ Open
Type	AI Architectural Issues > Architectural Issues

Description	Wood supports warping slightly.
Assigned to	—
Created by	Gabriel David (Cordogan Clark)
Created on	Jun 26, 2023
Location	Village Hall - First Floor
Location details	—
Due date	—
Start date	—
Placement	05 (Village Hall - First Floor Plan)
Root cause	—

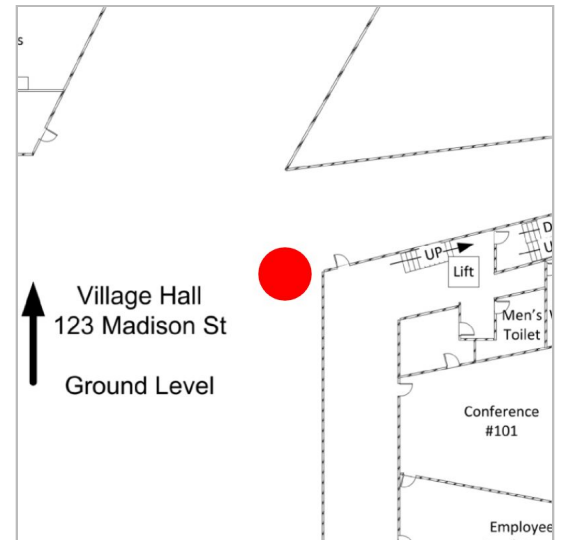
ID	#290
Pin	21
Status	 Open
Type	AI Architectural Issues > Architectural Issues

Description	Ivy growth at support connections.
Assigned to	—
Created by	Gabriel David (Cordogan Clark)
Created on	Jun 26, 2023
Location	Village Hall - First Floor
Location details	—
Due date	—
Start date	—
Placement	05 (Village Hall - First Floor Plan)
Root cause	—
