**OAK PARK VILLAGE HALL
123 Madison Street, Oak Park IL. 60302**

**PROPERTY CONDITION ASSESSMENT REPORT
07.08.23**

Property Condition Assessment Report

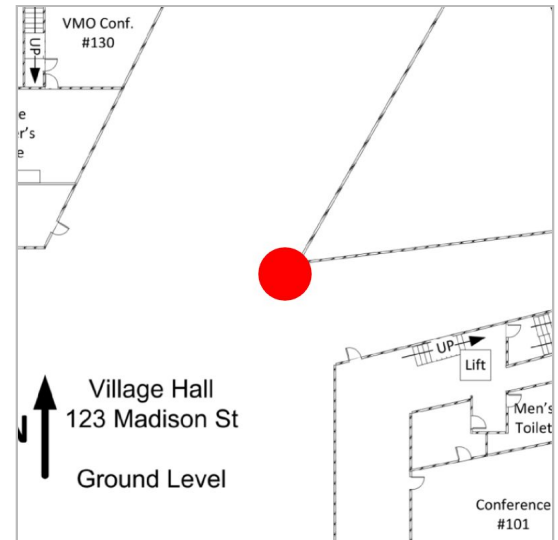
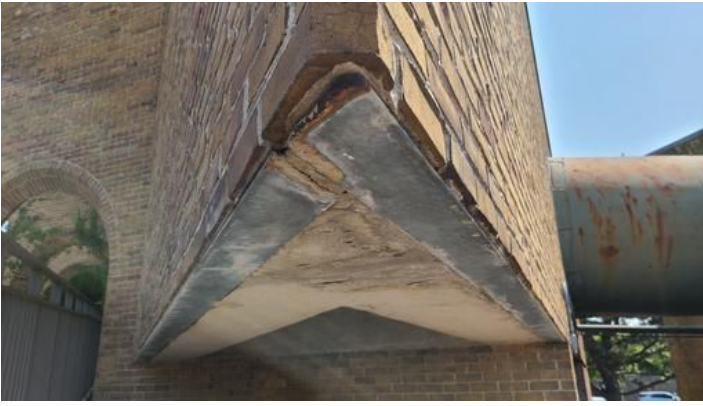
ID	#291
Pin	22
Status	■ Open
Type	AI Architectural Issues > Architectural Issues

Description	Rusting and corrosion.
Assigned to	—
Created by	Gabriel David (Cordogan Clark)
Created on	Jun 26, 2023
Location	Village Hall - First Floor
Location details	—
Due date	—
Start date	—
Placement	05 (Village Hall - First Floor Plan)
Root cause	—

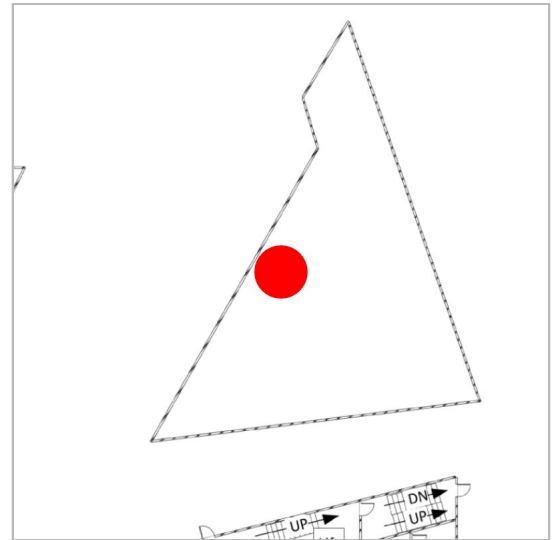
ID	#294
Pin	23
Status	■ Open
Type	AI Architectural Issues > Architectural Issues

Description	Damaged masonry.
Assigned to	—
Created by	Gabriel David (Cordogan Clark)
Created on	Jun 26, 2023
Location	Village Hall - First Floor
Location details	—
Due date	—
Start date	—
Placement	05 (Village Hall - First Floor Plan)
Root cause	—

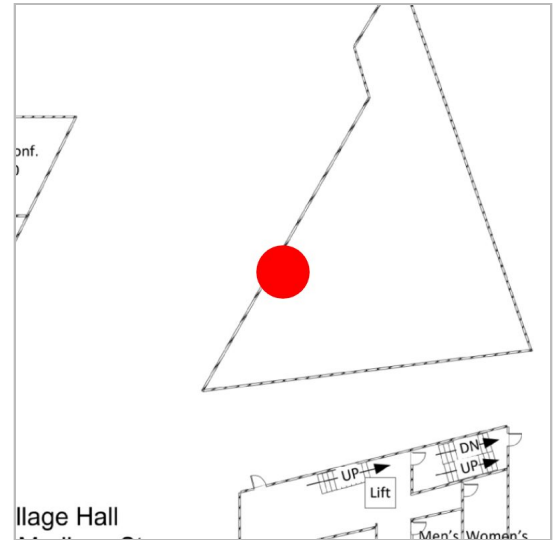
ID	#295
Pin	24
Status	■ Open
Type	AI Architectural Issues > Architectural Issues

Description	Cracked underside.
Assigned to	—
Created by	Gabriel David (Cordogan Clark)
Created on	Jun 26, 2023
Location	Village Hall - First Floor
Location details	—
Due date	—
Start date	—
Placement	05 (Village Hall - First Floor Plan)
Root cause	—

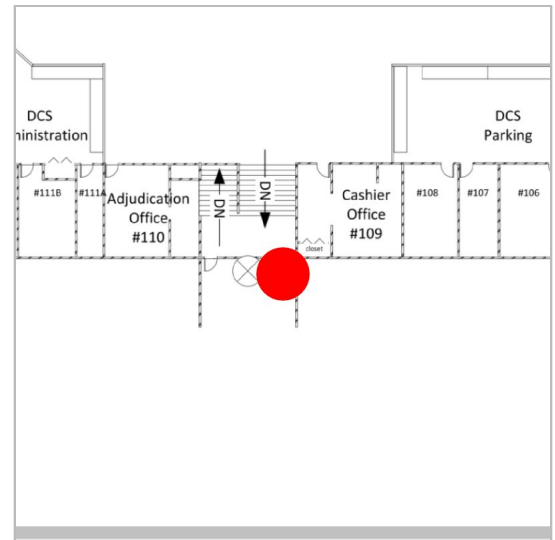
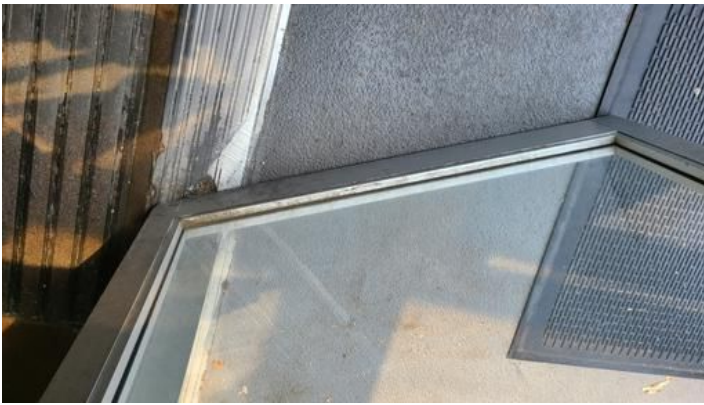
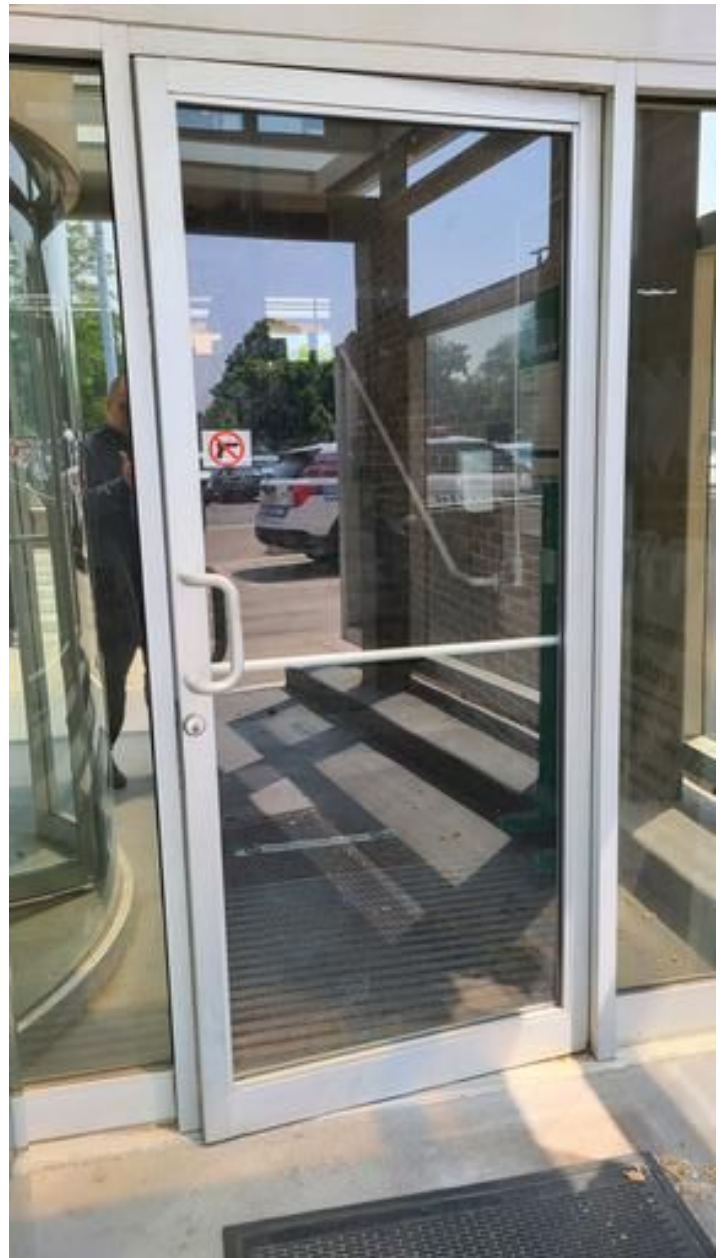
ID	#303
Pin	25
Status	 Open
Type	AI Architectural Issues > Architectural Issues

Description	Rusting and corroded door.
Assigned to	—
Created by	Gabriel David (Cordogan Clark)
Created on	Jun 26, 2023
Location	Village Hall - First Floor
Location details	—
Due date	—
Start date	—
Placement	05 (Village Hall - First Floor Plan)
Root cause	—

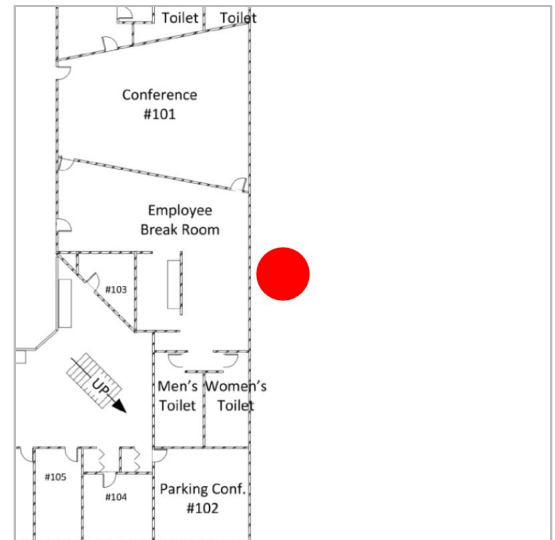
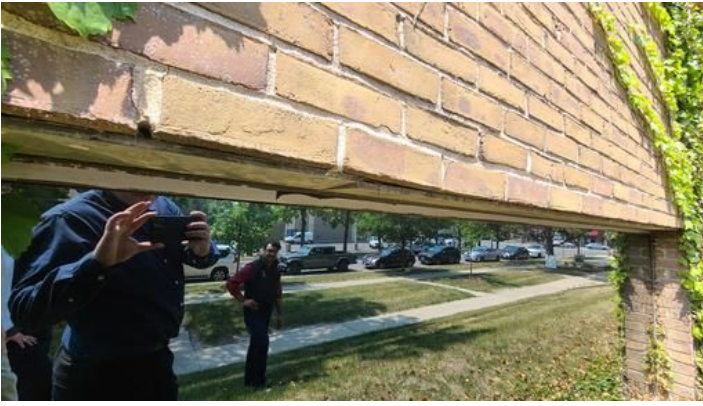
ID	#305
Pin	26
Status	 Open
Type	AI Architectural Issues > Architectural Issues

Description	Gap between steel lintel and masonry.
Assigned to	—
Created by	Gabriel David (Cordogan Clark)
Created on	Jun 26, 2023
Location	Village Hall - First Floor
Location details	—
Due date	—
Start date	—
Placement	05 (Village Hall - First Floor Plan)
Root cause	—

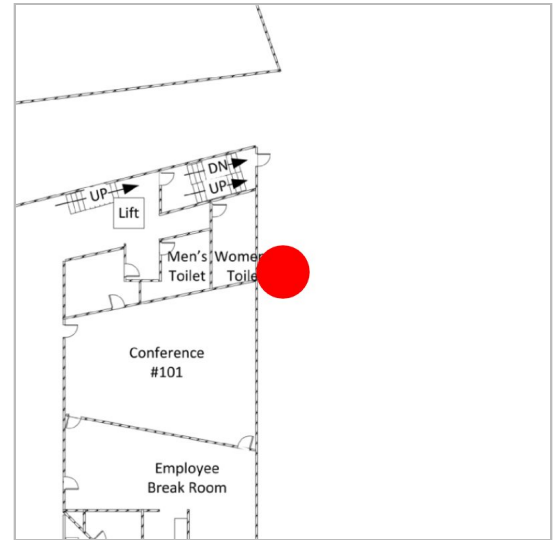
ID	#306
Pin	27
Status	■ Open
Type	AI Architectural Issues > Architectural Issues

Description	Pipe obscured by excess overgrowth.
Assigned to	—
Created by	Gabriel David (Cordogan Clark)
Created on	Jun 26, 2023
Location	Village Hall - First Floor
Location details	—
Due date	—
Start date	—
Placement	05 (Village Hall - First Floor Plan)
Root cause	—

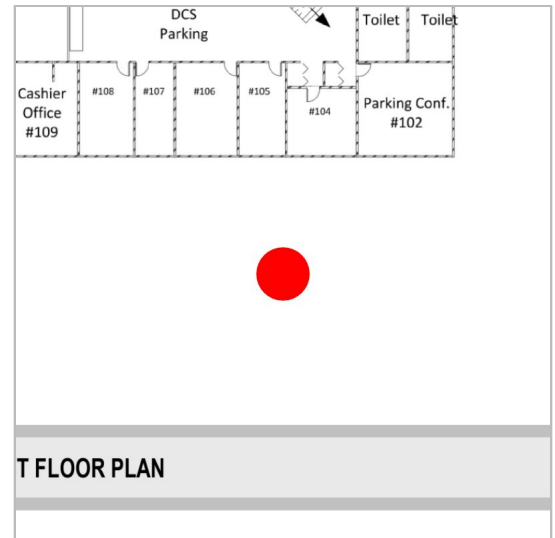
ID	#311
Pin	28
Status	 Open
Type	AI Architectural Issues > Architectural Issues

Description	Missing portion of tree grate.
Assigned to	—
Created by	Gabriel David (Cordogan Clark)
Created on	Jun 26, 2023
Location	Village Hall - First Floor
Location details	—
Due date	—
Start date	—
Placement	05 (Village Hall - First Floor Plan)
Root cause	—

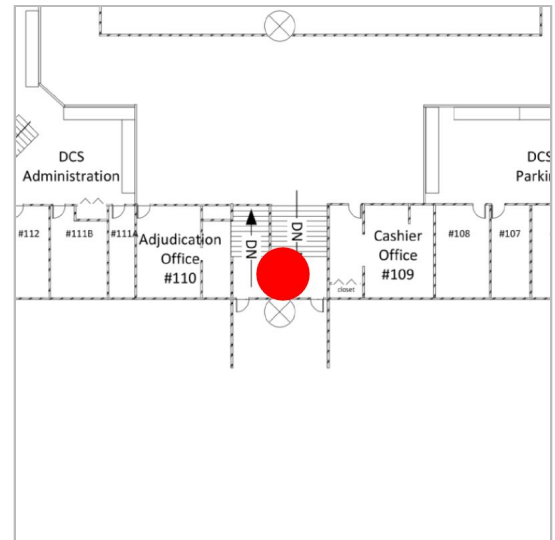
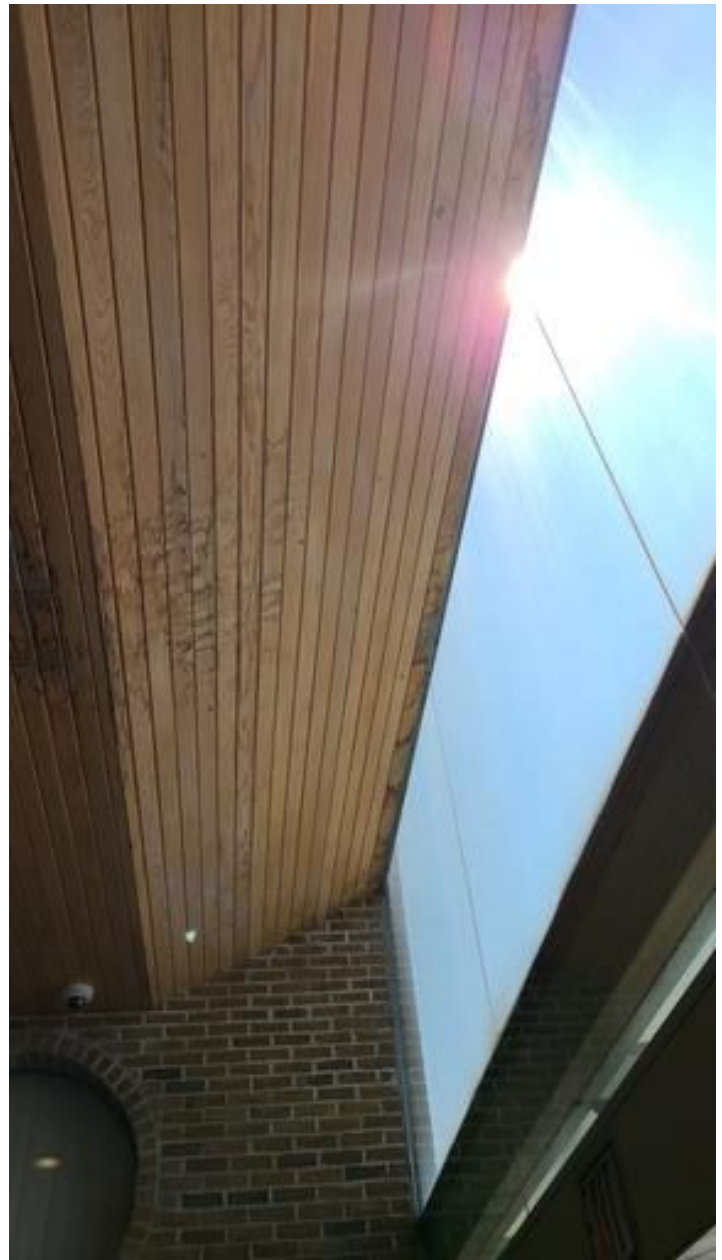
ID	#313
Pin	29
Status	 Open
Type	AI Architectural Issues > Architectural Issues

Description	Water staining at the underside of wood decking in the South entrance
Assigned to	—
Created by	Gabriel David (Cordogan Clark)
Created on	Jun 26, 2023
Location	Village Hall - First Floor
Location details	—
Due date	—
Start date	—
Placement	05 (Village Hall - First Floor Plan)
Root cause	—

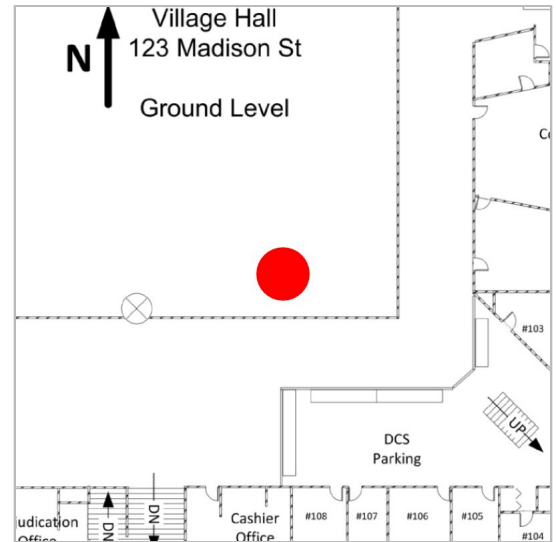
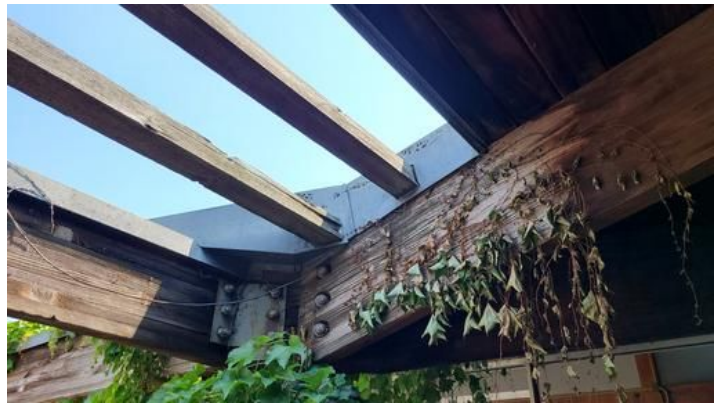
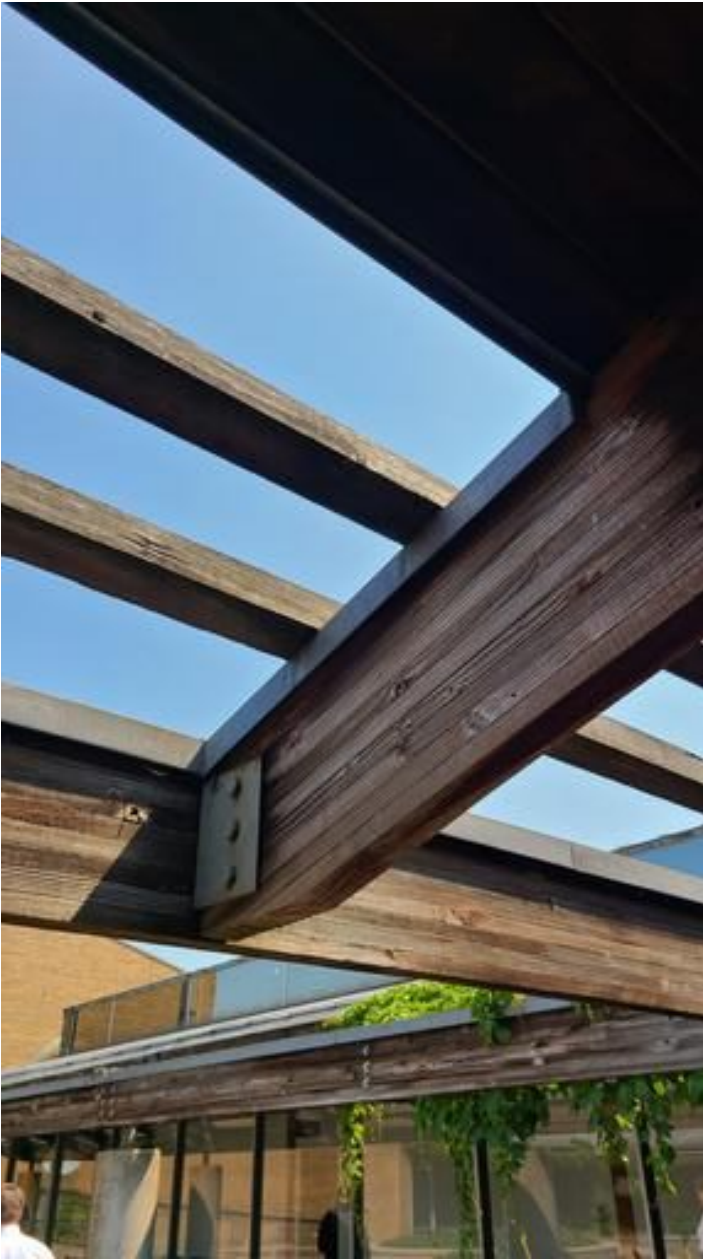
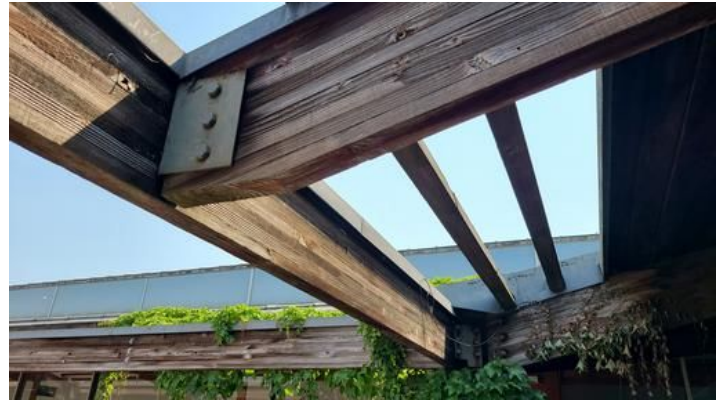
ID	#289
Pin	30
Status	■ Open
Type	AI Architectural Issues > Architectural Issues

Description	Ivy growth along beams.
Assigned to	—
Created by	Gabriel David (Cordogan Clark)
Created on	Jun 26, 2023
Location	Village Hall - First Floor
Location details	—
Due date	—
Start date	—
Placement	05 (Village Hall - First Floor Plan)
Root cause	—

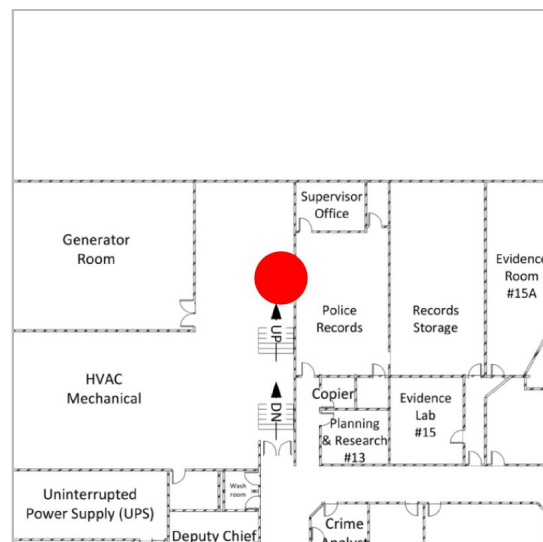
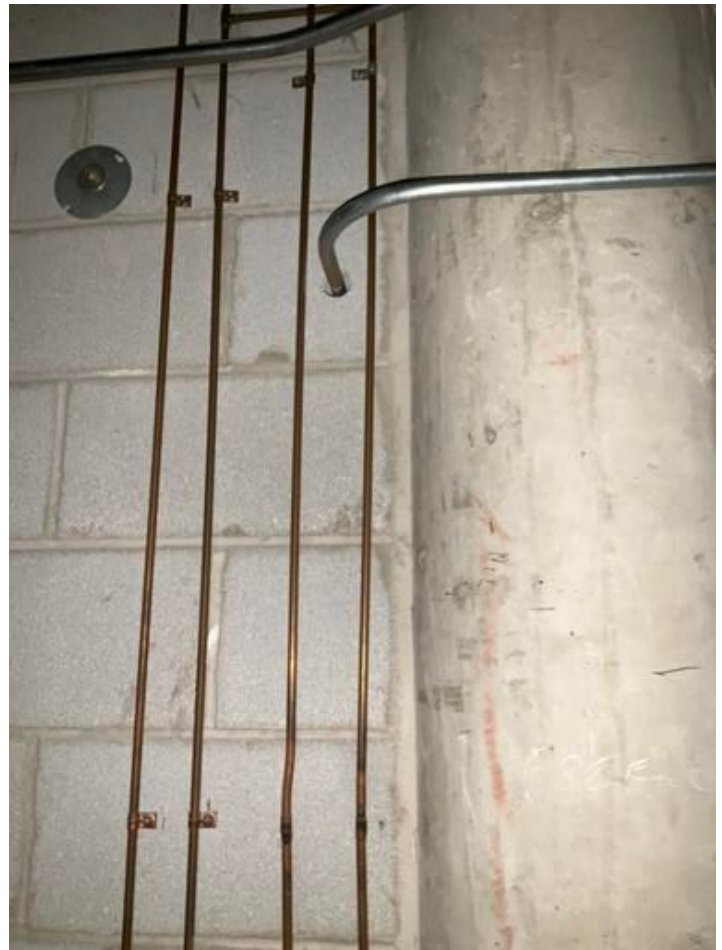
ID	#124
Pin	31
Status	■ Open
Type	MI Mechanical Issues > Mechanical Issues

Description	Unsealed penetration into boiler room.
Assigned to	—
Created by	Gabriel David (Cordogan Clark)
Created on	Jun 21, 2023
Location	Village Hall - Lower Level
Location details	—
Due date	—
Start date	—
Placement	04 (Village Hall - Lower Level Plan)
Root cause	—

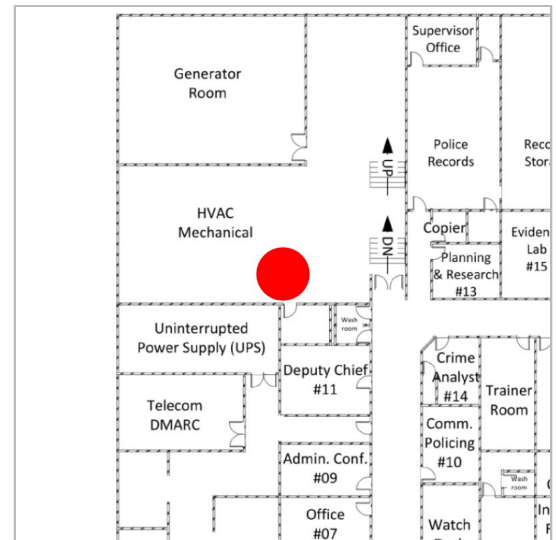
ID	#125
Pin	32
Status	■ Open
Type	MI Mechanical Issues > Mechanical Issues

Description	Missing junction box cover.
Assigned to	—
Created by	Gabriel David (Cordogan Clark)
Created on	Jun 21, 2023
Location	Village Hall - Lower Level
Location details	—
Due date	—
Start date	—
Placement	04 (Village Hall - Lower Level Plan)
Root cause	—

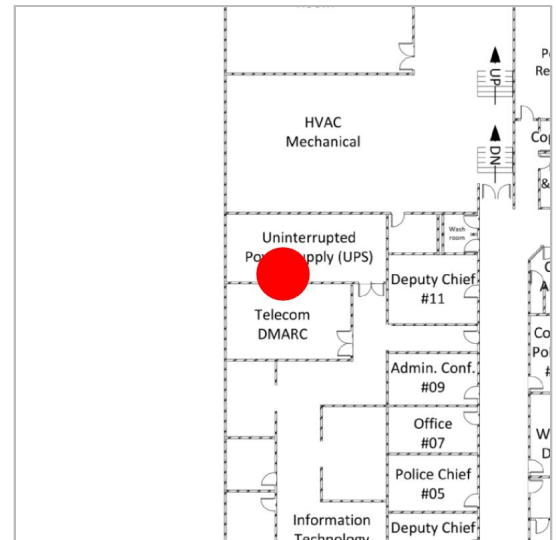
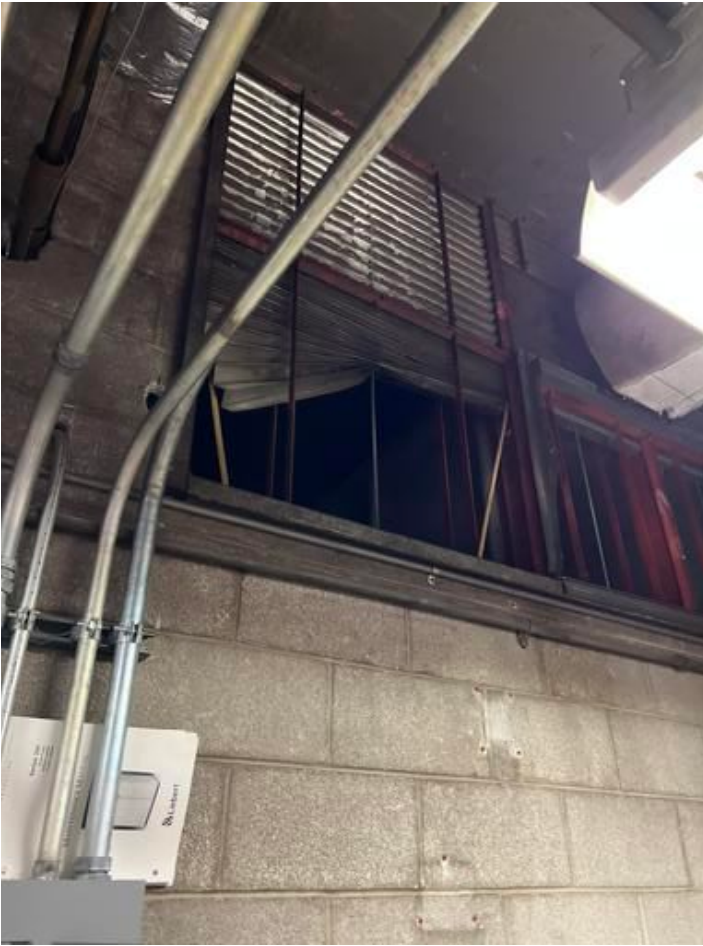
ID	#129
Pin	33
Status	■ Open
Type	MI Mechanical Issues > Mechanical Issues

Description	Photo of damaged fire damper.
Assigned to	—
Created by	Gabriel David (Cordogan Clark)
Created on	Jun 21, 2023
Location	Village Hall - Lower Level
Location details	—
Due date	—
Start date	—
Placement	04 (Village Hall - Lower Level Plan)
Root cause	—

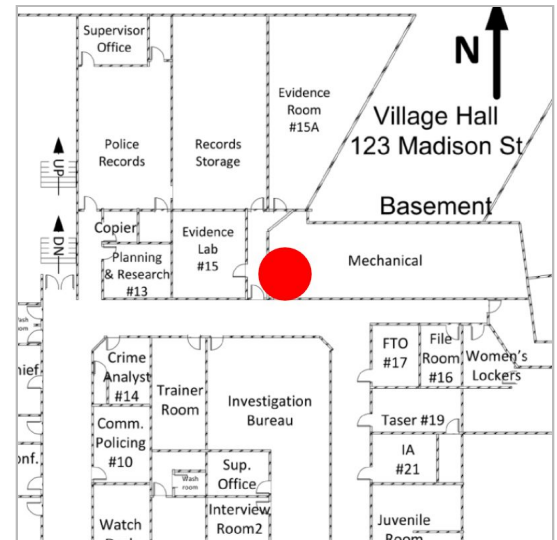
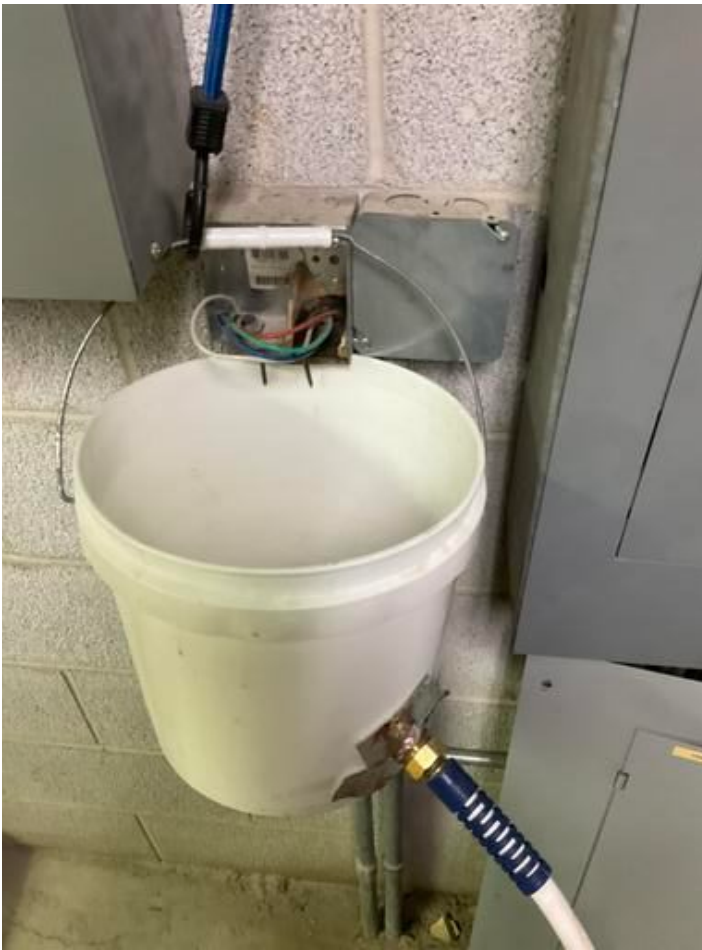
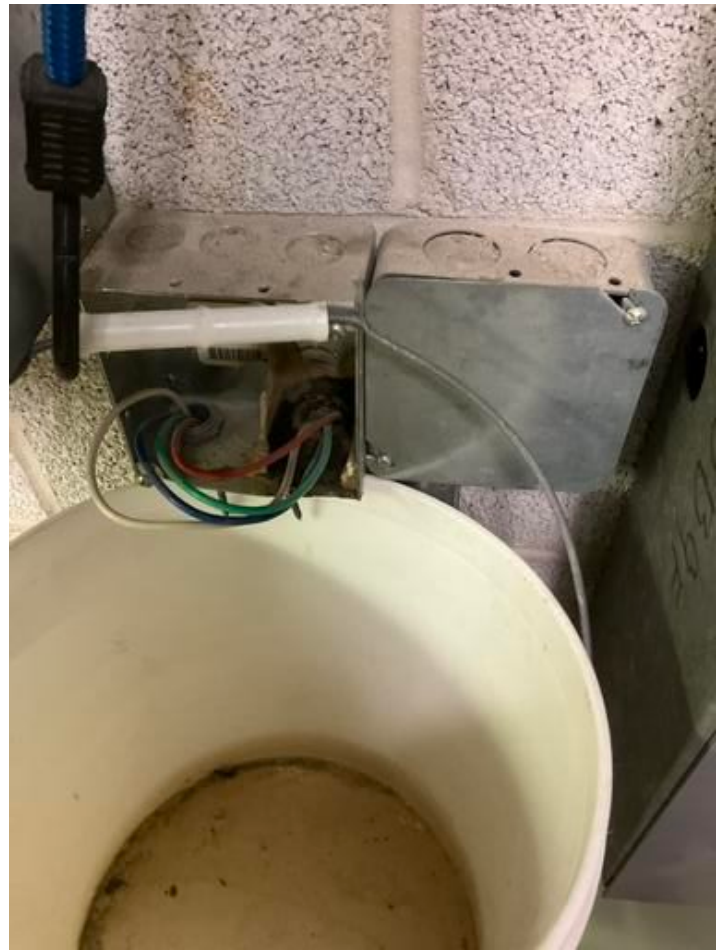
ID	#119
Pin	34
Status	■ Open
Type	EI Electrical Issues > Electrical Issues

Description	Existing underground conduit flooding, for existing exterior grade lighting.
Assigned to	—
Created by	Gabriel David (Cordogan Clark)
Created on	Jun 21, 2023
Location	Village Hall - Lower Level
Location details	—
Due date	—
Start date	—
Placement	04 (Village Hall - Lower Level Plan)
Root cause	—

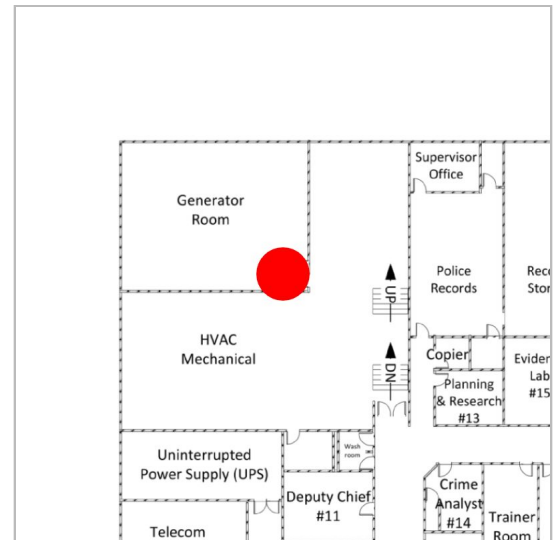
ID	#121
Pin	35
Status	■ Open
Type	EI Electrical Issues > Electrical Issues

Description	Non-illuminated exit for path egress from boiler room.
Assigned to	—
Created by	Gabriel David (Cordogan Clark)
Created on	Jun 21, 2023
Location	Village Hall - Lower Level
Location details	—
Due date	—
Start date	—
Placement	04 (Village Hall - Lower Level Plan)
Root cause	—

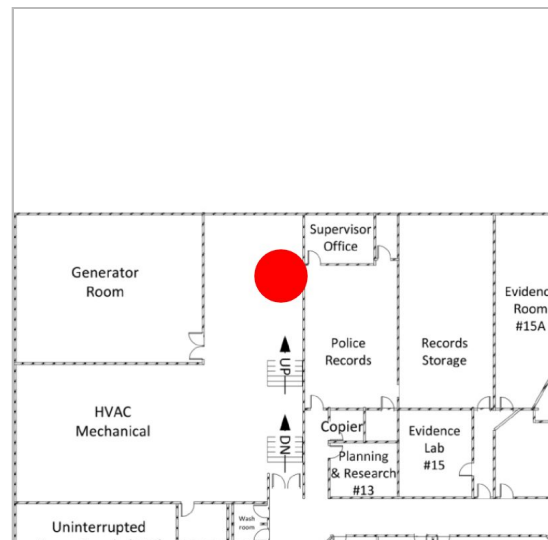
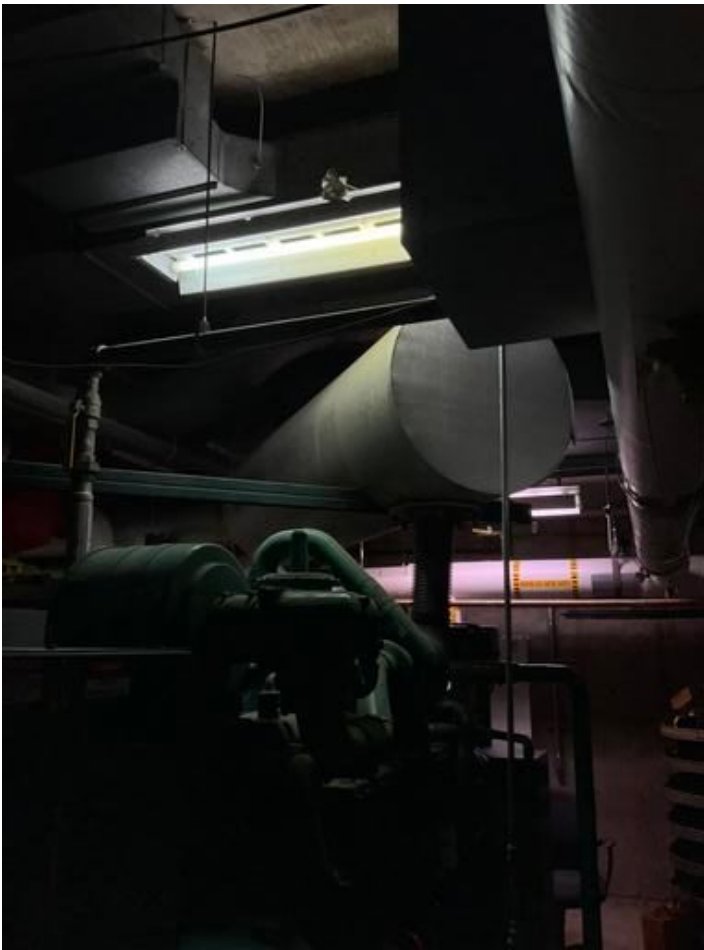
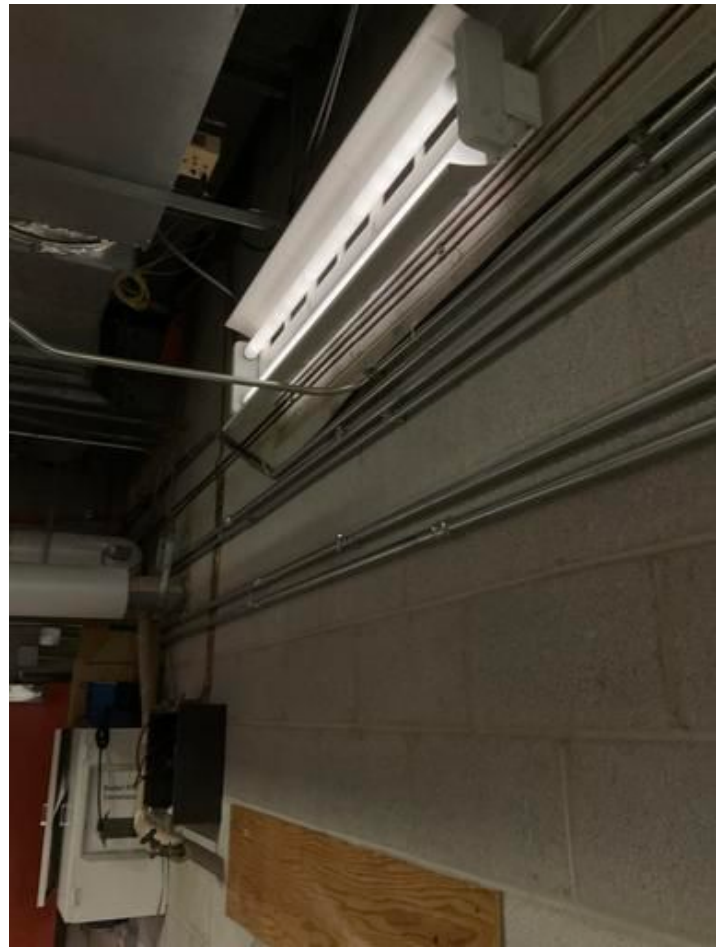
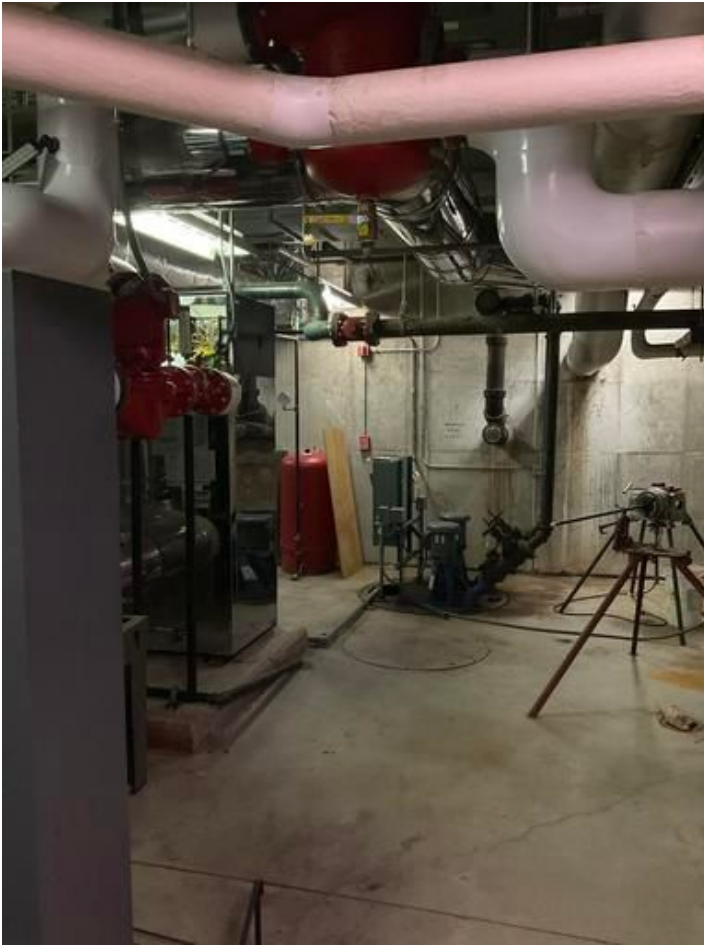
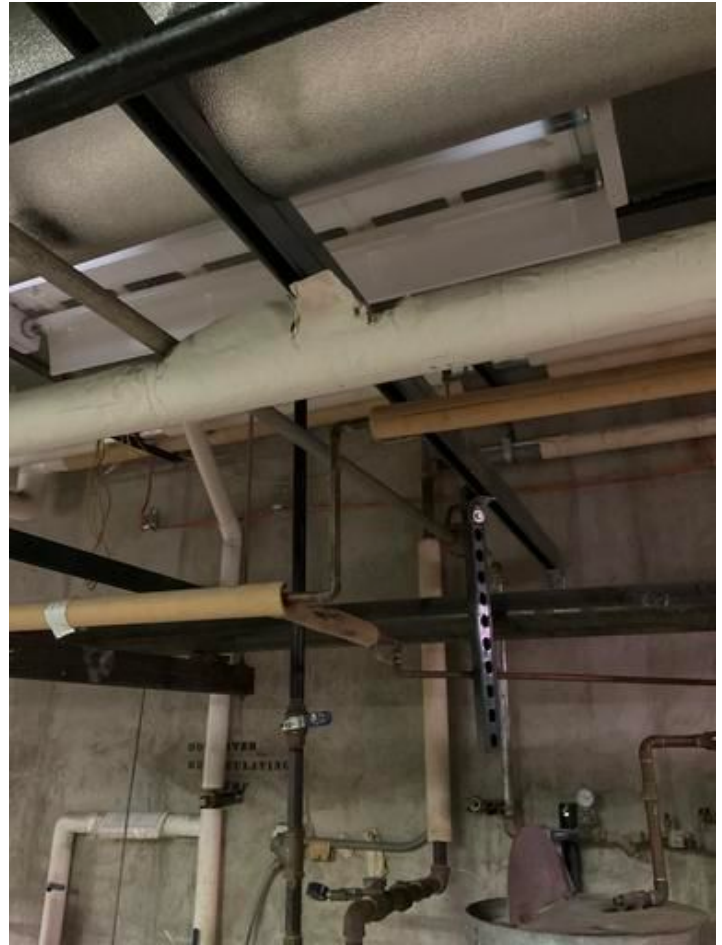
ID	#123
Pin	36
Status	■ Open
Type	EI Electrical Issues > Electrical Issues

Description	Poor lighting for boiler room, recommend direct.
Assigned to	—
Created by	Gabriel David (Cordogan Clark)
Created on	Jun 21, 2023
Location	Village Hall - Lower Level
Location details	—
Due date	—
Start date	—
Placement	04 (Village Hall - Lower Level Plan)
Root cause	—

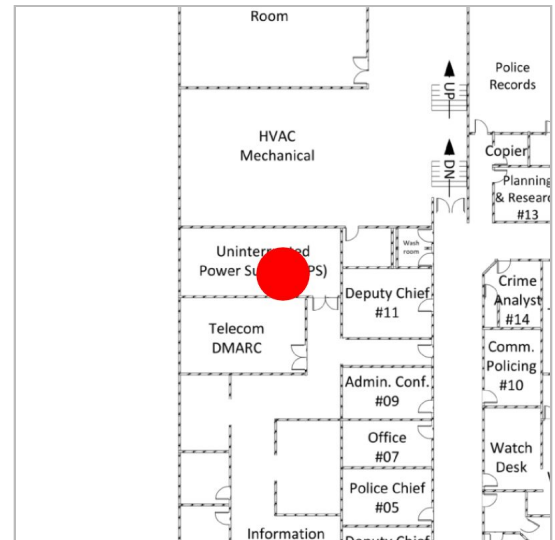
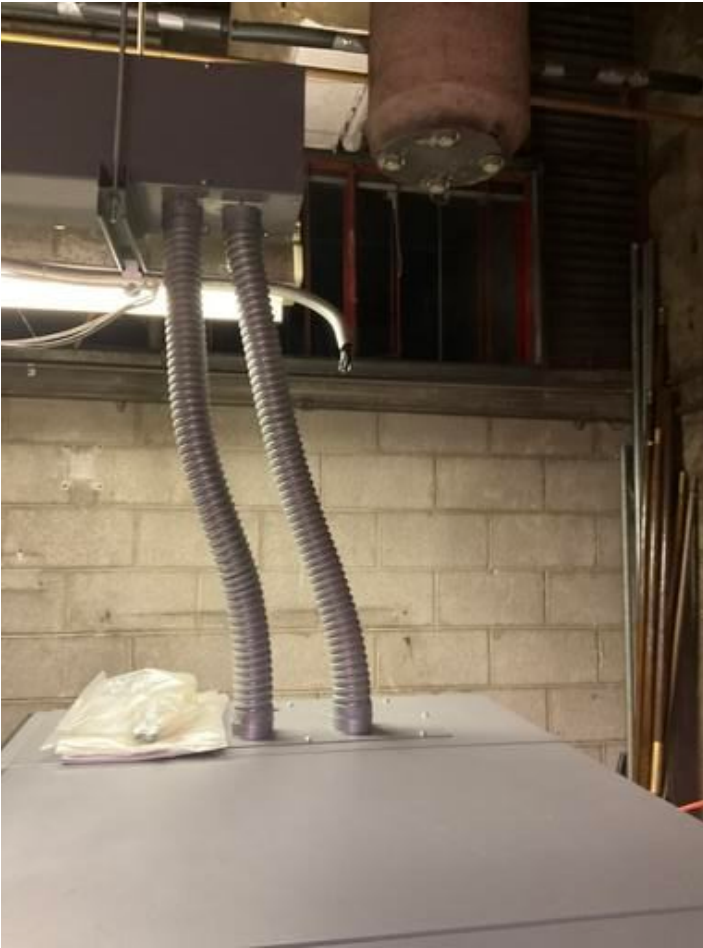
ID	#128
Pin	37
Status	■ Open
Type	EI Electrical Issues > Electrical Issues

Description	Abandoned wires at UPS.
Assigned to	—
Created by	Gabriel David (Cordogan Clark)
Created on	Jun 21, 2023
Location	Village Hall - Lower Level
Location details	—
Due date	—
Start date	—
Placement	04 (Village Hall - Lower Level Plan)
Root cause	—

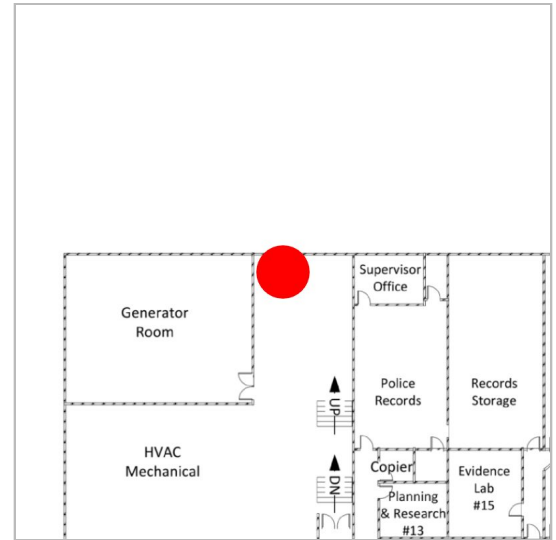
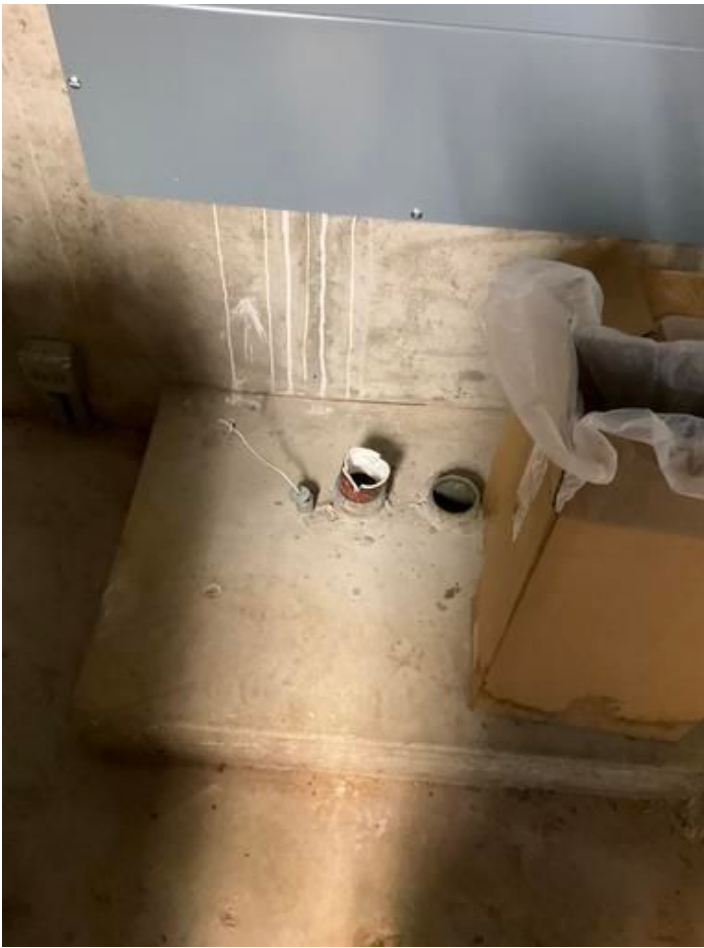
ID	#362
Pin	38
Status	■ Open
Type	EI Electrical Issues > Electrical Issues

Description	Overall photo of missing connection. open penetration.
Assigned to	—
Created by	Gabriel David (Cordogan Clark)
Created on	Jun 30, 2023
Location	Village Hall - Lower Level
Location details	—
Due date	—
Start date	—
Placement	04 (Village Hall - Lower Level Plan)
Root cause	—

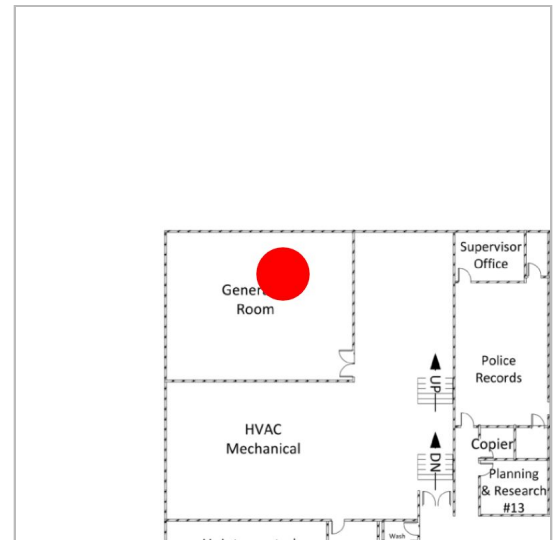
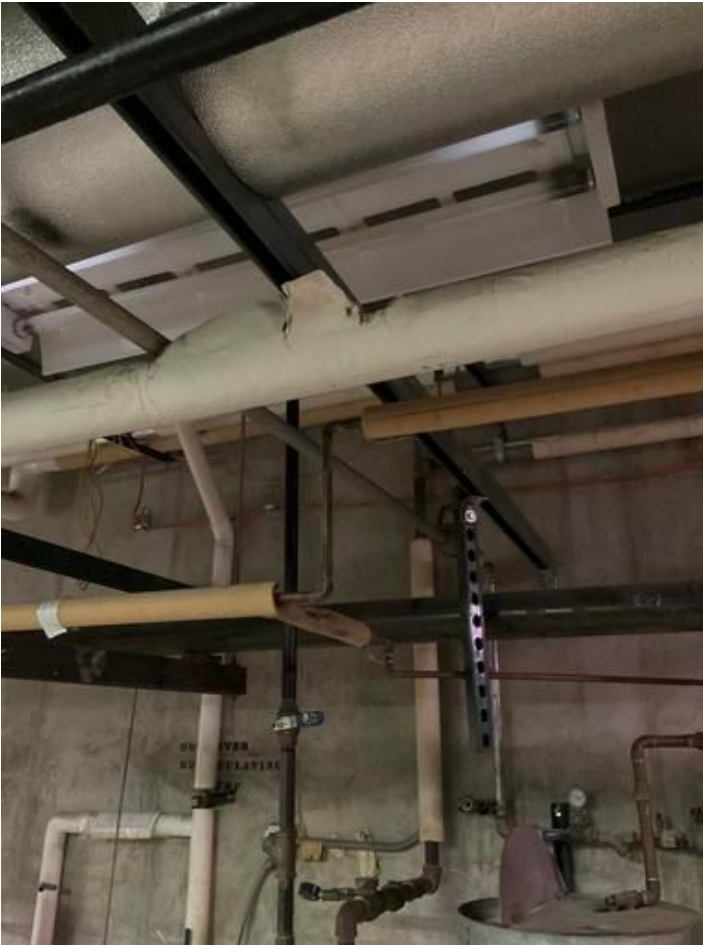
ID	#364
Pin	39
Status	■ Open
Type	EI Electrical Issues > Electrical Issues

Description	Overall image of insulation peeling.
Assigned to	—
Created by	Gabriel David (Cordogan Clark)
Created on	Jun 30, 2023
Location	Village Hall - Lower Level
Location details	—
Due date	—
Start date	—
Placement	04 (Village Hall - Lower Level Plan)
Root cause	—

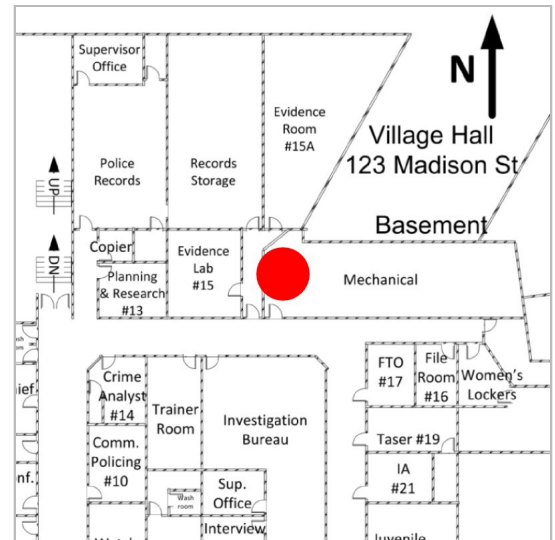
ID	#117
Pin	40
Status	■ Open
Type	AI Architectural Issues > Architectural Issues

Description	Water in conduit when heavy rain.
Assigned to	—
Created by	Gabriel David (Cordogan Clark)
Created on	Jun 21, 2023
Location	Village Hall - Lower Level
Location details	—
Due date	—
Start date	—
Placement	04 (Village Hall - Lower Level Plan)
Root cause	—

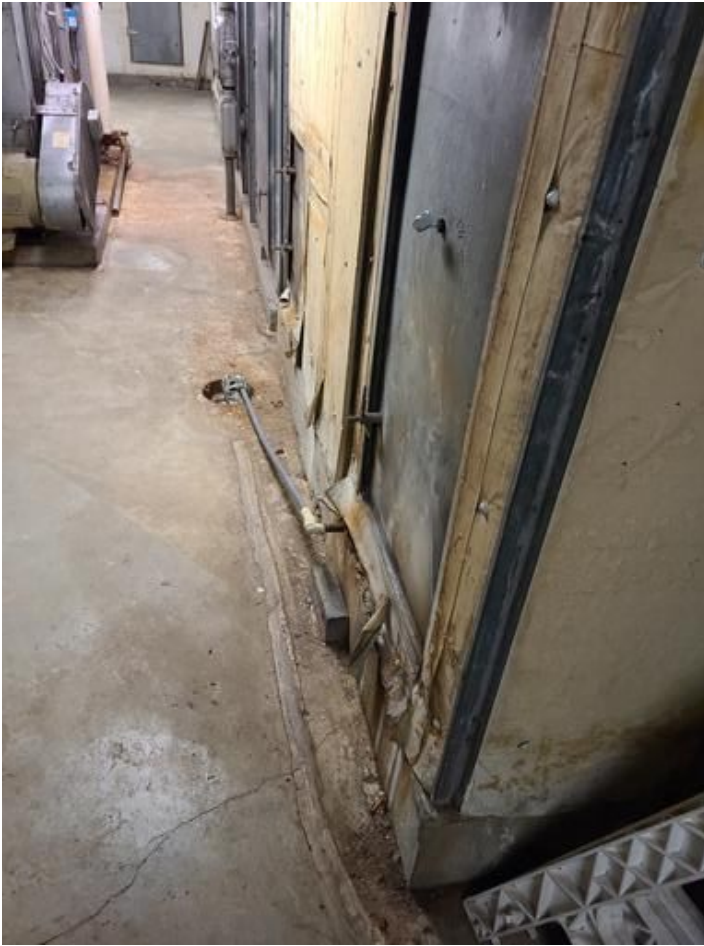
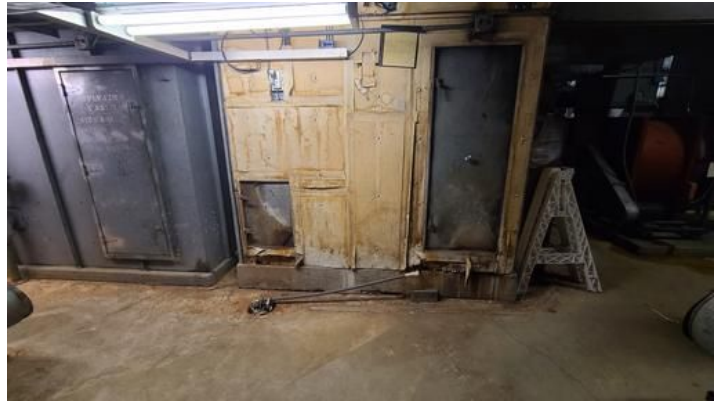
ID	#126
Pin	41
Status	■ Open
Type	AI Architectural Issues > Architectural Issues

Description	Moisture damage.
Assigned to	—
Created by	Gabriel David (Cordogan Clark)
Created on	Jun 21, 2023
Location	Village Hall - Lower Level
Location details	—
Due date	—
Start date	—
Placement	04 (Village Hall - Lower Level Plan)
Root cause	—

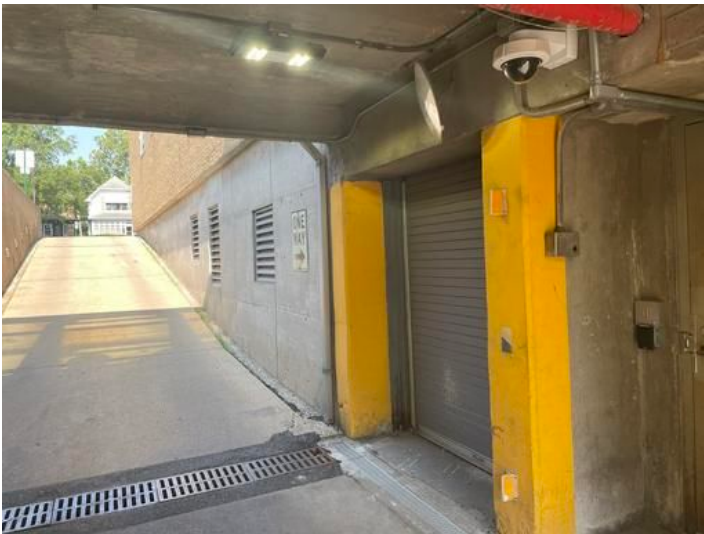
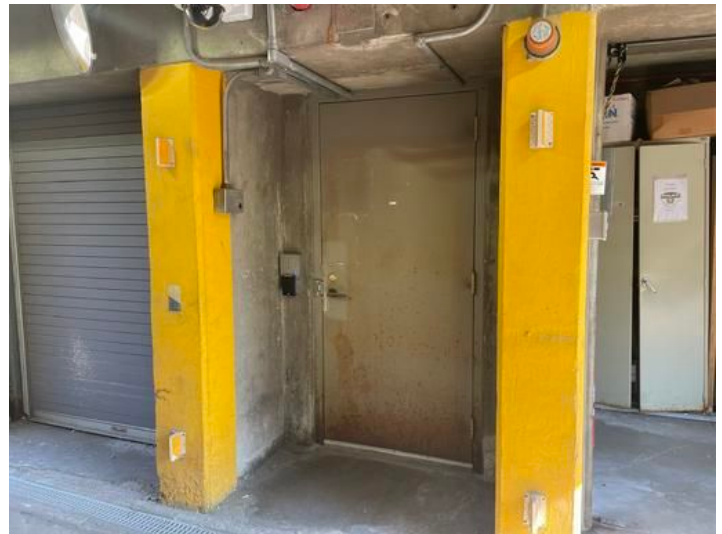
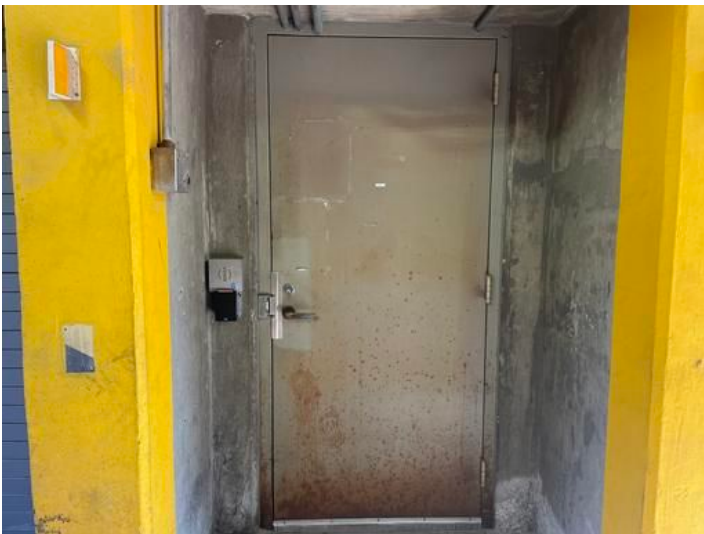
ID	#132
Pin	42
Status	■ Open
Type	AI Architectural Issues > Architectural Issues

Description	Rusted exterior door near Sally Port across from Underground Police Parking.
Assigned to	—
Created by	Gabriel David (Cordogan Clark)
Created on	Jun 21, 2023
Location	Village Hall - Lower Level
Location details	—
Due date	—
Start date	—
Placement	04 (Village Hall - Lower Level Plan)
Root cause	—

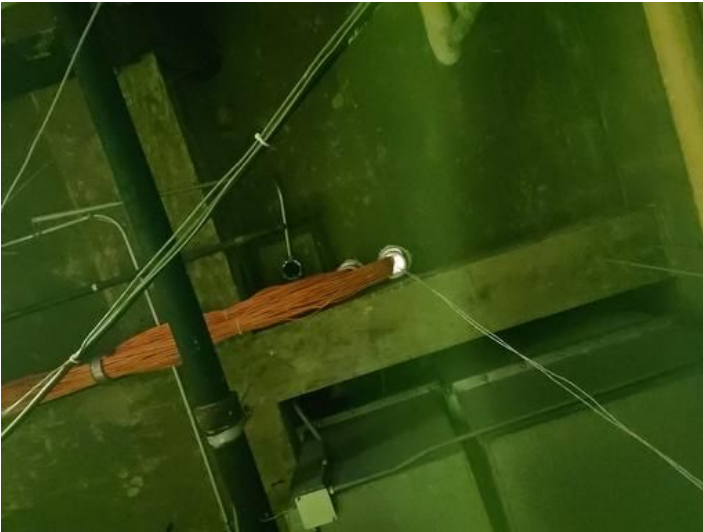
ID	#135
Pin	44
Status	■ Open
Type	AI Architectural Issues > Architectural Issues

Description	Open penetration.
Assigned to	—
Created by	Gabriel David (Cordogan Clark)
Created on	Jun 21, 2023
Location	Village Hall - Lower Level
Location details	—
Due date	—
Start date	—
Placement	04 (Village Hall - Lower Level Plan)
Root cause	—
