**OAK PARK VILLAGE HALL
123 Madison Street, Oak Park IL. 60302**

**PROPERTY CONDITION ASSESSMENT REPORT
07.08.23**

Property Condition Assessment Report

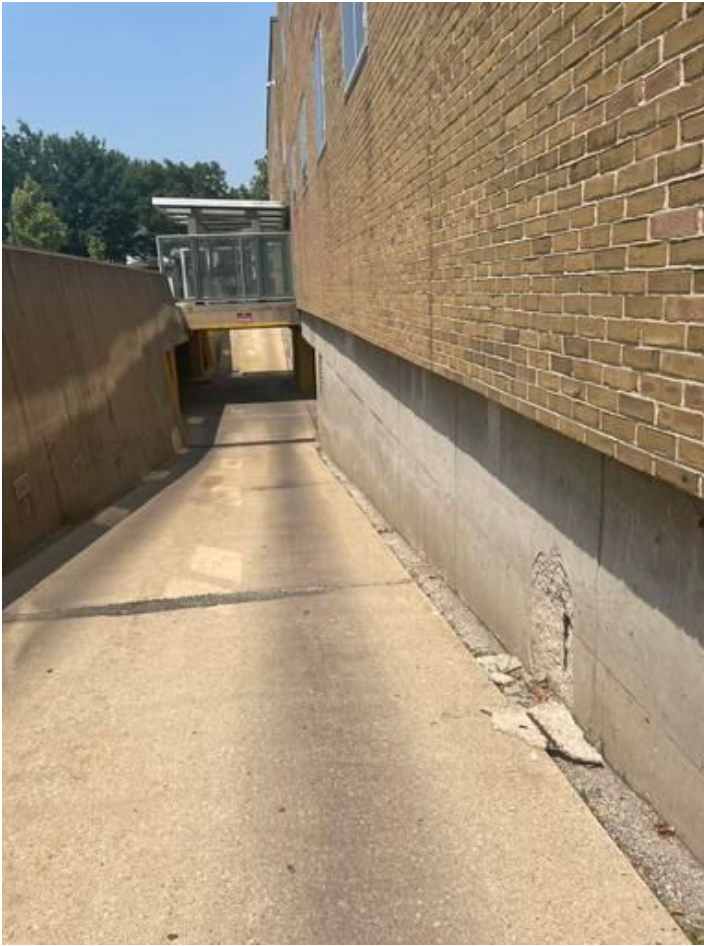
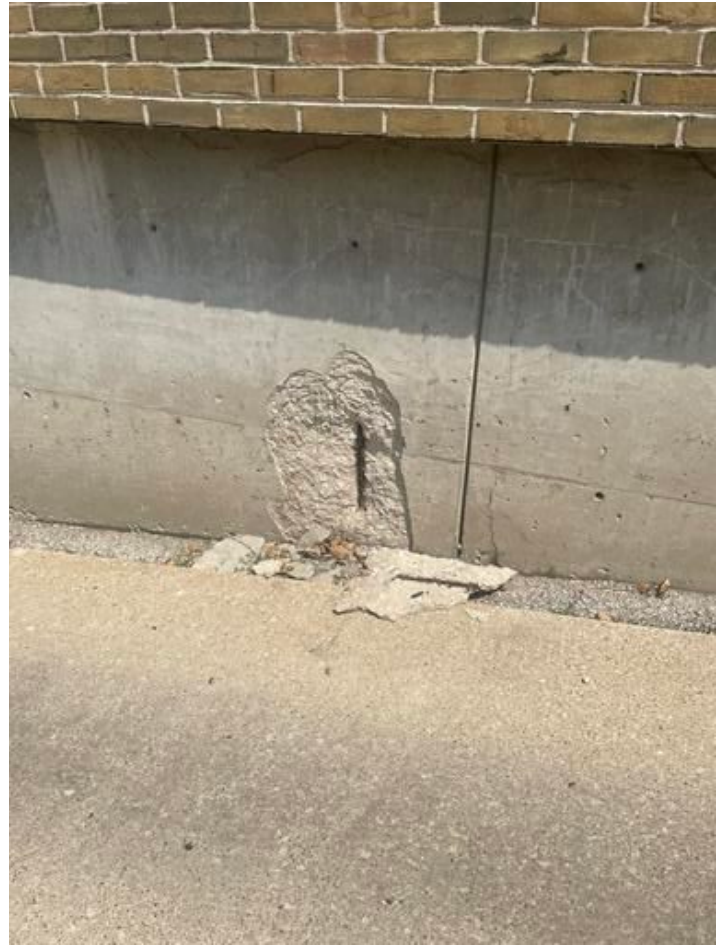
ID	#139
Pin	45
Status	<div>Open</div>
Type	<div>AI</div> Architectural Issues > Architectural Issues

Description	Exposed rebar and concrete chipping away.
Assigned to	—
Created by	Gabriel David (Cordogan Clark)
Created on	Jun 21, 2023
Location	Village Hall - Lower Level
Location details	—
Due date	—
Start date	—
Placement	04 (Village Hall - Lower Level Plan)
Root cause	—

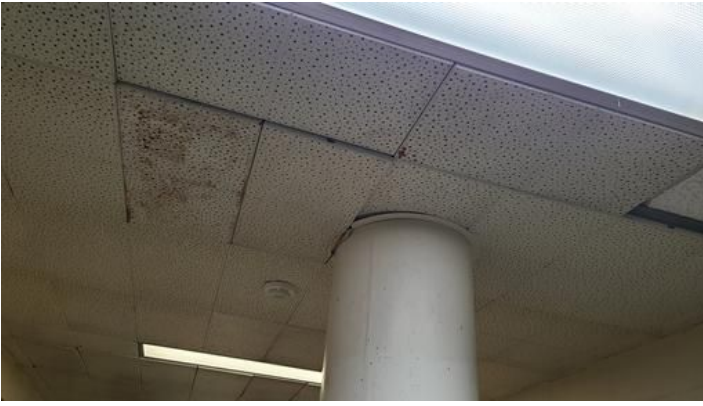
ID	#244
Pin	46
Status	<div>Open</div>
Type	<div>AI</div> Architectural Issues > Architectural Issues

Description	Damaged ceiling tiles, strip at the top of column peeling away.
Assigned to	—
Created by	Gabriel David (Cordogan Clark)
Created on	Jun 23, 2023
Location	Village Hall - Lower Level
Location details	—
Due date	—
Start date	—
Placement	04 (Village Hall - Lower Level Plan)
Root cause	—

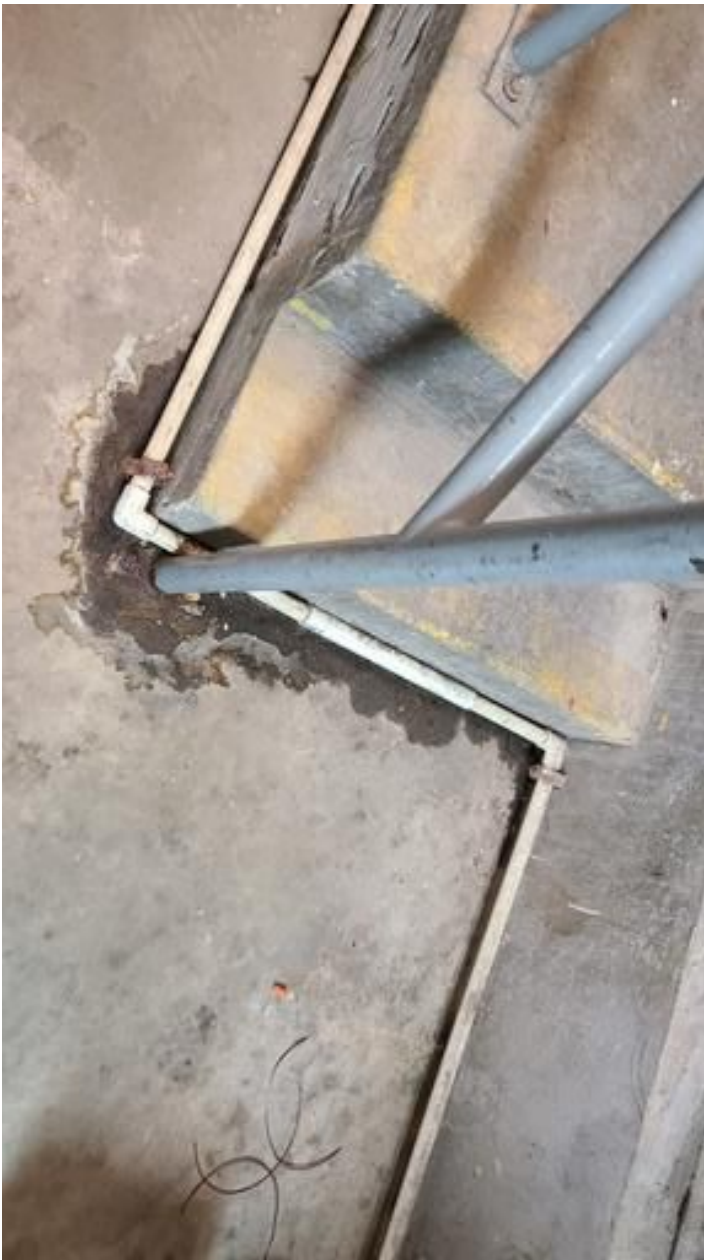
ID	#250
Pin	47
Status	■ Open
Type	AI Architectural Issues > Architectural Issues

Description	Water leaking from pipe, ponding, and staining concrete floor at the base of stairs.
Assigned to	—
Created by	Gabriel David (Cordogan Clark)
Created on	Jun 26, 2023
Location	Village Hall - Lower Level
Location details	—
Due date	—
Start date	—
Placement	04 (Village Hall - Lower Level Plan)
Root cause	—

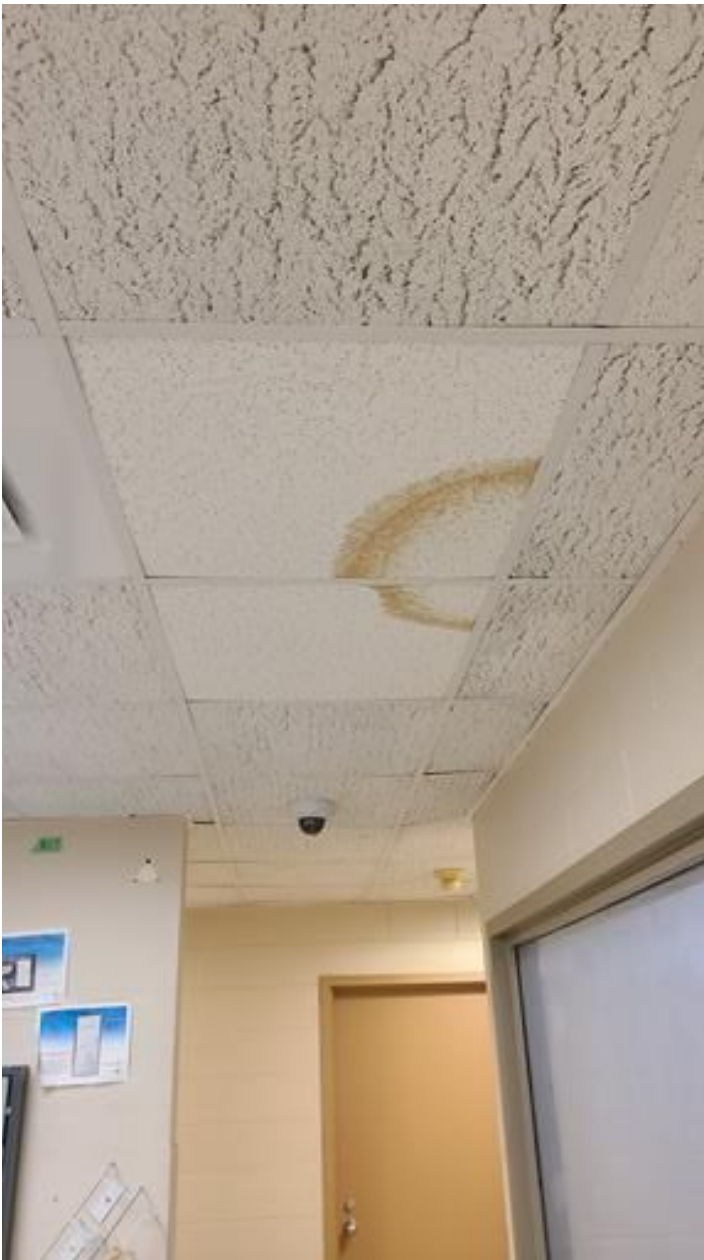
ID	#325
Pin	48
Status	■ Open
Type	AI Architectural Issues > Architectural Issues

Description	Water damaged ceiling tiles.
Assigned to	—
Created by	Gabriel David (Cordogan Clark)
Created on	Jun 26, 2023
Location	Village Hall - Lower Level
Location details	—
Due date	—
Start date	—
Placement	04 (Village Hall - Lower Level Plan)
Root cause	—

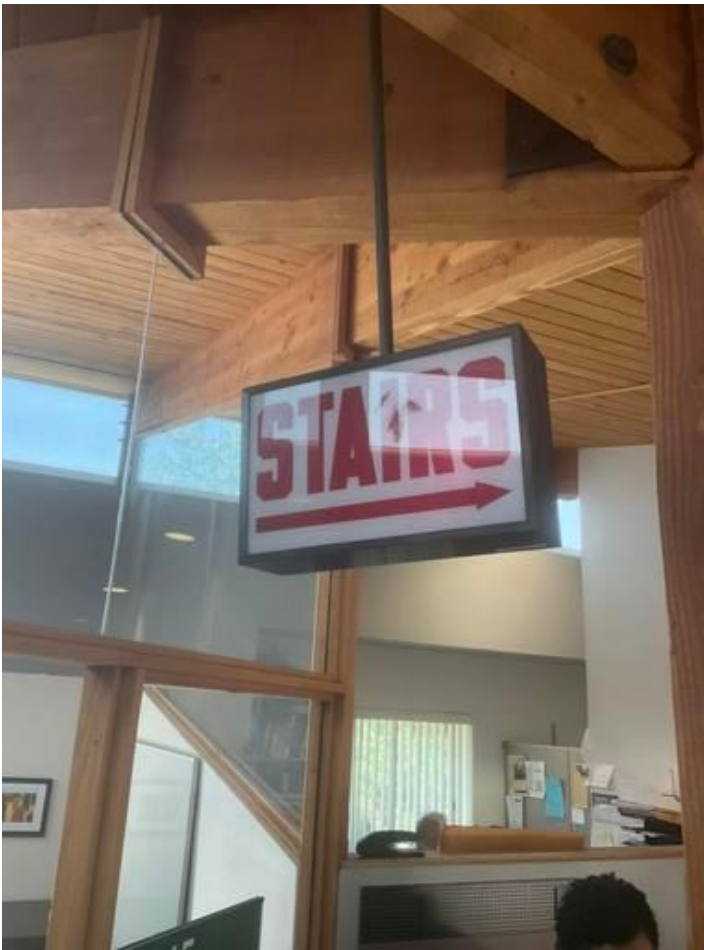
Description	Stair exit sign defunct.
Assigned to	—
Created by	Gabriel David (Cordogan Clark)
Created on	Jun 21, 2023
Location	Village Hall - Mezzanine Level
Location details	—
Due date	—
Start date	—
Placement	06 (Village Hall - Mezzanine Level Plan)
Root cause	—

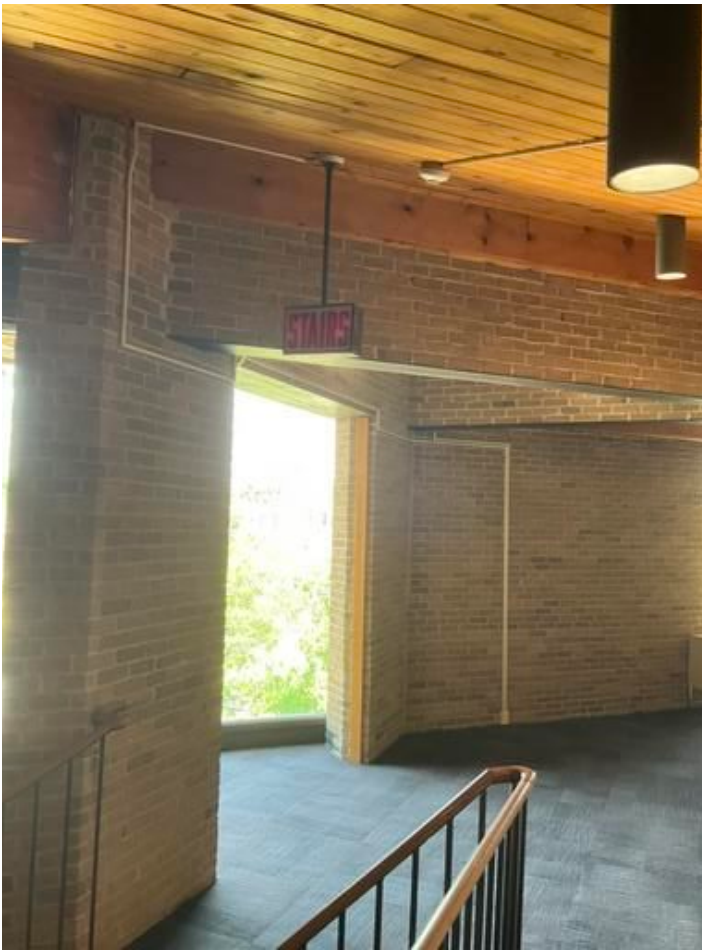
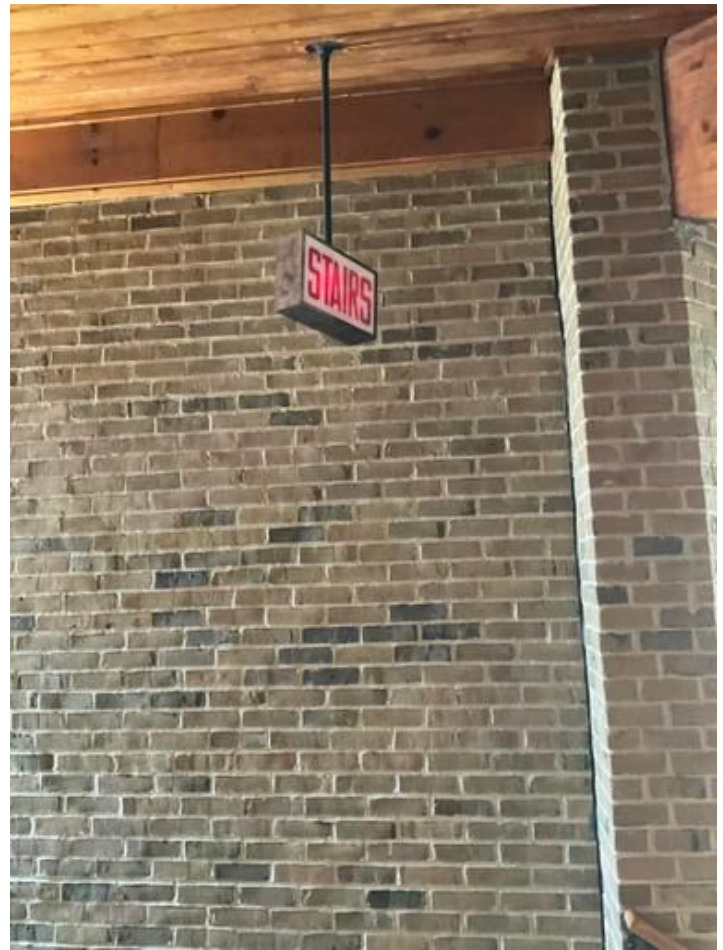
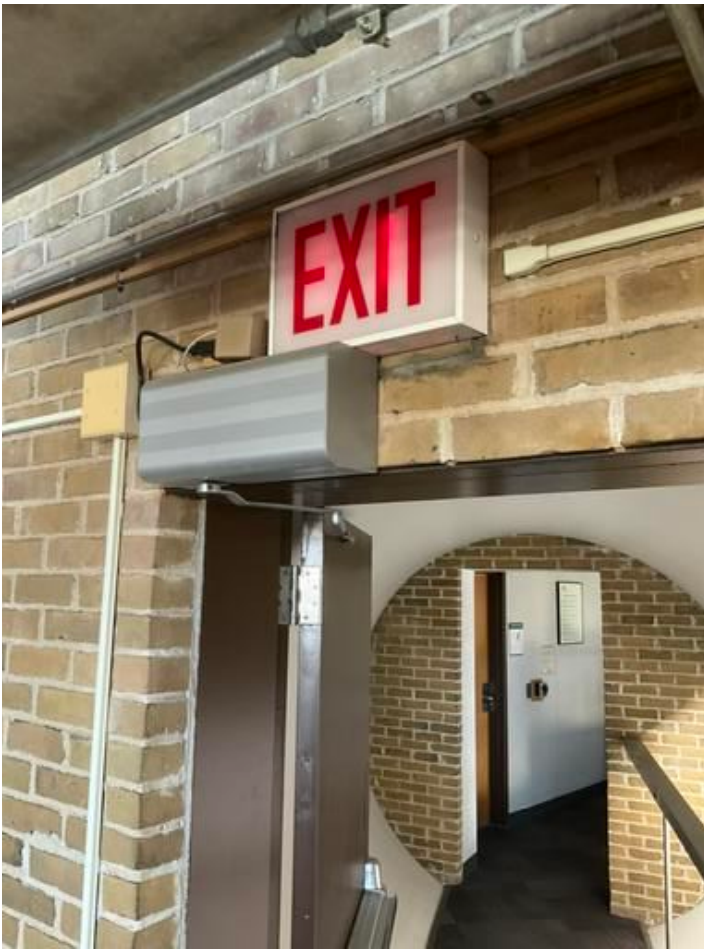
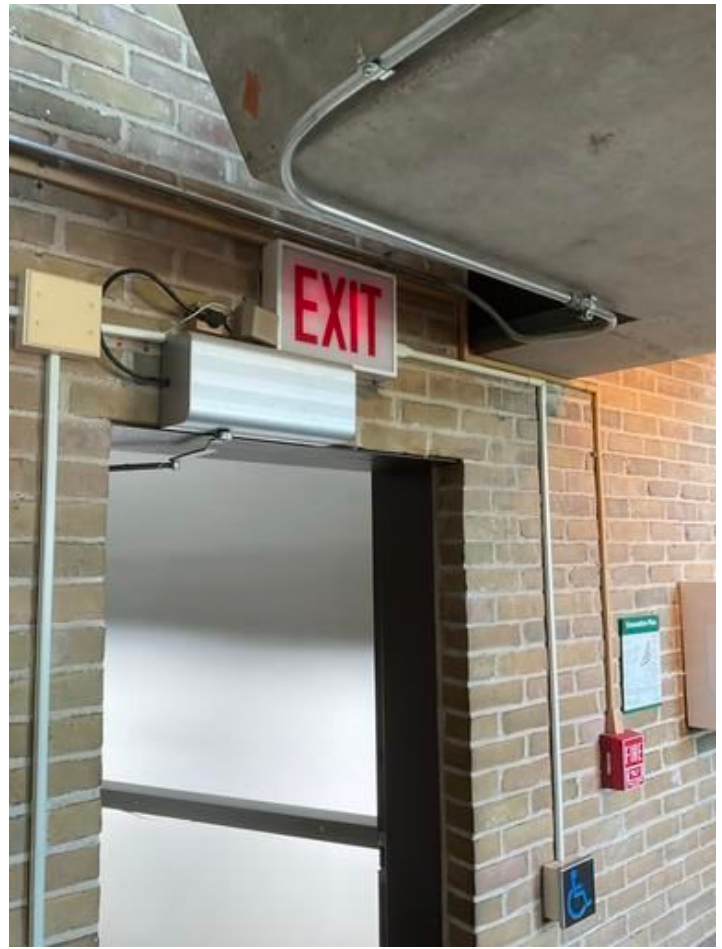
Description	Exit sign needing to be replaced.
Assigned to	—
Created by	Gabriel David (Cordogan Clark)
Created on	Jun 21, 2023
Location	Village Hall - Mezzanine Level
Location details	—
Due date	—
Start date	—
Placement	06 (Village Hall - Mezzanine Level Plan)
Root cause	—

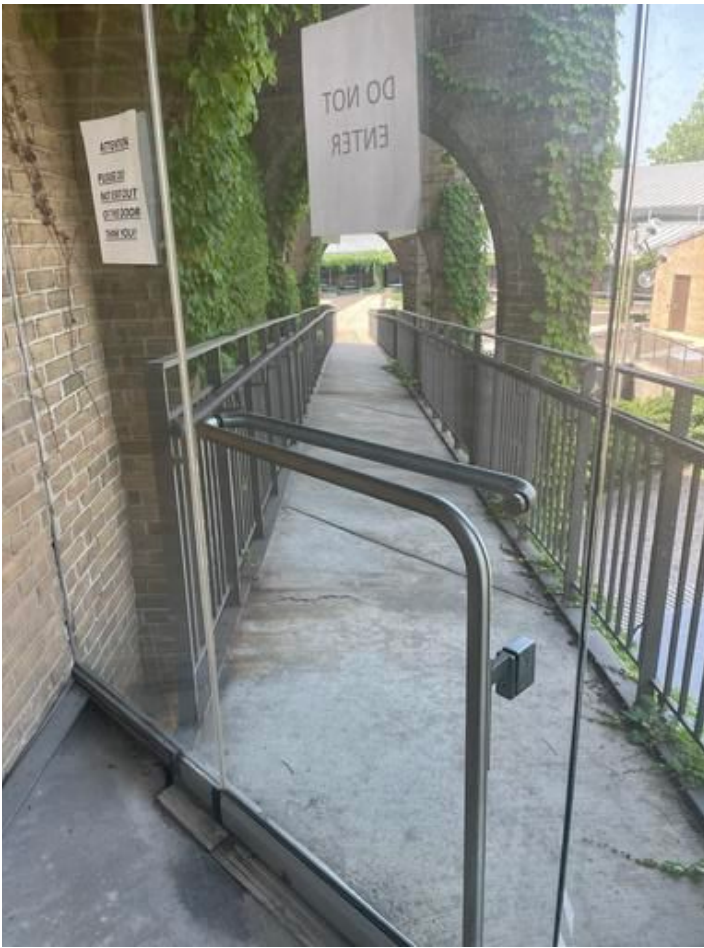
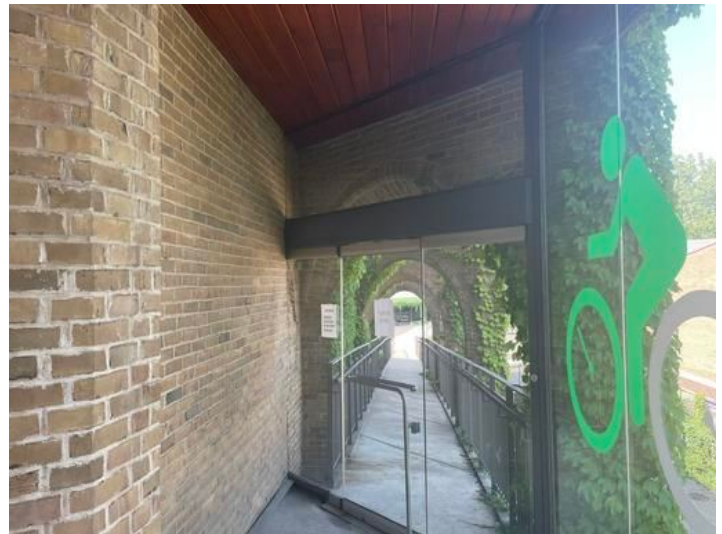
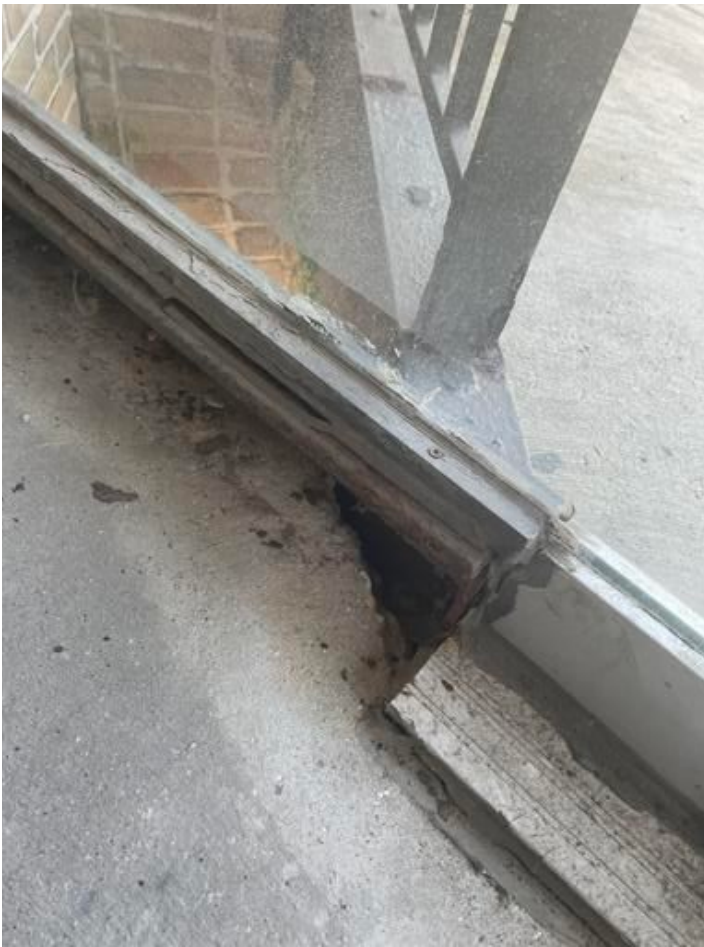
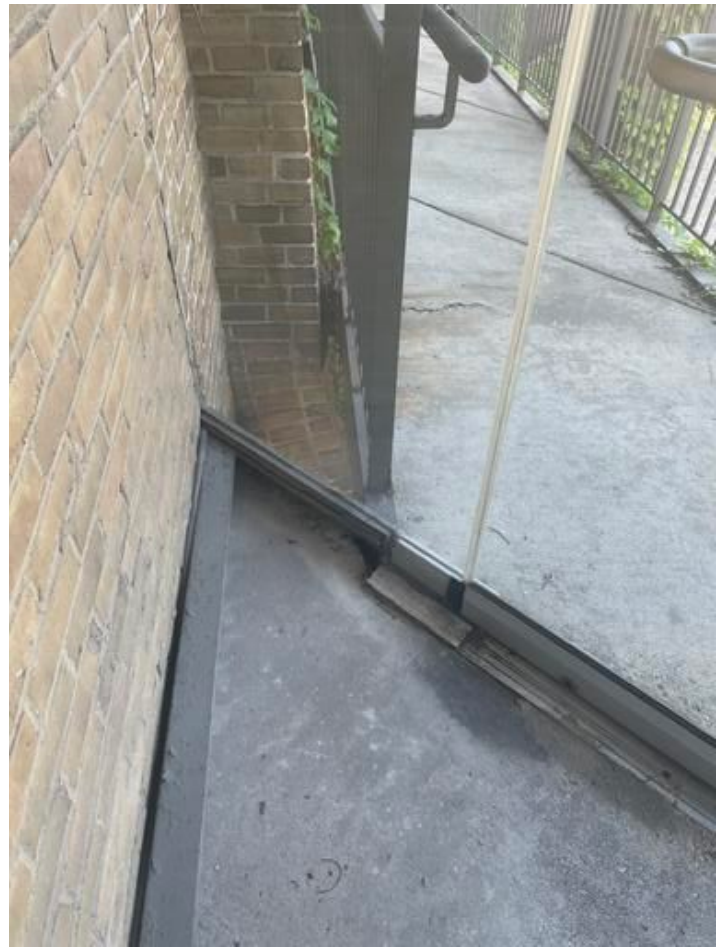
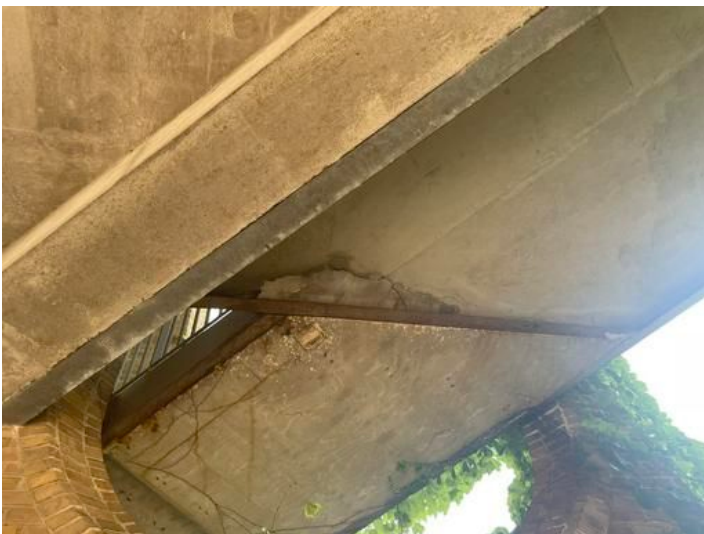
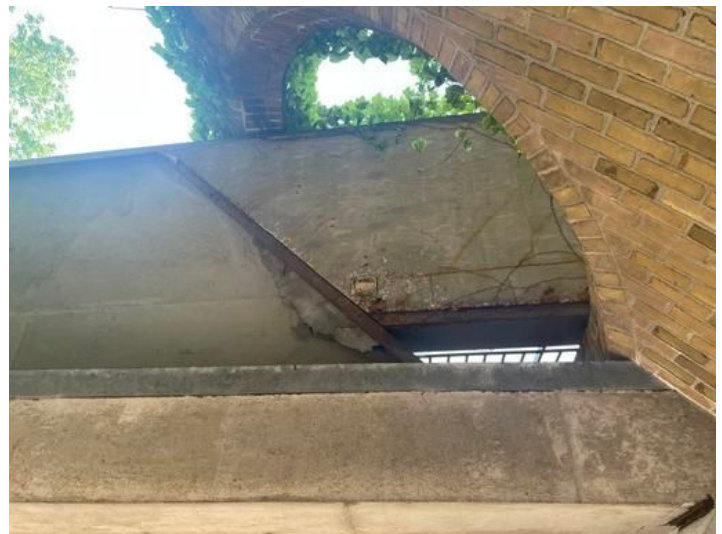
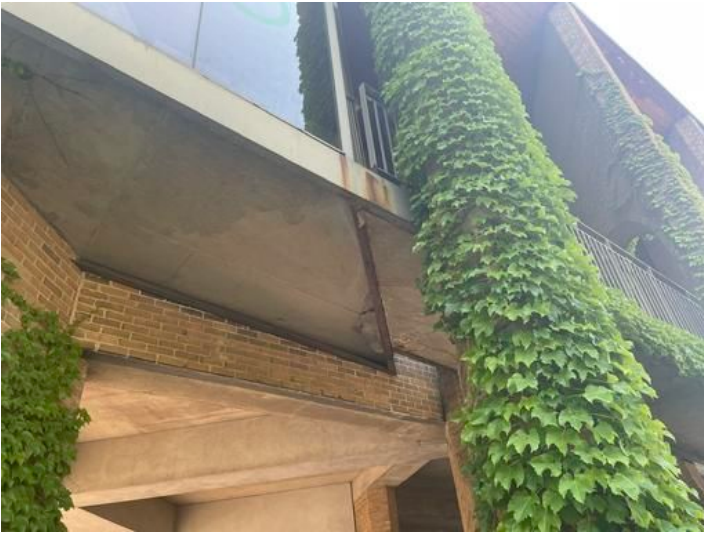
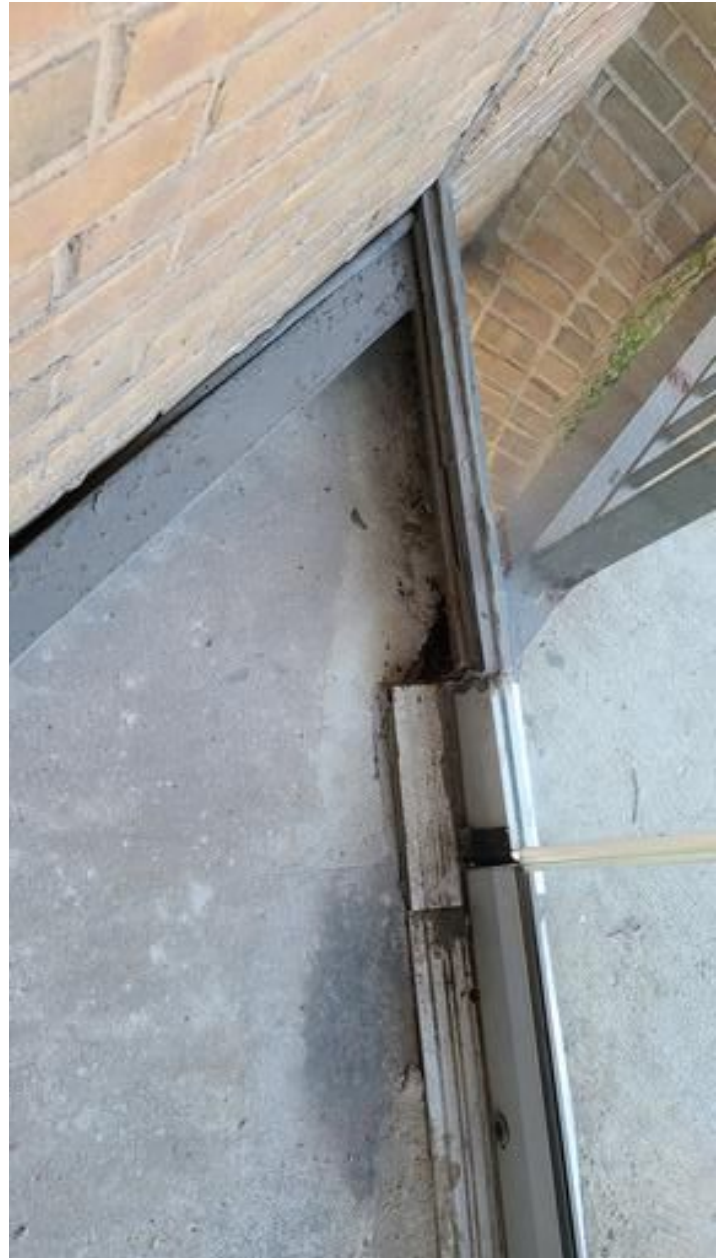
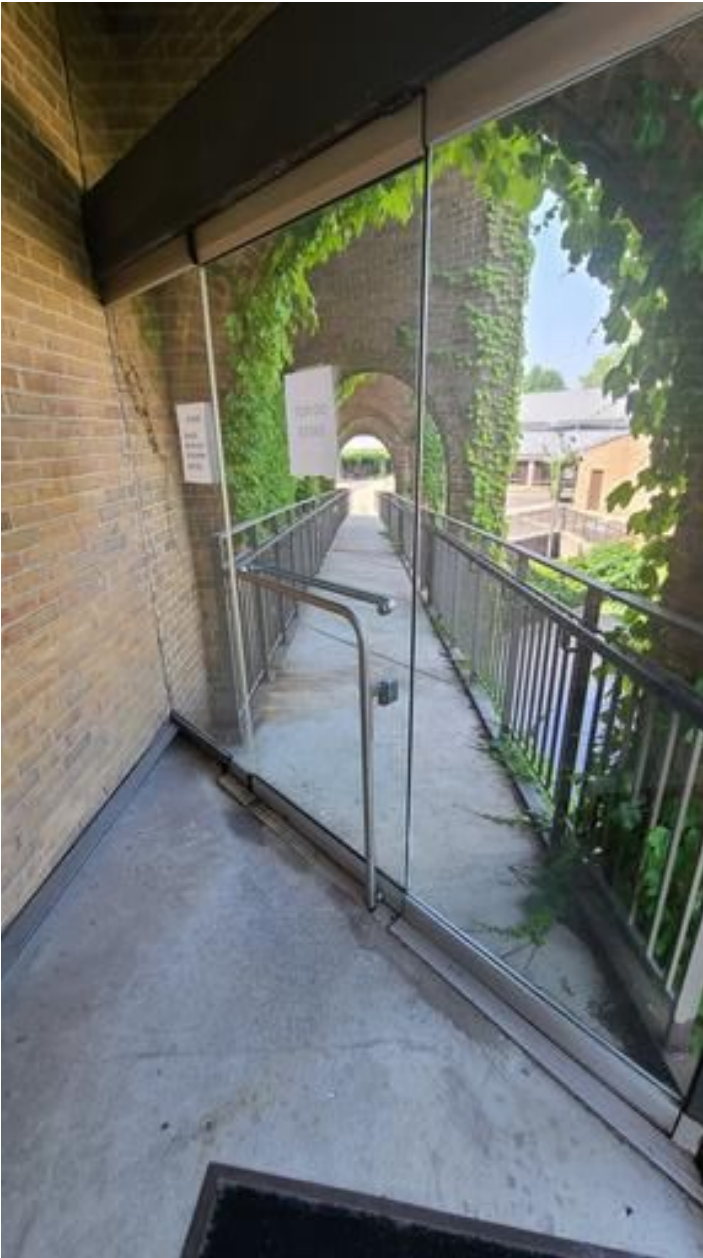
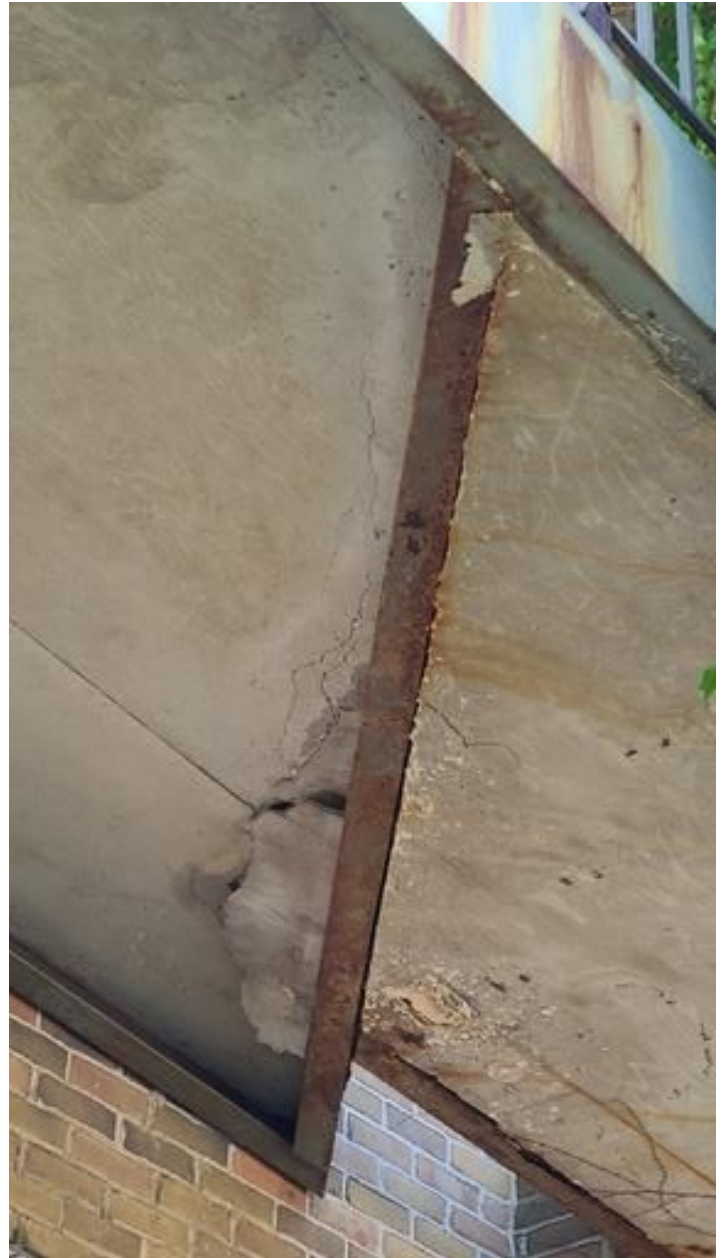
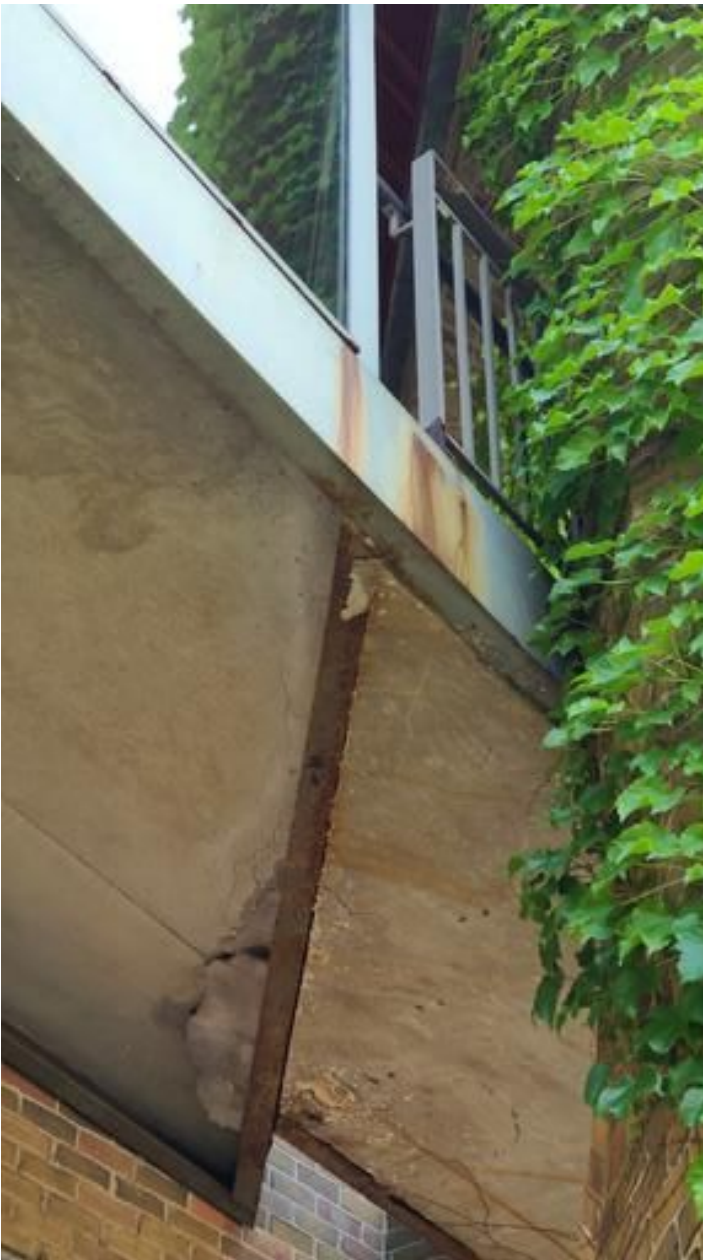
Description	Hole in concrete floor near Ramp Exit. Exterior Photos show condition underneath. Corrosion of steel supports.
Assigned to	—
Created by	Gabriel David (Cordogan Clark)
Created on	Jun 21, 2023
Location	Village Hall - Mezzanine Level
Location details	—
Due date	—
Start date	—
Placement	06 (Village Hall - Mezzanine Level Plan)
Root cause	—

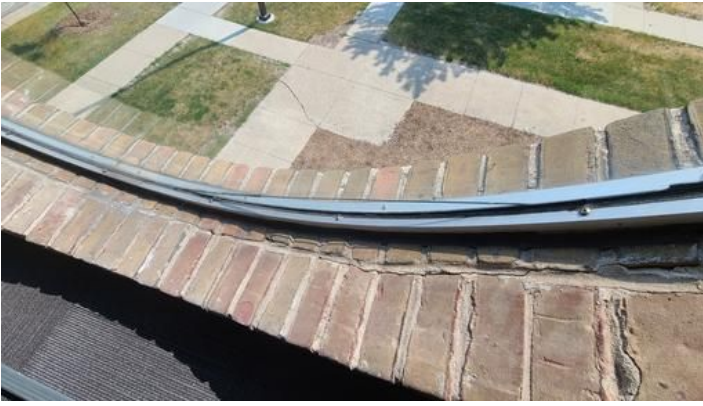
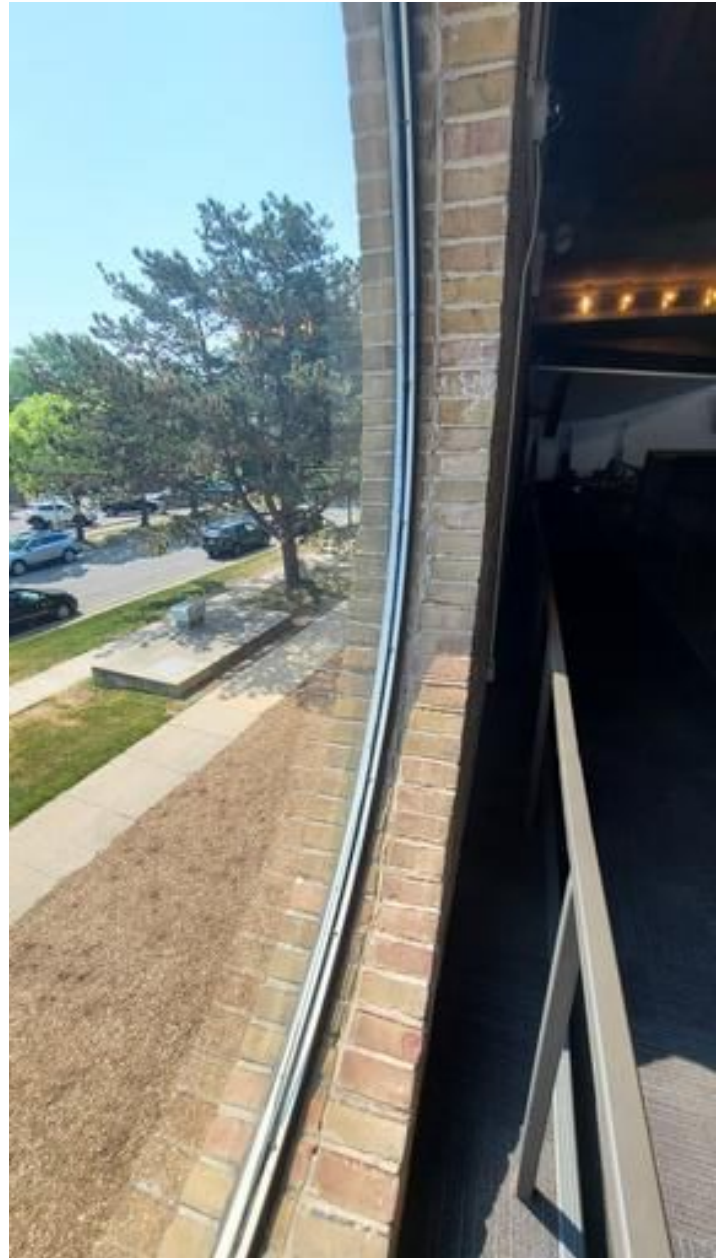
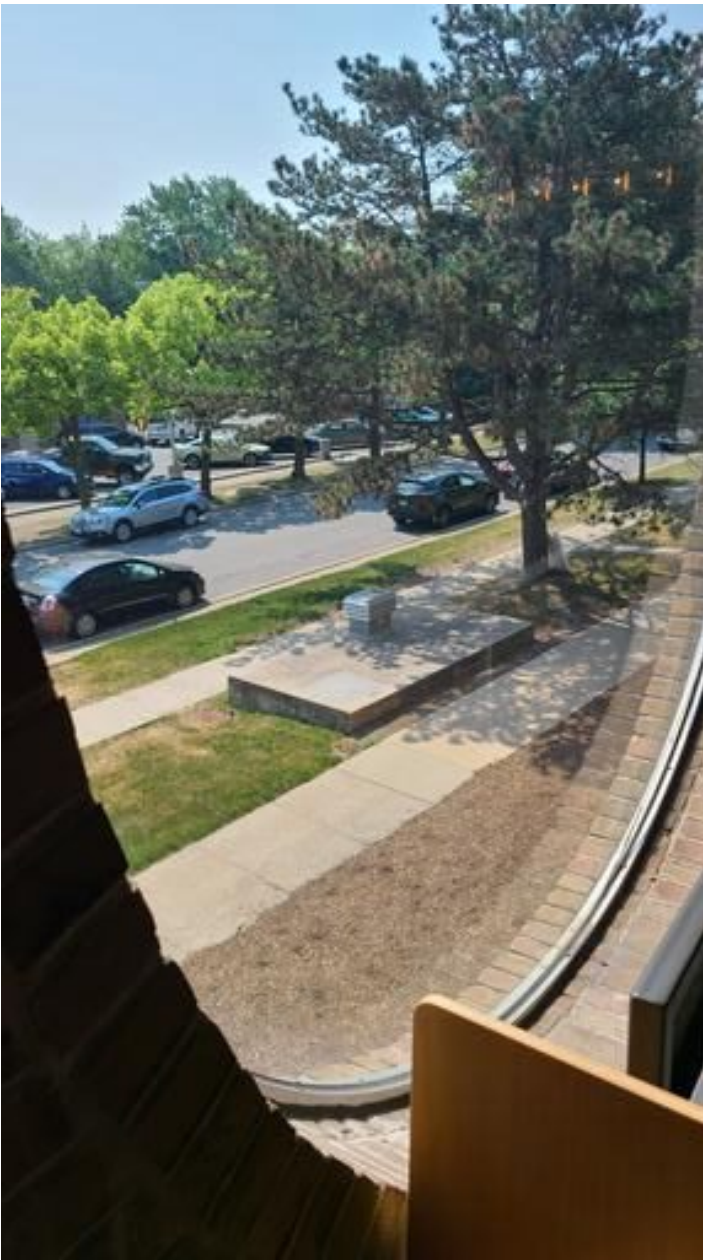
Description	Crack in circular window.
Assigned to	—
Created by	Gabriel David (Cordogan Clark)
Created on	Jun 26, 2023
Location	Village Hall - Mezzanine Level
Location details	—
Due date	—
Start date	—
Placement	06 (Village Hall - Mezzanine Level Plan)
Root cause	—

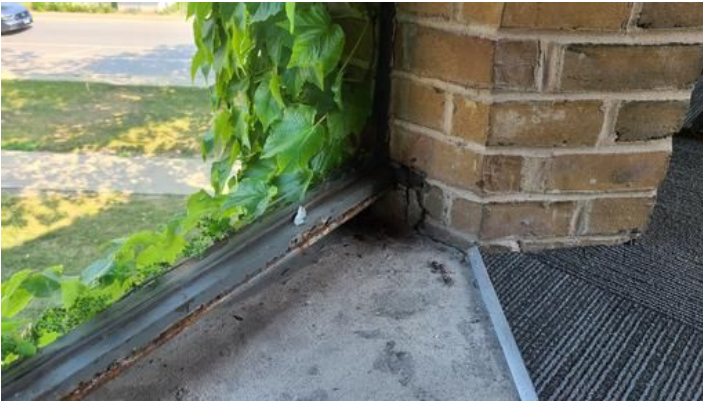
Description	Rusted window frame.
Assigned to	—
Created by	Gabriel David (Cordogan Clark)
Created on	Jun 26, 2023
Location	Village Hall - Mezzanine Level
Location details	—
Due date	—
Start date	—
Placement	06 (Village Hall - Mezzanine Level Plan)
Root cause	—

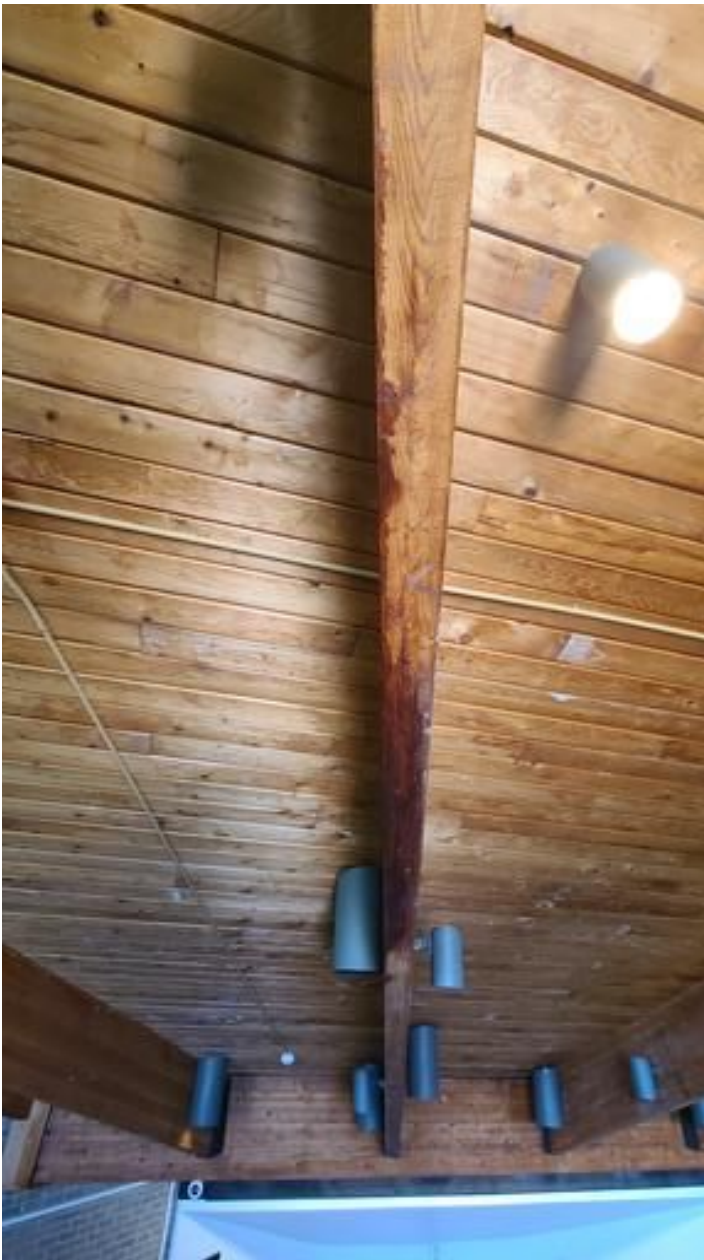
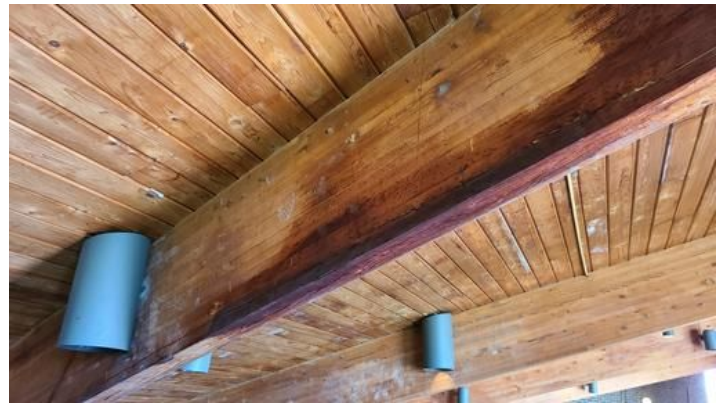
Description	Water stained beam.
Assigned to	—
Created by	Gabriel David (Cordogan Clark)
Created on	Jun 26, 2023
Location	Village Hall - Mezzanine Level
Location details	—
Due date	—
Start date	—
Placement	06 (Village Hall - Mezzanine Level Plan)
Root cause	—

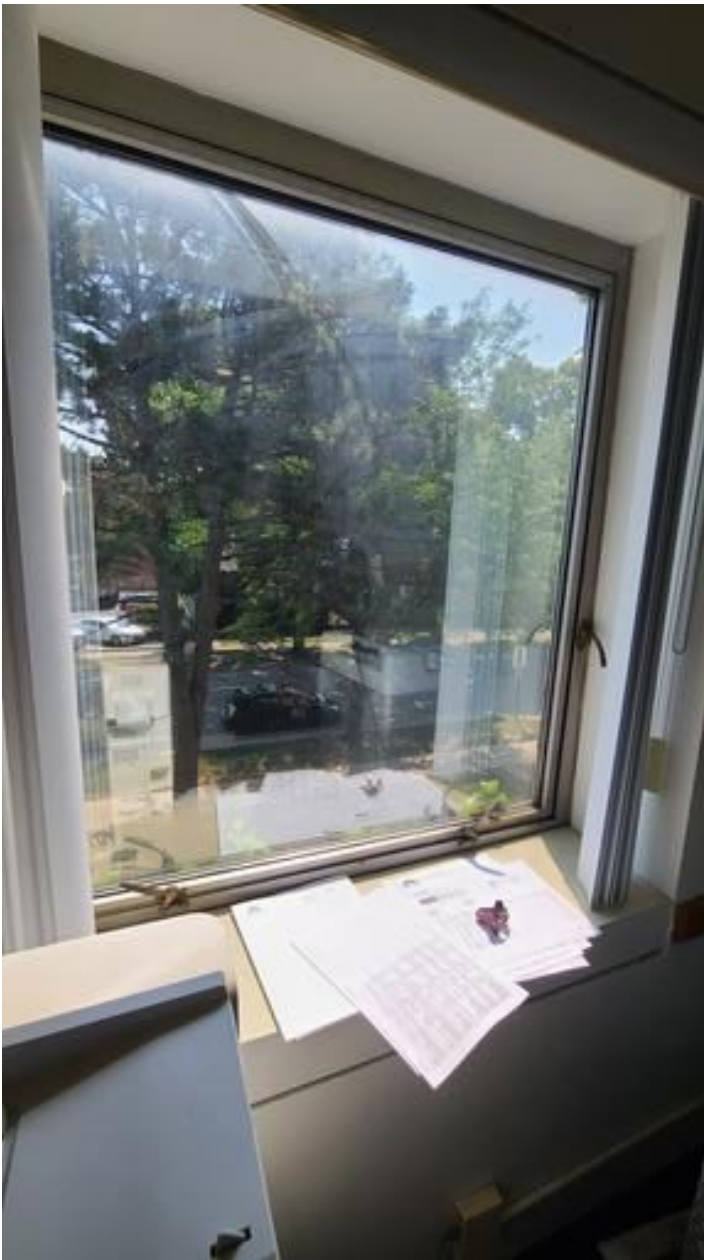
Description	Overall image of rusting window frame.
Assigned to	—
Created by	Gabriel David (Cordogan Clark)
Created on	Jun 26, 2023
Location	Village Hall - Mezzanine Level
Location details	—
Due date	—
Start date	—
Placement	06 (Village Hall - Mezzanine Level Plan)
Root cause	—

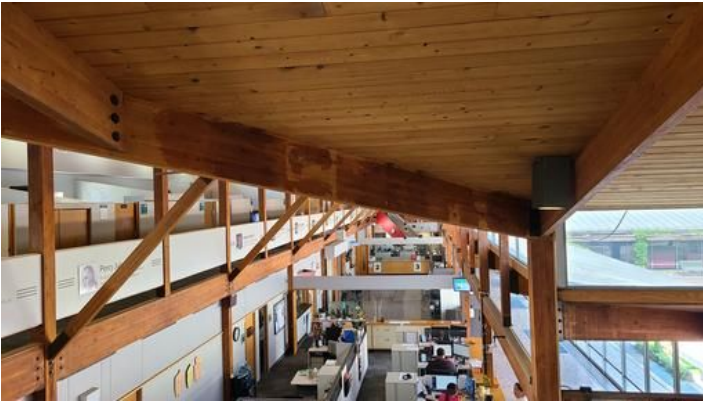
Description	Water stained beam.
Assigned to	—
Created by	Gabriel David (Cordogan Clark)
Created on	Jun 26, 2023
Location	Village Hall - Mezzanine Level
Location details	—
Due date	—
Start date	—
Placement	06 (Village Hall - Mezzanine Level Plan)
Root cause	—

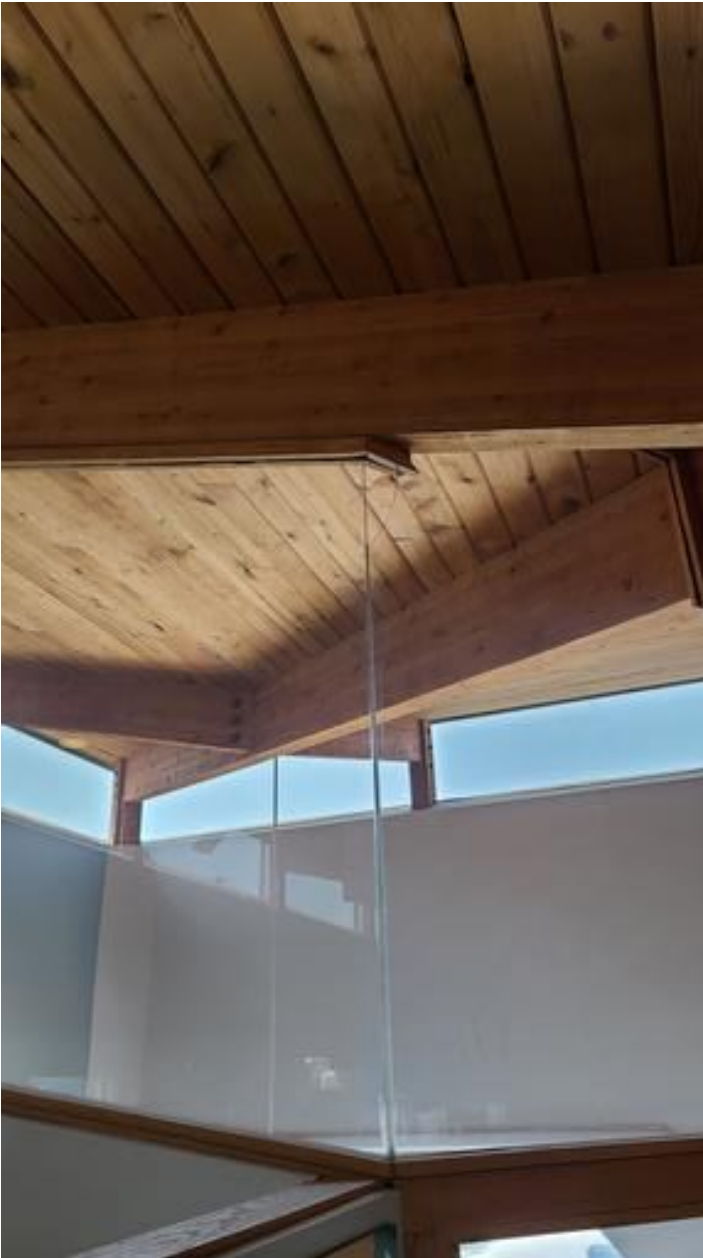
Description	Cracked glass in interior window overlooking conference room on mezzanine level.
Assigned to	—
Created by	Gabriel David (Cordogan Clark)
Created on	Jun 26, 2023
Location	Village Hall - Mezzanine Level
Location details	—
Due date	—
Start date	—
Placement	06 (Village Hall - Mezzanine Level Plan)
Root cause	—

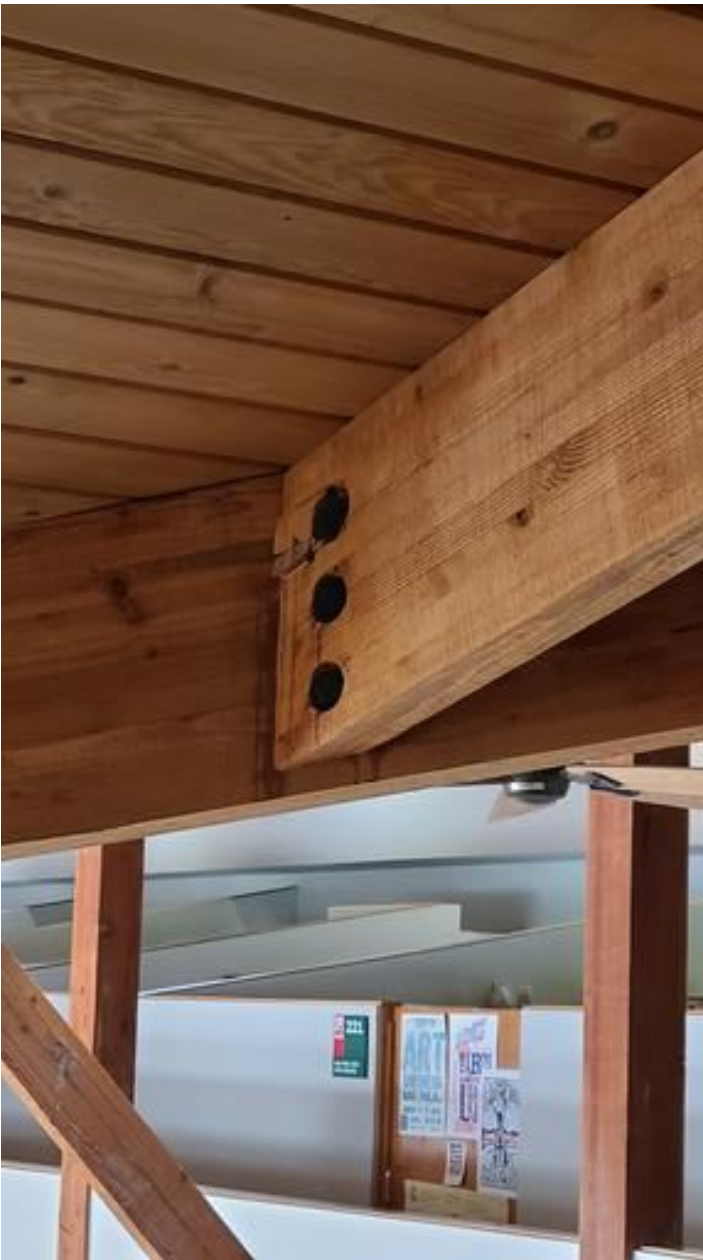
Description	Cracked connection between beams.
Assigned to	—
Created by	Gabriel David (Cordogan Clark)
Created on	Jun 26, 2023
Location	Village Hall - Mezzanine Level
Location details	—
Due date	—
Start date	—
Placement	06 (Village Hall - Mezzanine Level Plan)
Root cause	—

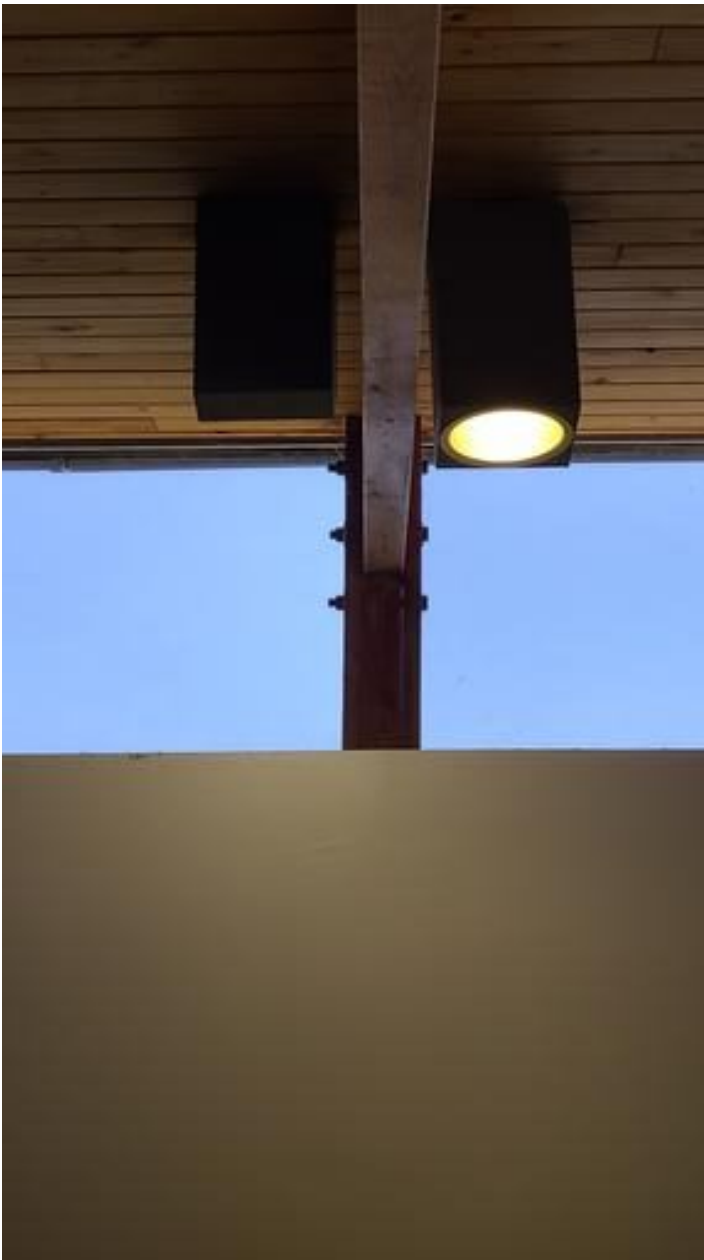
Description	Slightly warped beam.
Assigned to	—
Created by	Gabriel David (Cordogan Clark)
Created on	Jun 26, 2023
Location	Village Hall - Mezzanine Level
Location details	—
Due date	—
Start date	—
Placement	06 (Village Hall - Mezzanine Level Plan)
Root cause	—

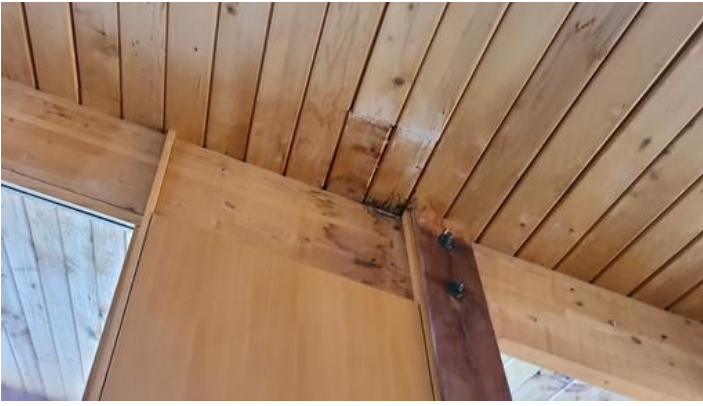
Description	Water stained beam.
Assigned to	—
Created by	Gabriel David (Cordogan Clark)
Created on	Jun 26, 2023
Location	Village Hall - Mezzanine Level
Location details	—
Due date	—
Start date	—
Placement	06 (Village Hall - Mezzanine Level Plan)
Root cause	—
