**OAK PARK VILLAGE HALL
123 Madison Street, Oak Park IL. 60302**

**PROPERTY CONDITION ASSESSMENT REPORT
07.08.23**

Property Condition Assessment Report

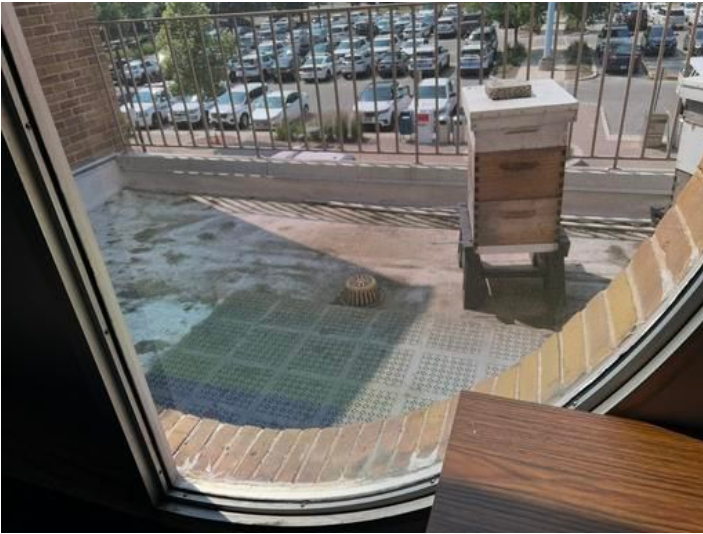
[20230608_103142_photo](#)

Description	Overall image of roof drain on Exterior Balcony.
Assigned to	—
Created by	Gabriel David (Cordogan Clark)
Created on	Jun 21, 2023
Location	Village Hall - Mezzanine Level
Location details	—
Due date	—
Start date	—
Placement	06 (Village Hall - Mezzanine Level Plan)
Root cause	—

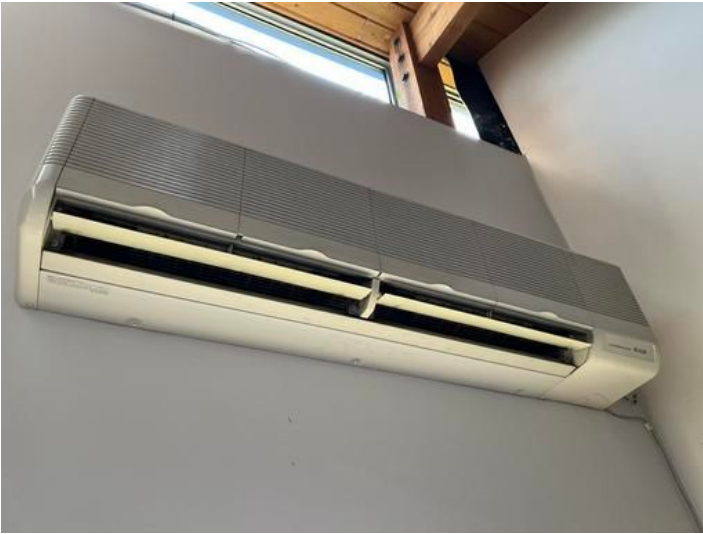
[20230608_102914_photo](#)

Description	Overall photo of HVAC unit.
Assigned to	—
Created by	Gabriel David (Cordogan Clark)
Created on	Jun 21, 2023
Location	Village Hall - Mezzanine Level
Location details	—
Due date	—
Start date	—
Placement	06 (Village Hall - Mezzanine Level Plan)
Root cause	—

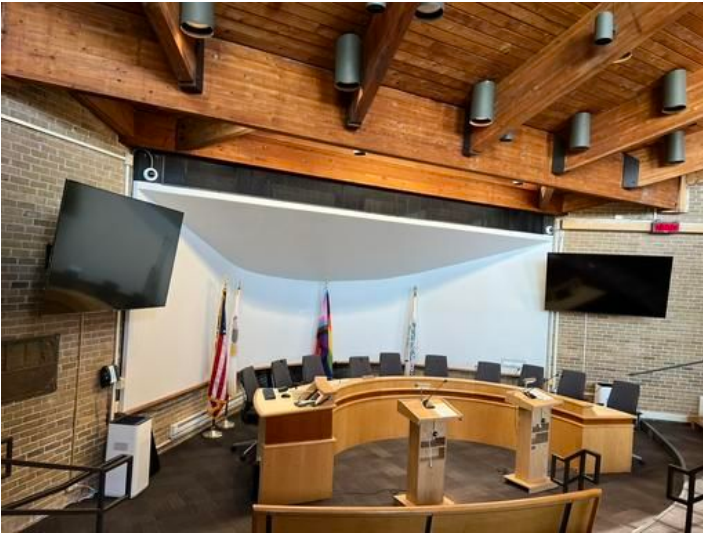
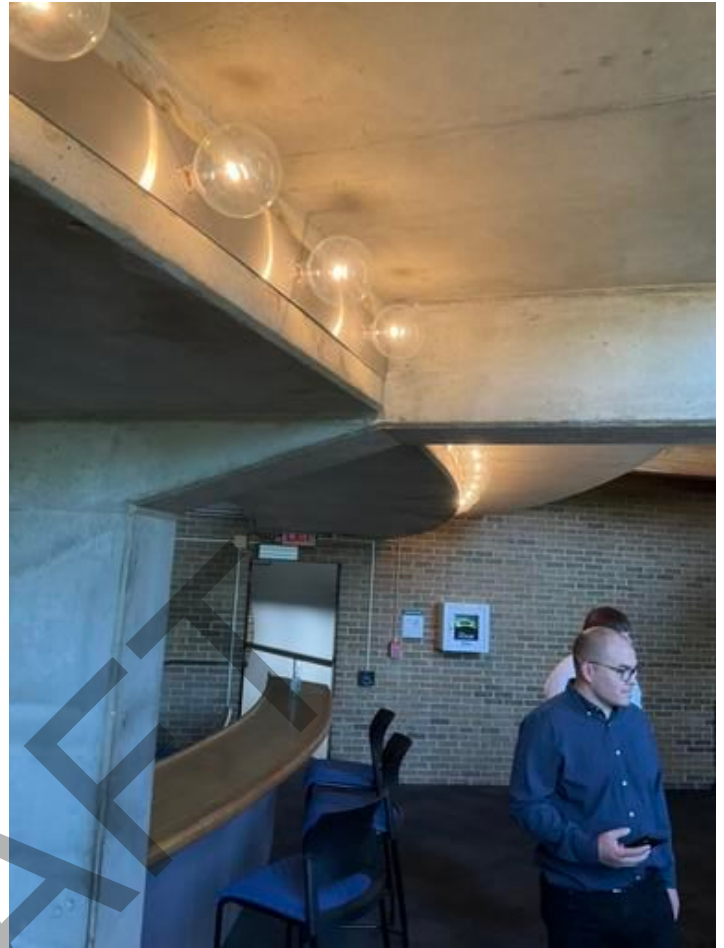
Description	Overall image of council seats, podiums, and lighting.
Assigned to	—
Created by	Gabriel David (Cordogan Clark)
Created on	Jun 21, 2023
Location	Village Hall - Mezzanine Level
Location details	—
Due date	—
Start date	—
Placement	06 (Village Hall - Mezzanine Level Plan)
Root cause	—

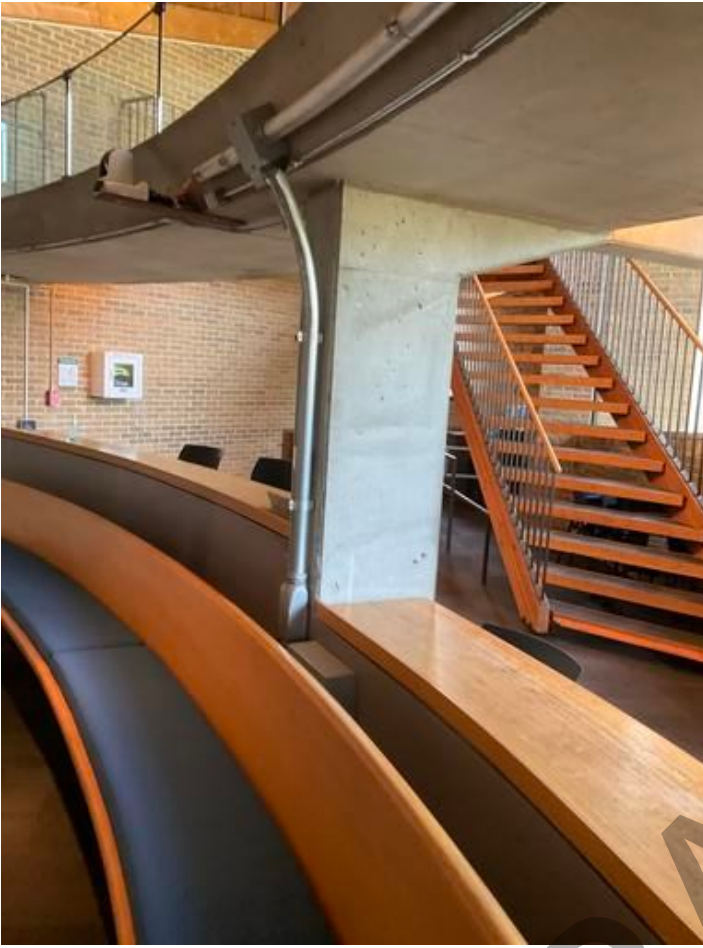
[20230608_102007_photo](#)

Description	Overall image of electrical conduit and security camera.
Assigned to	—
Created by	Gabriel David (Cordogan Clark)
Created on	Jun 21, 2023
Location	Village Hall - Mezzanine Level
Location details	—
Due date	—
Start date	—
Placement	06 (Village Hall - Mezzanine Level Plan)
Root cause	—

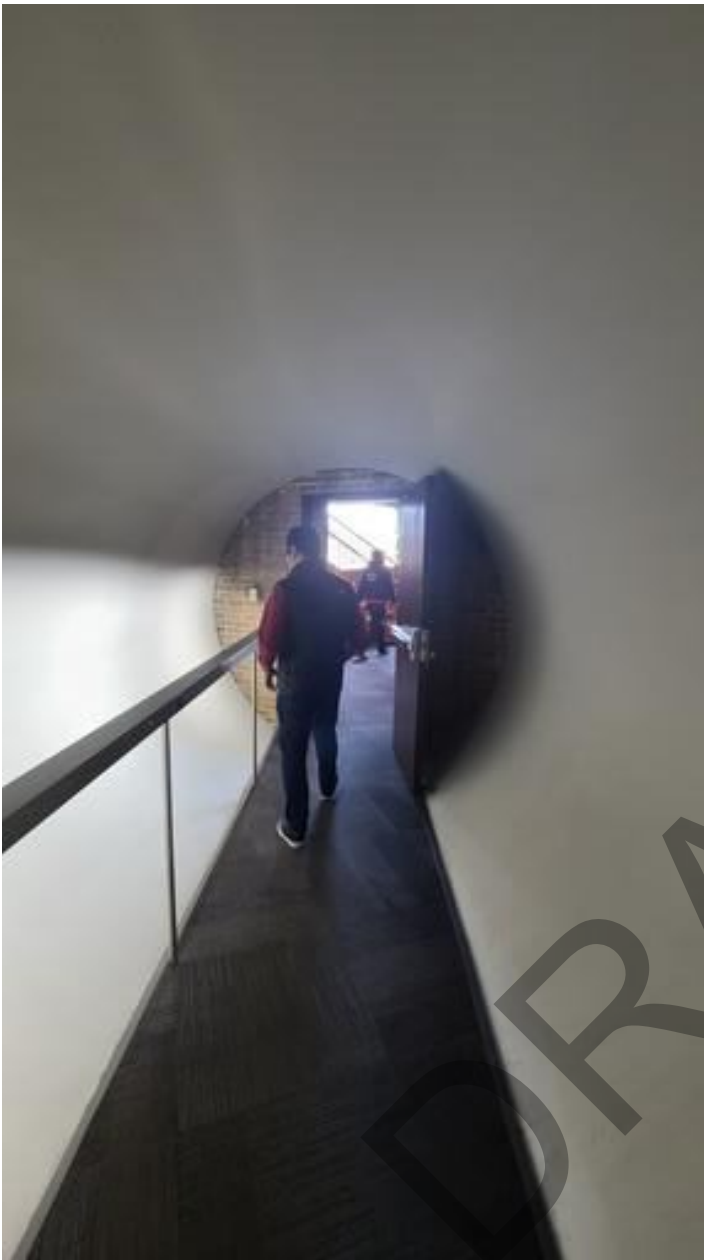
[20230608_101907](#)

Description	Overall interior image of steel tube connecting Council Chamber to Main Building.
Assigned to	—
Created by	Gabriel David (Cordogan Clark)
Created on	Jun 26, 2023
Location	Village Hall - Mezzanine Level
Location details	—
Due date	—
Start date	—
Placement	06 (Village Hall - Mezzanine Level Plan)
Root cause	—

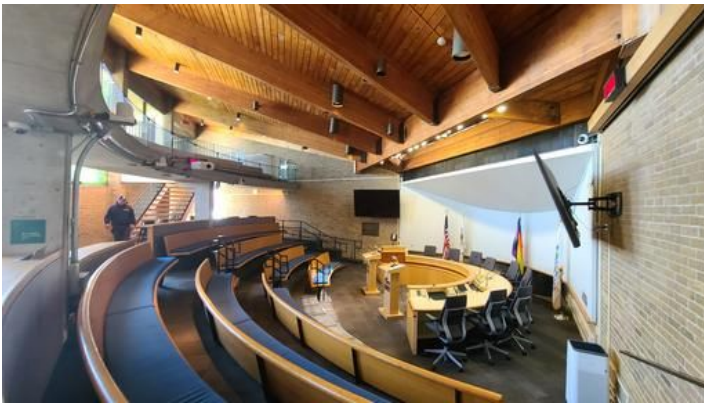
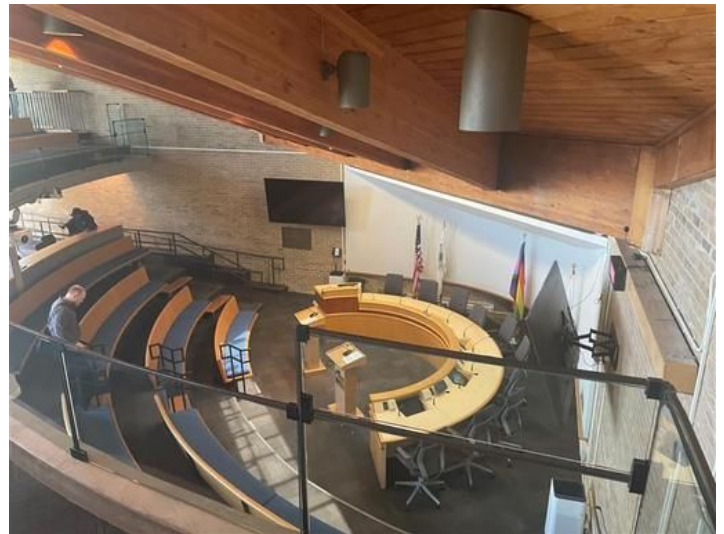
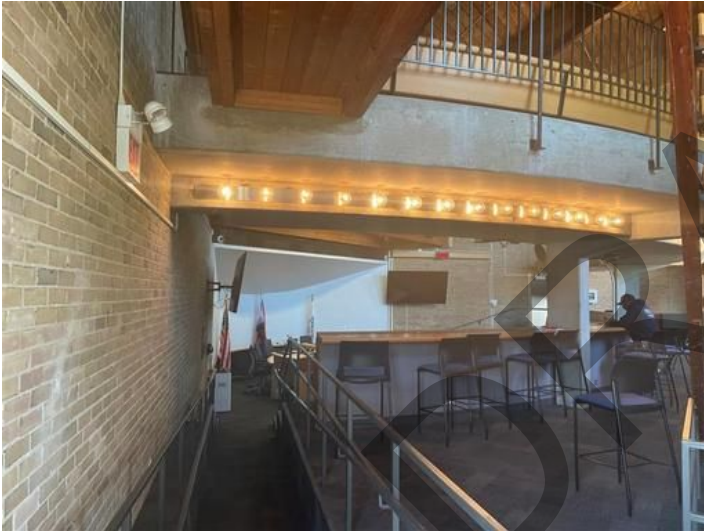
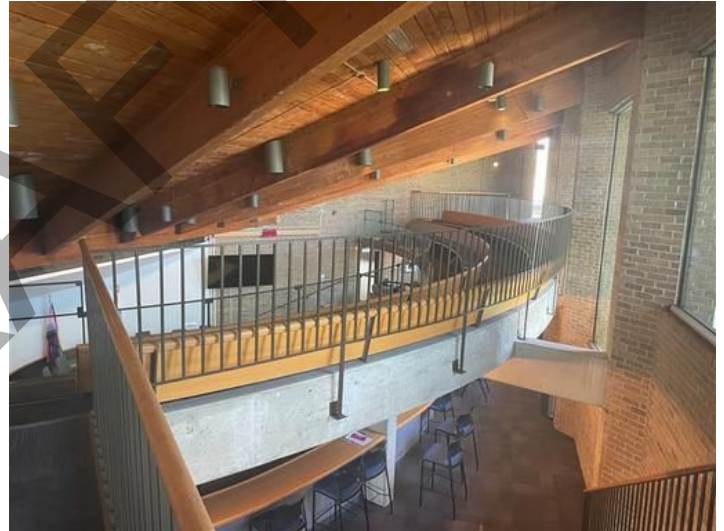
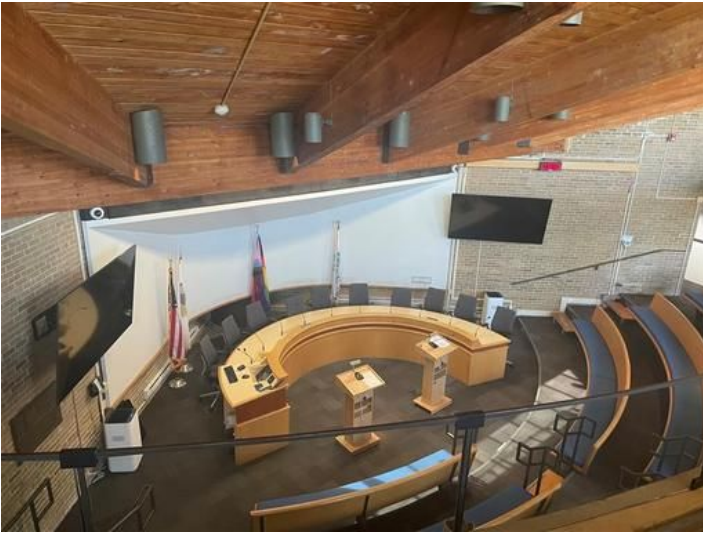
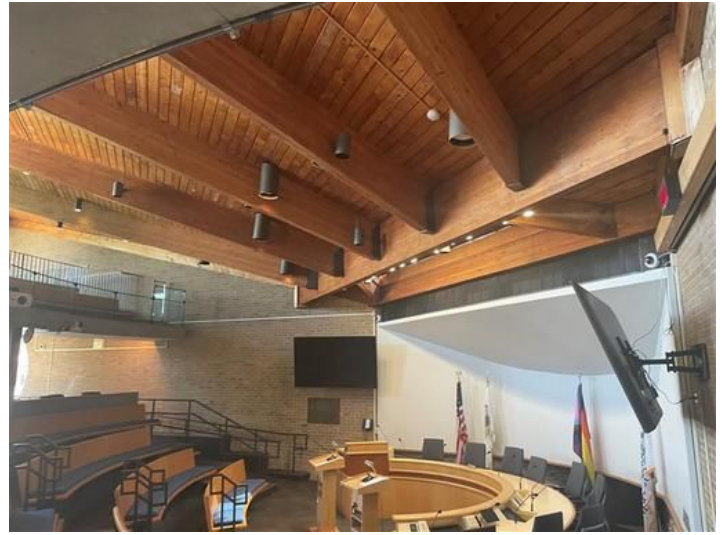
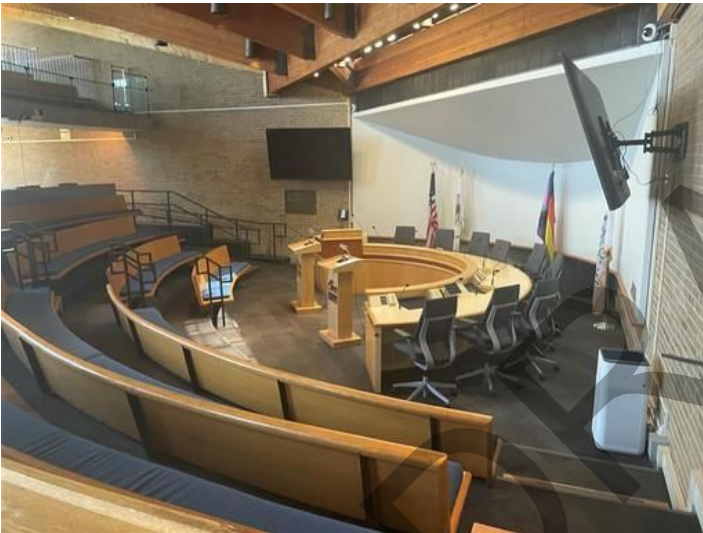
Description	Overall photos of Council Chambers from lower level and balcony level above.
Assigned to	—
Created by	Gabriel David (Cordogan Clark)
Created on	Jun 26, 2023
Location	Village Hall - Mezzanine Level
Location details	—
Due date	—
Start date	—
Placement	06 (Village Hall - Mezzanine Level Plan)
Root cause	—

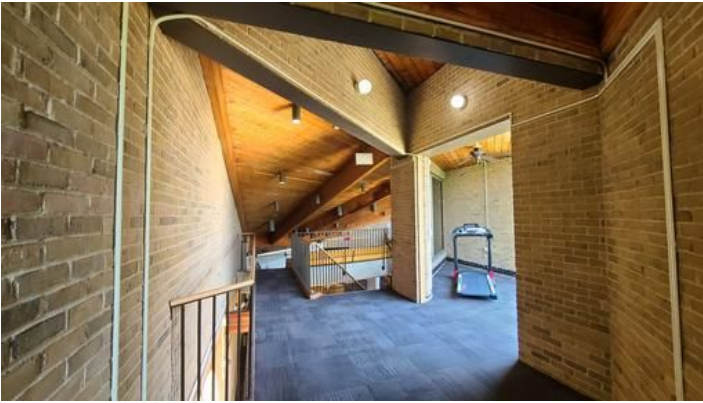
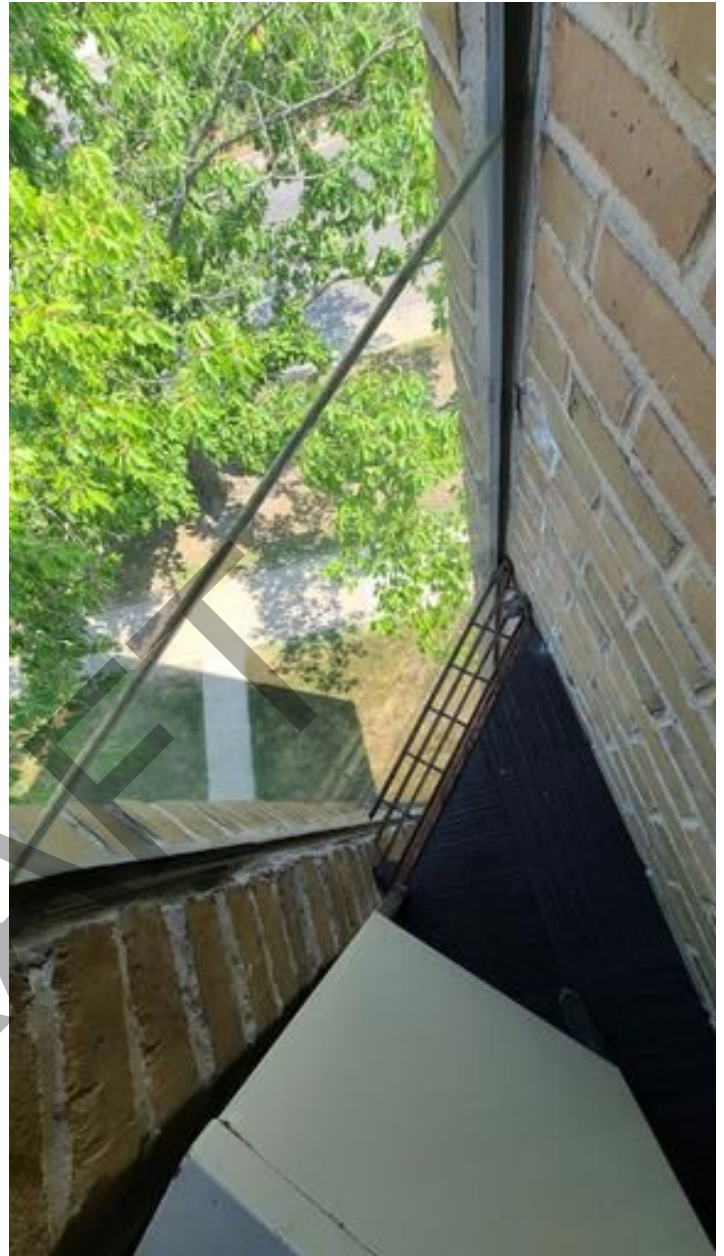
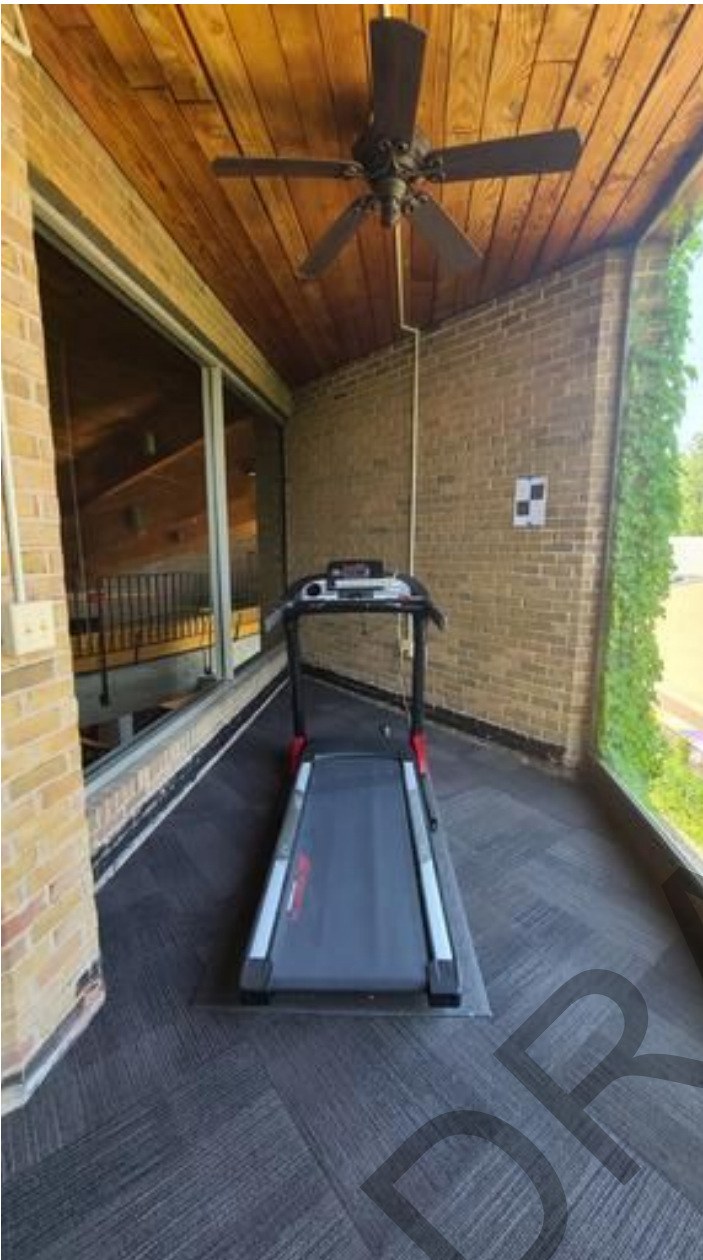
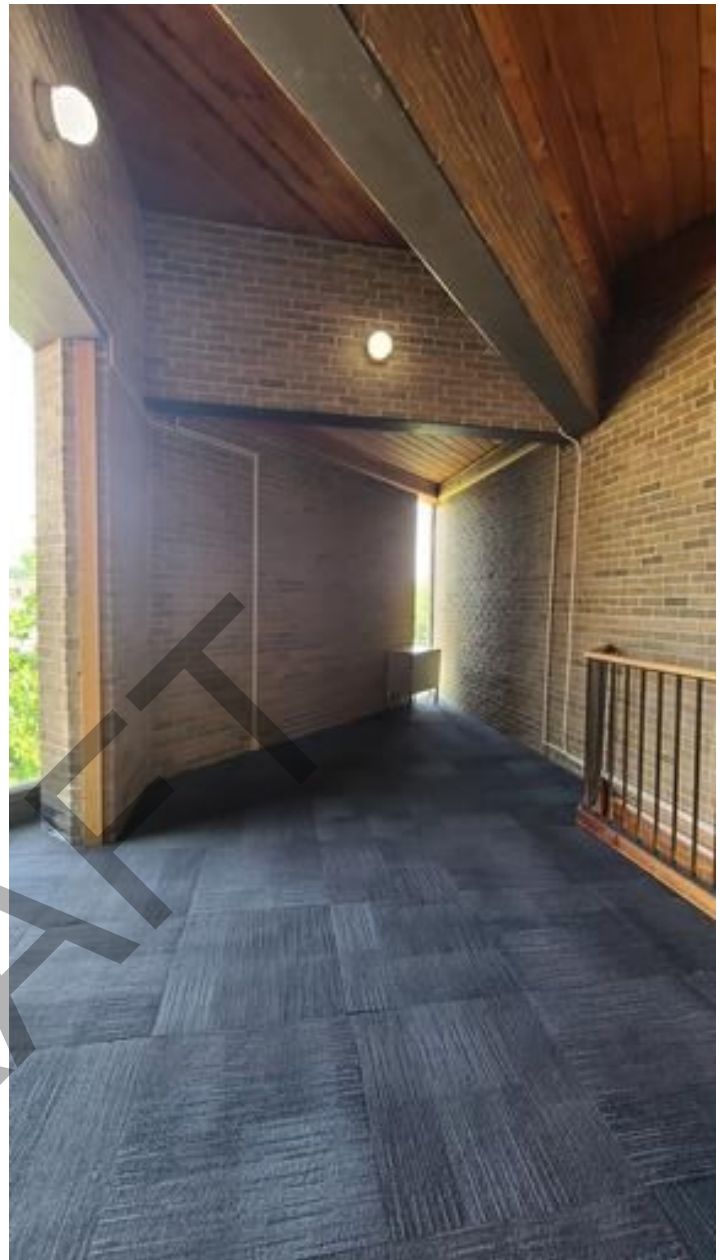
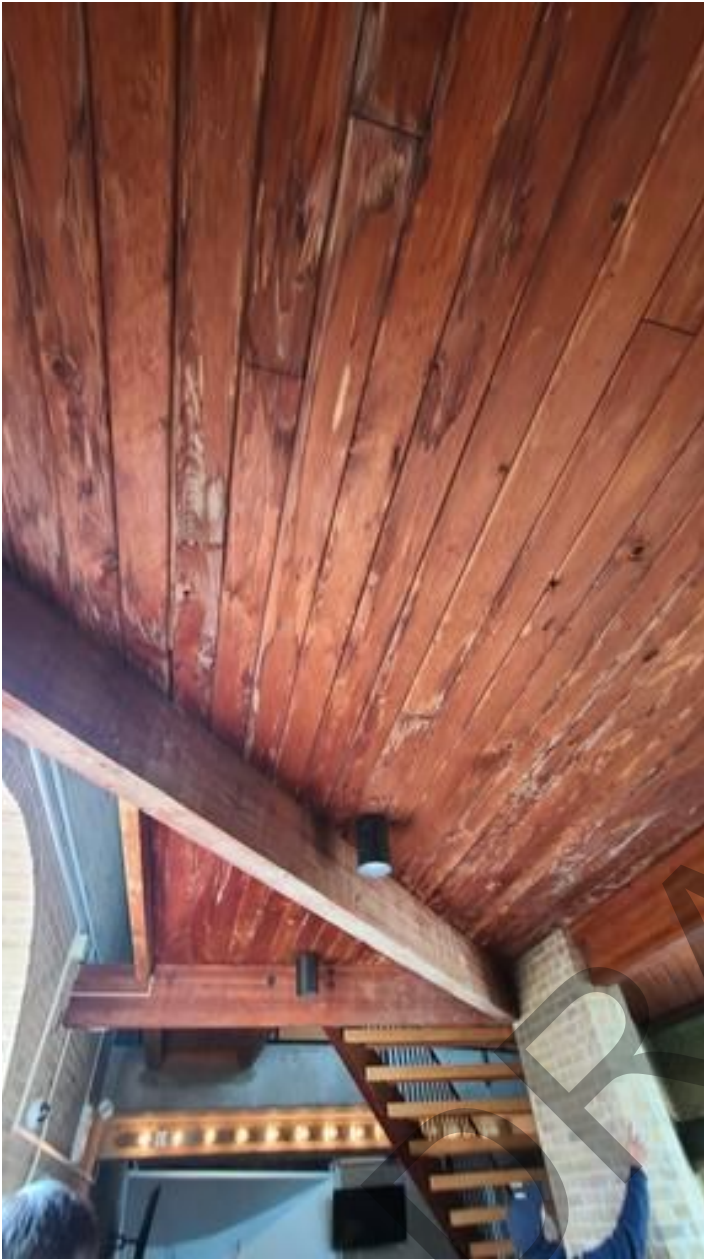
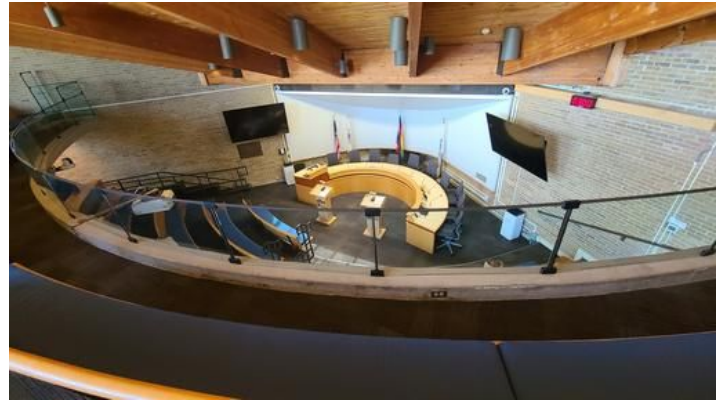
Description	Overall images of Council Chambers balcony level.
Assigned to	—
Created by	Gabriel David (Cordogan Clark)
Created on	Jun 26, 2023
Location	Village Hall - Mezzanine Level
Location details	—
Due date	—
Start date	—
Placement	06 (Village Hall - Mezzanine Level Plan)
Root cause	—

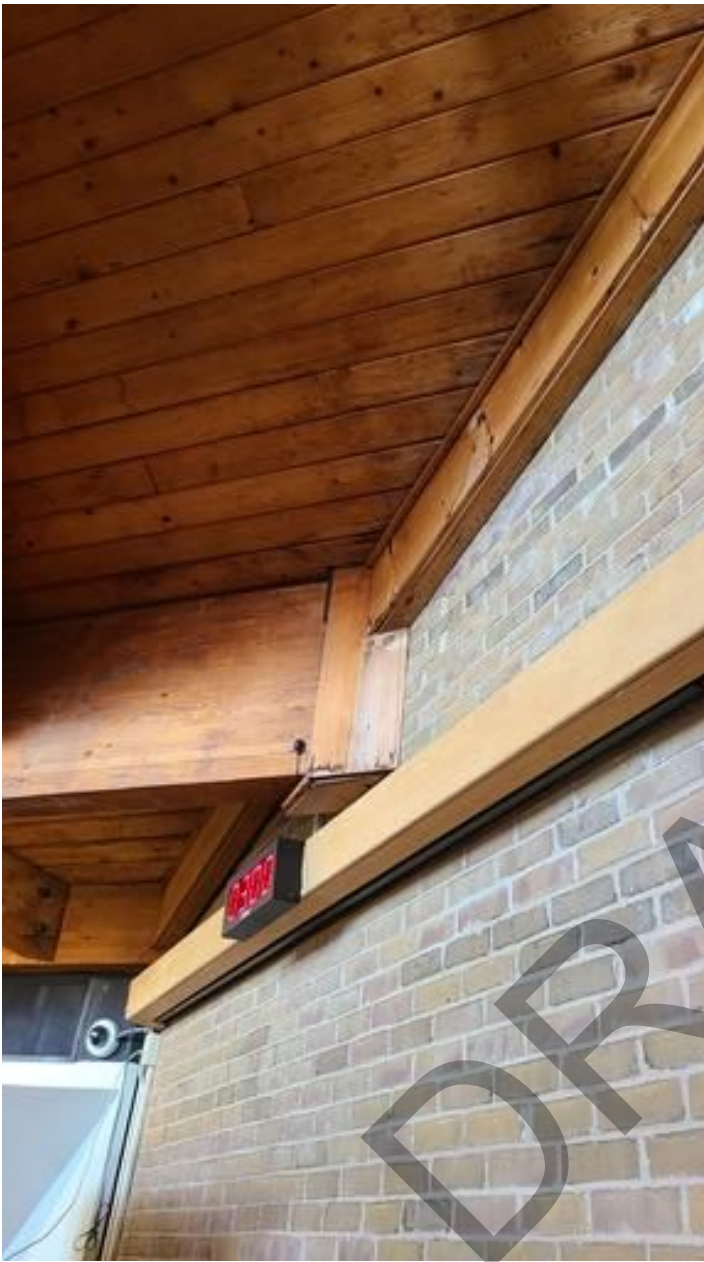
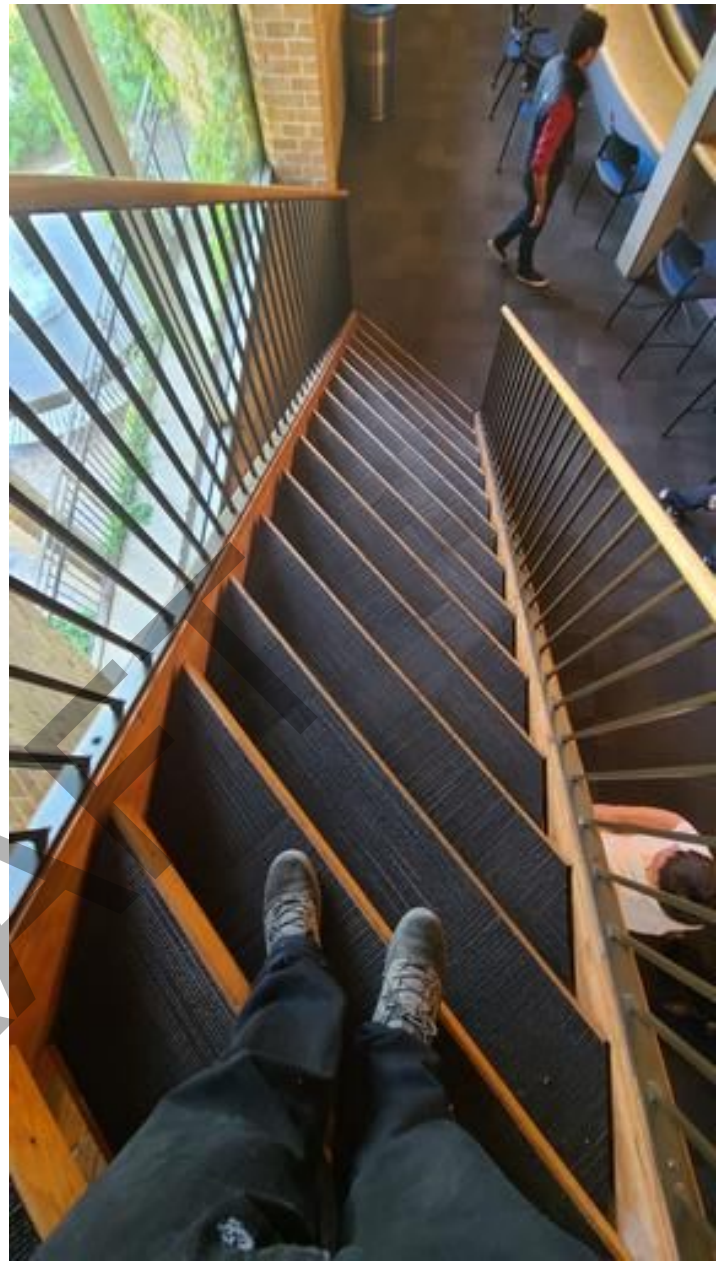
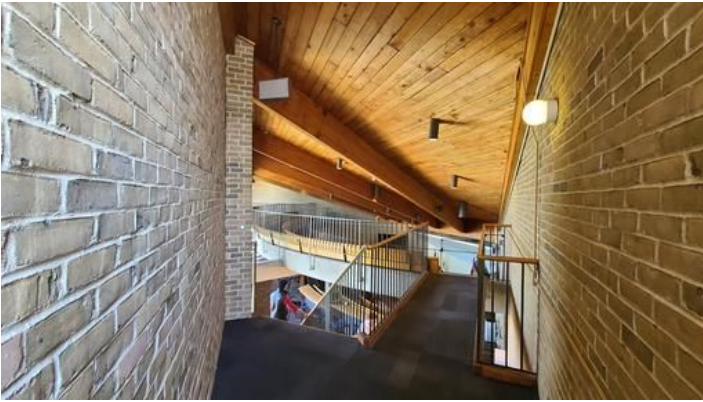
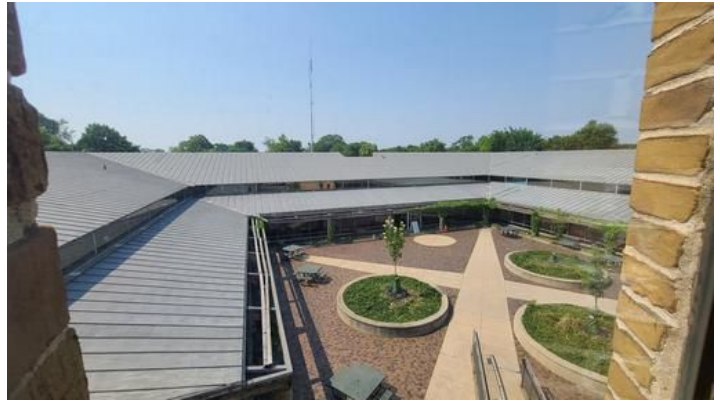
Description	Interior views of Council Chamber, and overall view of roof and courtyard.
Assigned to	—
Created by	Gabriel David (Cordogan Clark)
Created on	Jun 26, 2023
Location	Village Hall - Mezzanine Level
Location details	—
Due date	—
Start date	—
Placement	06 (Village Hall - Mezzanine Level Plan)
Root cause	—

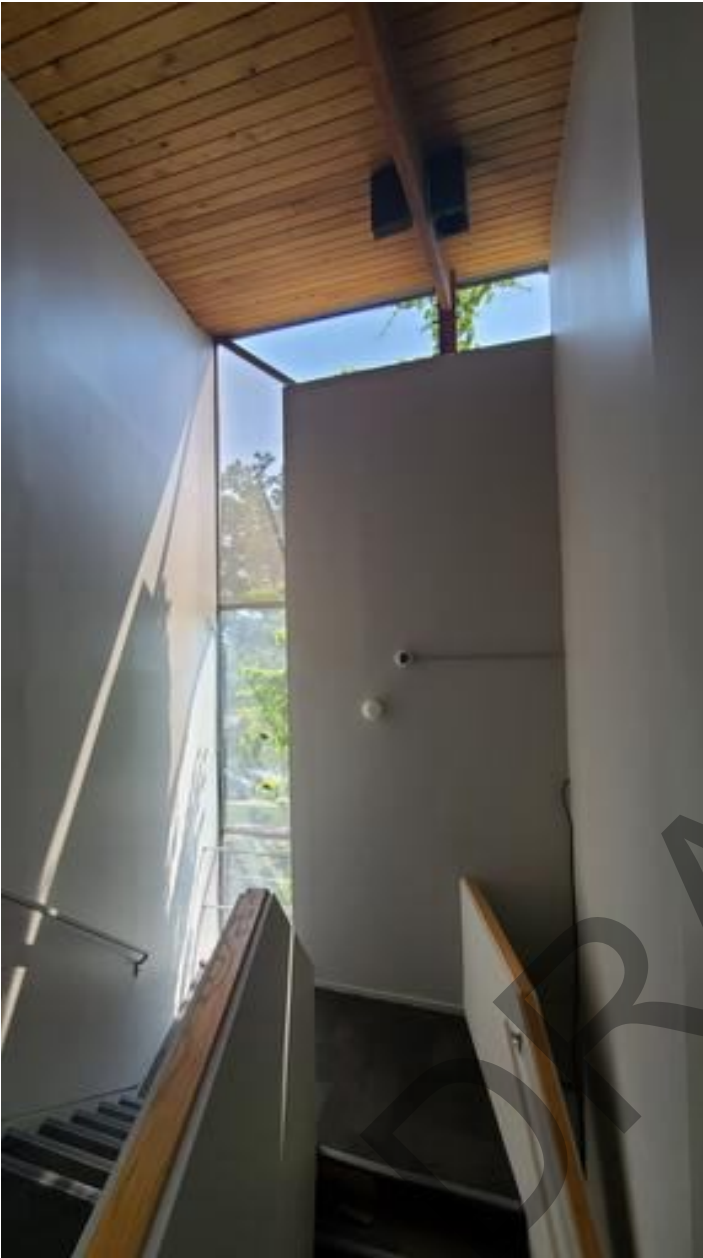
[20230608_102743](#)

Description	Overall image of enclosed emergency stair.
Assigned to	—
Created by	Gabriel David (Cordogan Clark)
Created on	Jun 26, 2023
Location	Village Hall - Mezzanine Level
Location details	—
Due date	—
Start date	—
Placement	06 (Village Hall - Mezzanine Level Plan)
Root cause	—

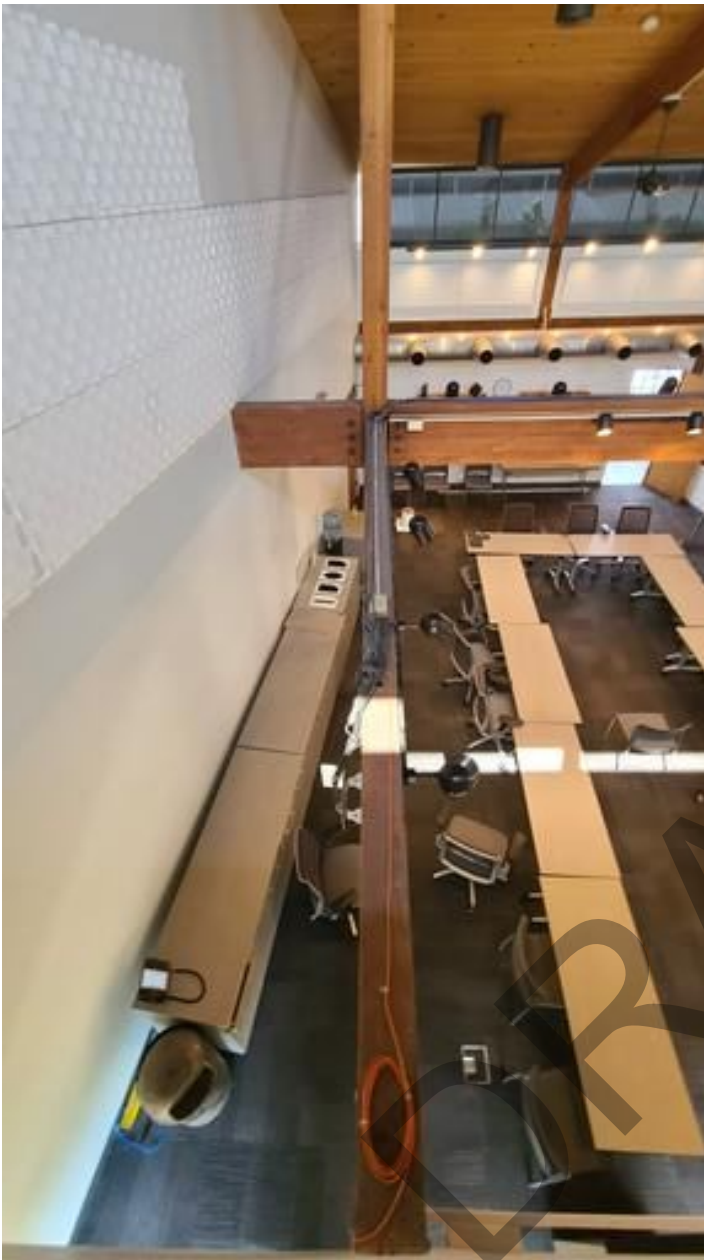
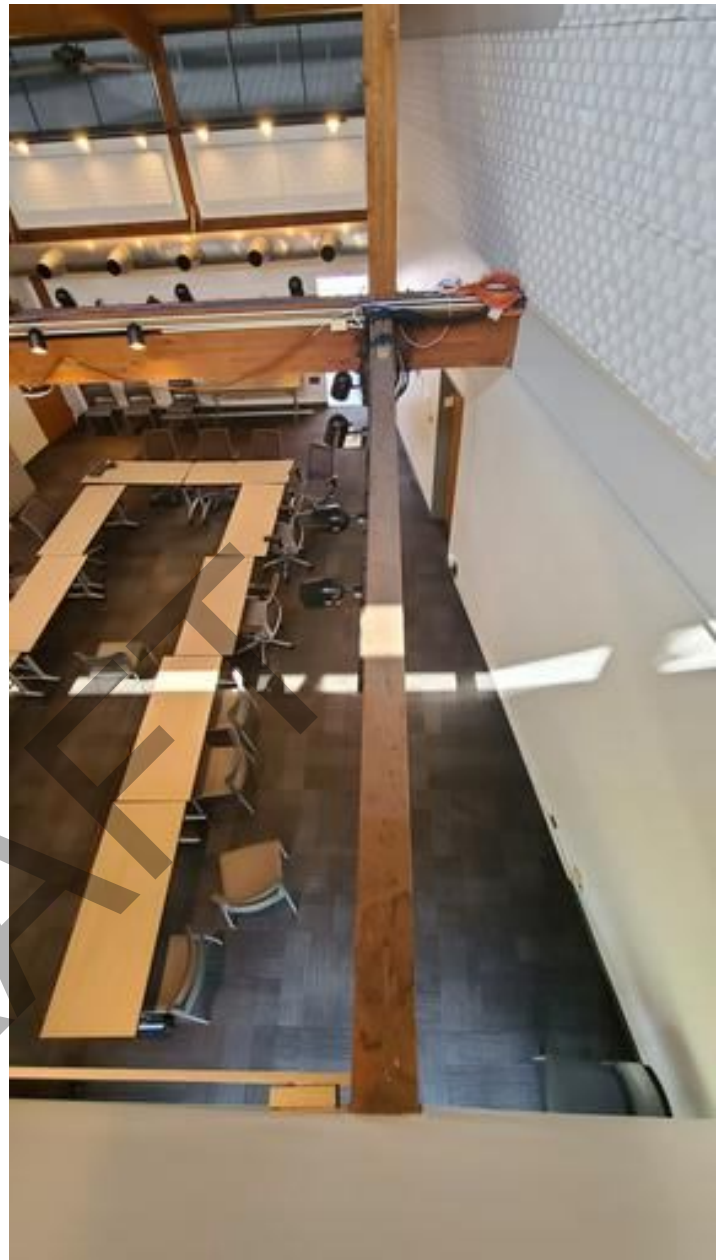
Description	Overall photos of Conference room from mezzanine level walkway.
Assigned to	—
Created by	Gabriel David (Cordogan Clark)
Created on	Jun 26, 2023
Location	Village Hall - Mezzanine Level
Location details	—
Due date	—
Start date	—
Placement	06 (Village Hall - Mezzanine Level Plan)
Root cause	—

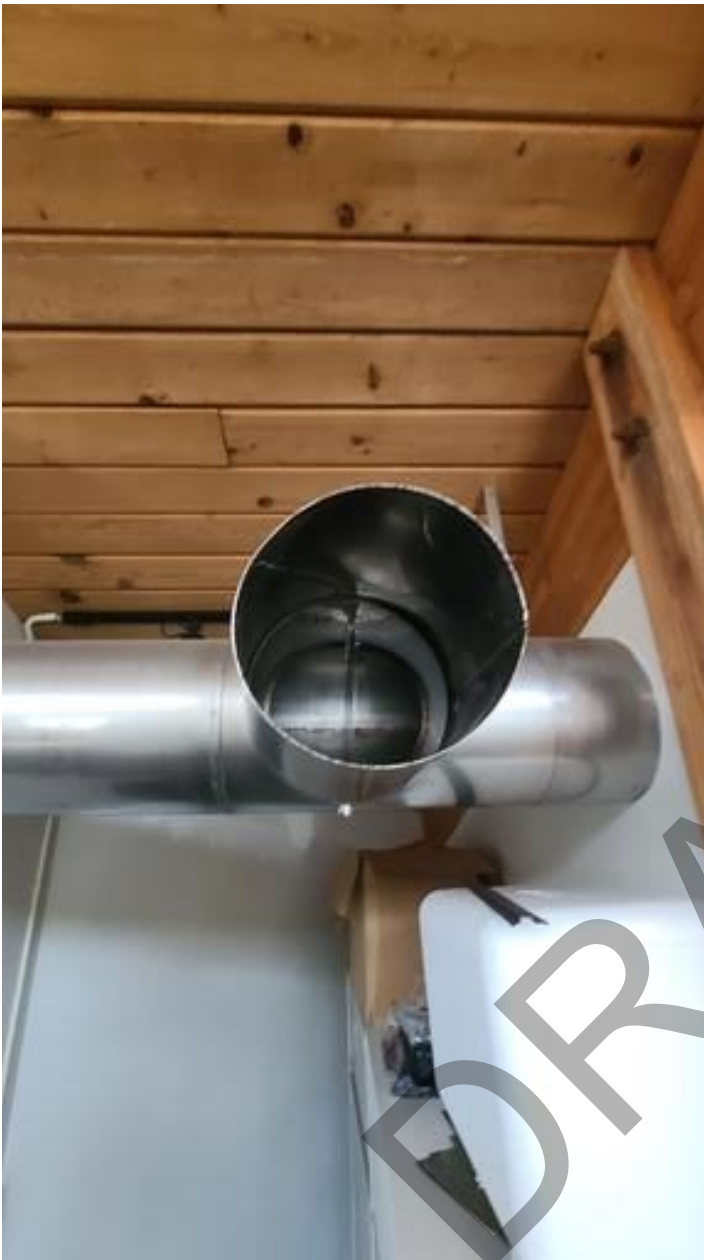
[20230608_103004](#)

Description	Close up image of mechanical duct.
Assigned to	—
Created by	Gabriel David (Cordogan Clark)
Created on	Jun 26, 2023
Location	Village Hall - Mezzanine Level
Location details	—
Due date	—
Start date	—
Placement	06 (Village Hall - Mezzanine Level Plan)
Root cause	—

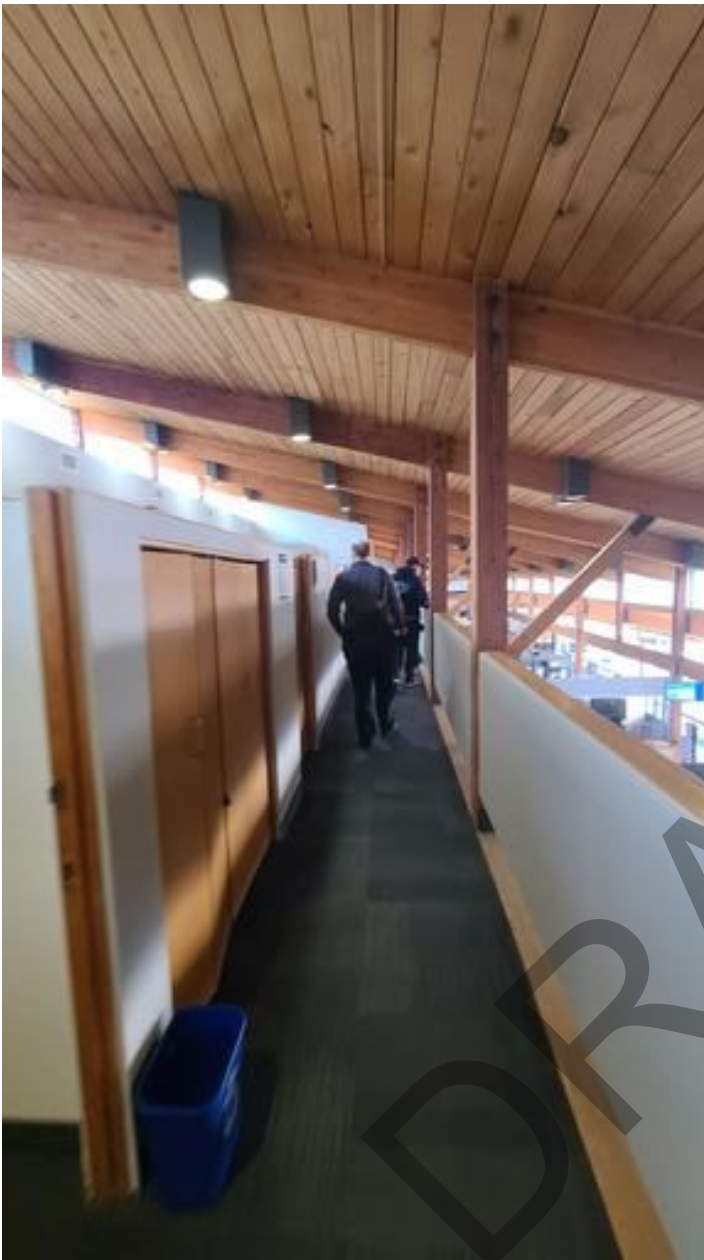
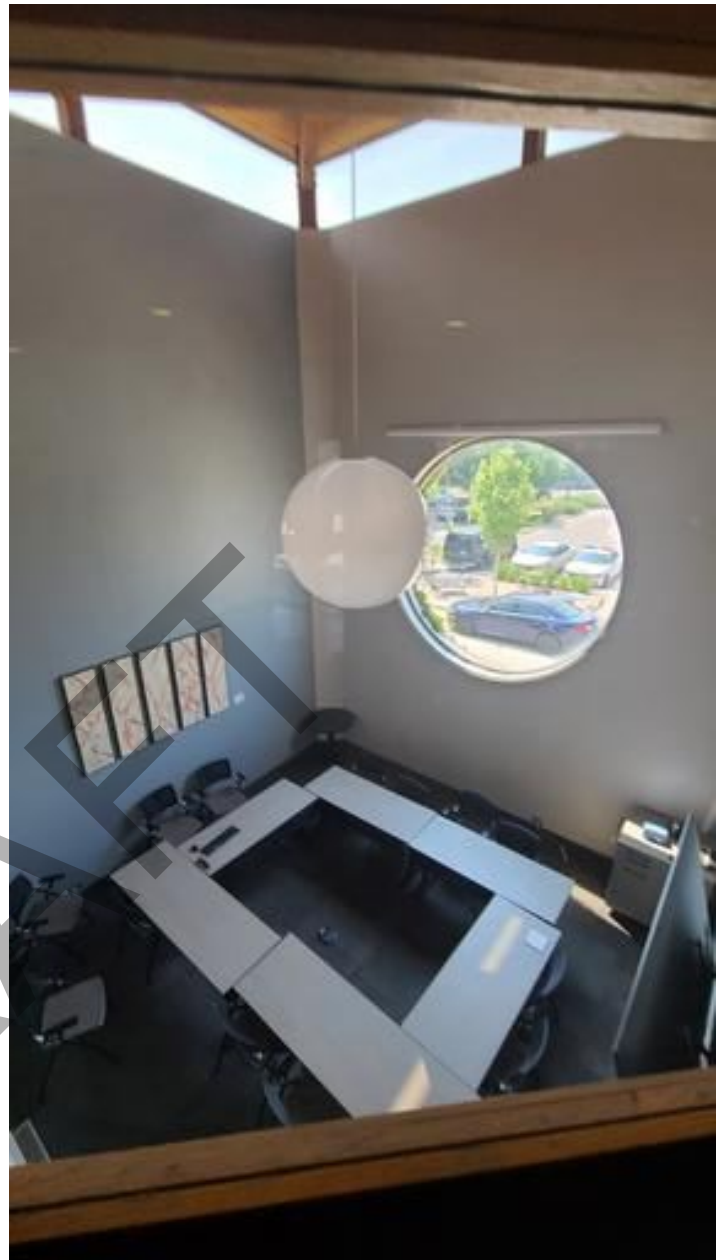
Description	Overall images of conference room and walkway from mezzanine level.
Assigned to	—
Created by	Gabriel David (Cordogan Clark)
Created on	Jun 26, 2023
Location	Village Hall - Mezzanine Level
Location details	—
Due date	—
Start date	—
Placement	06 (Village Hall - Mezzanine Level Plan)
Root cause	—

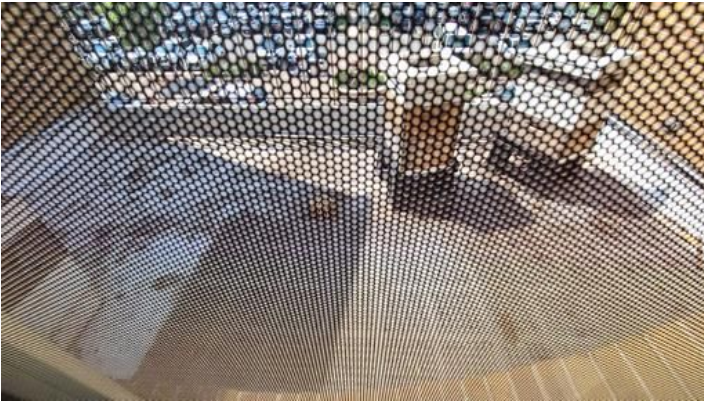
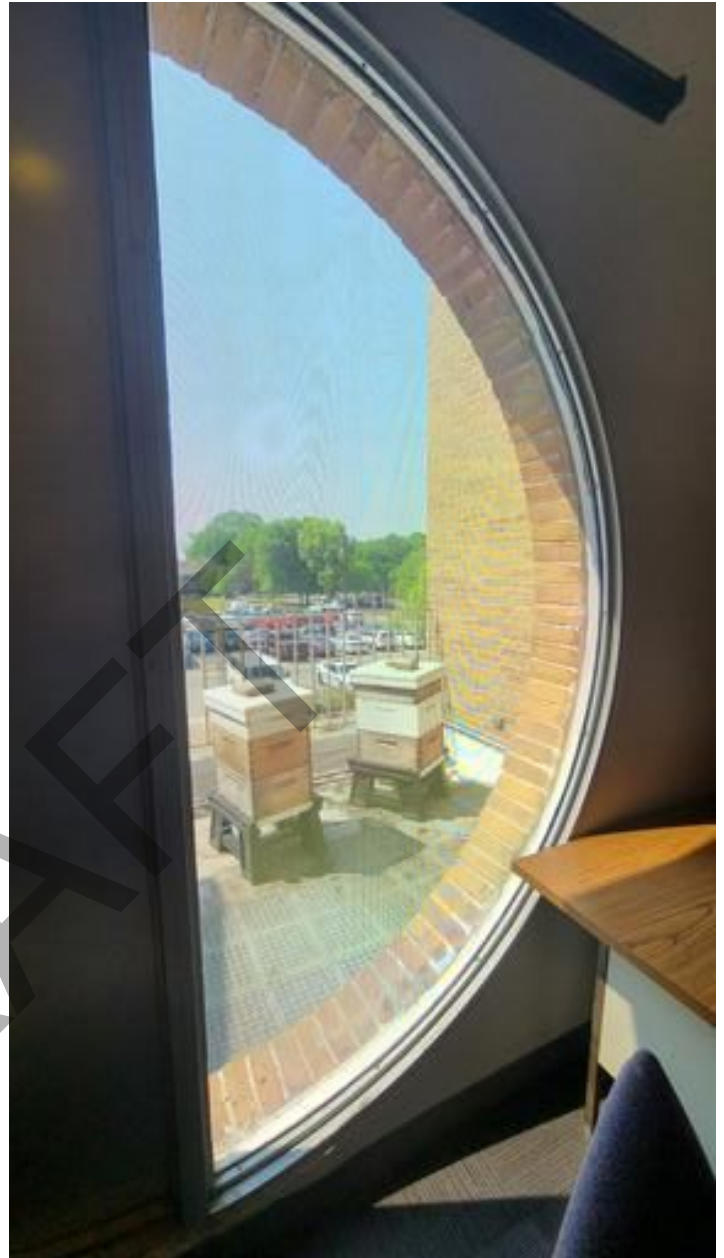
Description	Overall images of exterior balcony.
Assigned to	—
Created by	Gabriel David (Cordogan Clark)
Created on	Jun 26, 2023
Location	Village Hall - Mezzanine Level
Location details	—
Due date	—
Start date	—
Placement	06 (Village Hall - Mezzanine Level Plan)
Root cause	—

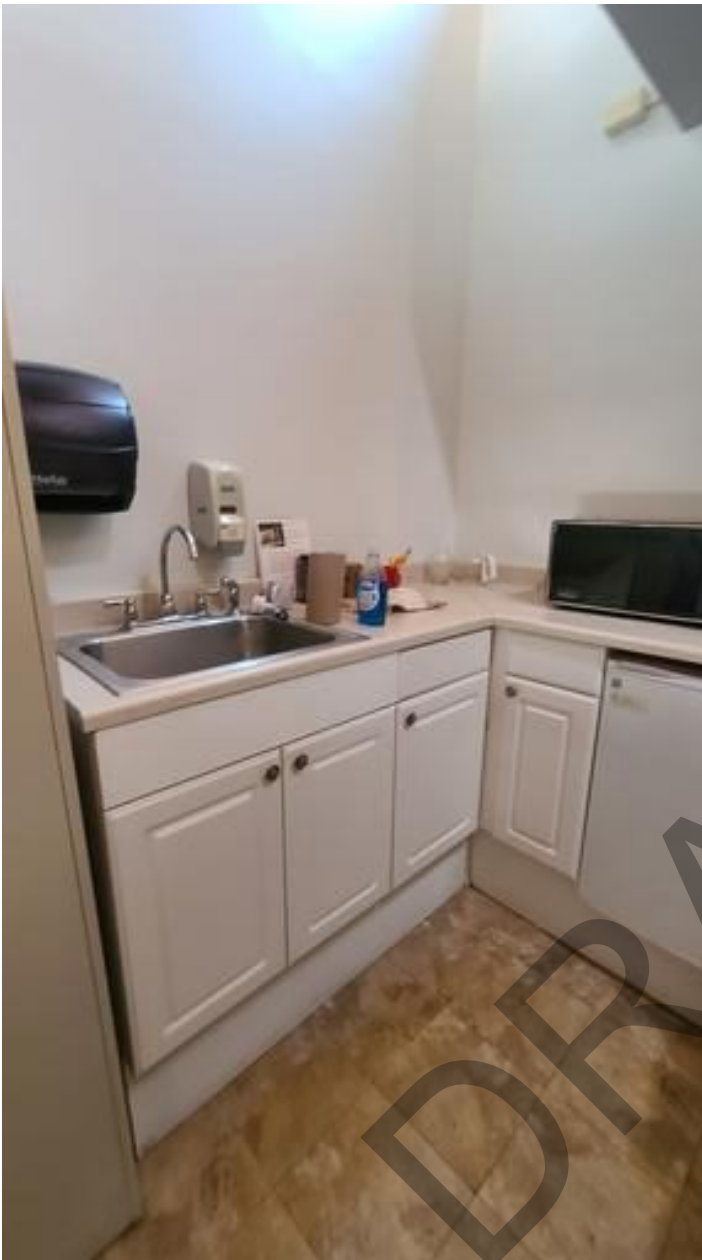
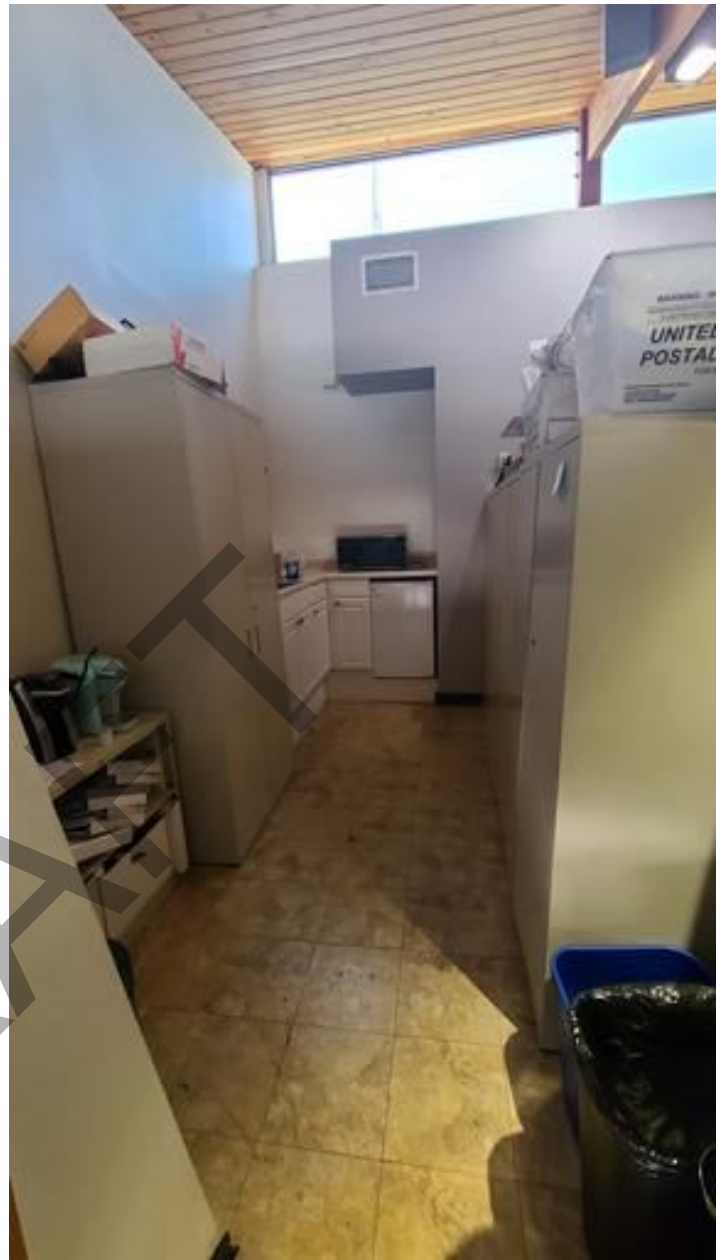
Description	Overall images of food prep area.
Assigned to	—
Created by	Gabriel David (Cordogan Clark)
Created on	Jun 26, 2023
Location	Village Hall - Mezzanine Level
Location details	—
Due date	—
Start date	—
Placement	06 (Village Hall - Mezzanine Level Plan)
Root cause	—
