**OAK PARK VILLAGE HALL
123 Madison Street, Oak Park IL. 60302**

**PROPERTY CONDITION ASSESSMENT REPORT
07.08.23**

Property Condition Assessment Report

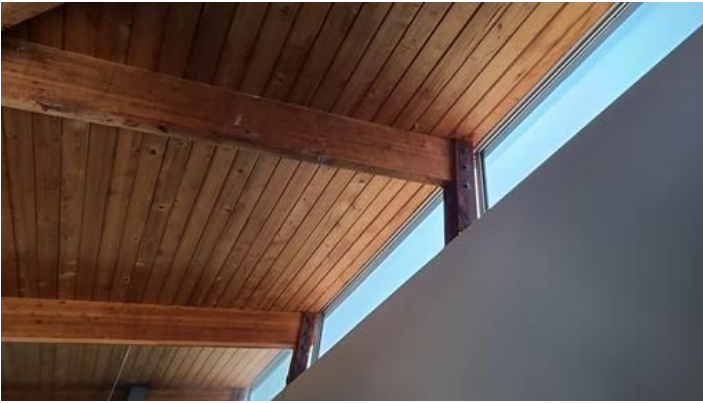
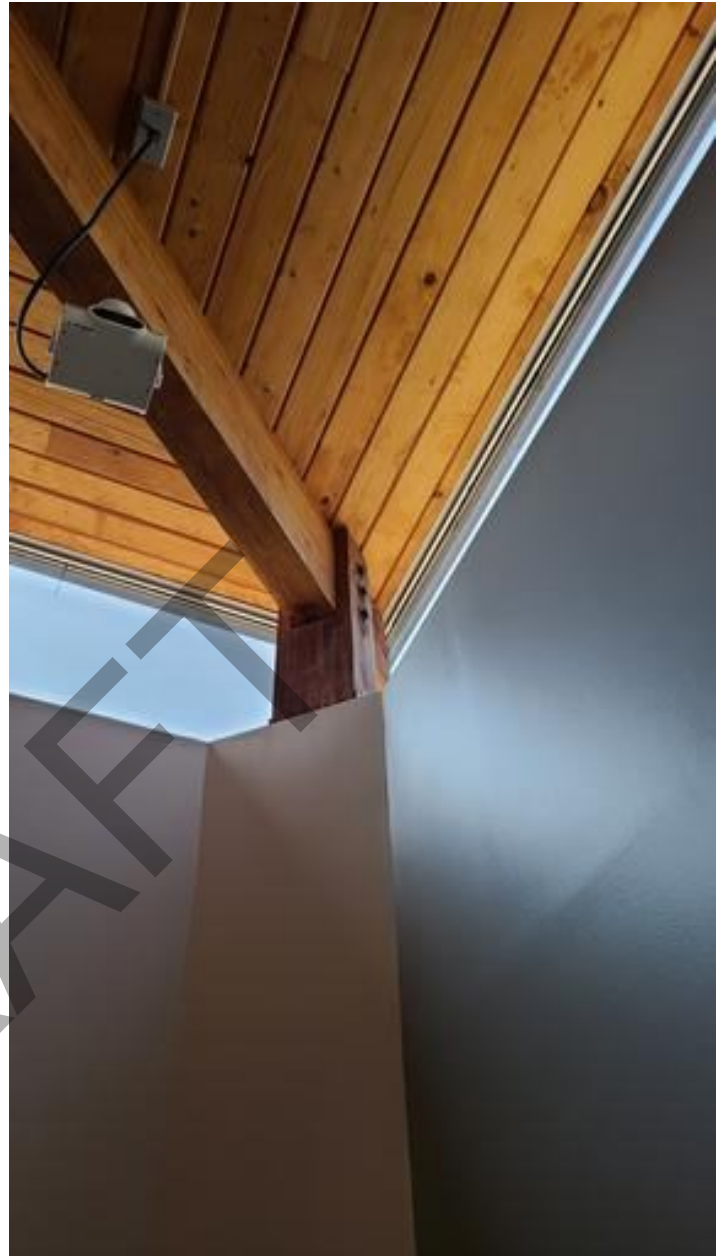
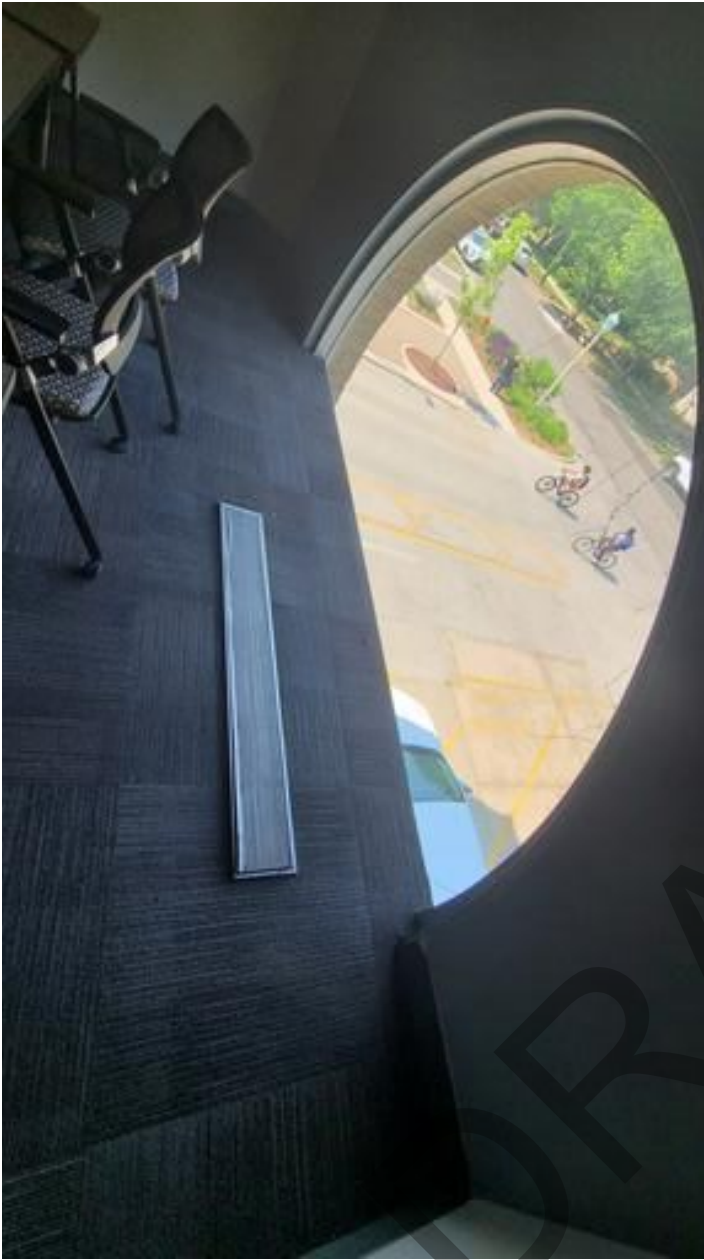
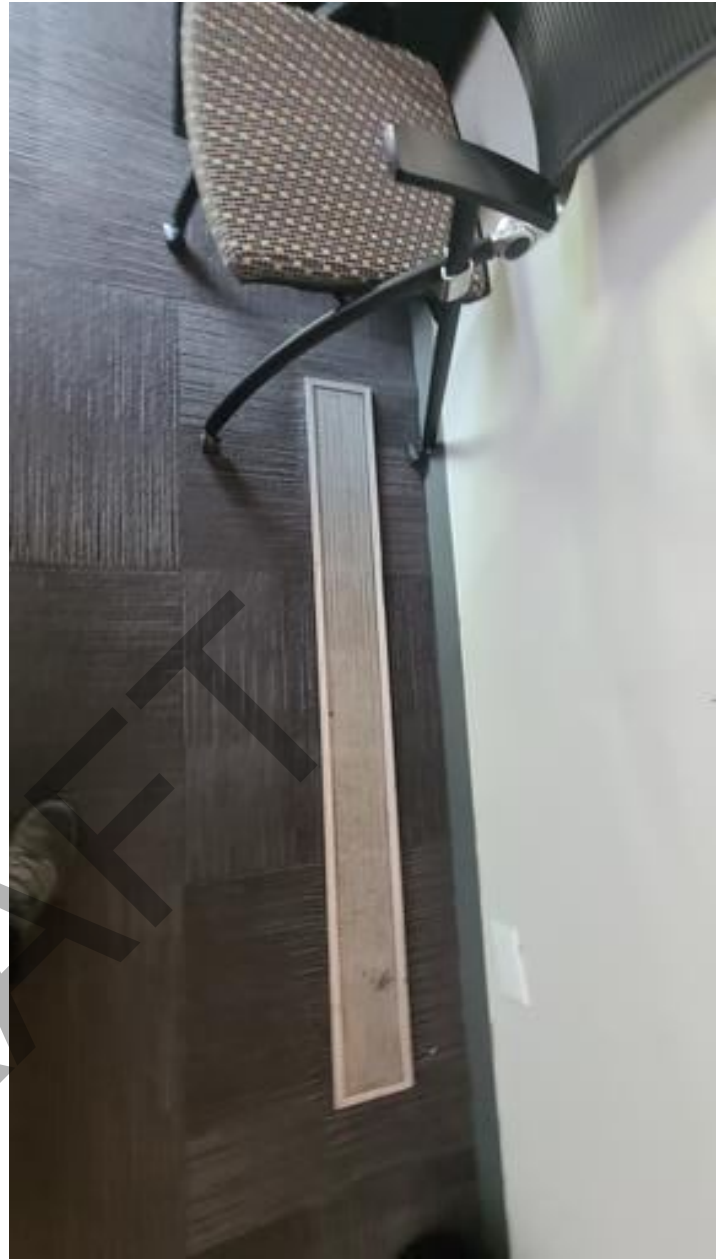
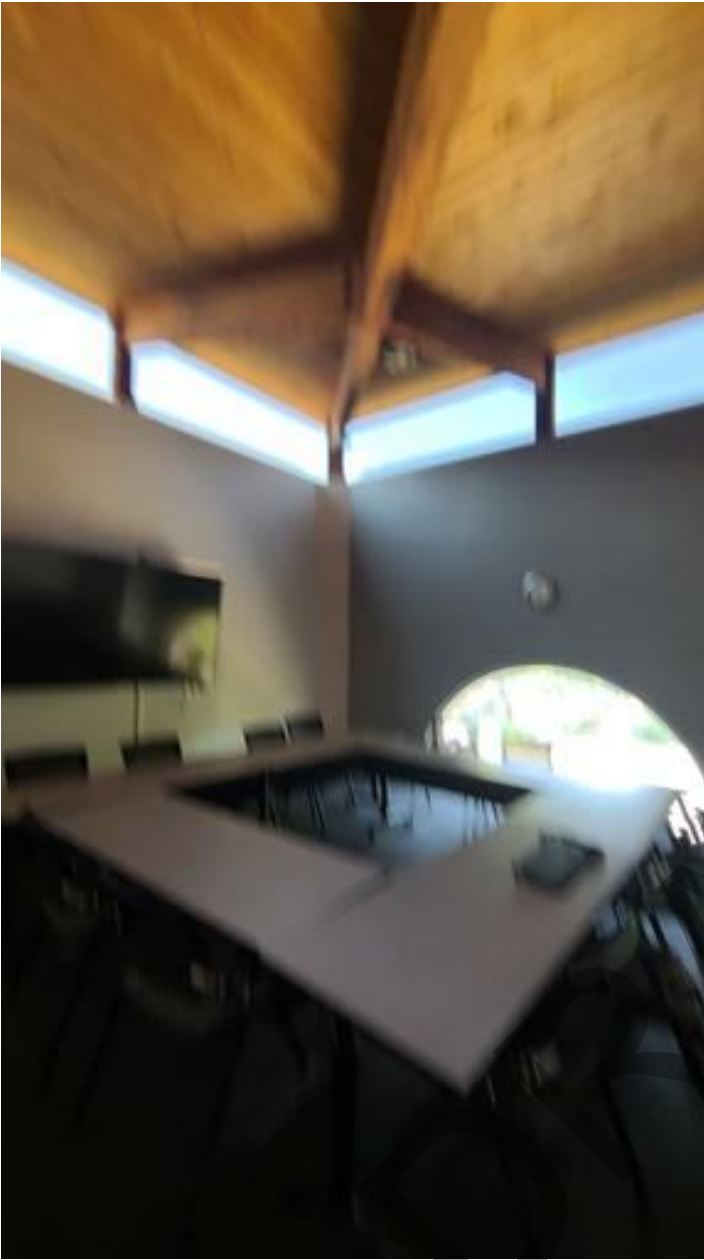
Description	Overall photos of conference room.
Assigned to	—
Created by	Gabriel David (Cordogan Clark)
Created on	Jun 26, 2023
Location	Village Hall - Mezzanine Level
Location details	—
Due date	—
Start date	—
Placement	06 (Village Hall - Mezzanine Level Plan)
Root cause	—

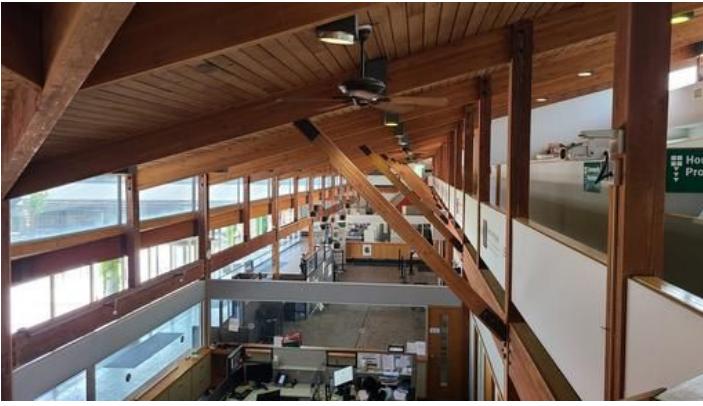
Description	Overall interior photo from mezzanine level looking down to ground level.
Assigned to	—
Created by	Gabriel David (Cordogan Clark)
Created on	Jun 26, 2023
Location	Village Hall - Mezzanine Level
Location details	—
Due date	—
Start date	—
Placement	06 (Village Hall - Mezzanine Level Plan)
Root cause	—

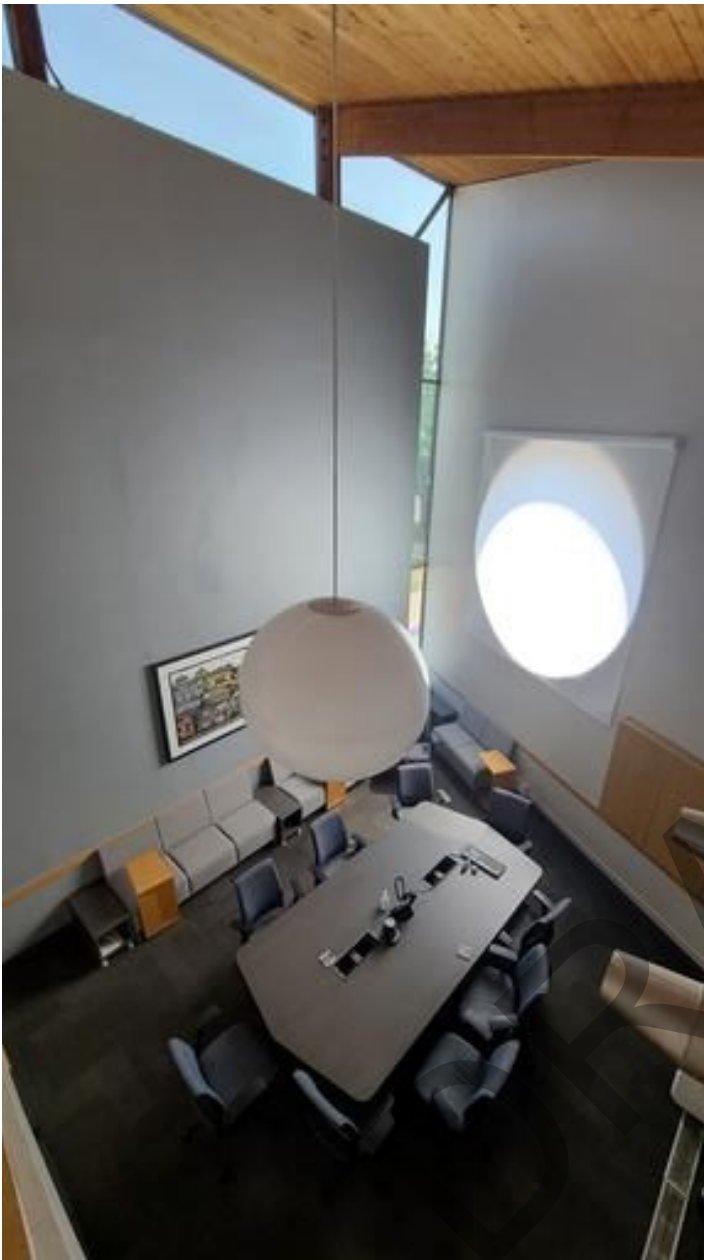
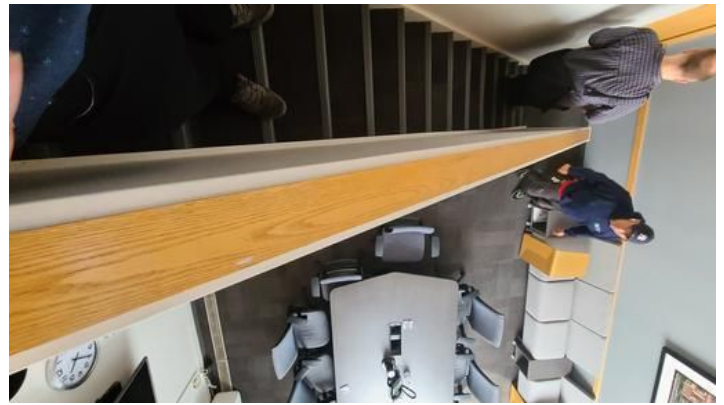
Description	Overall photos on conference room, and stair leading down.
Assigned to	—
Created by	Gabriel David (Cordogan Clark)
Created on	Jun 26, 2023
Location	Village Hall - Mezzanine Level
Location details	—
Due date	—
Start date	—
Placement	06 (Village Hall - Mezzanine Level Plan)
Root cause	—

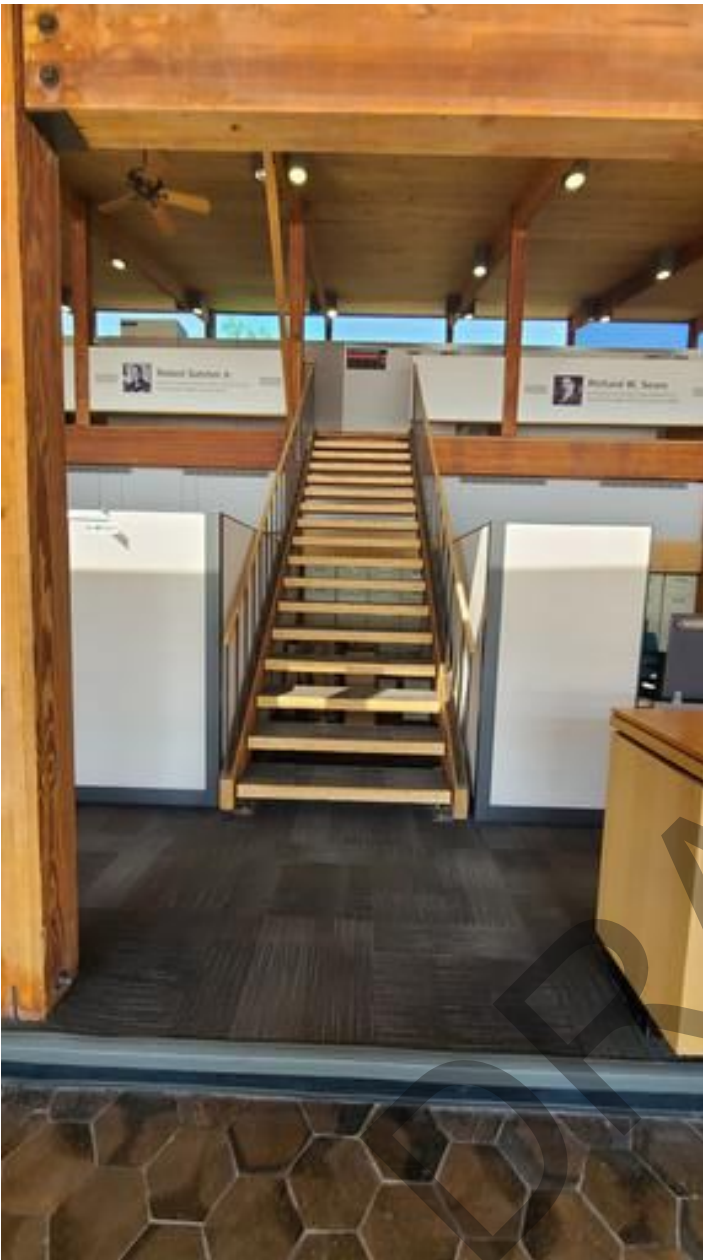
Description	Overall image of unenclosed stair leading up to mezzanine level.
Assigned to	—
Created by	Gabriel David (Cordogan Clark)
Created on	Jun 26, 2023
Location	Village Hall - Mezzanine Level
Location details	—
Due date	—
Start date	—
Placement	06 (Village Hall - Mezzanine Level Plan)
Root cause	—

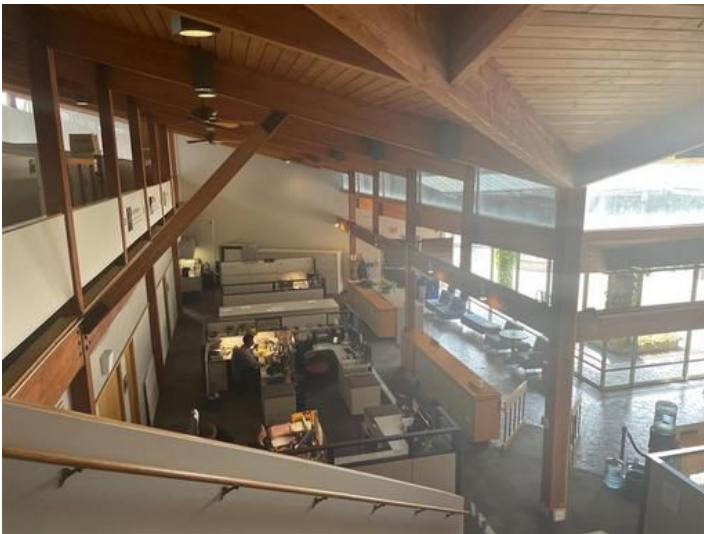
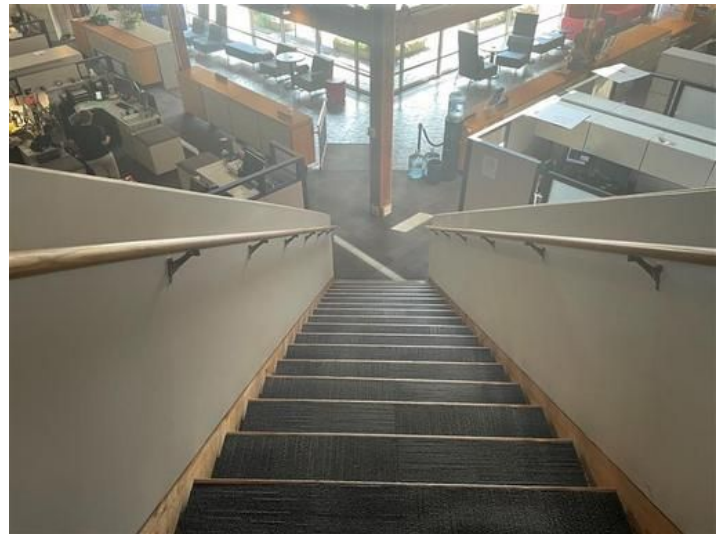
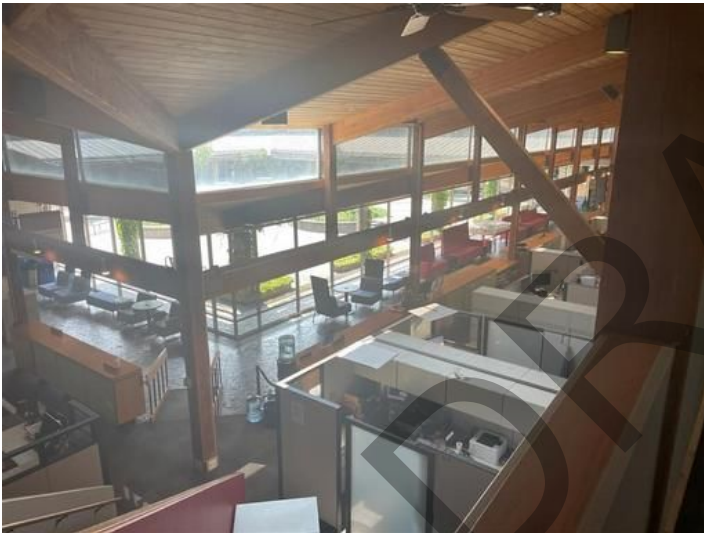
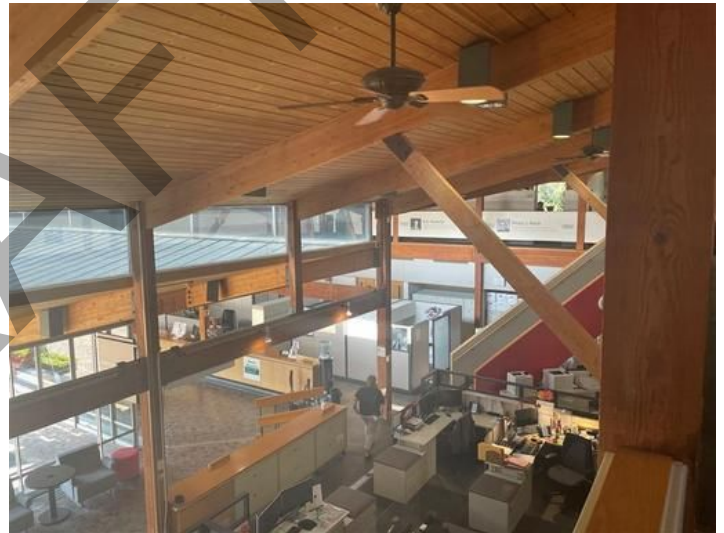
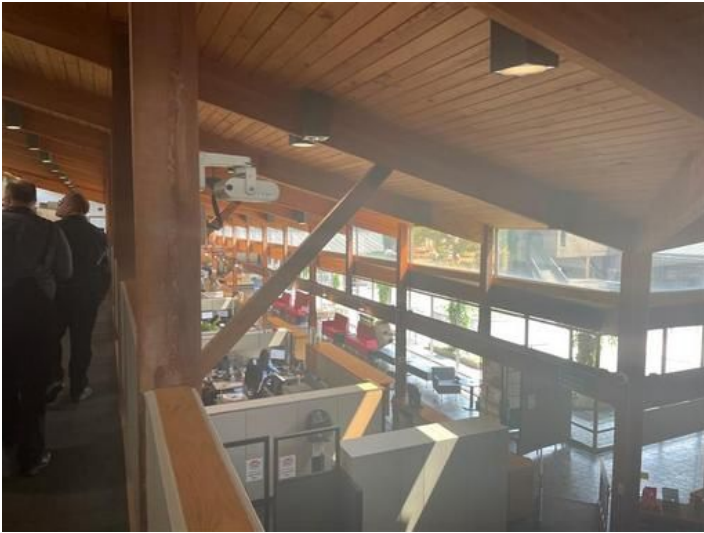
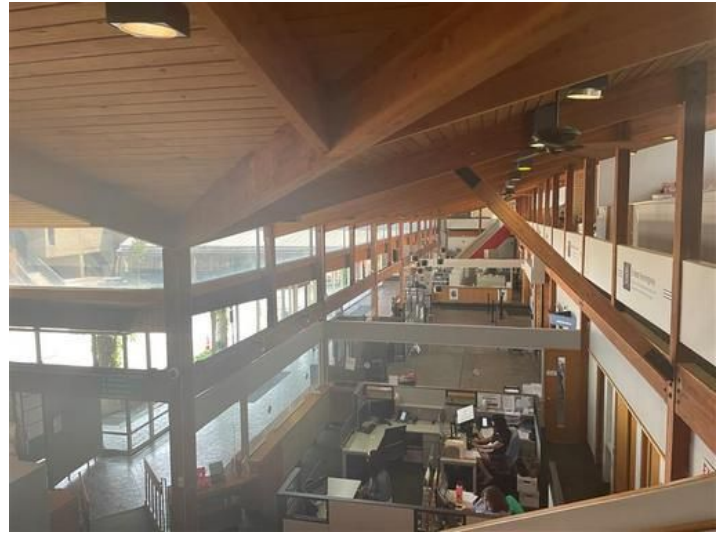
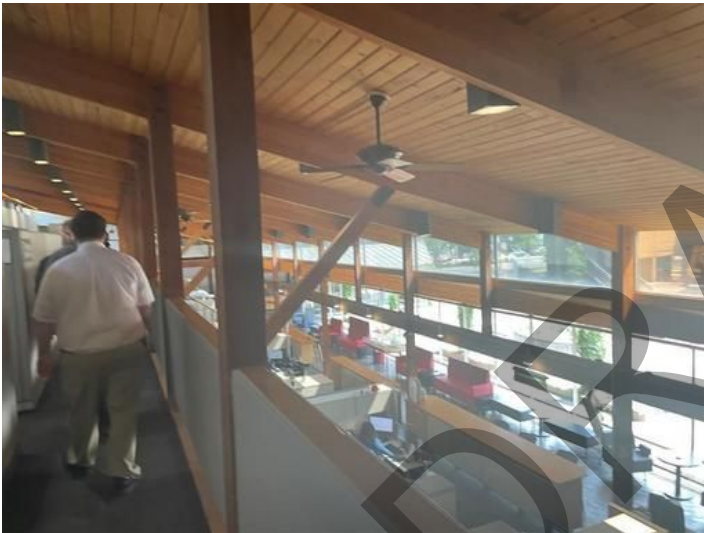
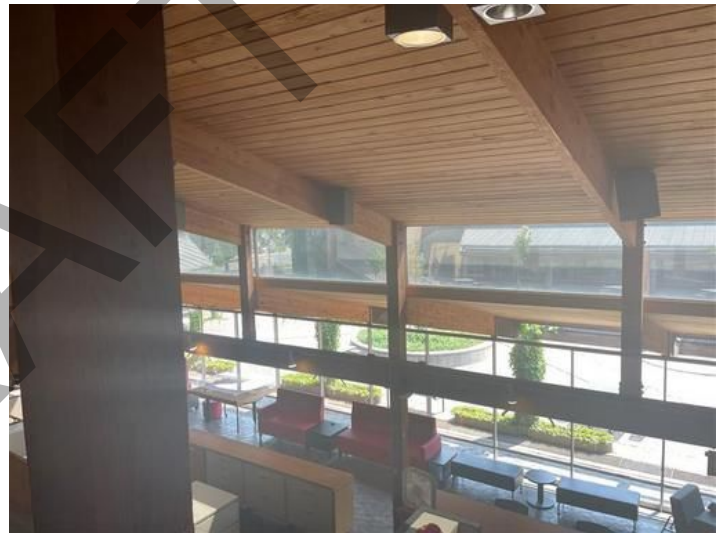
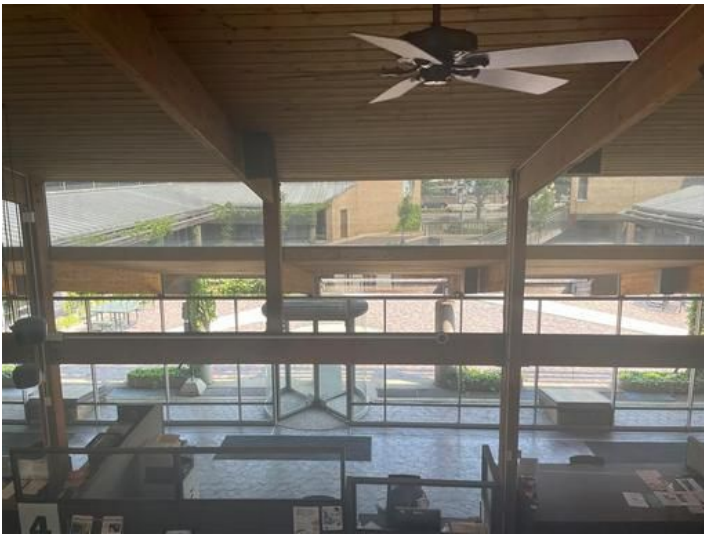
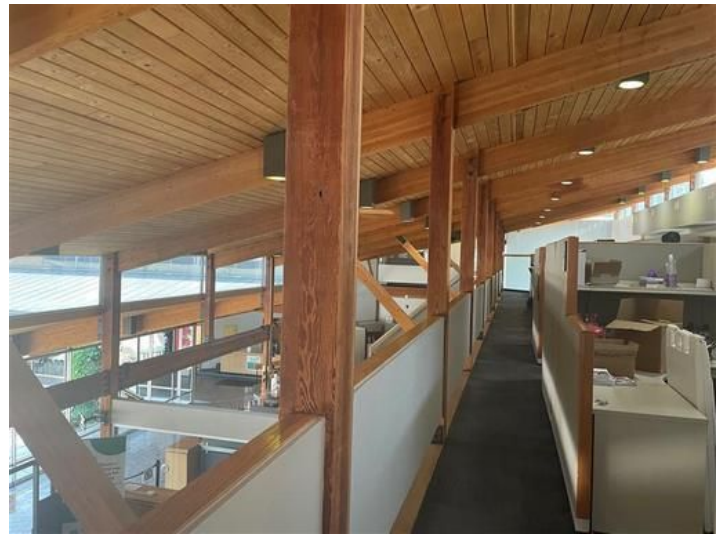
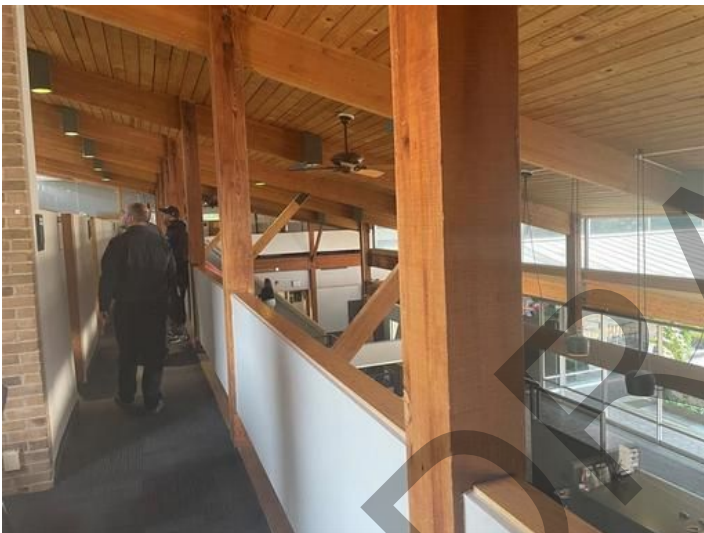
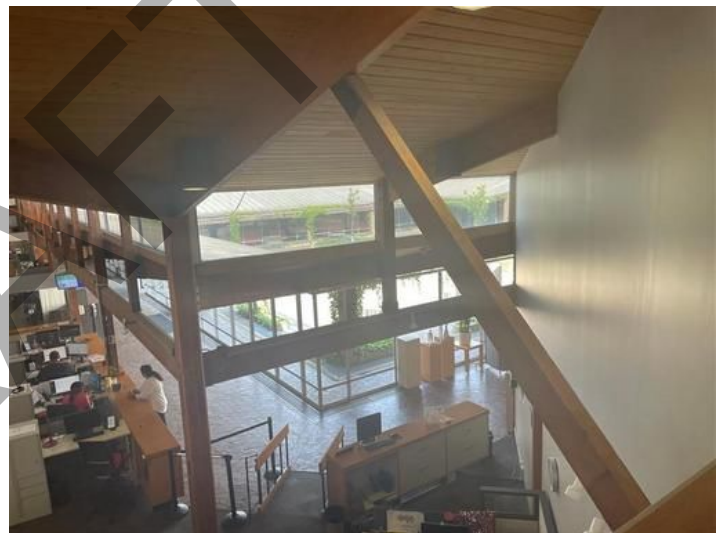
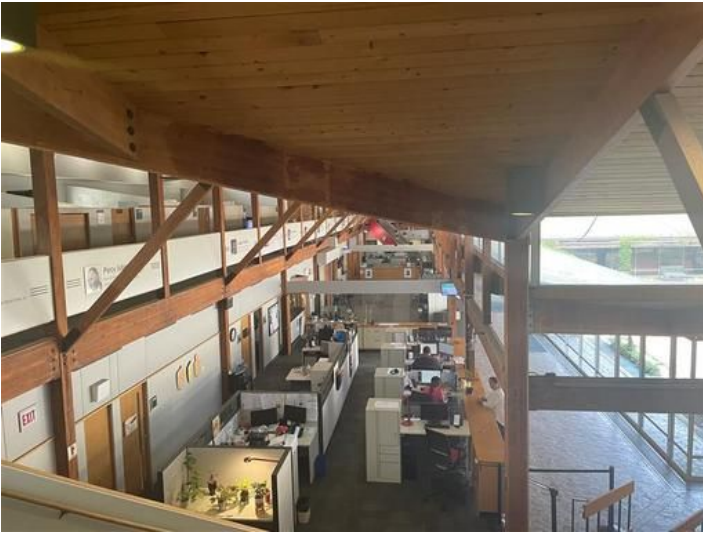
Description	Interior view looking down from mezzanine level to ground level.
Assigned to	—
Created by	Gabriel David (Cordogan Clark)
Created on	Jun 26, 2023
Location	Village Hall - Mezzanine Level
Location details	—
Due date	—
Start date	—
Placement	06 (Village Hall - Mezzanine Level Plan)
Root cause	—

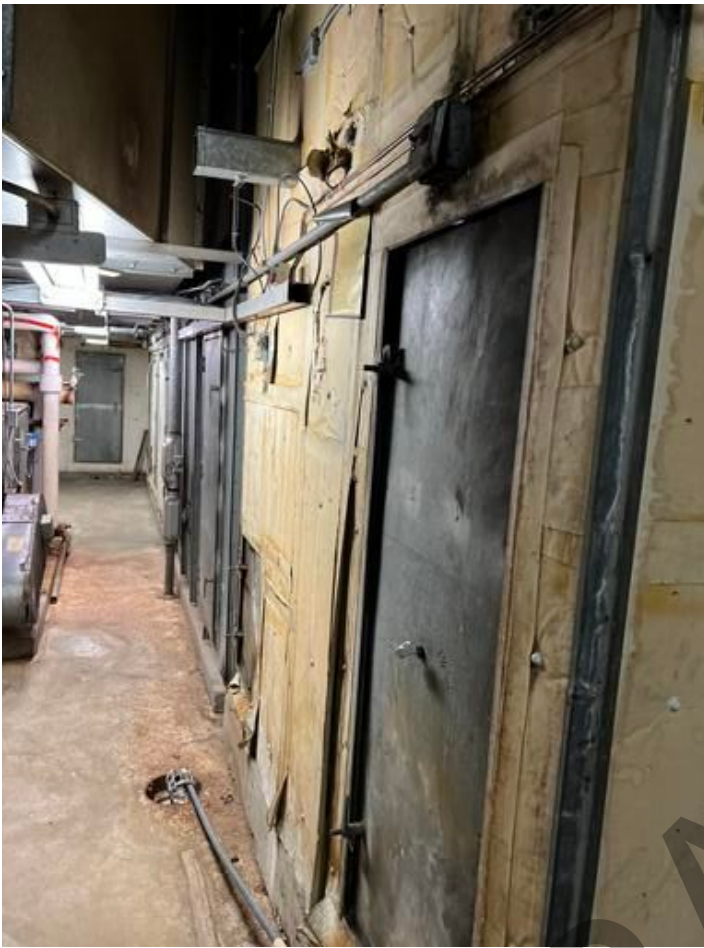
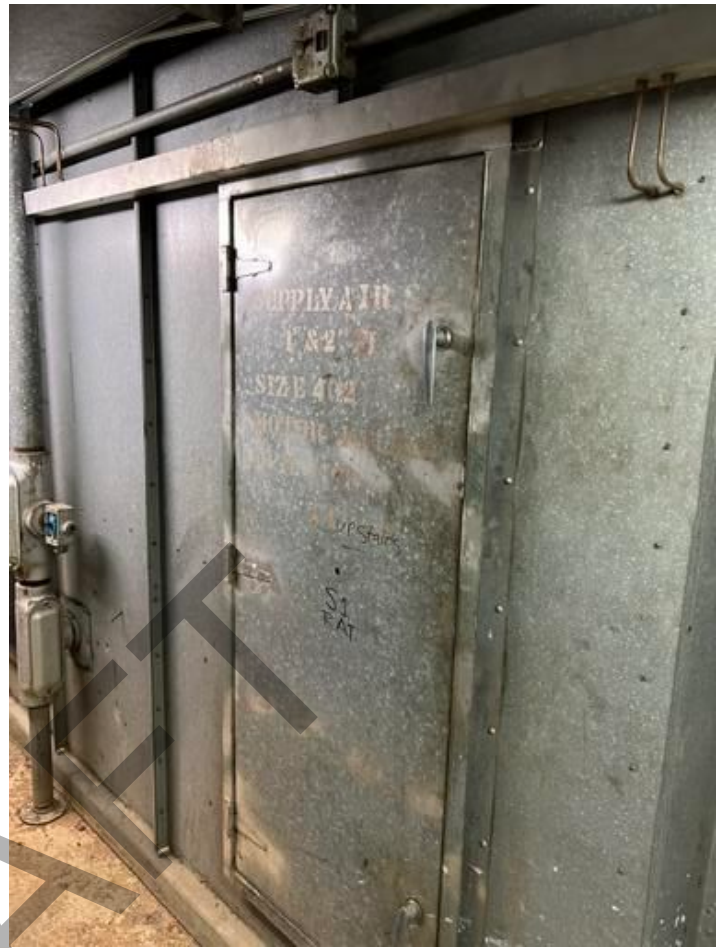
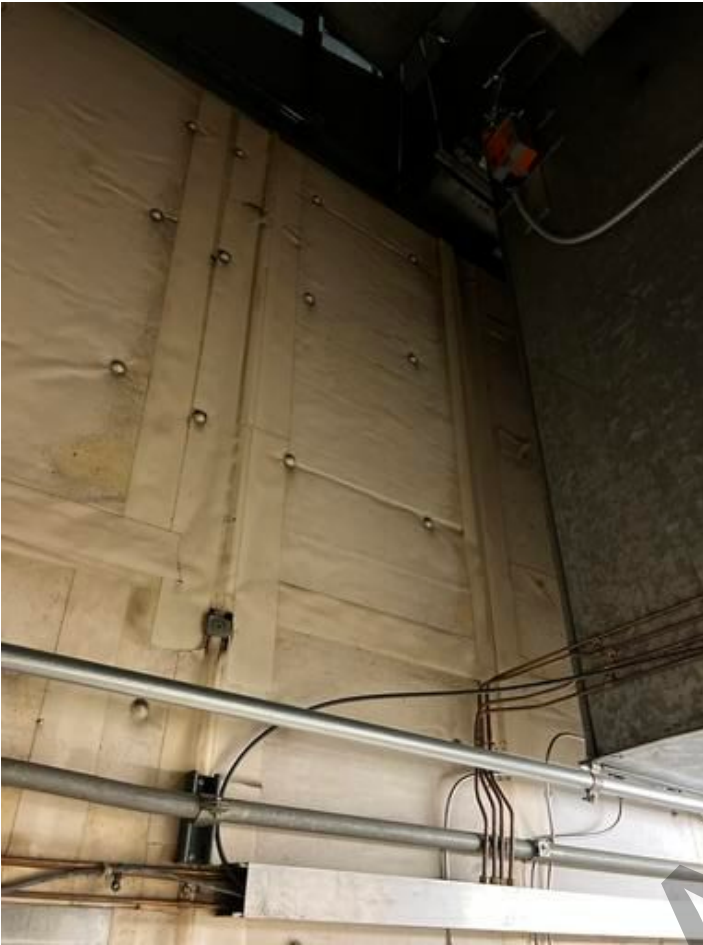
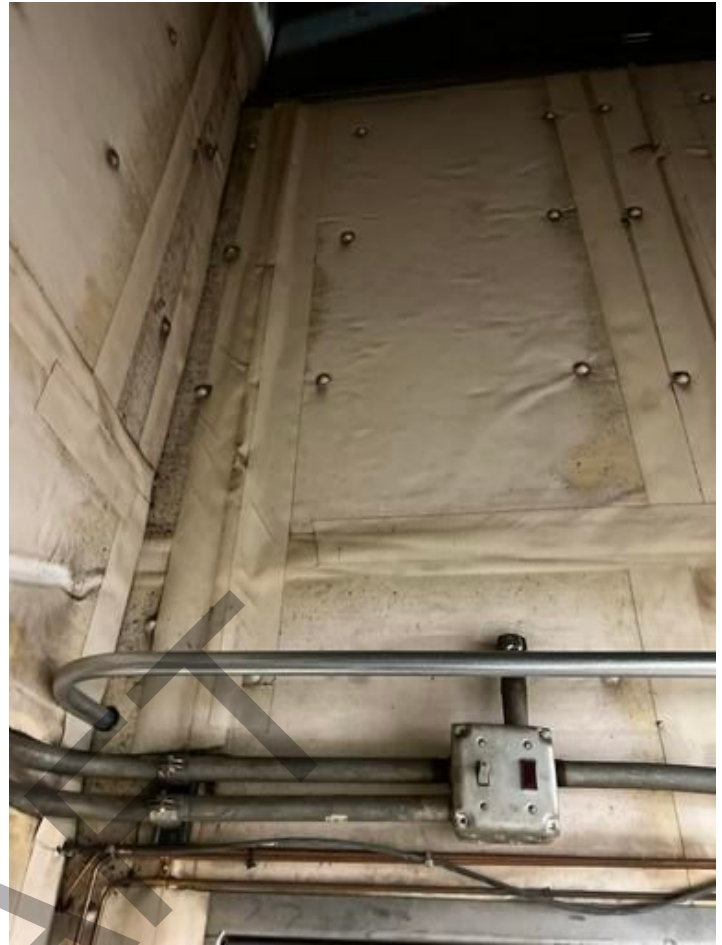
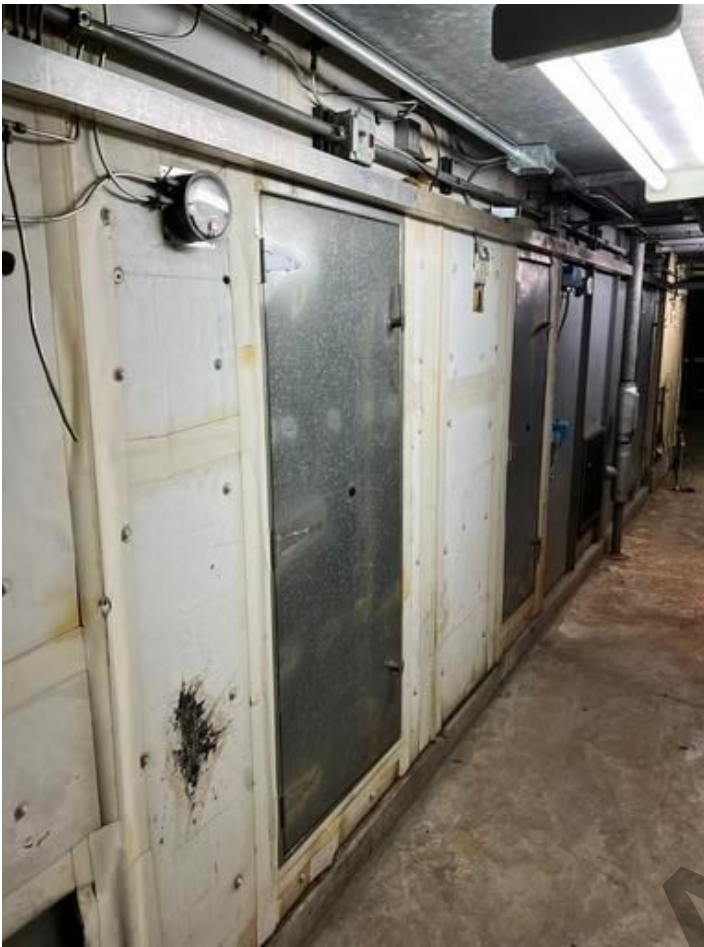
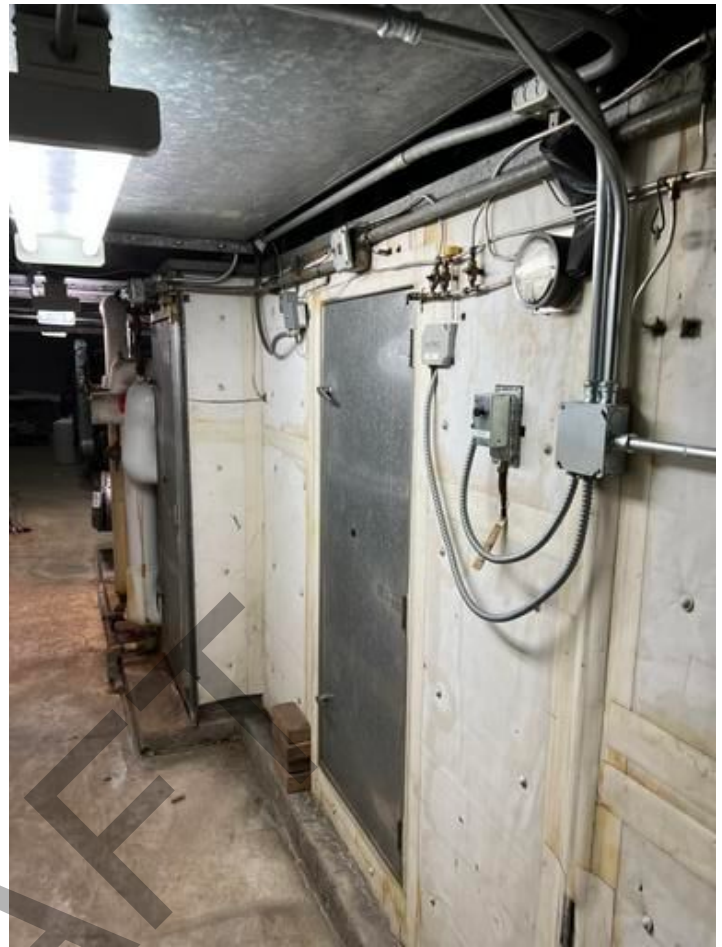
Description	Overall images of mechanical equipment in larger mechanical and HVAC area.
Assigned to	—
Created by	Gabriel David (Cordogan Clark)
Created on	Jun 21, 2023
Location	Village Hall - Lower Level
Location details	—
Due date	—
Start date	—
Placement	04 (Village Hall - Lower Level Plan)
Root cause	—

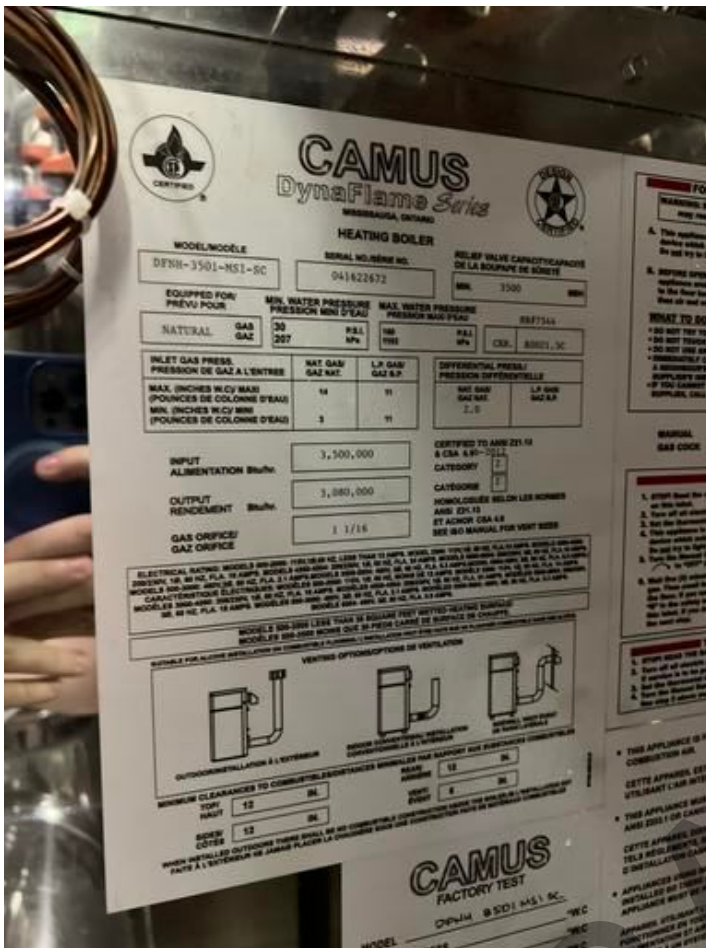
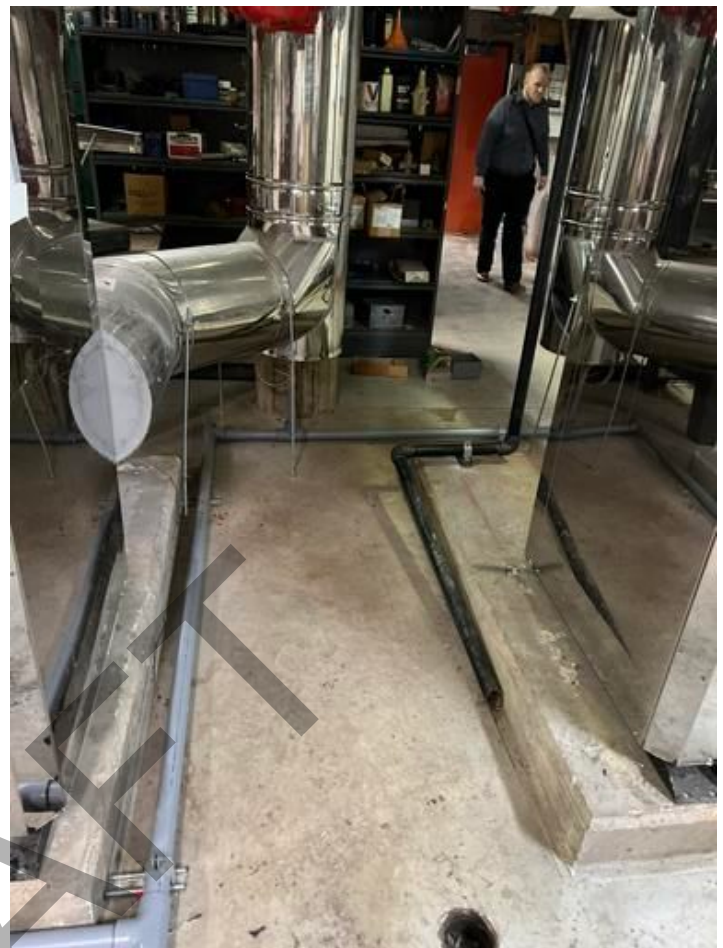
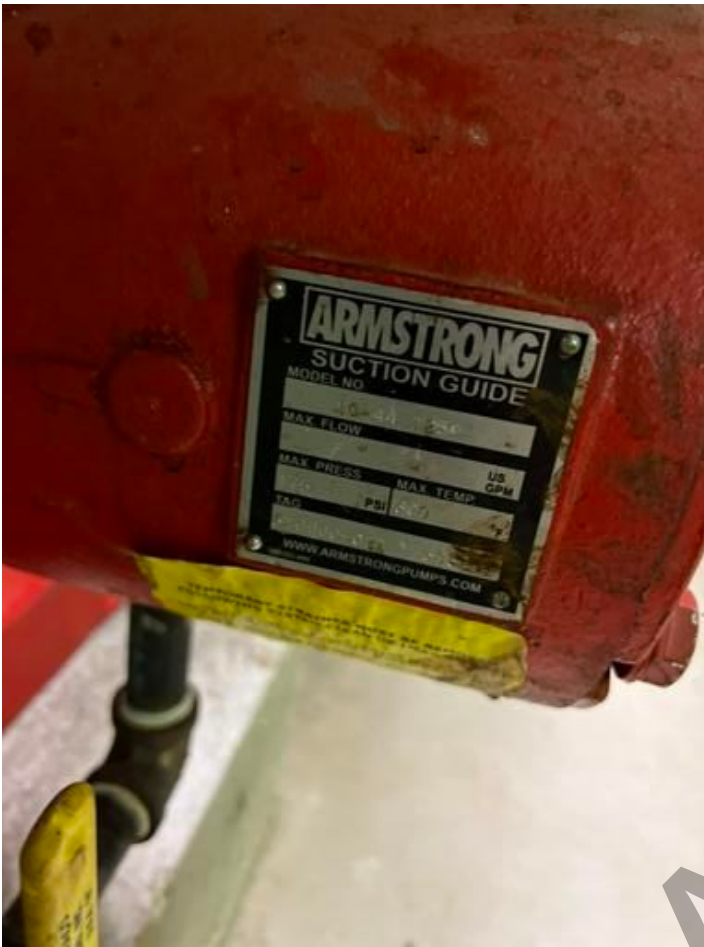
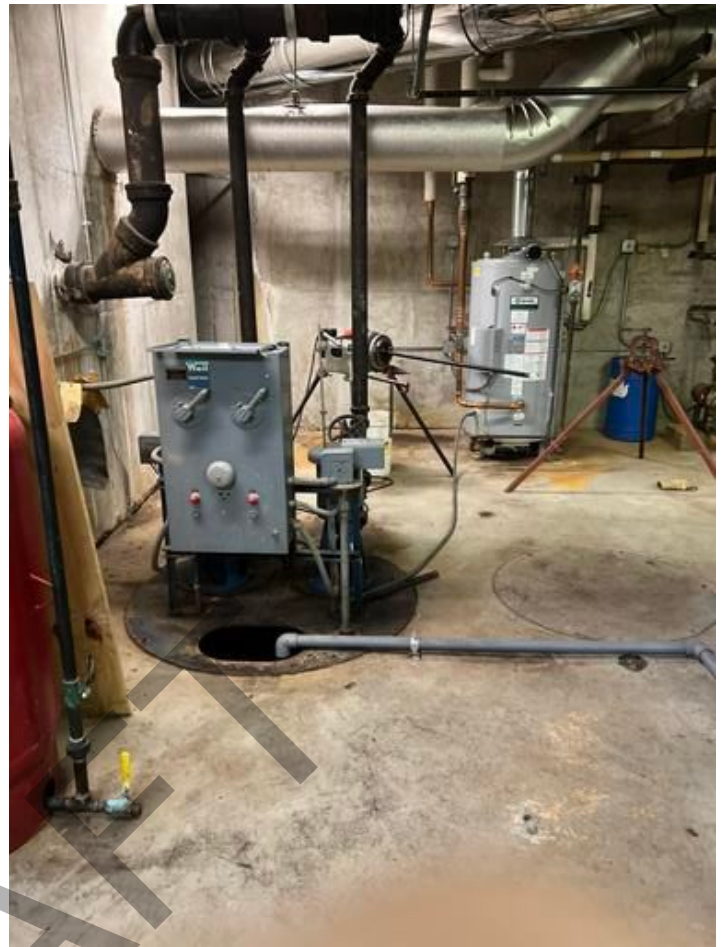
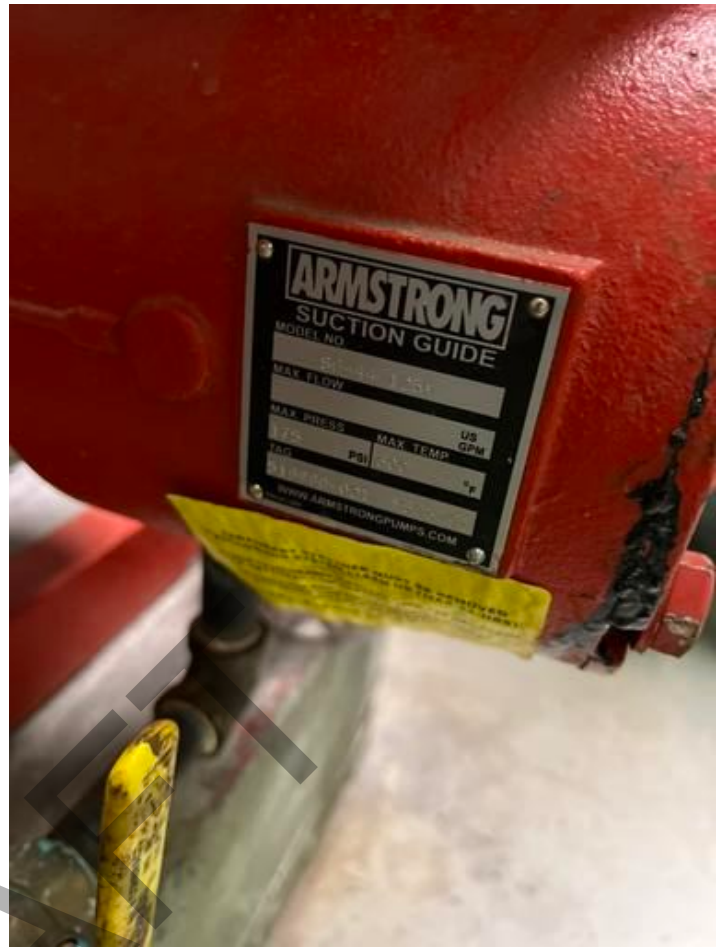
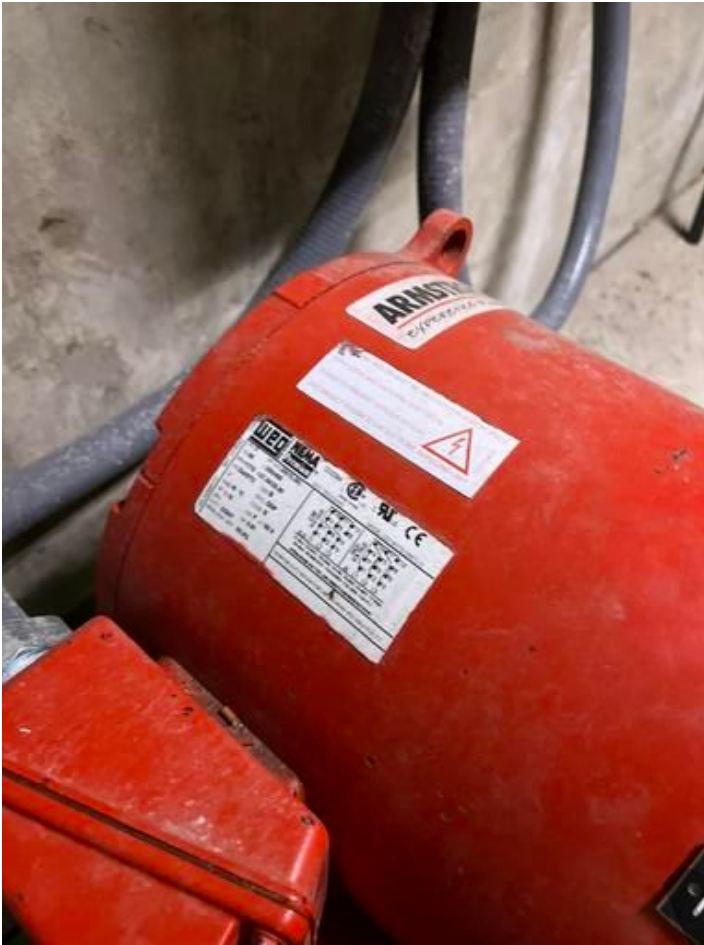
ID	#115
Pin	21
Status	■ Open
Type	MG Mechanical General > Mechanical General

Description	Overall images of mechanical equipment in generator room area.
Assigned to	—
Created by	Gabriel David (Cordogan Clark)
Created on	Jun 21, 2023
Location	Village Hall - Lower Level
Location details	—
Due date	—
Start date	—
Placement	04 (Village Hall - Lower Level Plan)
Root cause	—
