**OAK PARK VILLAGE HALL
123 Madison Street, Oak Park IL. 60302**

**PROPERTY CONDITION ASSESSMENT REPORT
07.08.23**

Property Condition Assessment Report

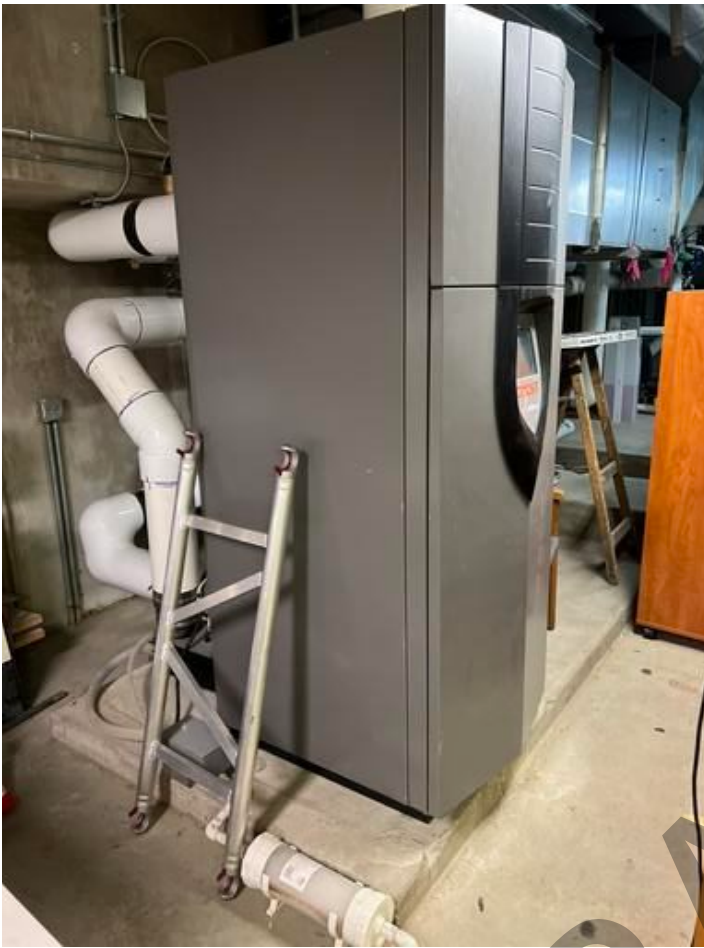
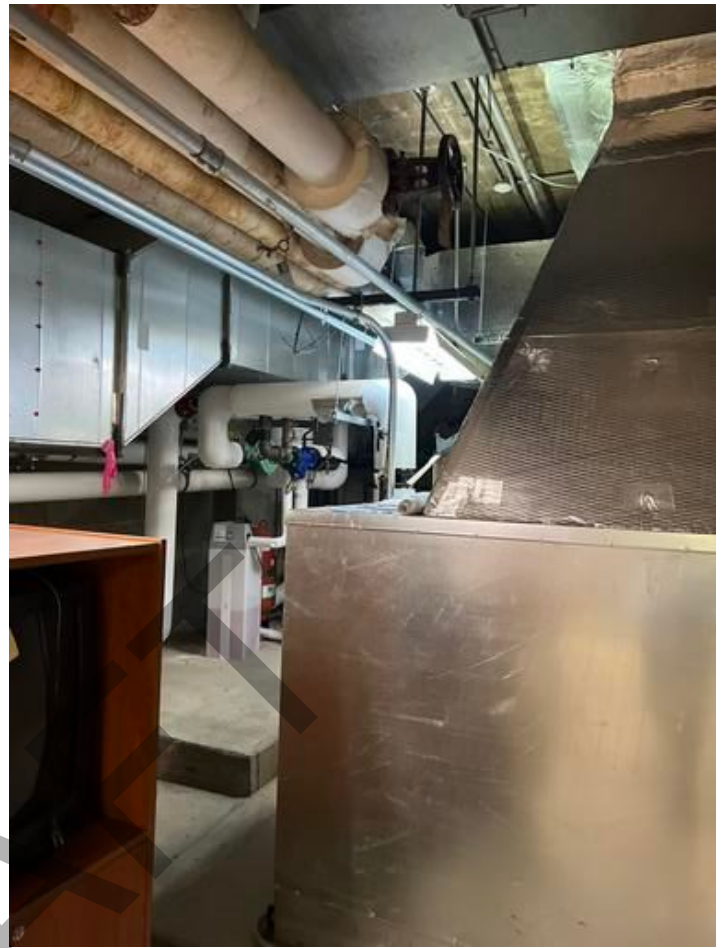
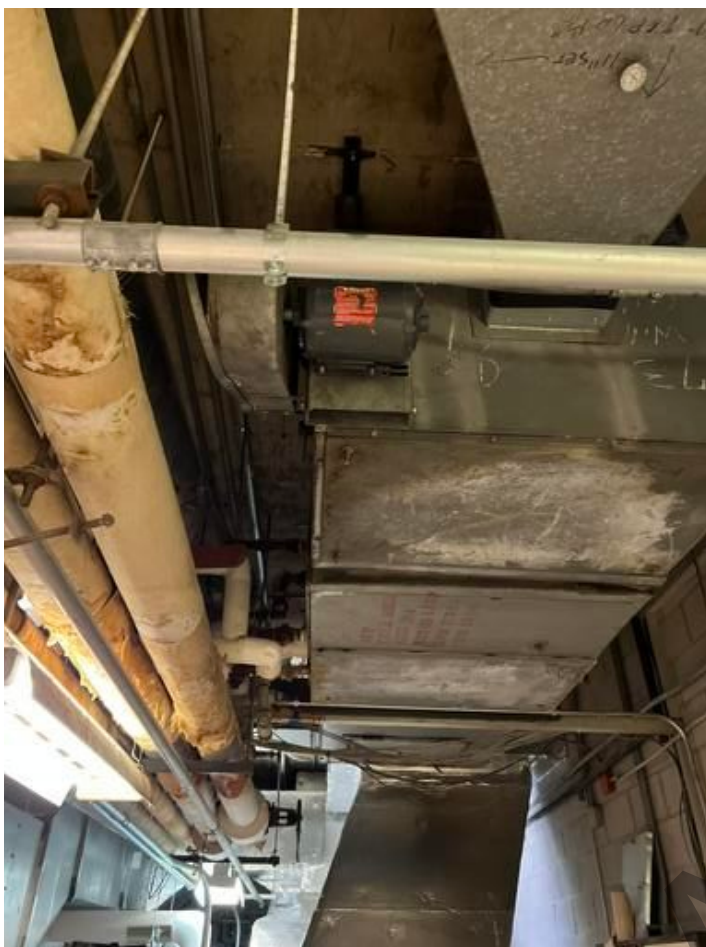
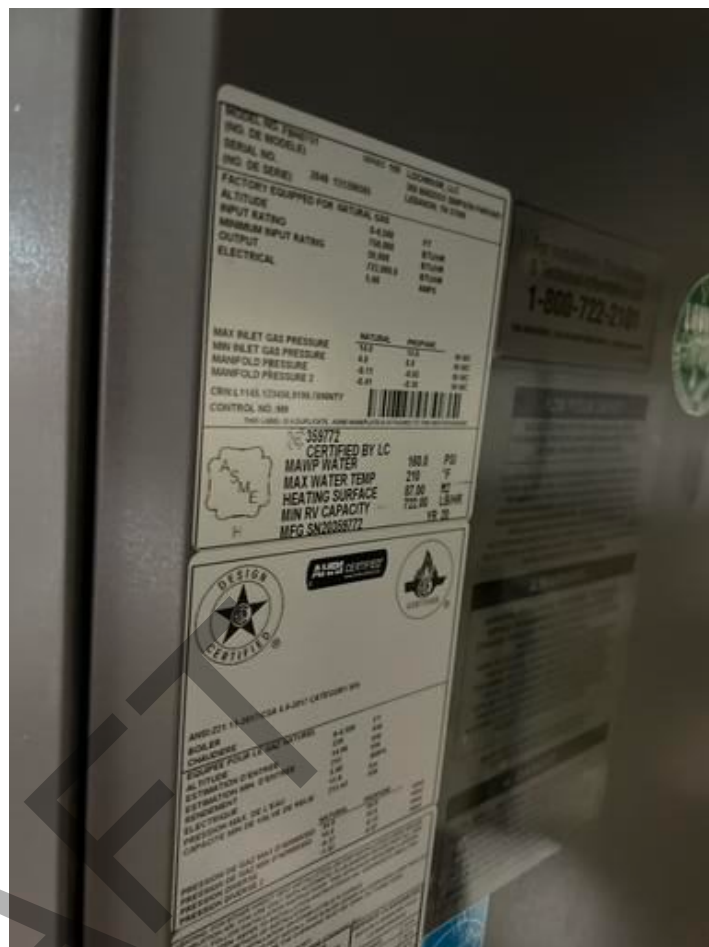
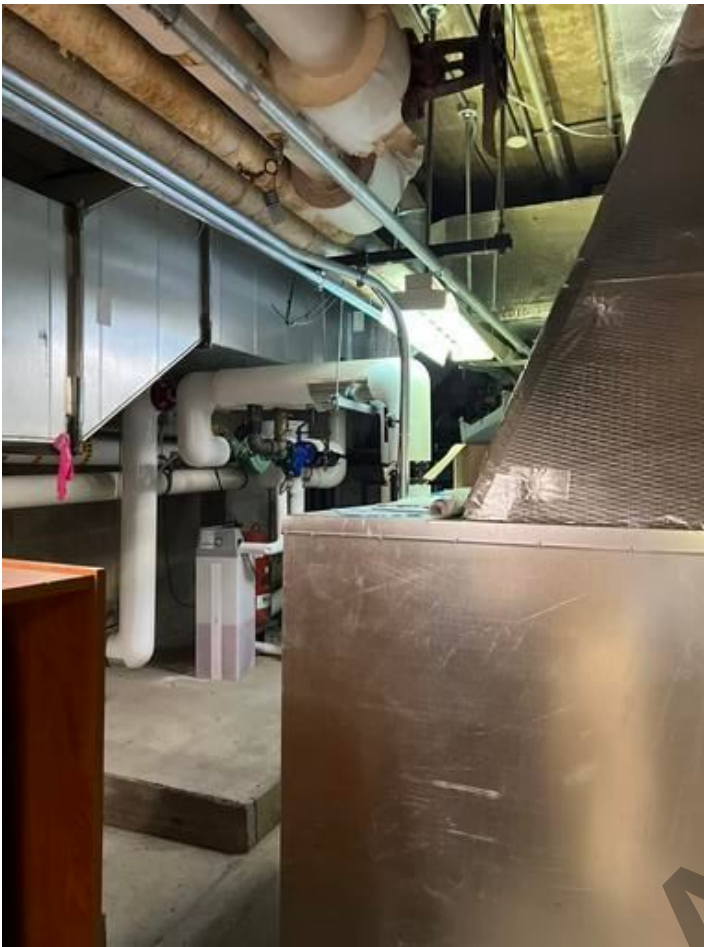
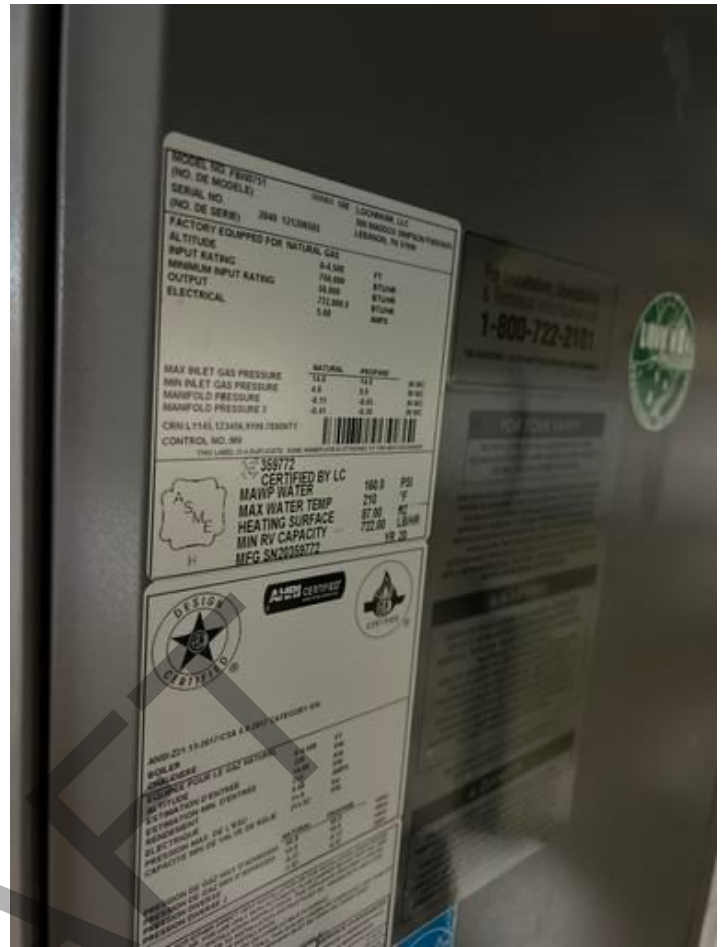
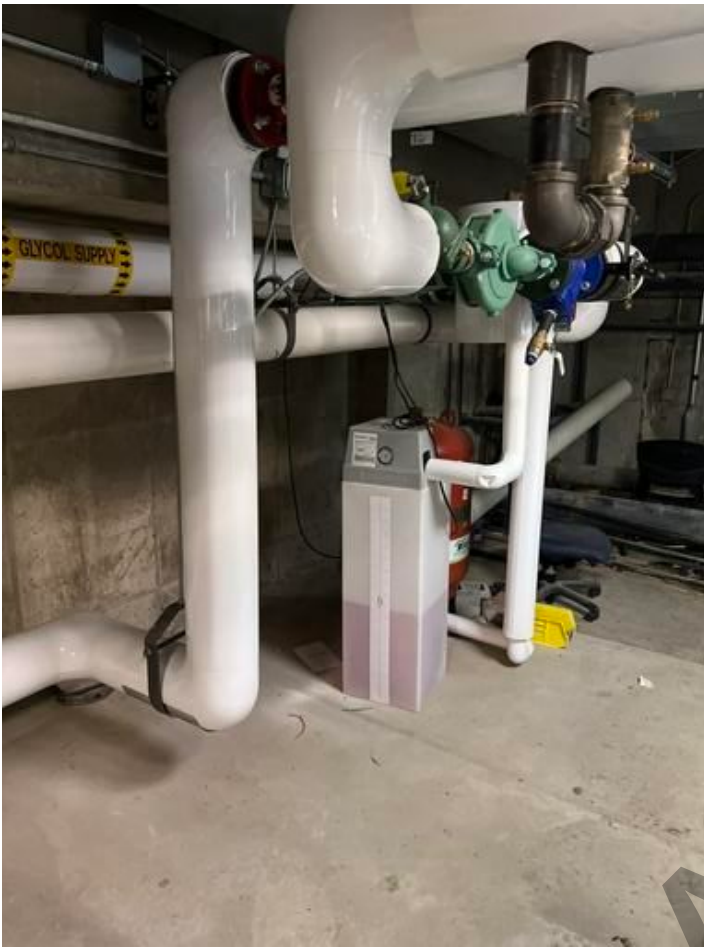
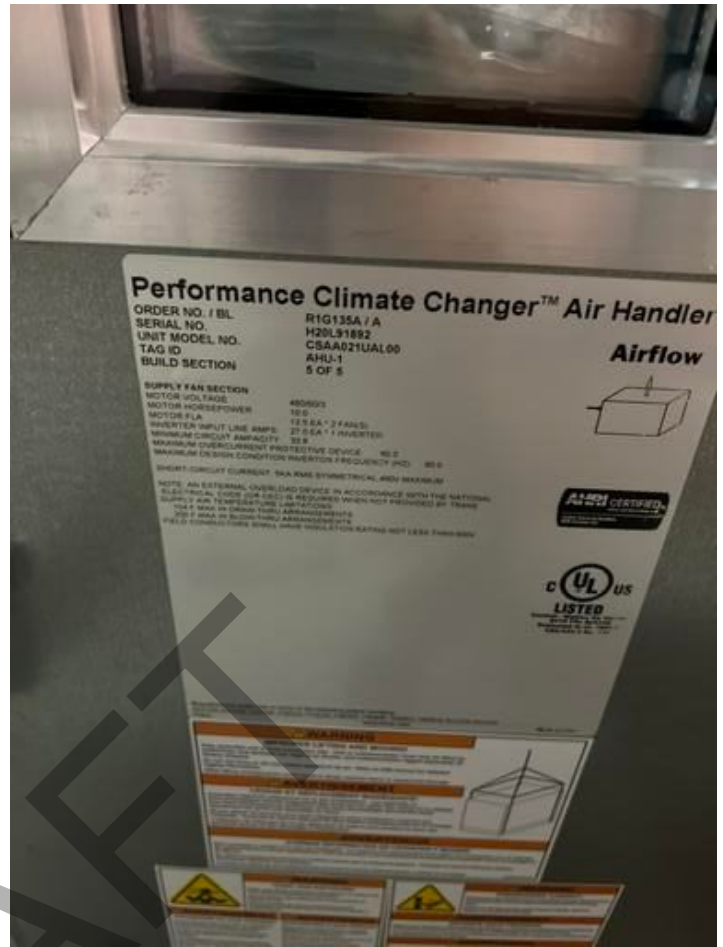
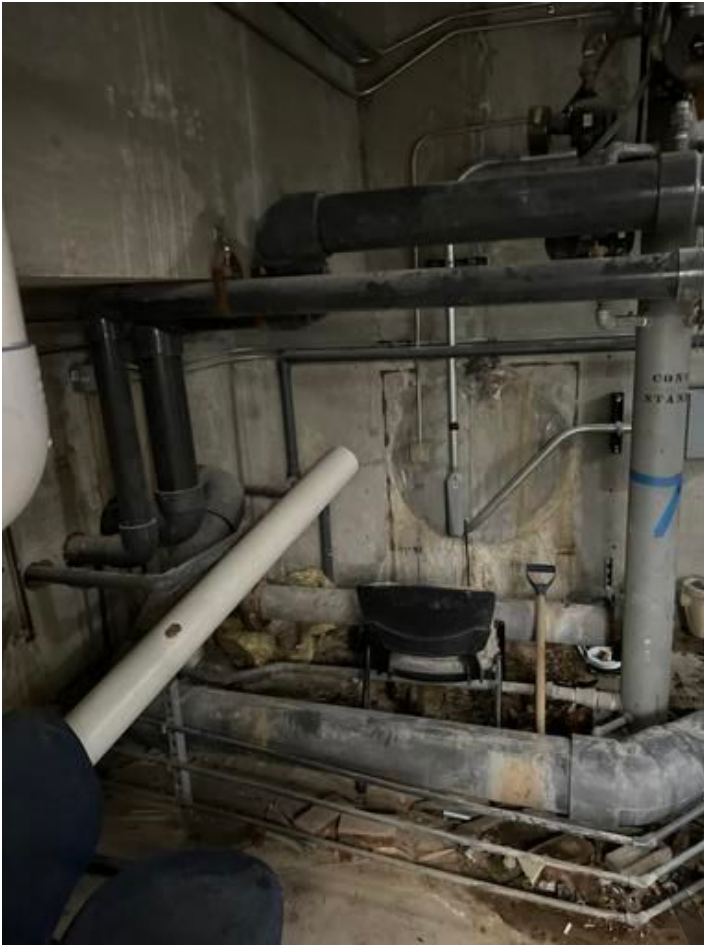
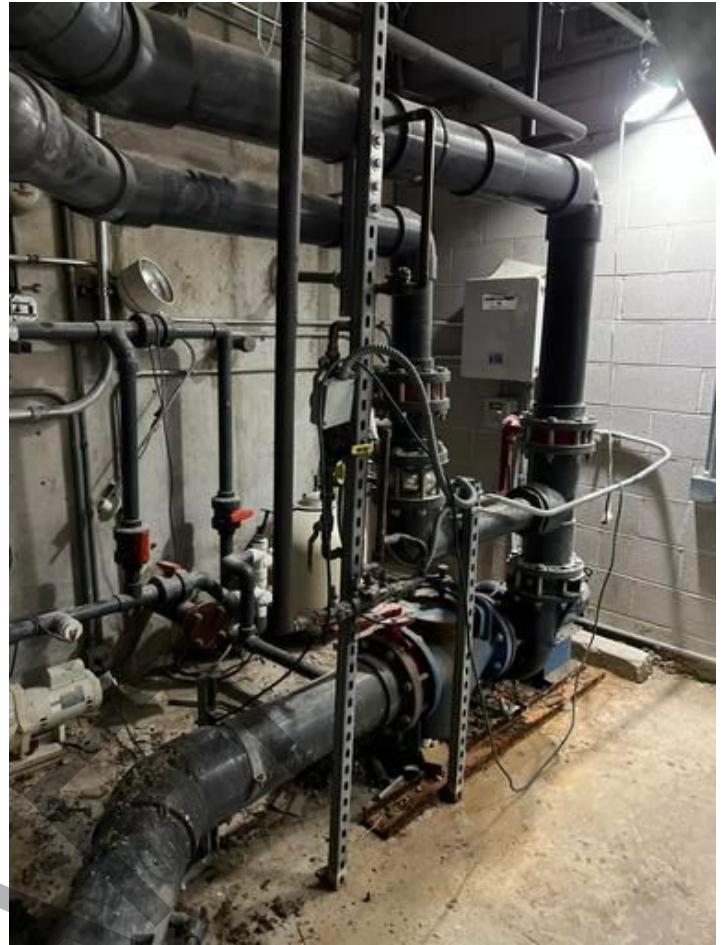
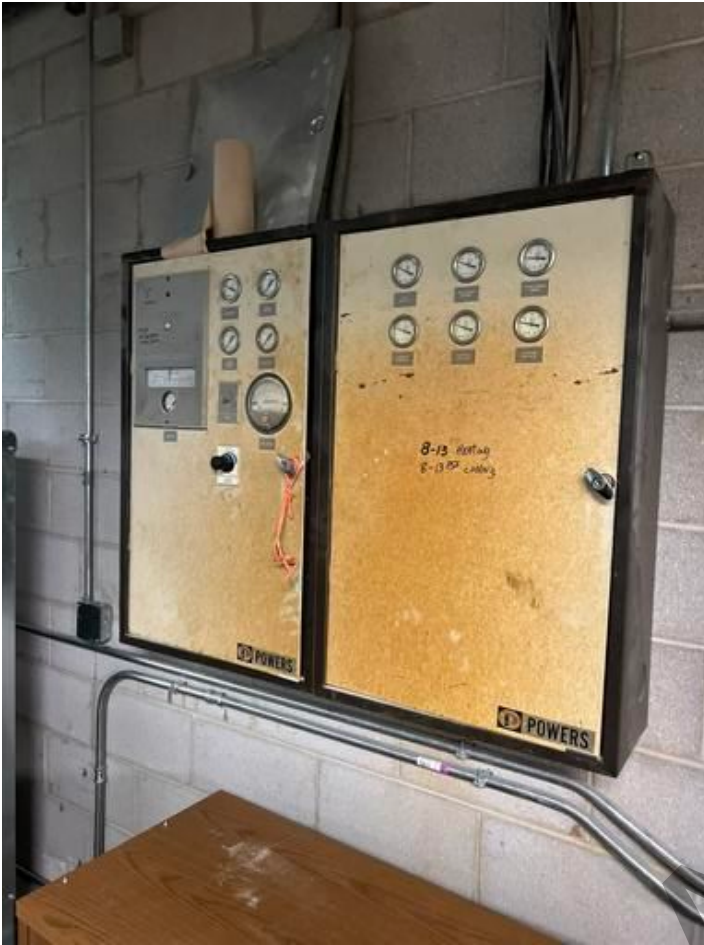
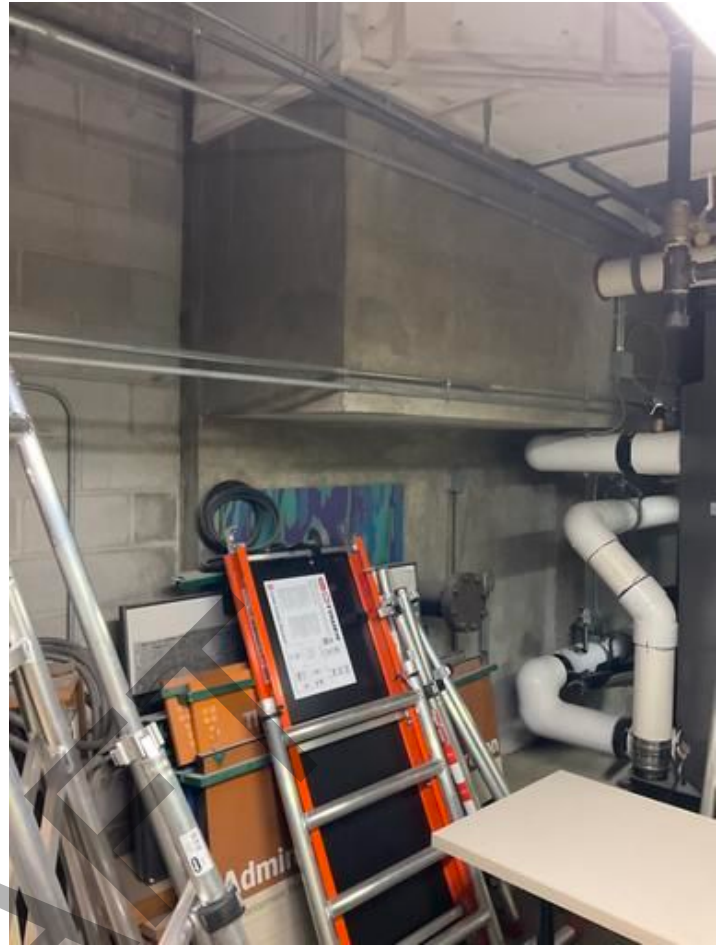
ID	#116
Pin	22
Status	 Open
Type	MG Mechanical General > Mechanical General

Description	Overall images of mechanical equipment in Mechanical Room.
Assigned to	—
Created by	Gabriel David (Cordogan Clark)
Created on	Jun 21, 2023
Location	Village Hall - Lower Level
Location details	—
Due date	—
Start date	—
Placement	04 (Village Hall - Lower Level Plan)
Root cause	—

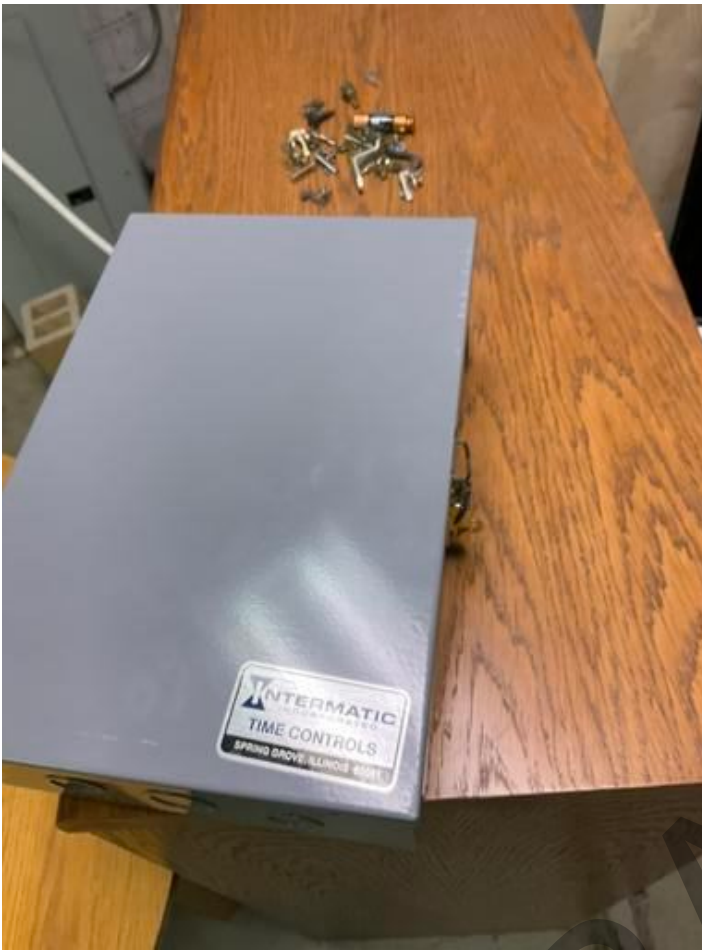
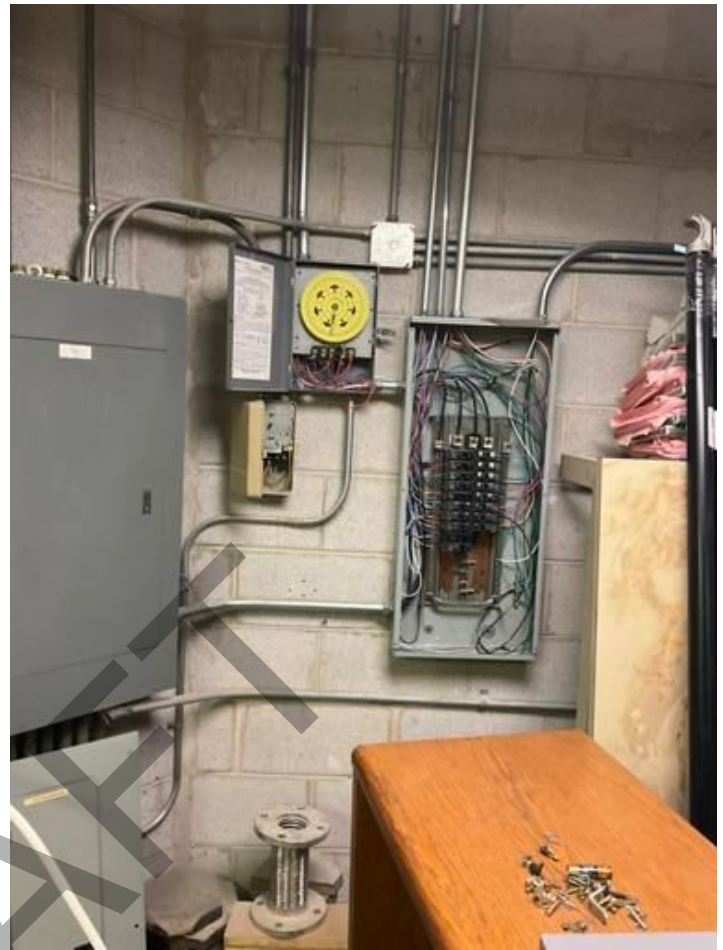
ID	#118
Pin	23
Status	■ Open
Type	MG Mechanical General > Mechanical General

Description	Exterior lighting timeclock in process of being replaced.
Assigned to	—
Created by	Gabriel David (Cordogan Clark)
Created on	Jun 21, 2023
Location	Village Hall - Lower Level
Location details	—
Due date	—
Start date	—
Placement	04 (Village Hall - Lower Level Plan)
Root cause	—

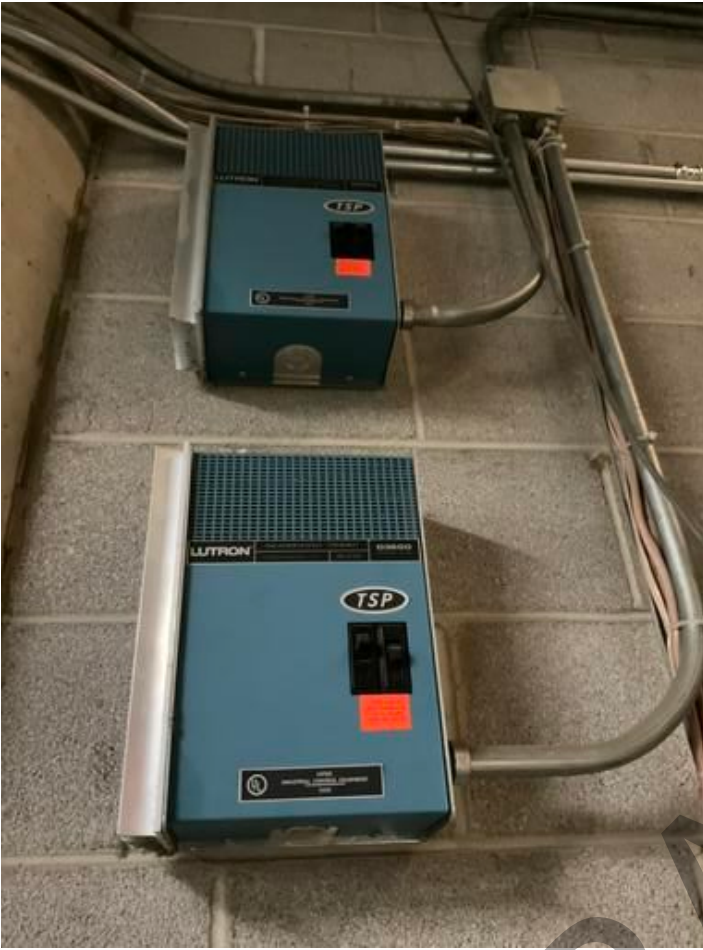
ID	#120
Pin	24
Status	■ Open
Type	MG Mechanical General > Mechanical General

Description	Incandescent dimmers.
Assigned to	—
Created by	Gabriel David (Cordogan Clark)
Created on	Jun 21, 2023
Location	Village Hall - Lower Level
Location details	—
Due date	—
Start date	—
Placement	04 (Village Hall - Lower Level Plan)
Root cause	—

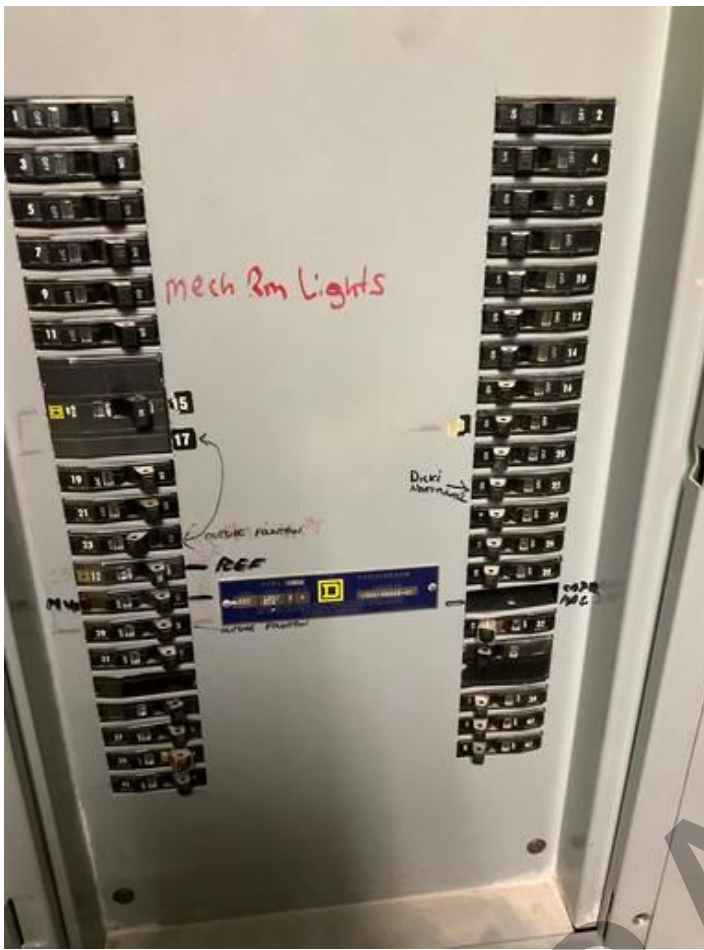
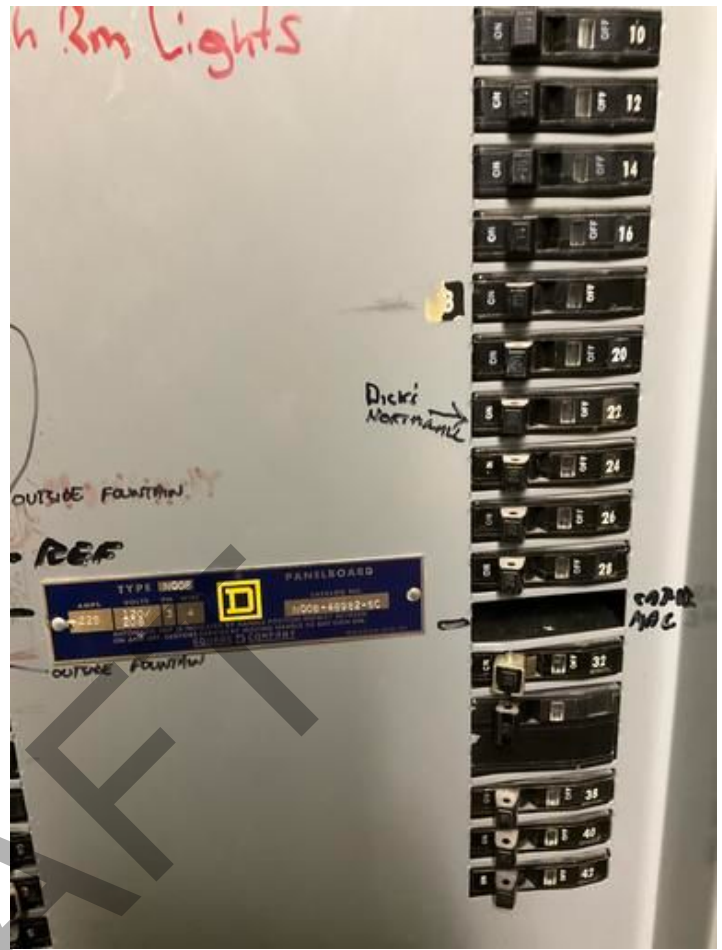
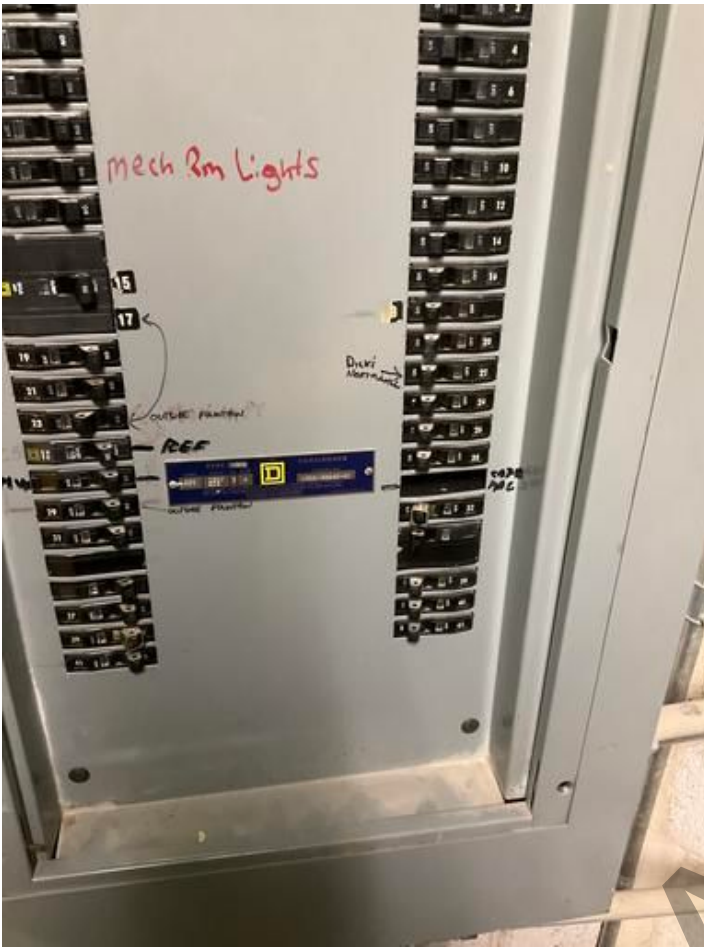
ID	#127
Pin	25
Status	■ Open
Type	MG Mechanical General > Mechanical General

Description	Electrical MCC and panel boards
Assigned to	—
Created by	Gabriel David (Cordogan Clark)
Created on	Jun 21, 2023
Location	Village Hall - Lower Level
Location details	—
Due date	—
Start date	—
Placement	04 (Village Hall - Lower Level Plan)
Root cause	—

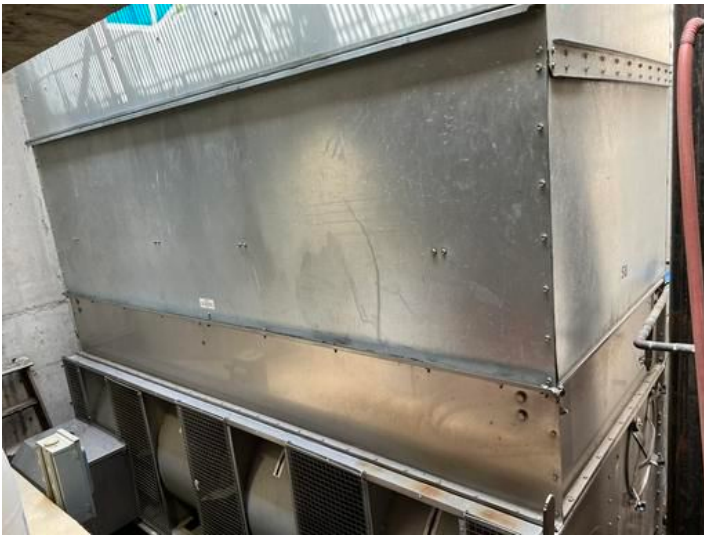
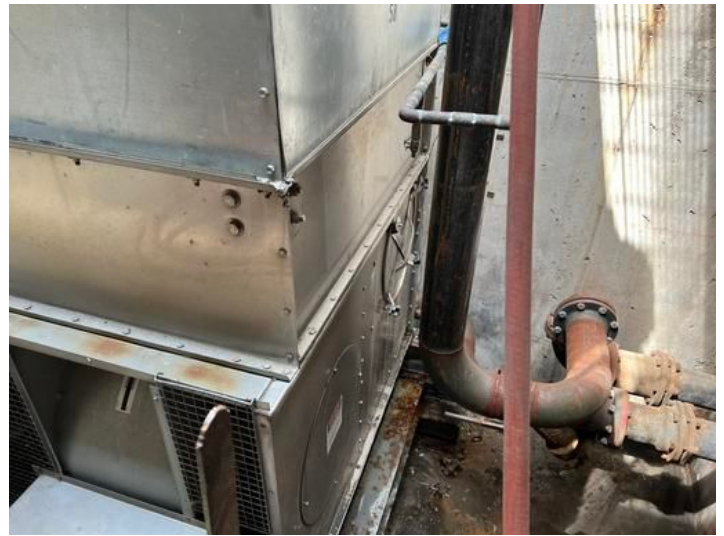
ID	#134
Pin	26
Status	 Open
Type	MG Mechanical General > Mechanical General

Description	Overall images of mechanical unit in underground parking garage.
Assigned to	—
Created by	Gabriel David (Cordogan Clark)
Created on	Jun 21, 2023
Location	Village Hall - Lower Level
Location details	—
Due date	—
Start date	—
Placement	04 (Village Hall - Lower Level Plan)
Root cause	—

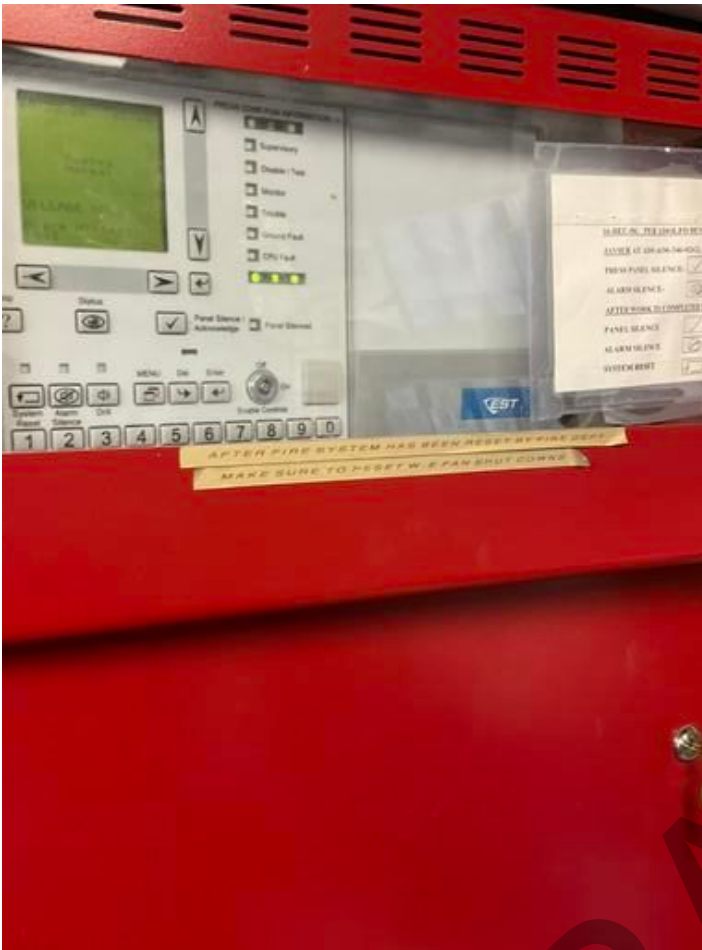
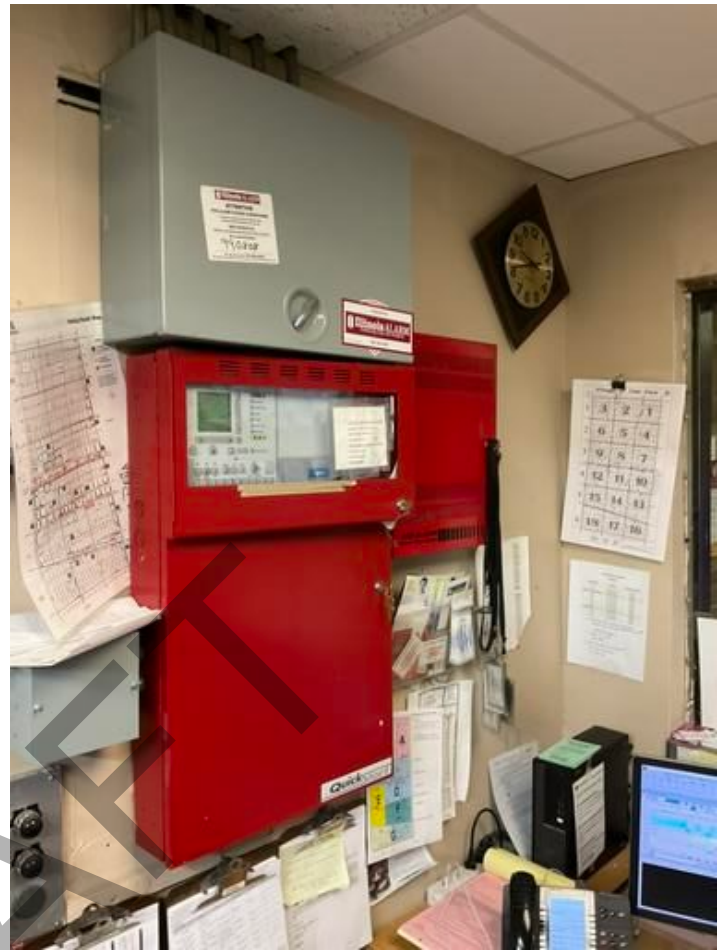
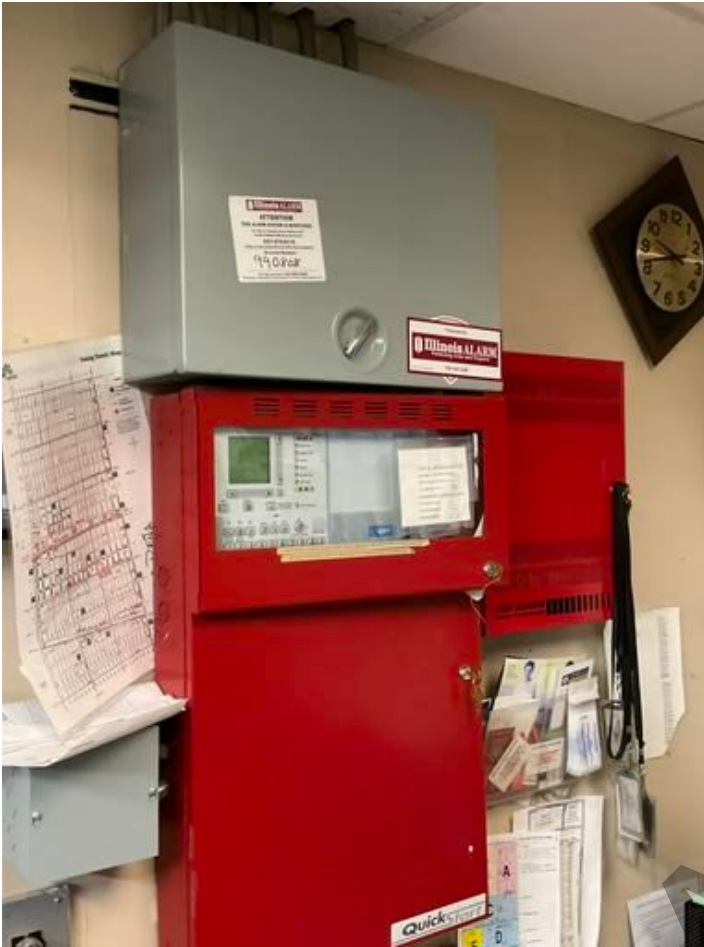
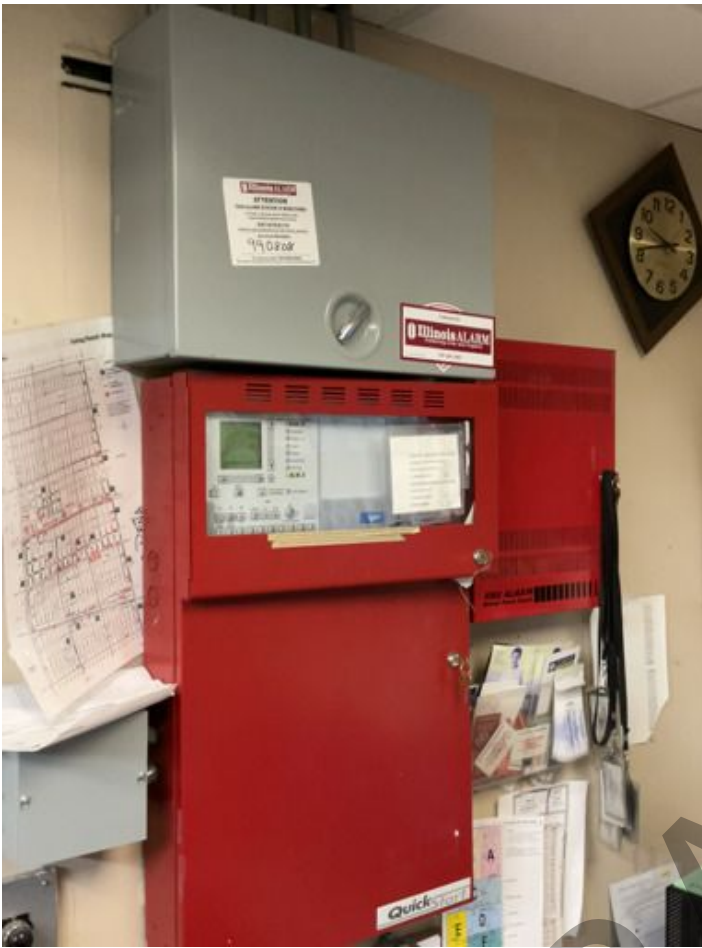
ID	#161
Pin	27
Status	<div></div> Open
Type	<div>MG</div> Mechanical General > Mechanical General

Description	Overall images of fire alarm systems.
Assigned to	—
Created by	Gabriel David (Cordogan Clark)
Created on	Jun 21, 2023
Location	Village Hall - Lower Level
Location details	—
Due date	—
Start date	—
Placement	04 (Village Hall - Lower Level Plan)
Root cause	—

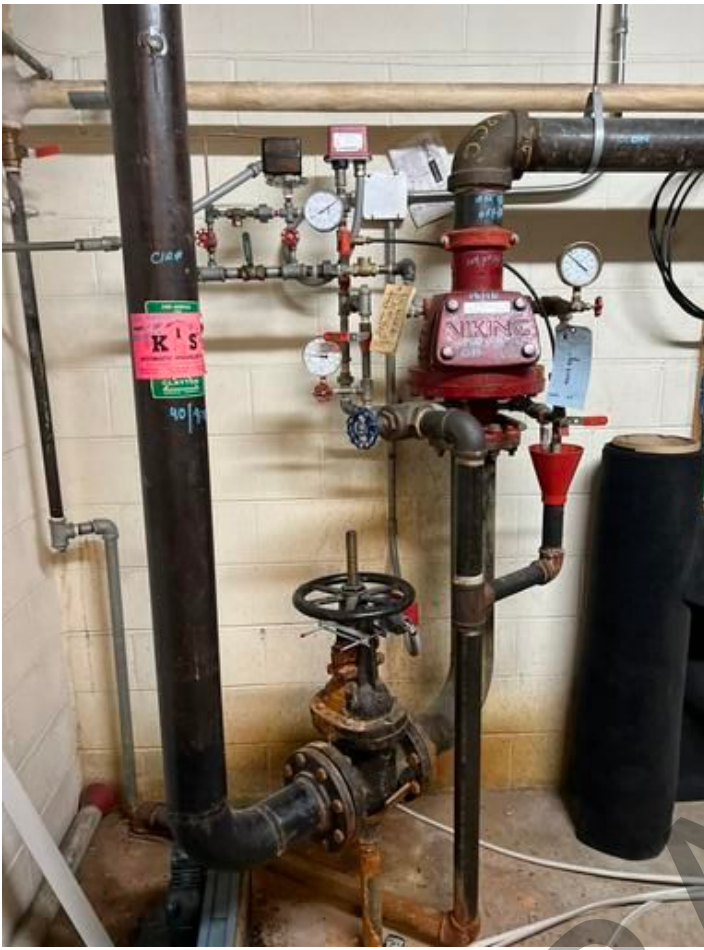
ID	#164
Pin	28
Status	<div></div> Open
Type	<div>MG</div> Mechanical General > Mechanical General

Description	Overall photo of sprinkler piping connections.
Assigned to	—
Created by	Gabriel David (Cordogan Clark)
Created on	Jun 21, 2023
Location	Village Hall - Lower Level
Location details	—
Due date	—
Start date	—
Placement	04 (Village Hall - Lower Level Plan)
Root cause	—

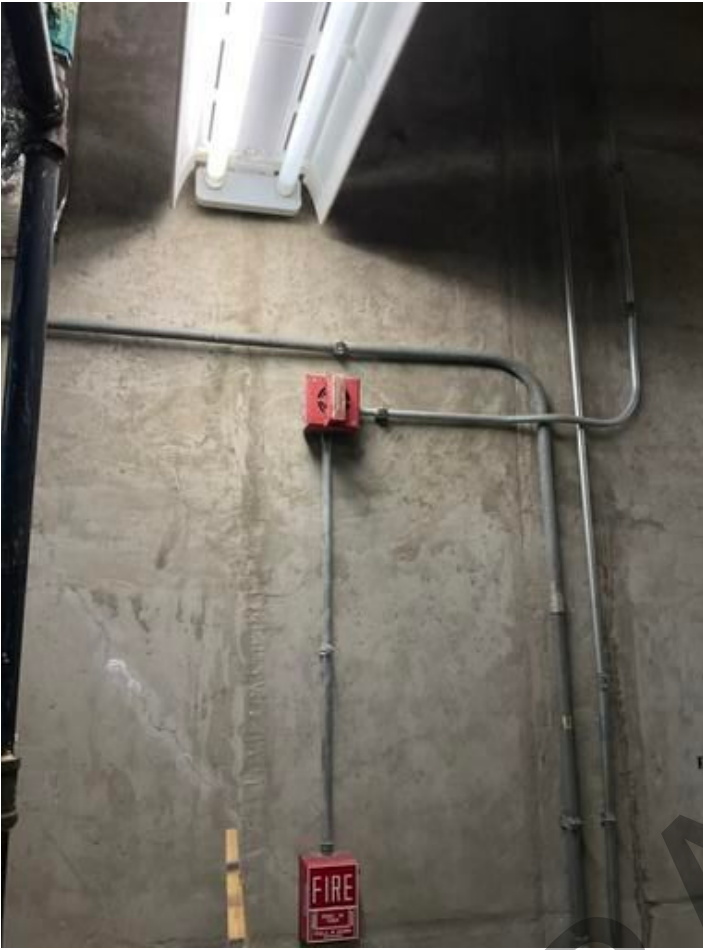
ID	#122

Pin	29	
Status	<div><div></div>Open</div>	
Type	<div><div>EG</div>Electrical General > Electrical General</div>	
Standard fields		
Description	Boiler room horn strobe.	
Assigned to	—	
Created by	Gabriel David (Cordogan Clark)	
Created on	Jun 21, 2023	
Location	Village Hall - Lower Level	
Location details	—	
Due date	—	
Start date	—	
Placement	04 (Village Hall - Lower Level Plan)	
Root cause	—

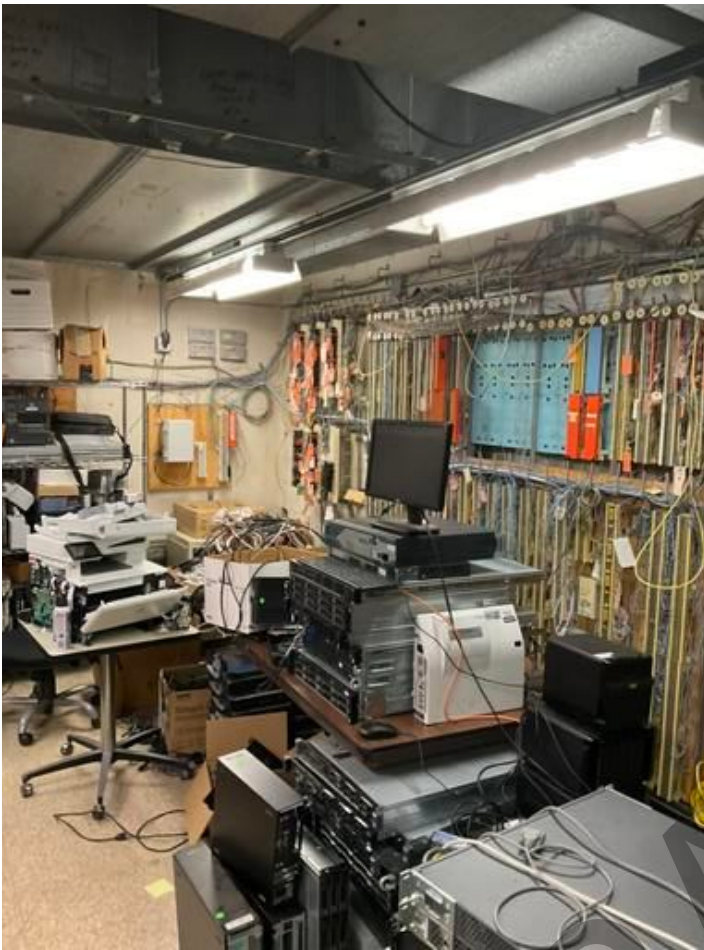
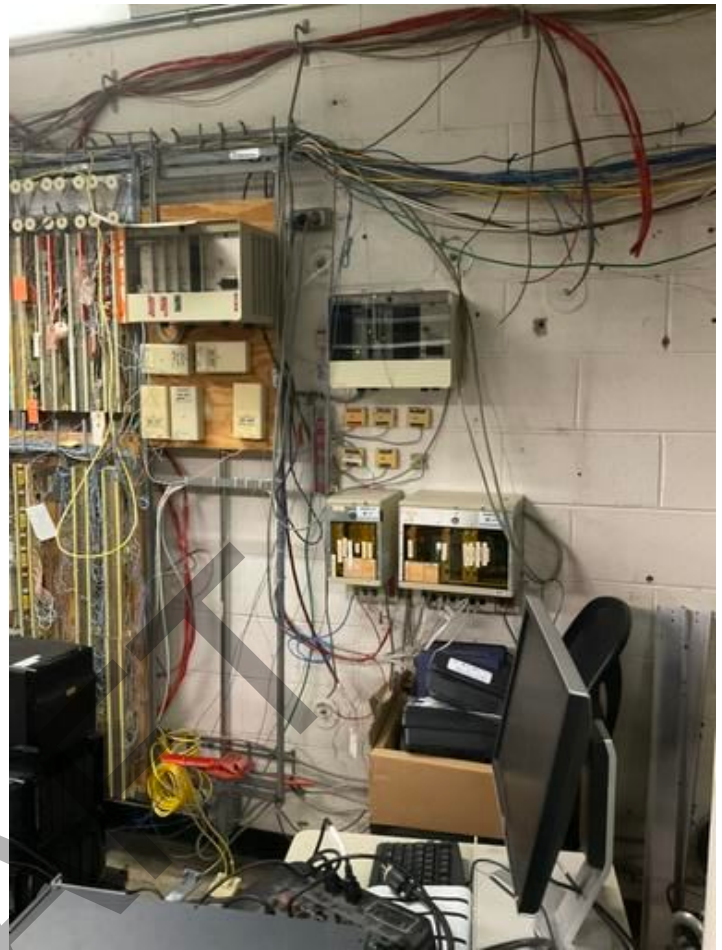
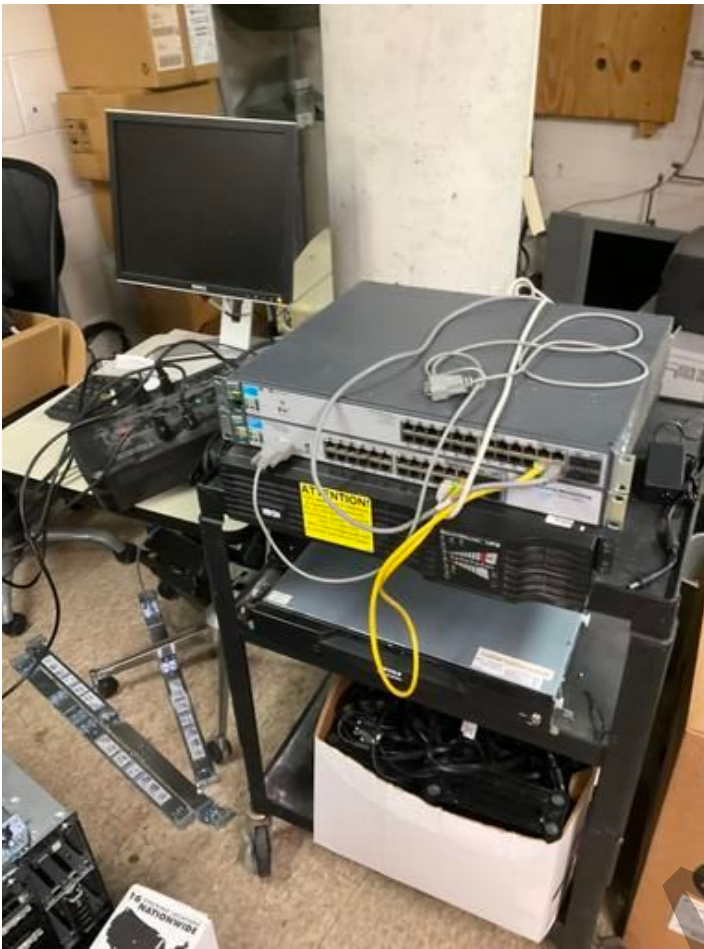
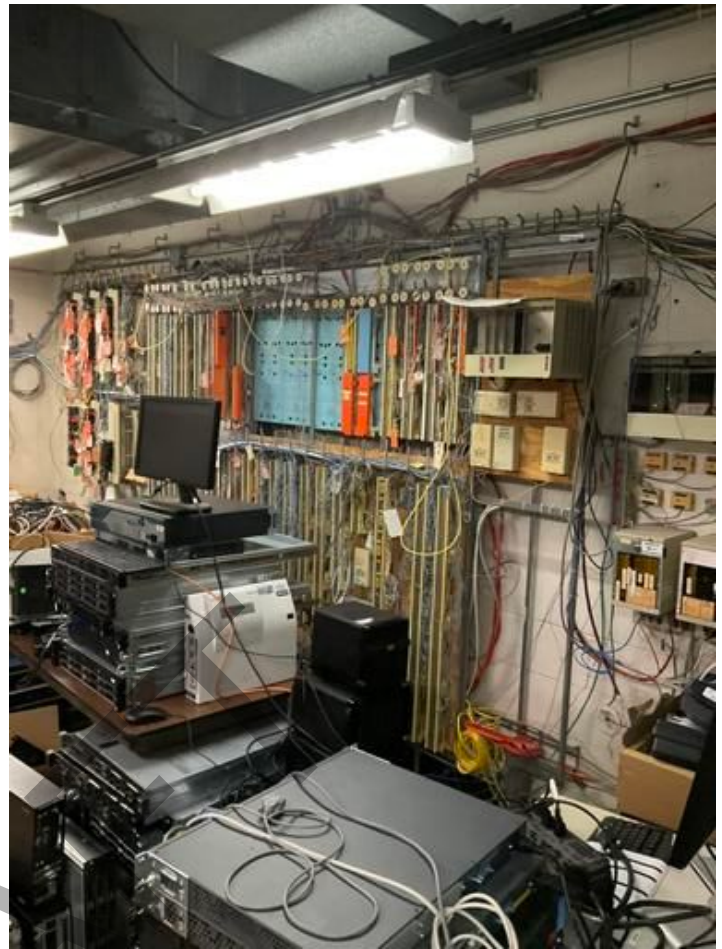
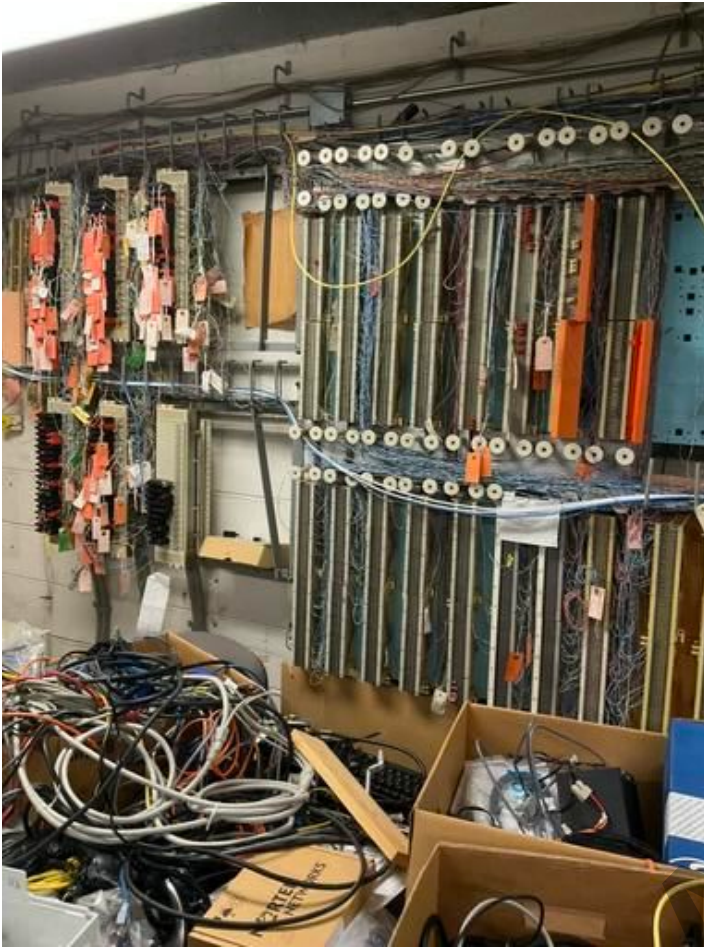
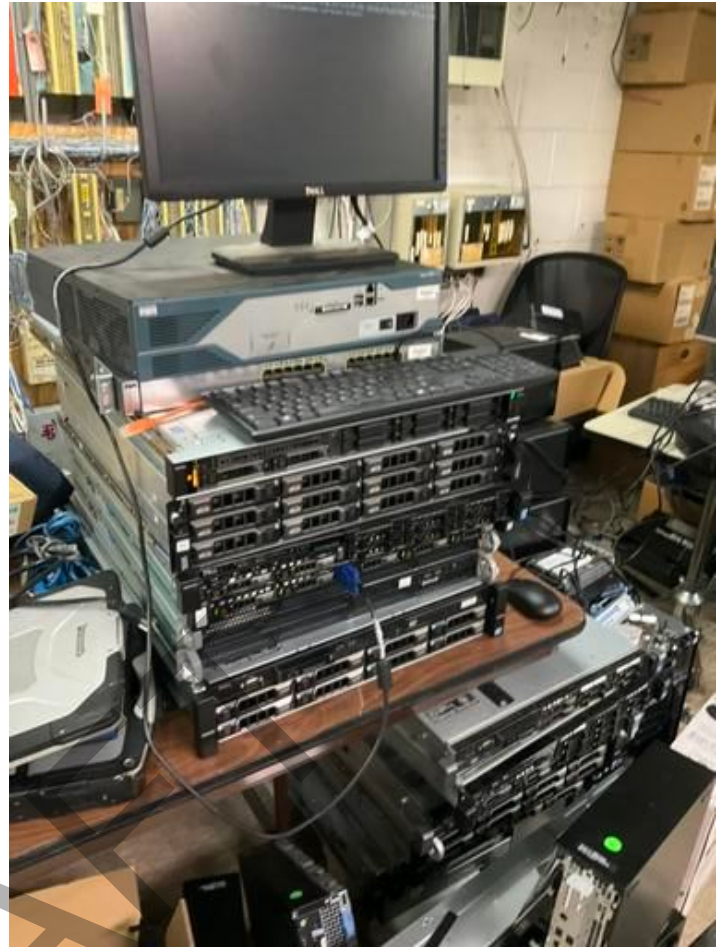
ID	#130
Pin	30
Status	■ Open
Type	EG Electrical General > Electrical General

Description	Overall photos of Telecom DMARC area.
Assigned to	—
Created by	Gabriel David (Cordogan Clark)
Created on	Jun 21, 2023
Location	Village Hall - Lower Level
Location details	—
Due date	—
Start date	—
Placement	04 (Village Hall - Lower Level Plan)
Root cause	—
