**OAK PARK VILLAGE HALL
123 Madison Street, Oak Park IL. 60302**

**PROPERTY CONDITION ASSESSMENT REPORT
07.08.23**

Property Condition Assessment Report

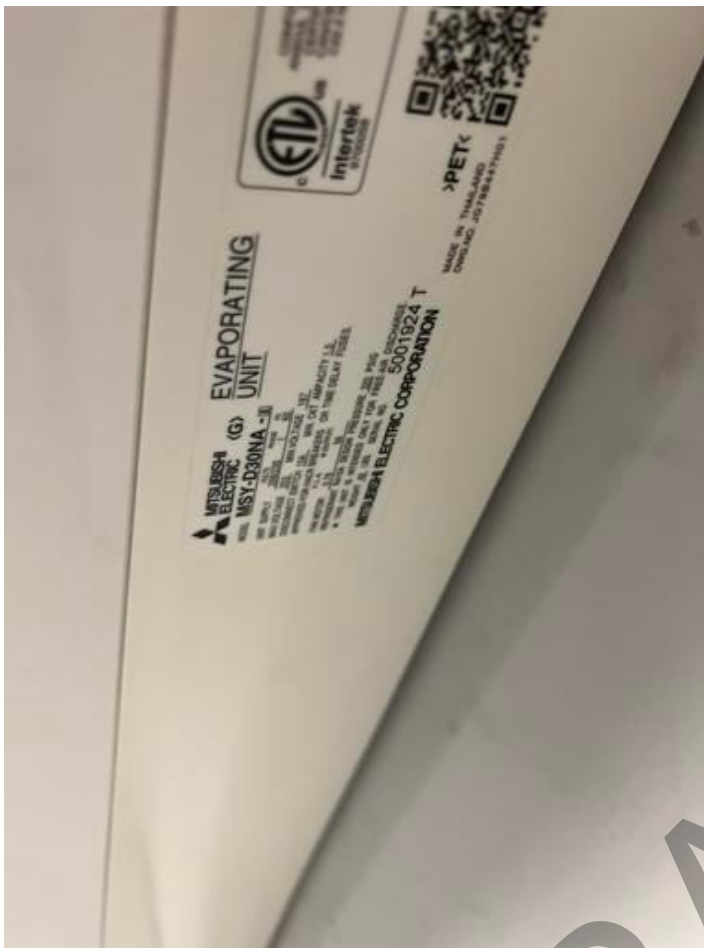
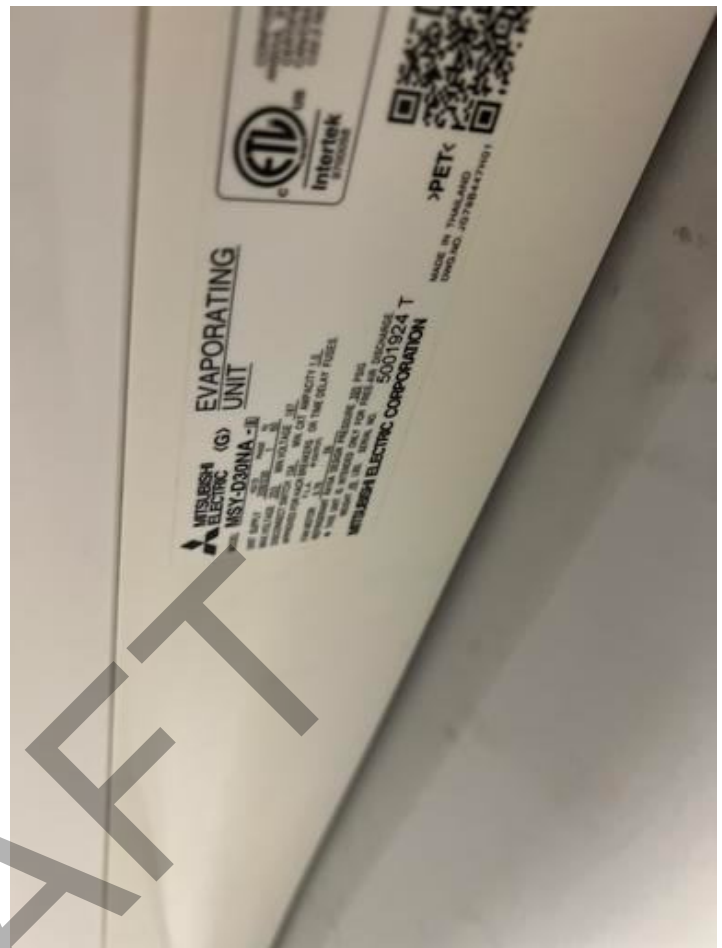
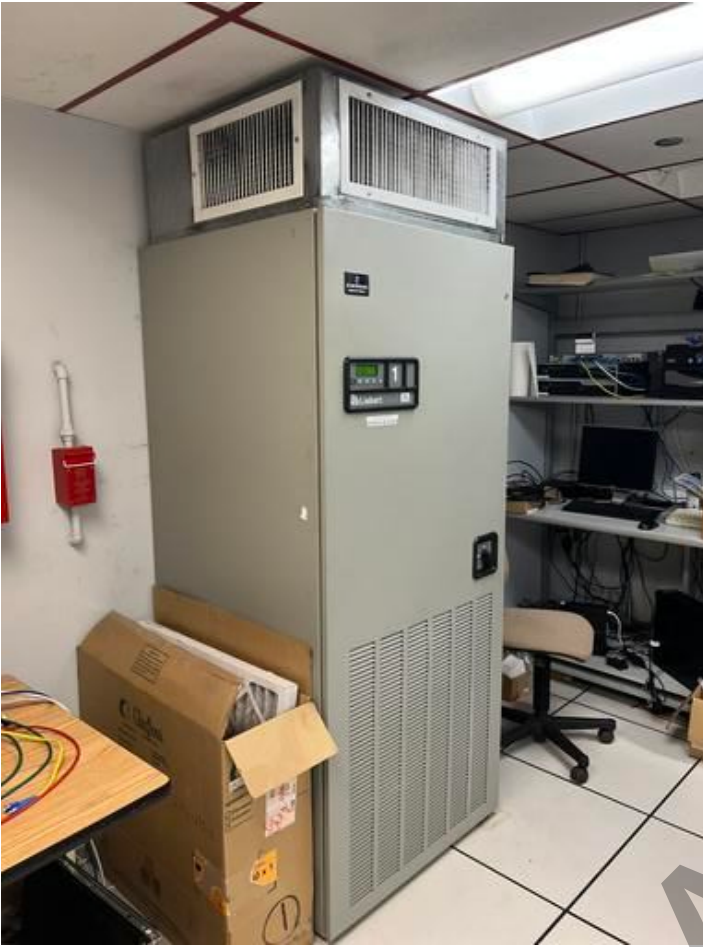
ID	#131
Pin	31
Status	■ Open
Type	EG Electrical General > Electrical General

Description	Closer inspection of electrical equipment in MDF Computer Room.
Assigned to	—
Created by	Gabriel David (Cordogan Clark)
Created on	Jun 21, 2023
Location	Village Hall - Lower Level
Location details	—
Due date	—
Start date	—
Placement	04 (Village Hall - Lower Level Plan)
Root cause	—

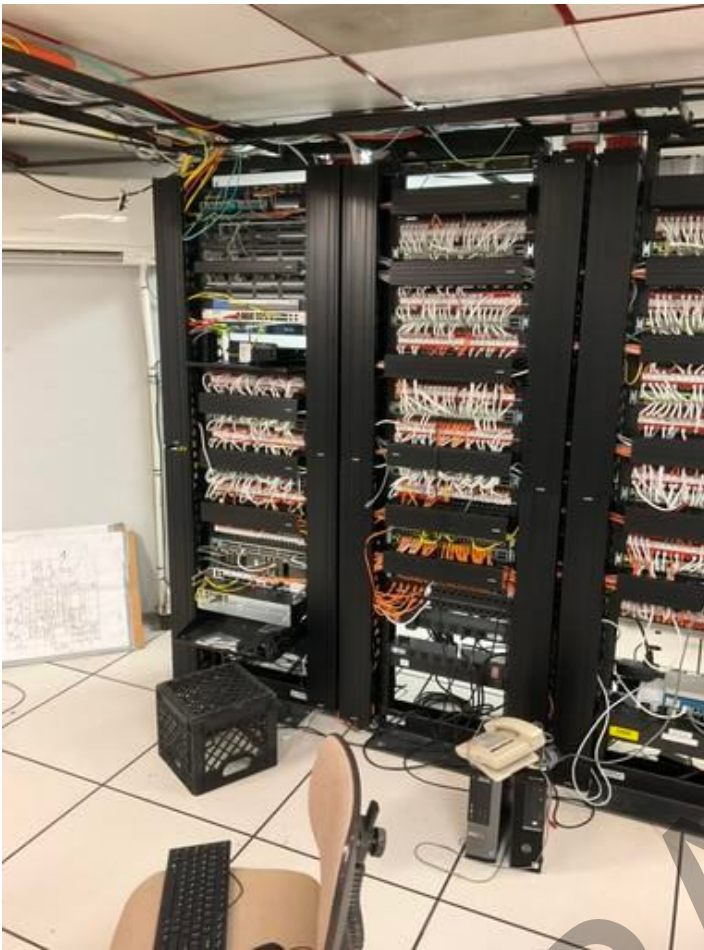
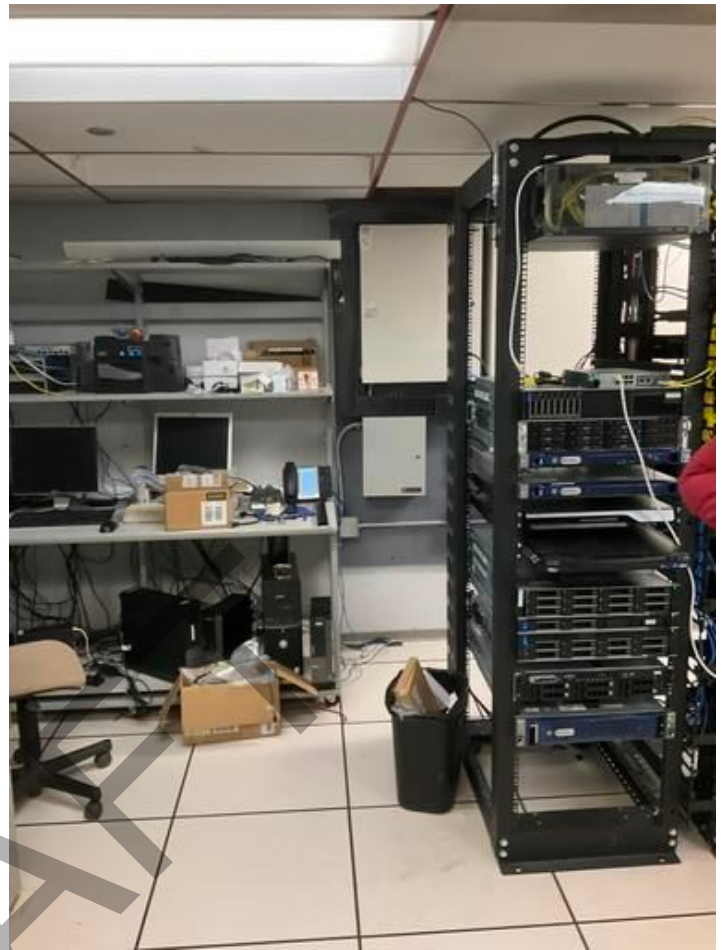
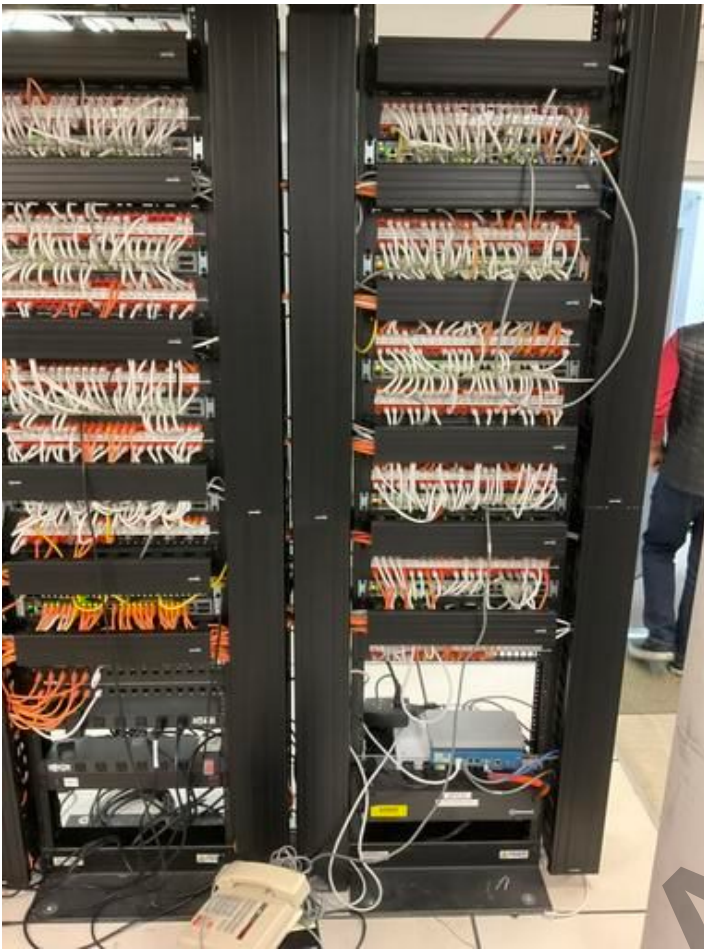
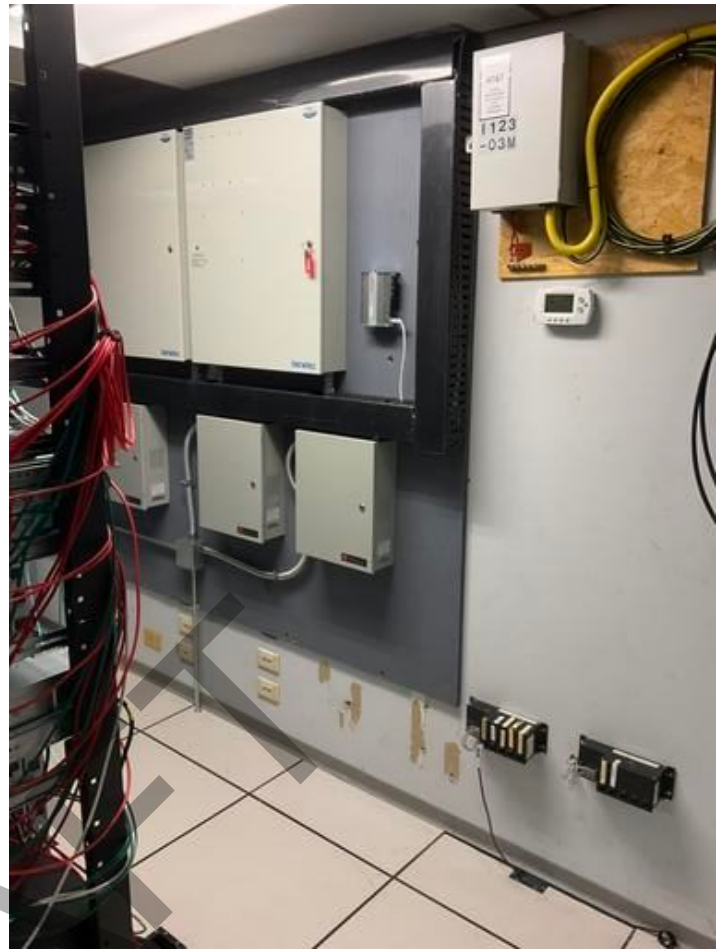
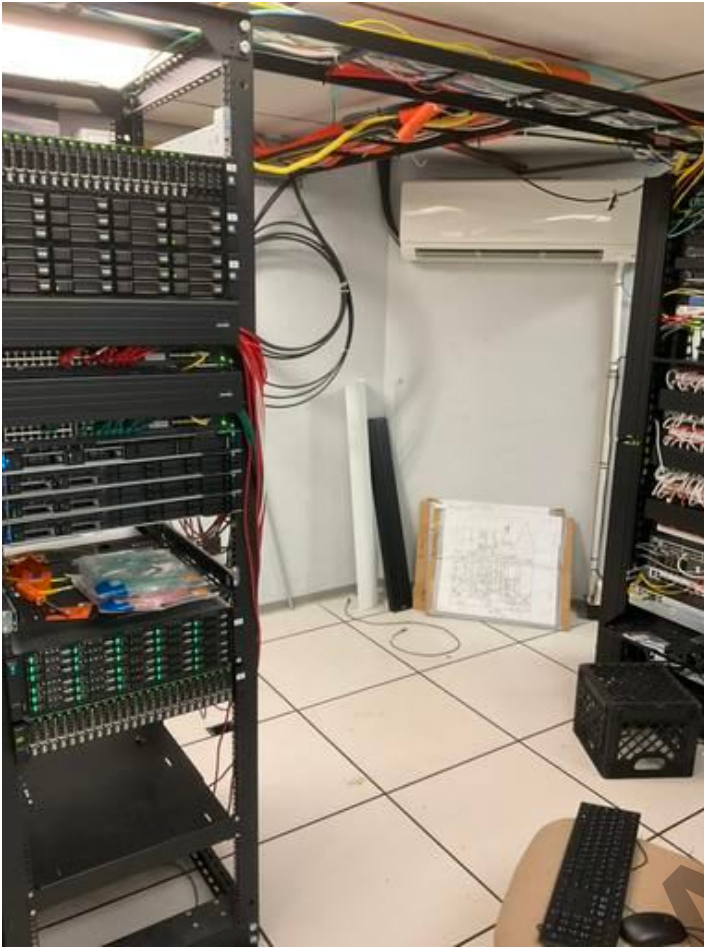
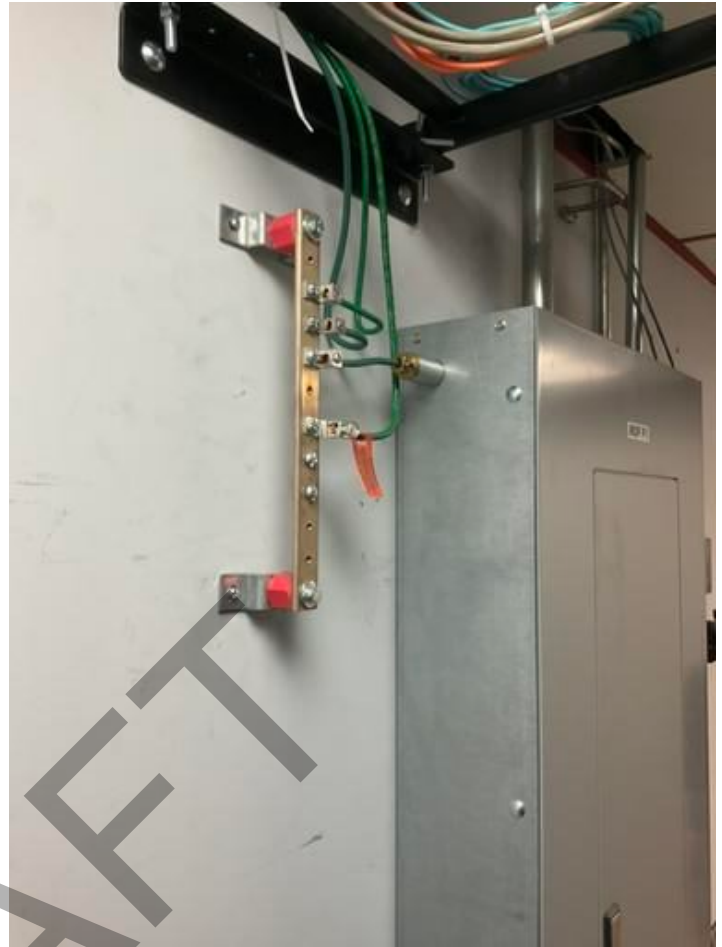
ID	#138
Pin	32
Status	<div></div> Open
Type	<div>EG</div> Electrical General > Electrical General

Description	Overall photos of MDF Computer Room.
Assigned to	—
Created by	Gabriel David (Cordogan Clark)
Created on	Jun 21, 2023
Location	Village Hall - Lower Level
Location details	—
Due date	—
Start date	—
Placement	04 (Village Hall - Lower Level Plan)
Root cause	—

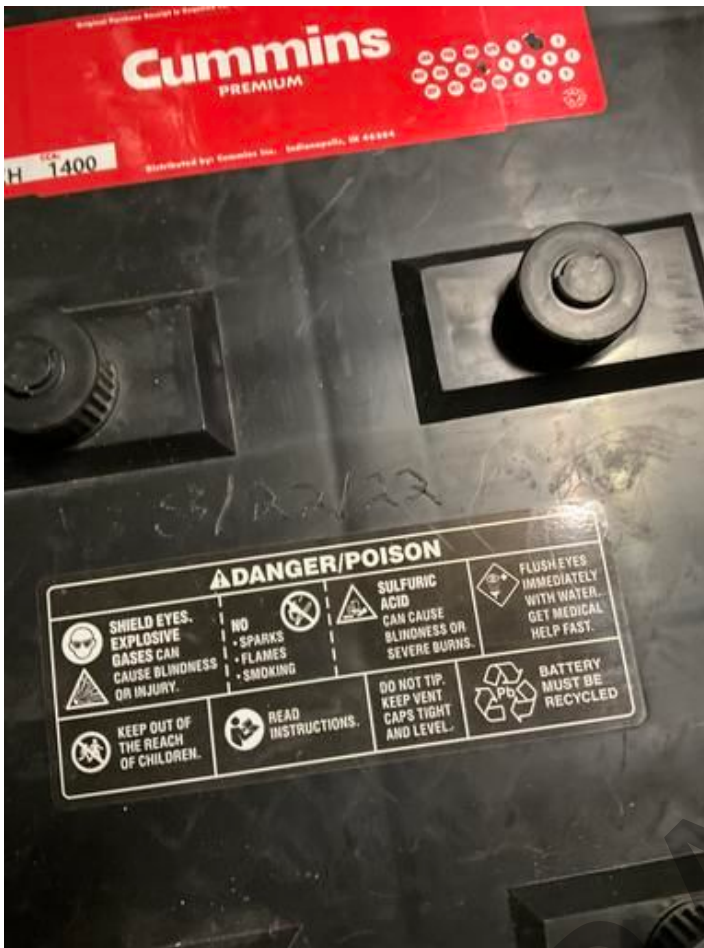
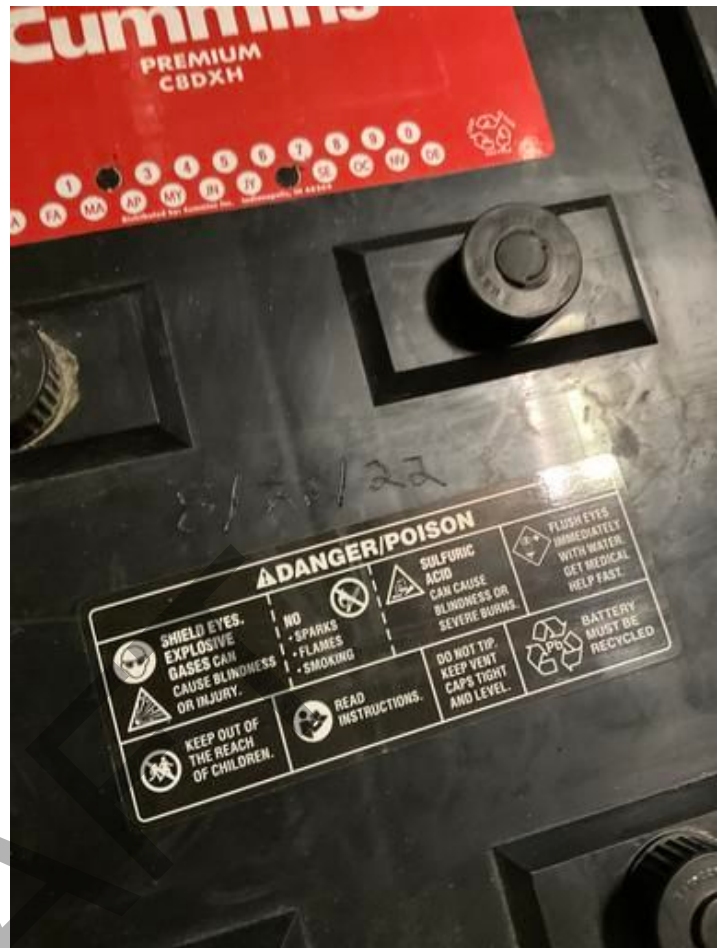
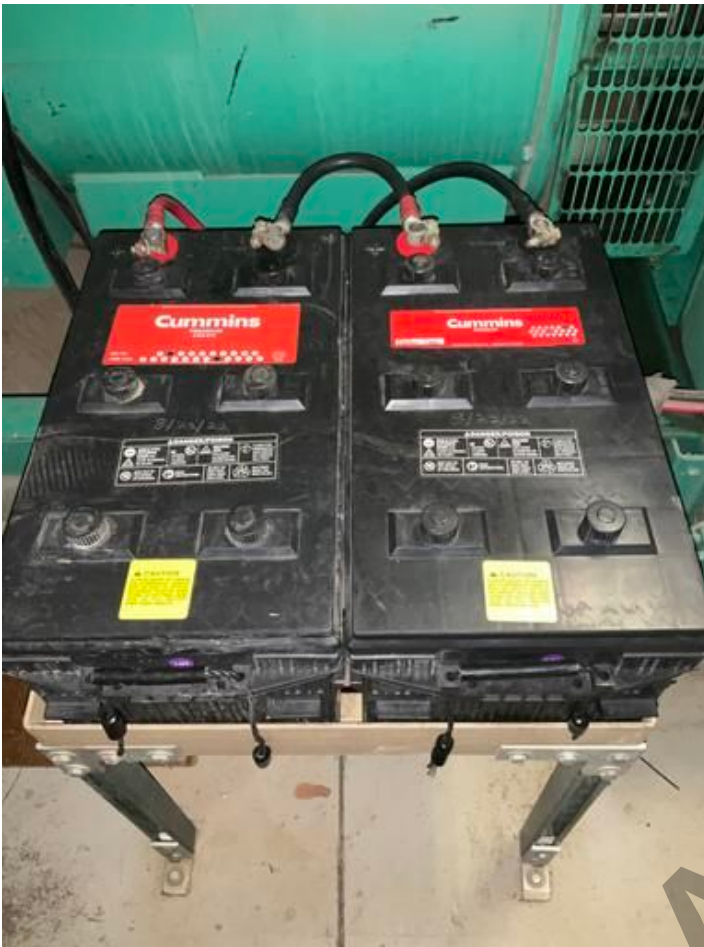
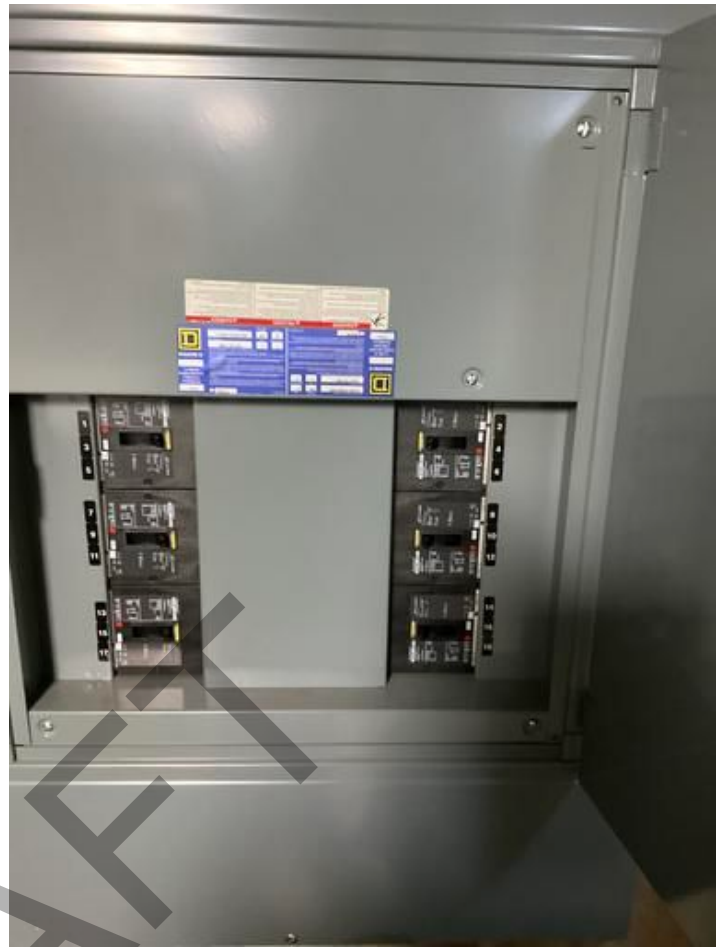
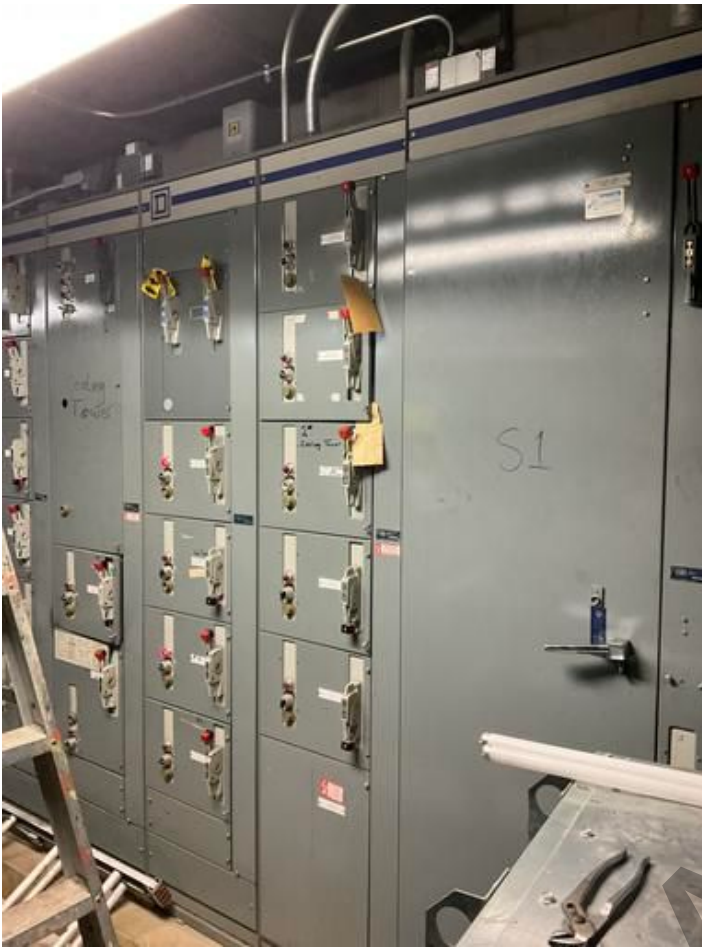
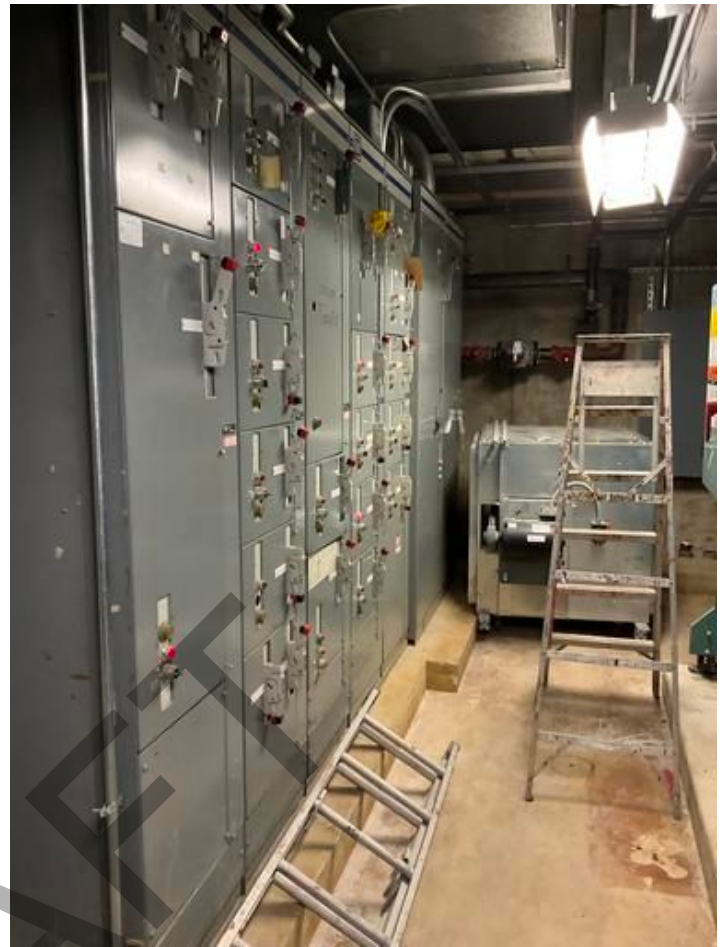
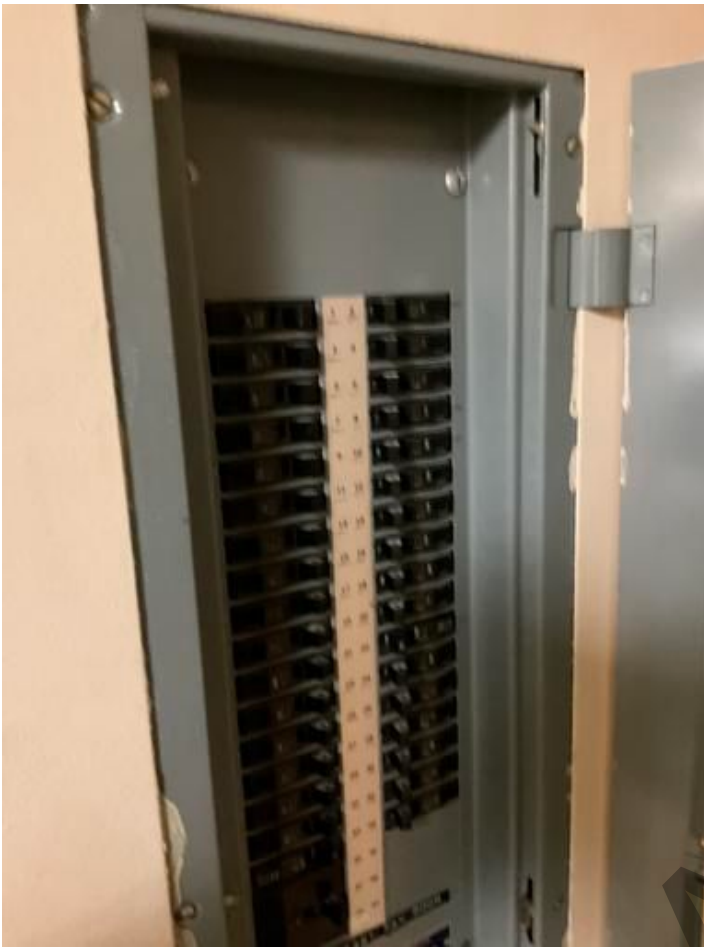
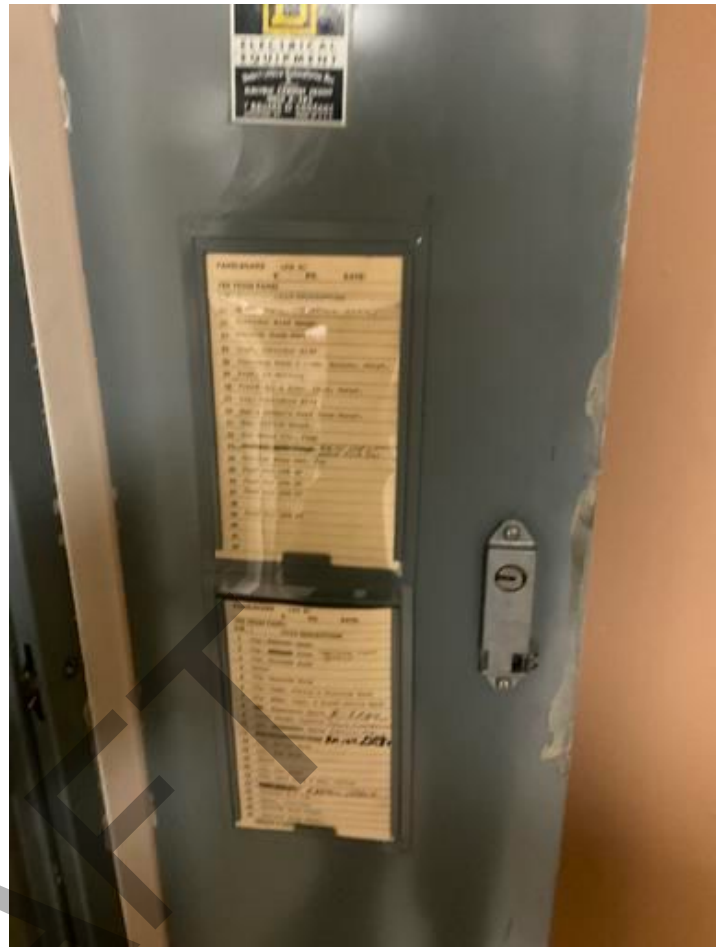
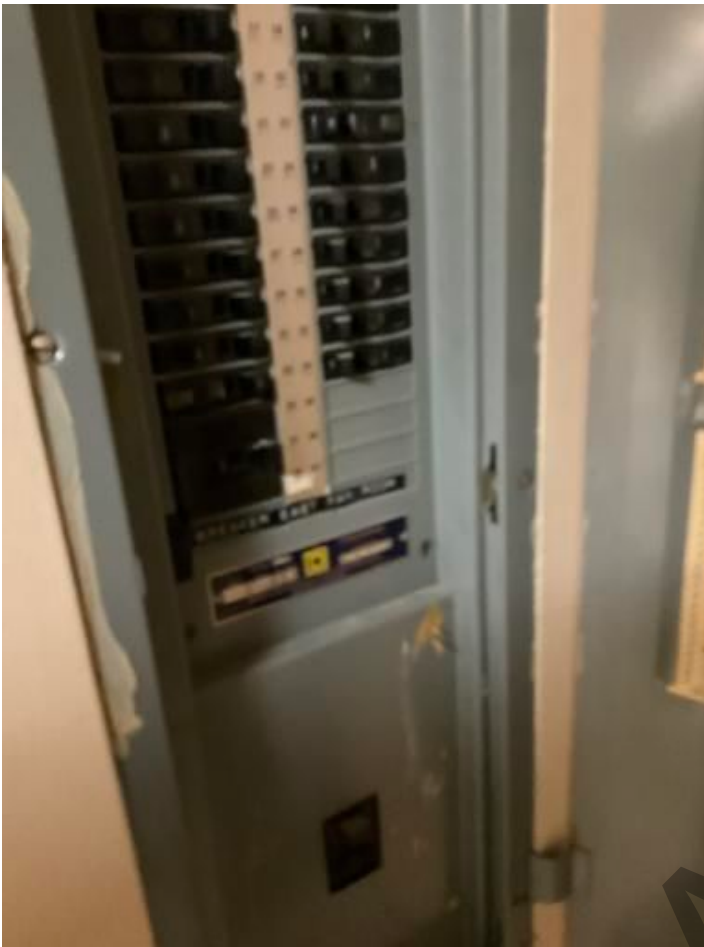
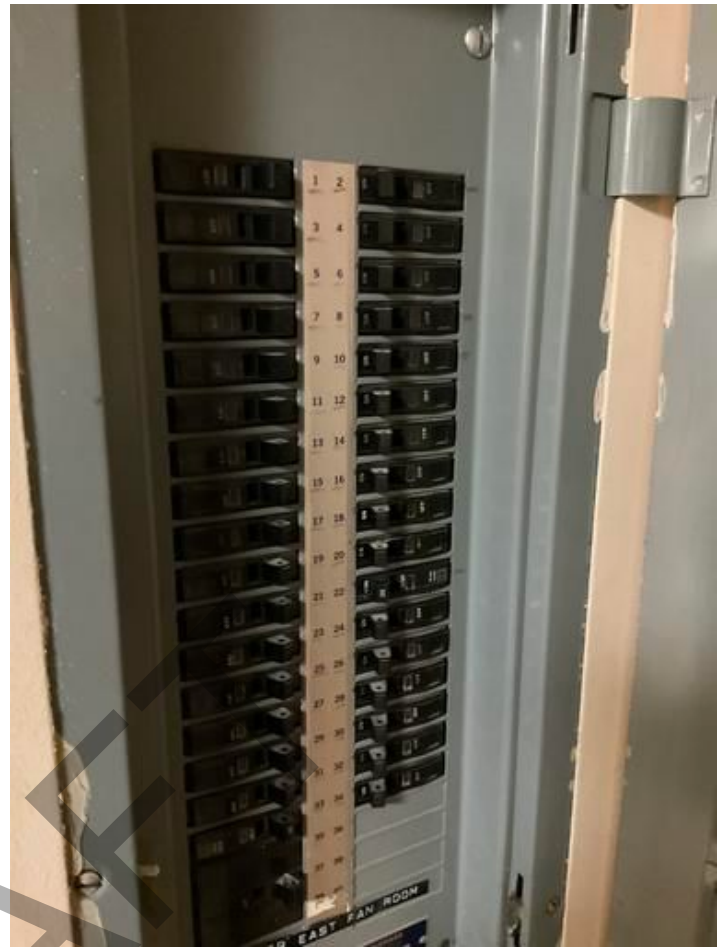
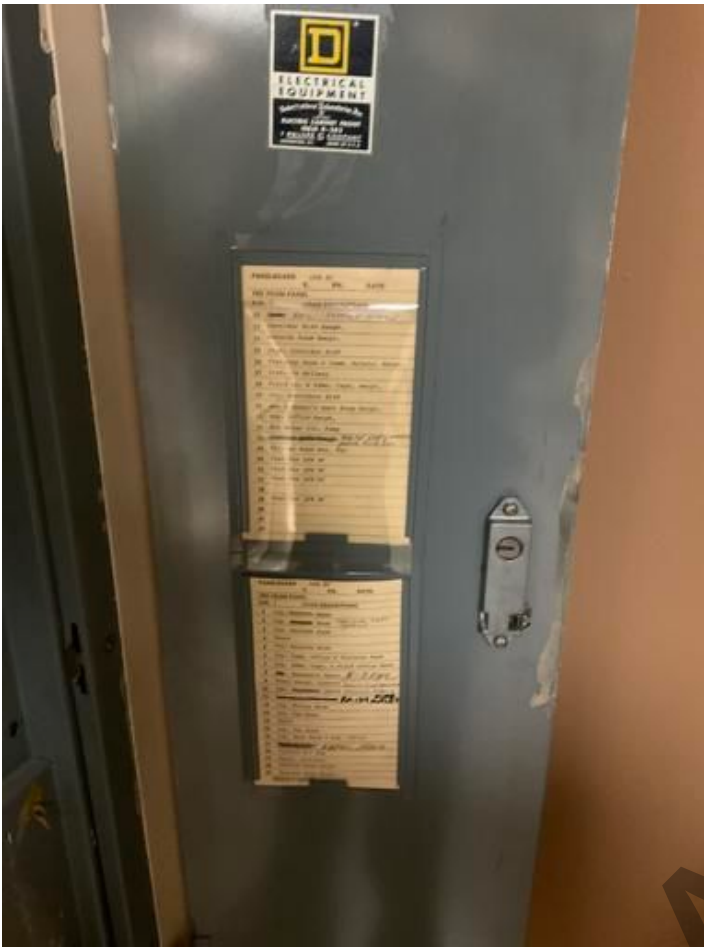
ID	#355
Pin	33
Status	<div></div> Open
Type	<div>EG</div> Electrical General > Electrical General

Description	Overall images of electrical panels, switch boards, and batteries.
Assigned to	—
Created by	Gabriel David (Cordogan Clark)
Created on	Jun 29, 2023
Location	Village Hall - Lower Level
Location details	—
Due date	—
Start date	—
Placement	04 (Village Hall - Lower Level Plan)
Root cause	—

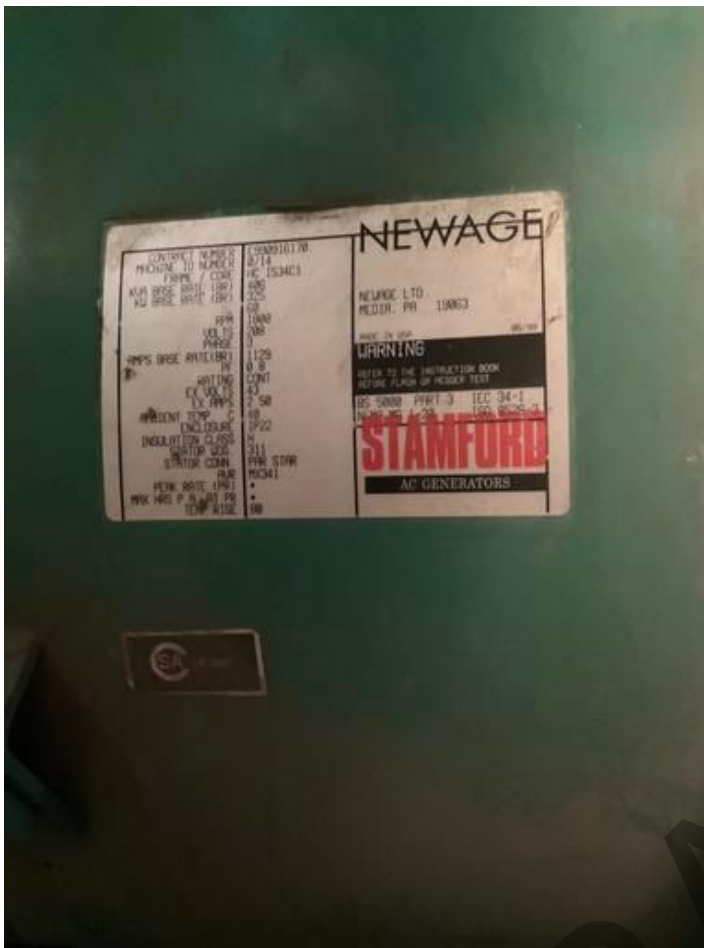
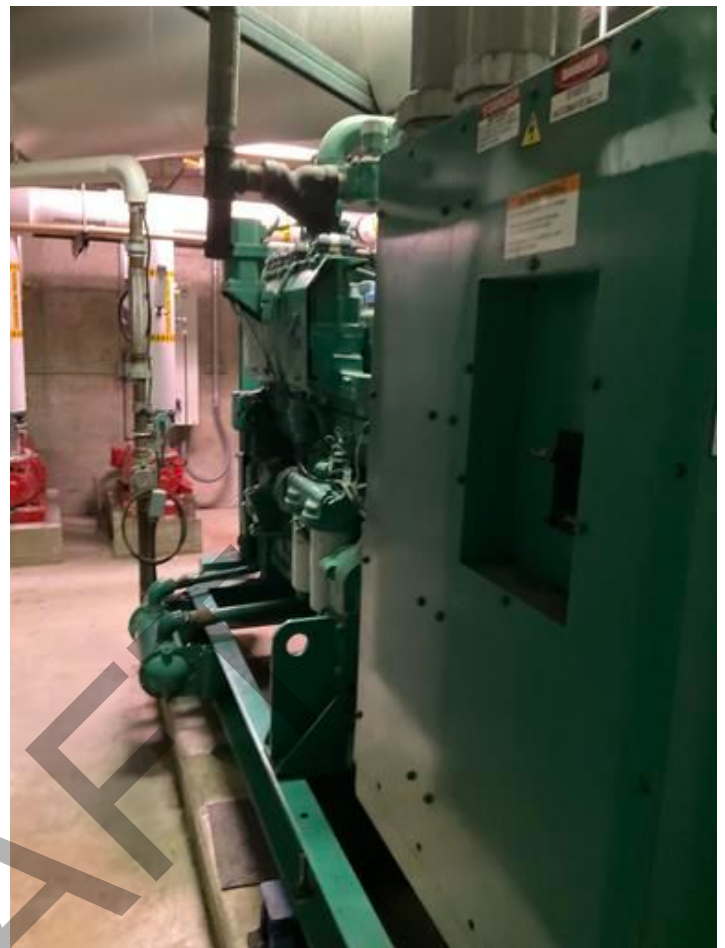
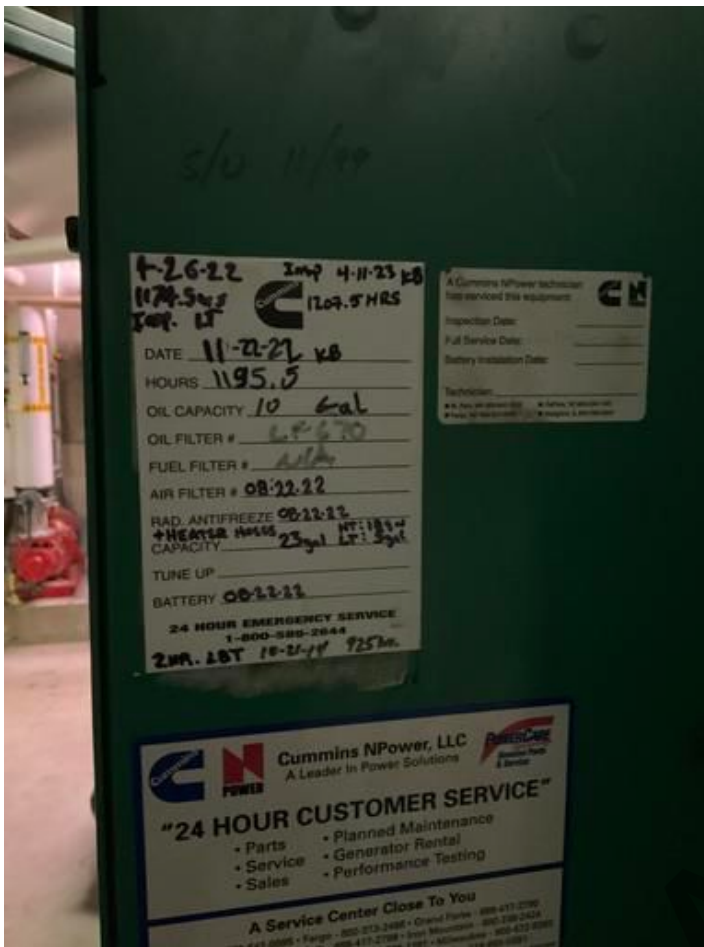
ID	#356
Pin	34
Status	<div></div> Open
Type	<div>EG</div> Electrical General > Electrical General

Description	Overall images of generator and specifications.
Assigned to	—
Created by	Gabriel David (Cordogan Clark)
Created on	Jun 29, 2023
Location	Village Hall - Lower Level
Location details	—
Due date	—
Start date	—
Placement	04 (Village Hall - Lower Level Plan)
Root cause	—
