**OAK PARK VILLAGE HALL
123 Madison Street, Oak Park IL. 60302**

**PROPERTY CONDITION ASSESSMENT REPORT
07.08.23**

Property Condition Assessment Report

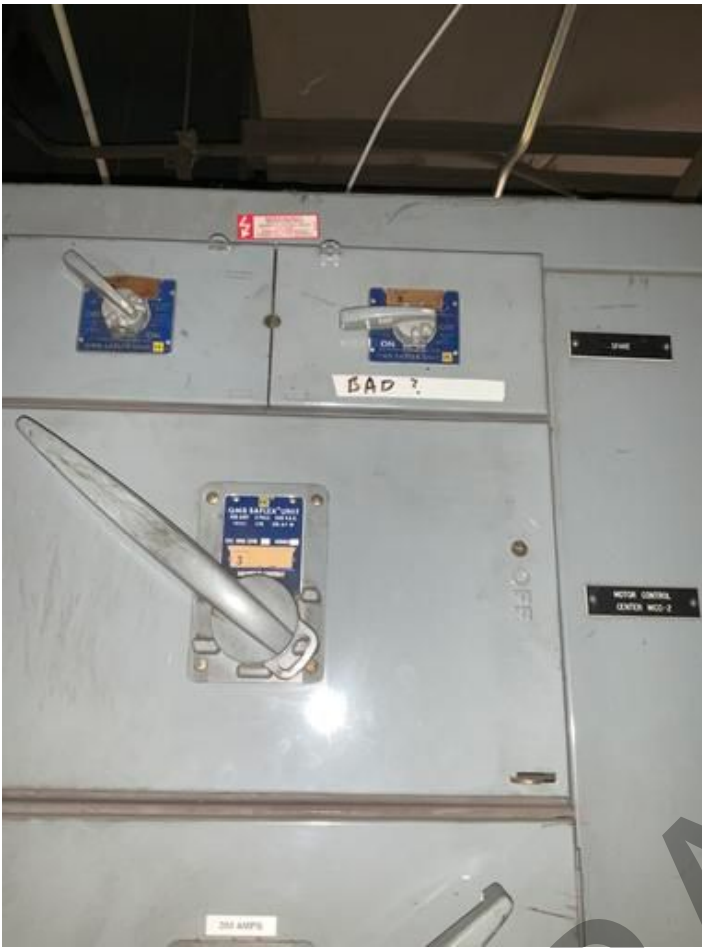
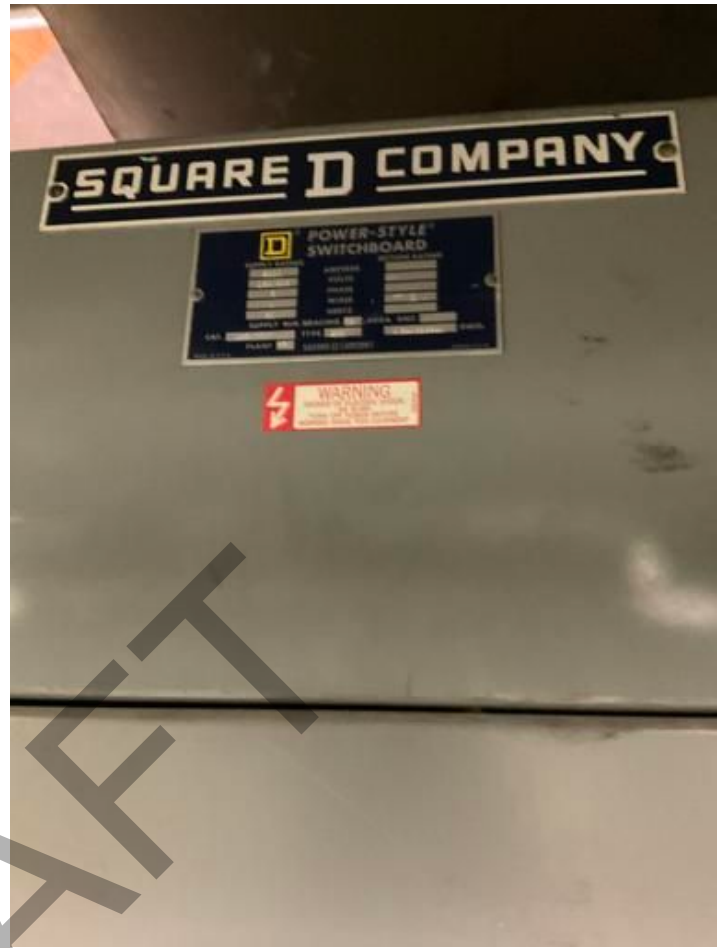
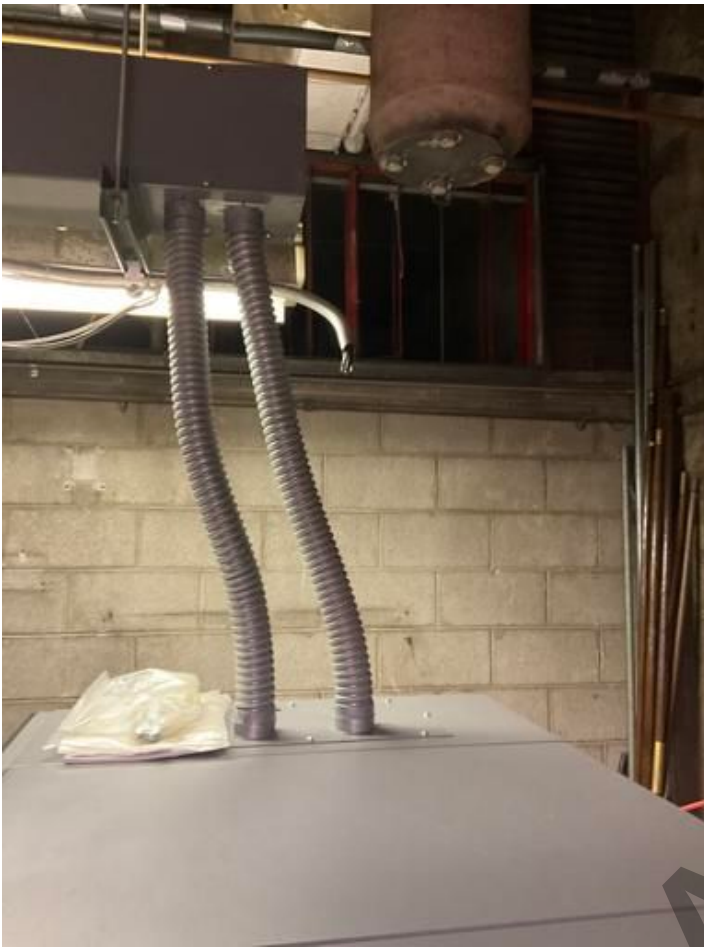
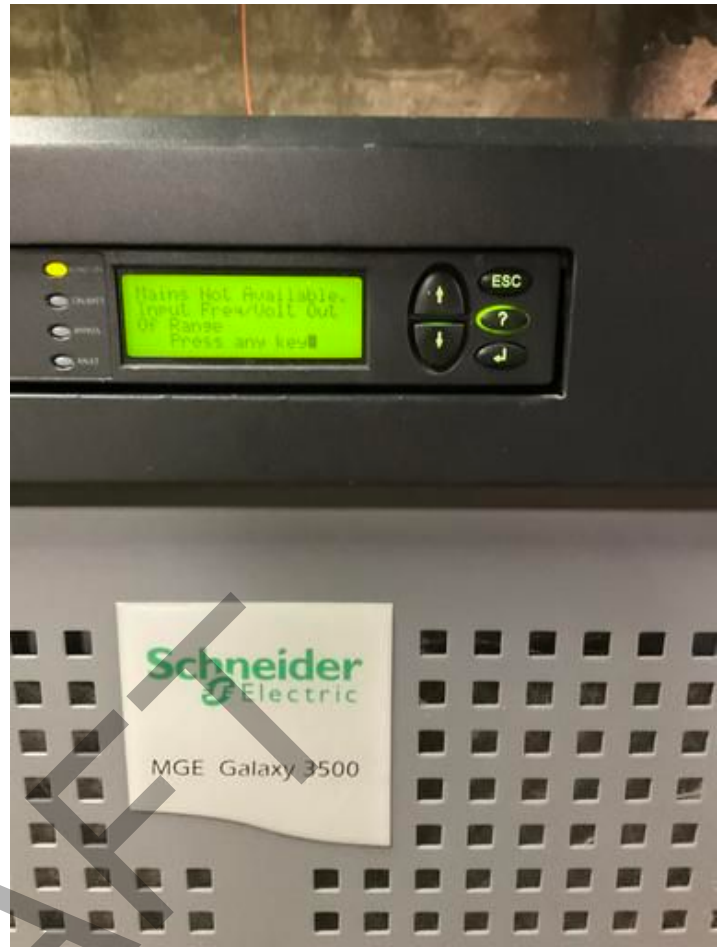
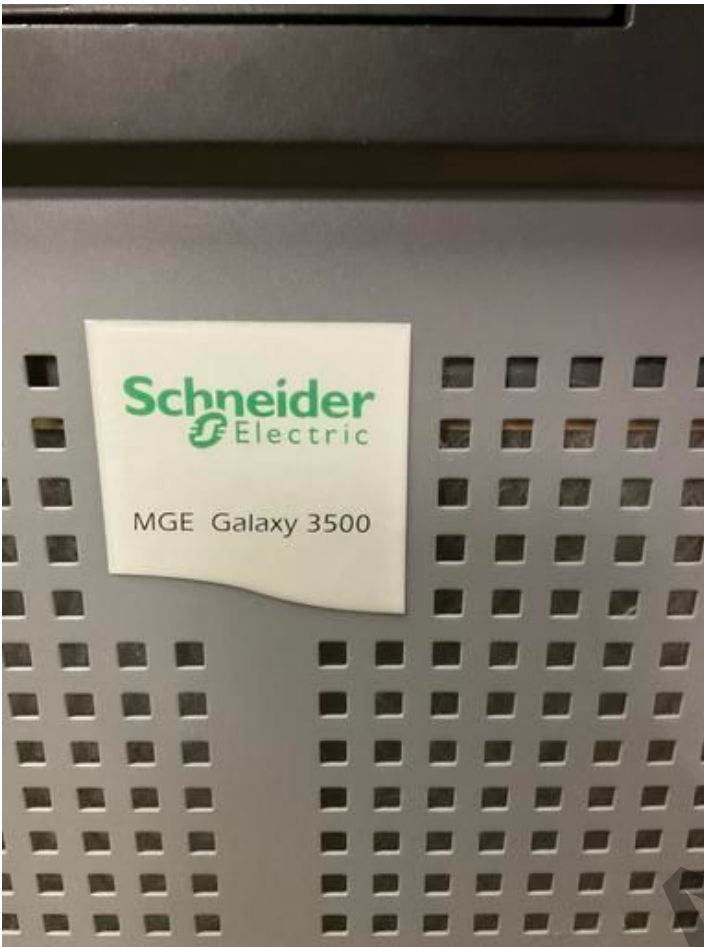
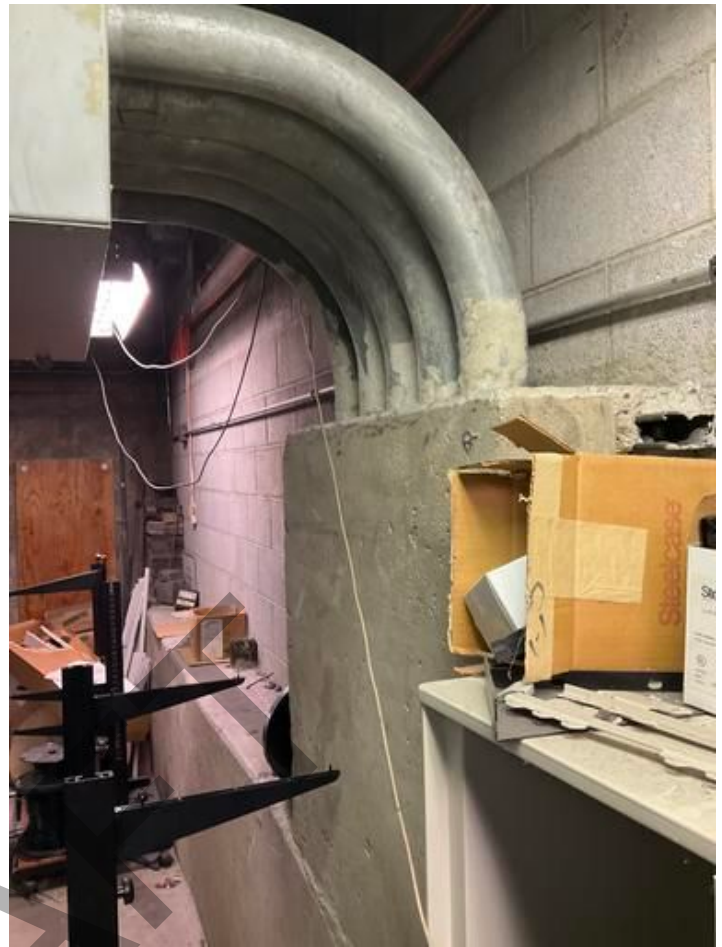
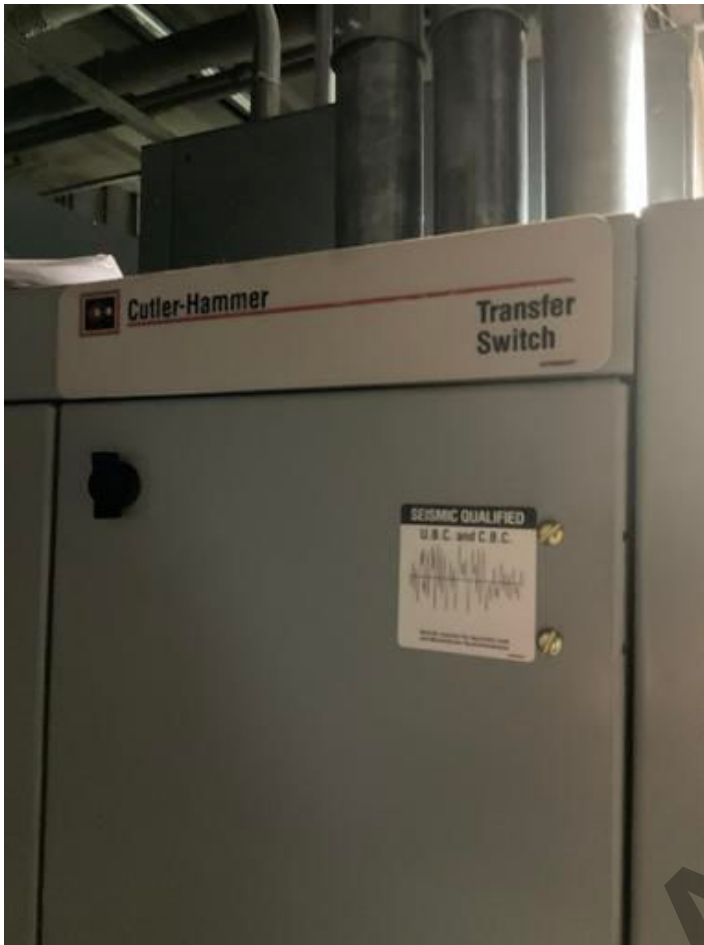
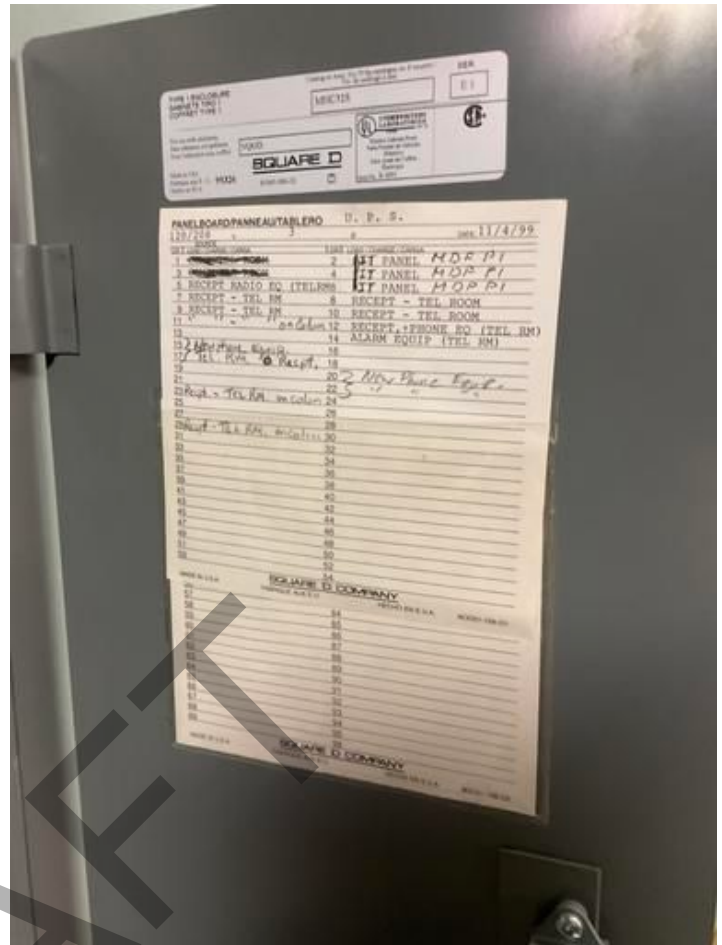
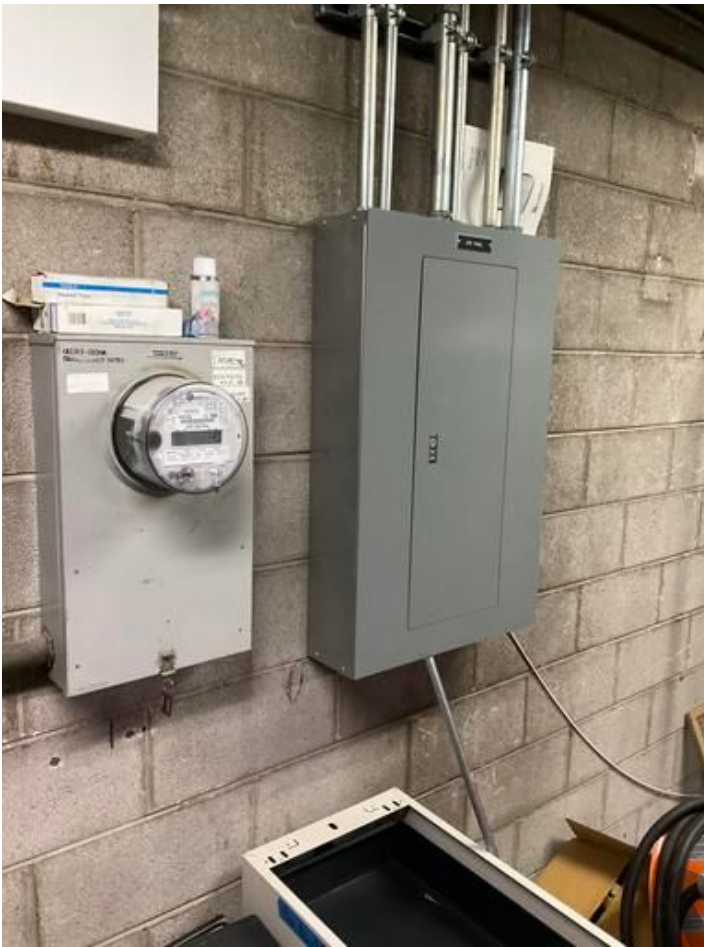
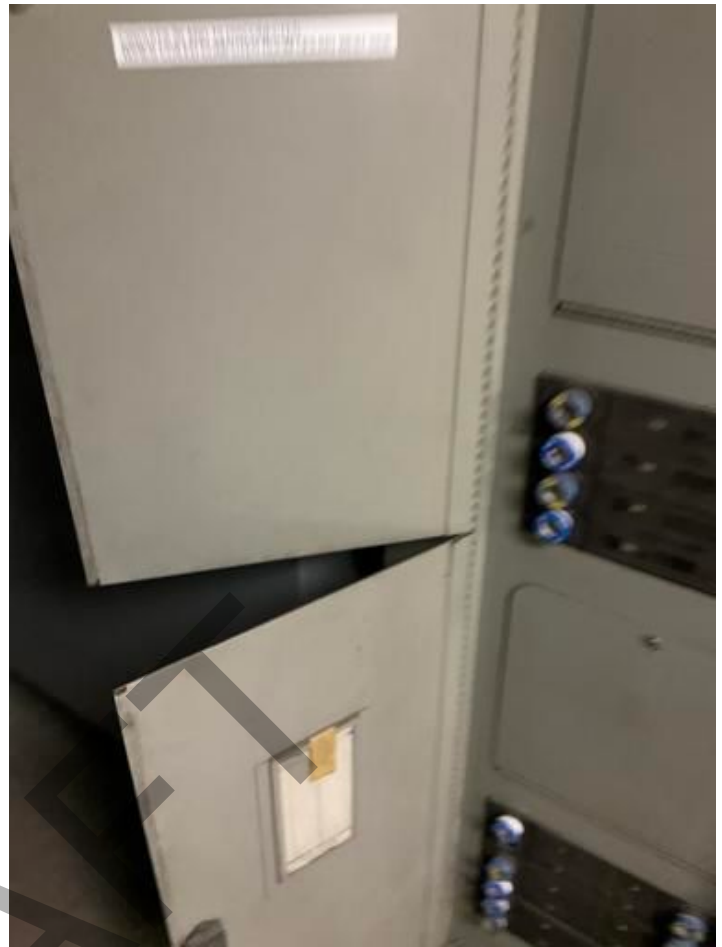
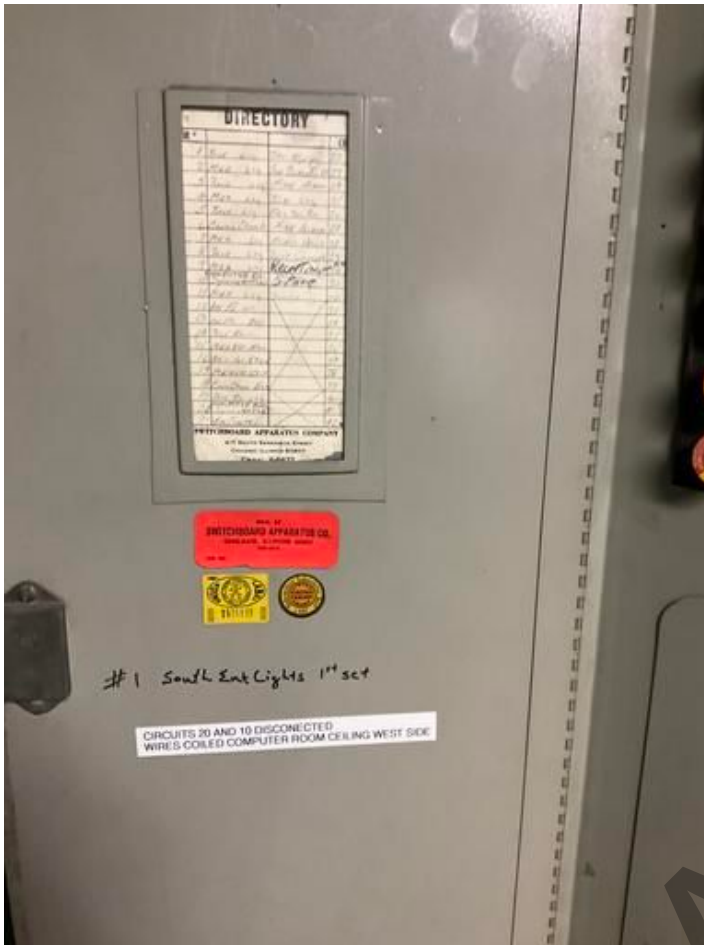
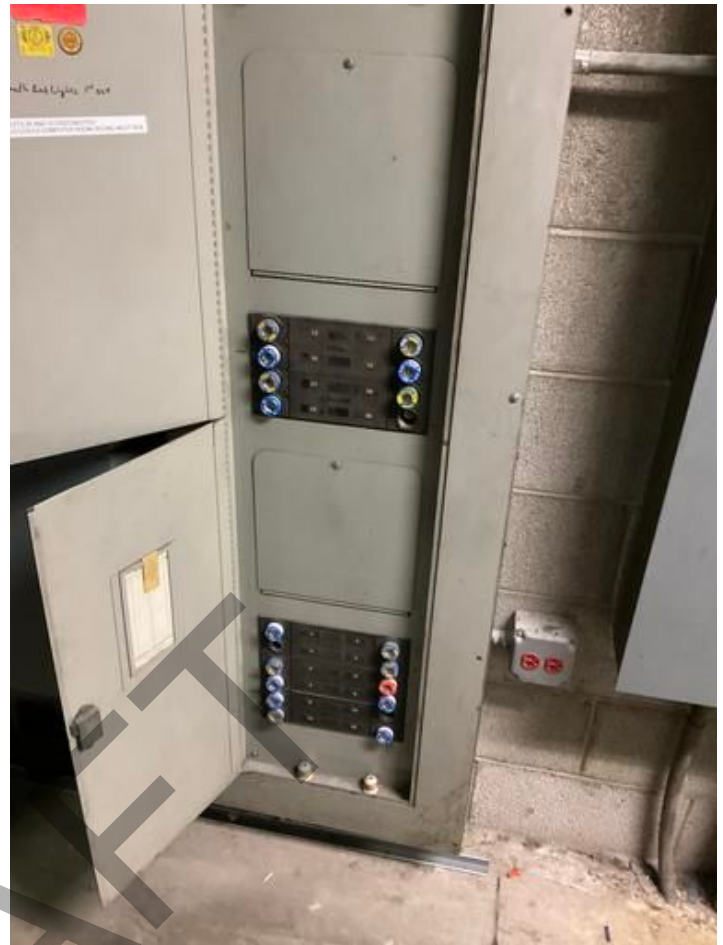
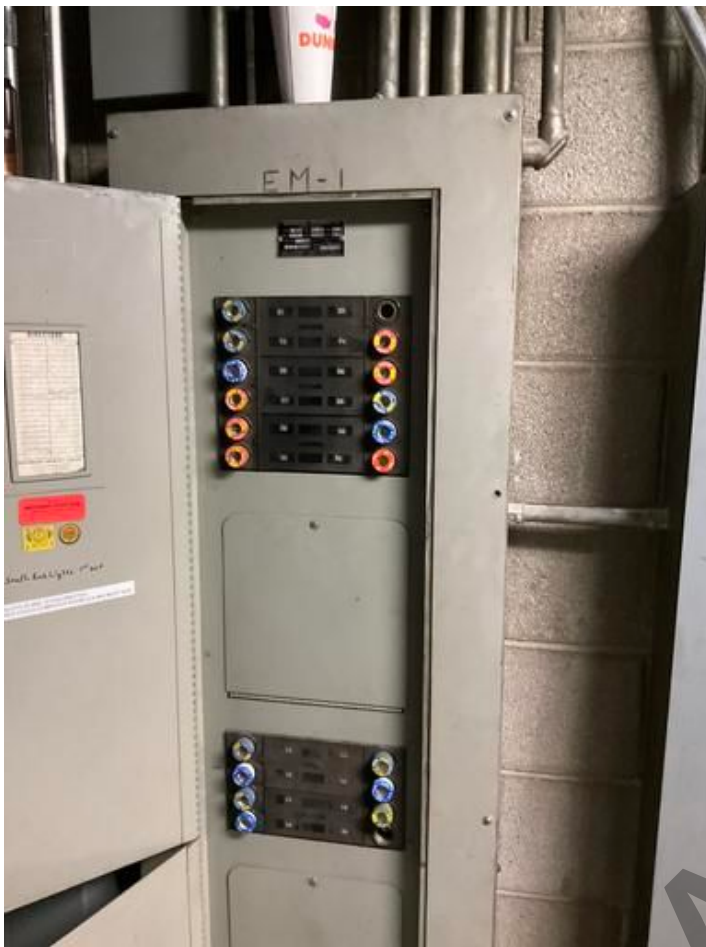
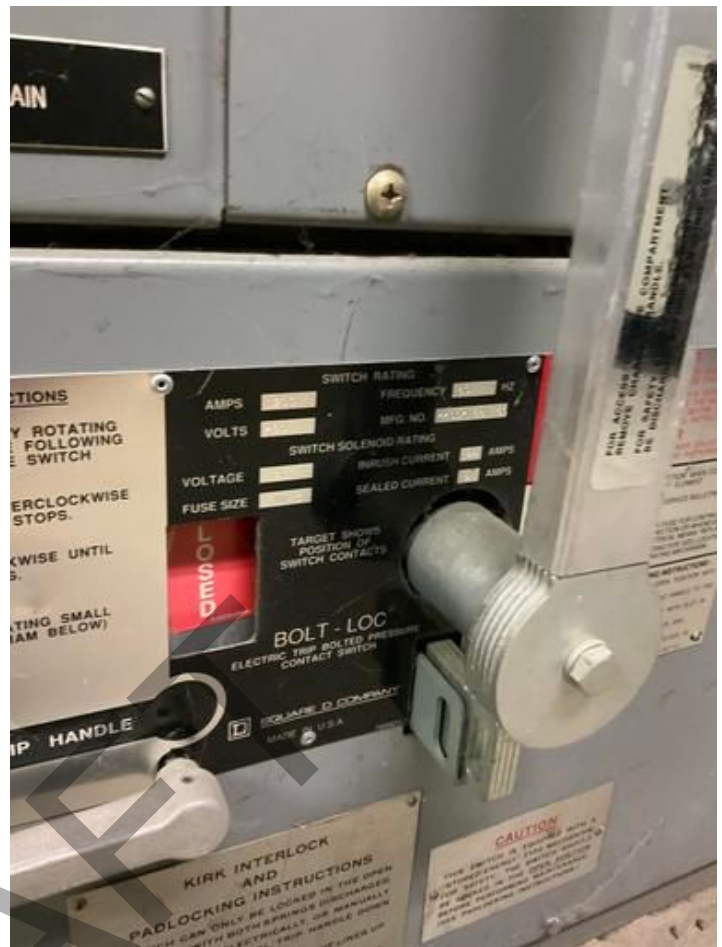
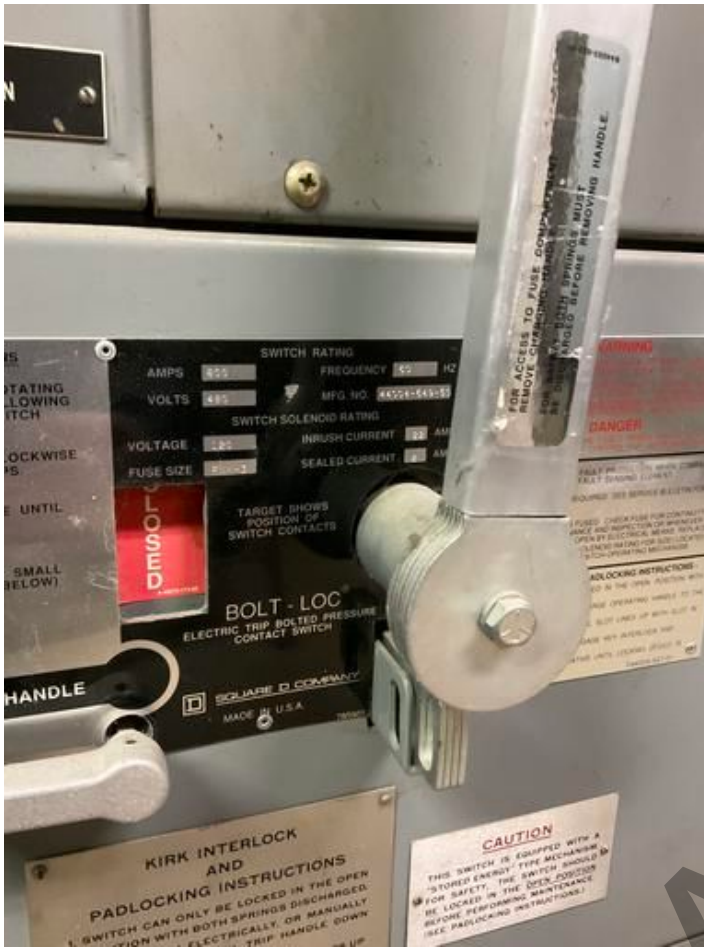
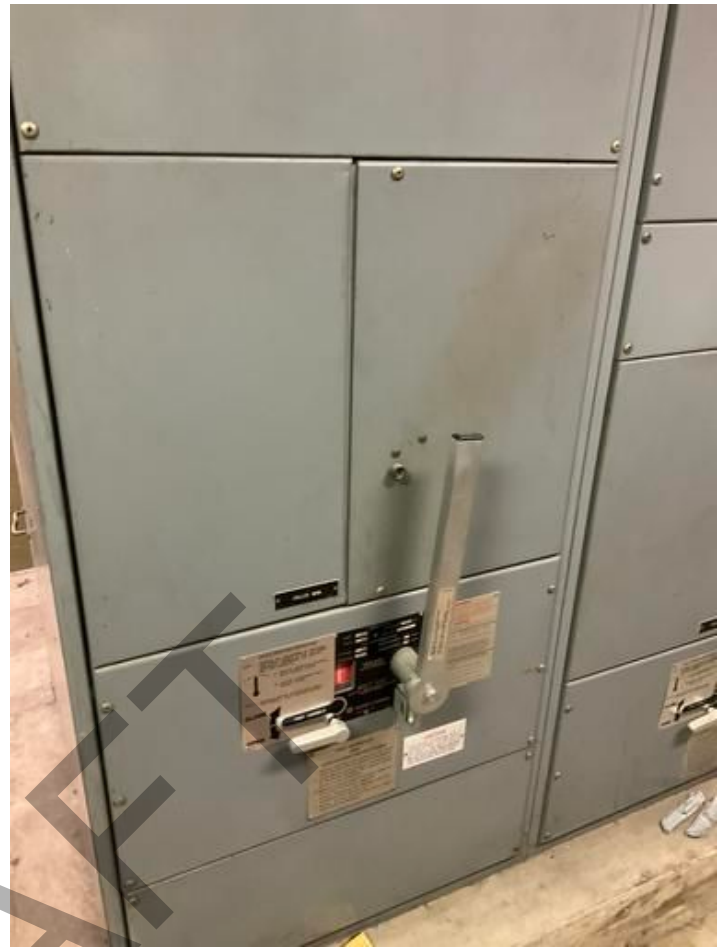
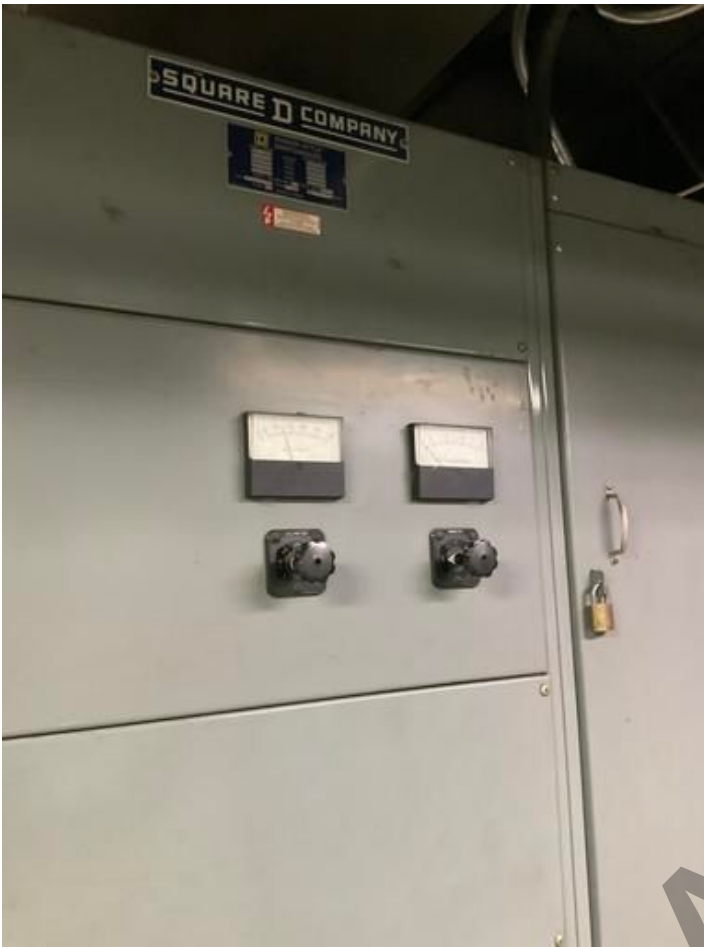
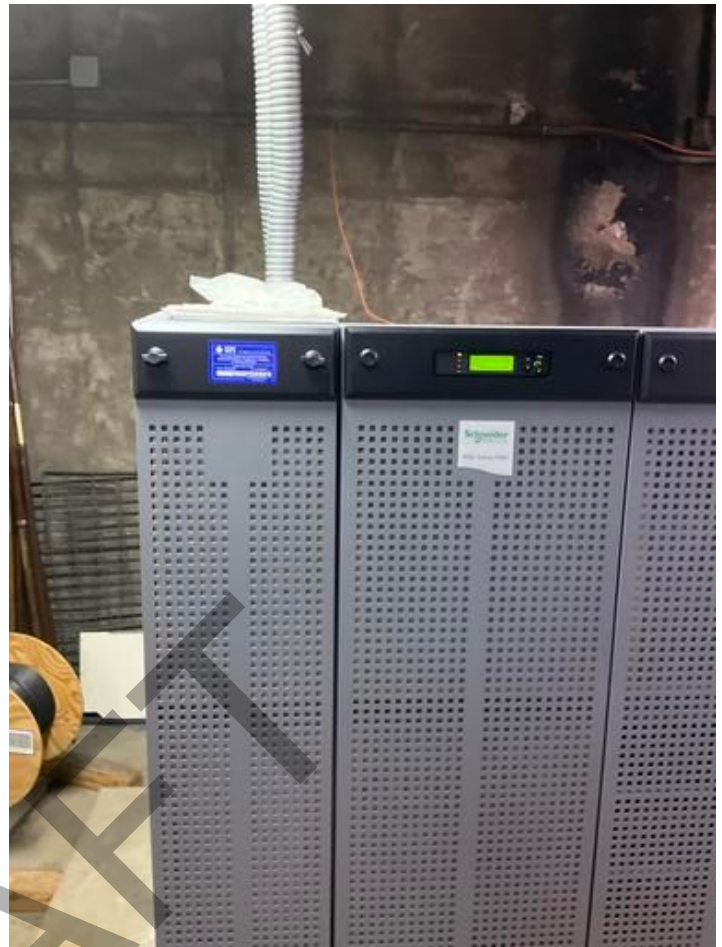
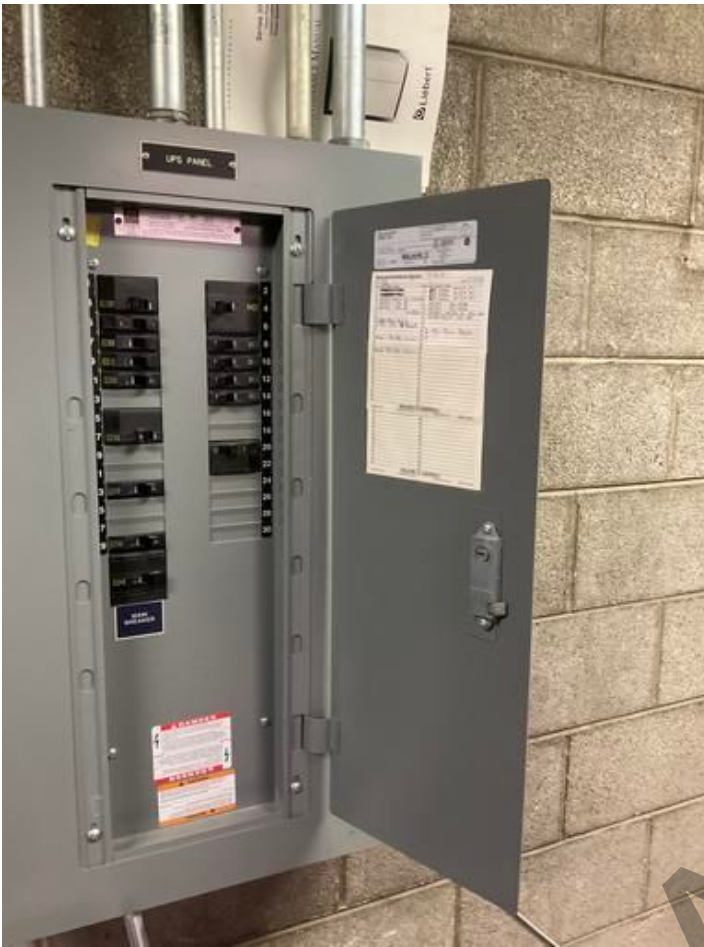
ID	#357
Pin	35
Status	■ Open
Type	EG Electrical General > Electrical General

Description	Overall photos of electrical equipment in UPS Room. Including images of panels, electric meters, switches, and specifications.
Assigned to	—
Created by	Gabriel David (Cordogan Clark)
Created on	Jun 30, 2023
Location	Village Hall - Lower Level
Location details	—
Due date	—
Start date	—
Placement	04 (Village Hall - Lower Level Plan)
Root cause	—

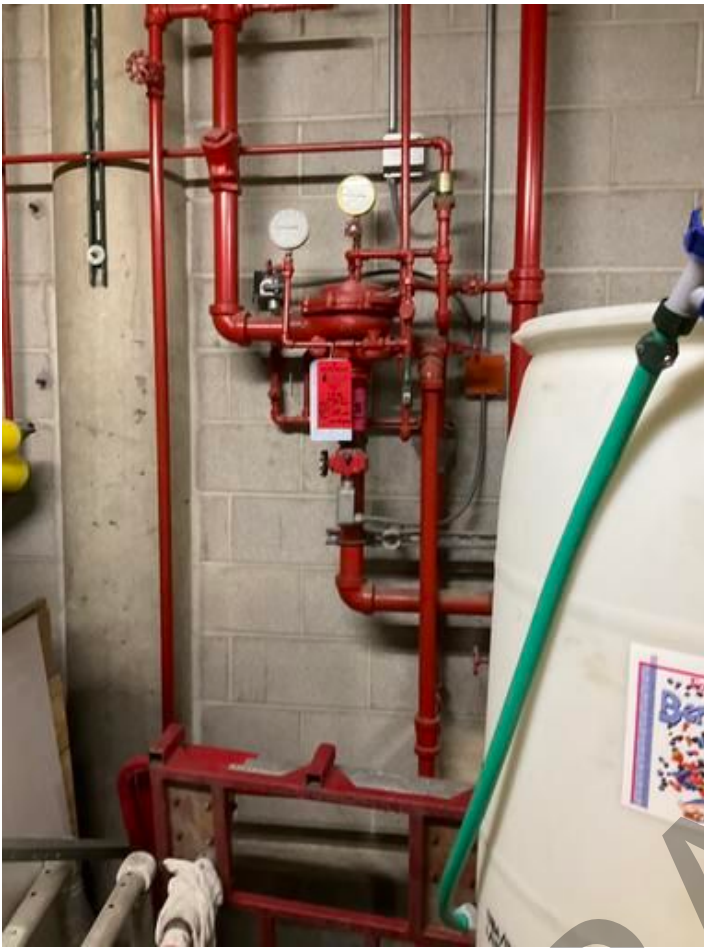
ID	#358
Pin	36
Status	<div></div> Open
Type	<div>EG</div> Electrical General > Electrical General

Description	Overall photo of fire suppression system.
Assigned to	—
Created by	Gabriel David (Cordogan Clark)
Created on	Jun 30, 2023
Location	Village Hall - Lower Level
Location details	—
Due date	—
Start date	—
Placement	04 (Village Hall - Lower Level Plan)
Root cause	—

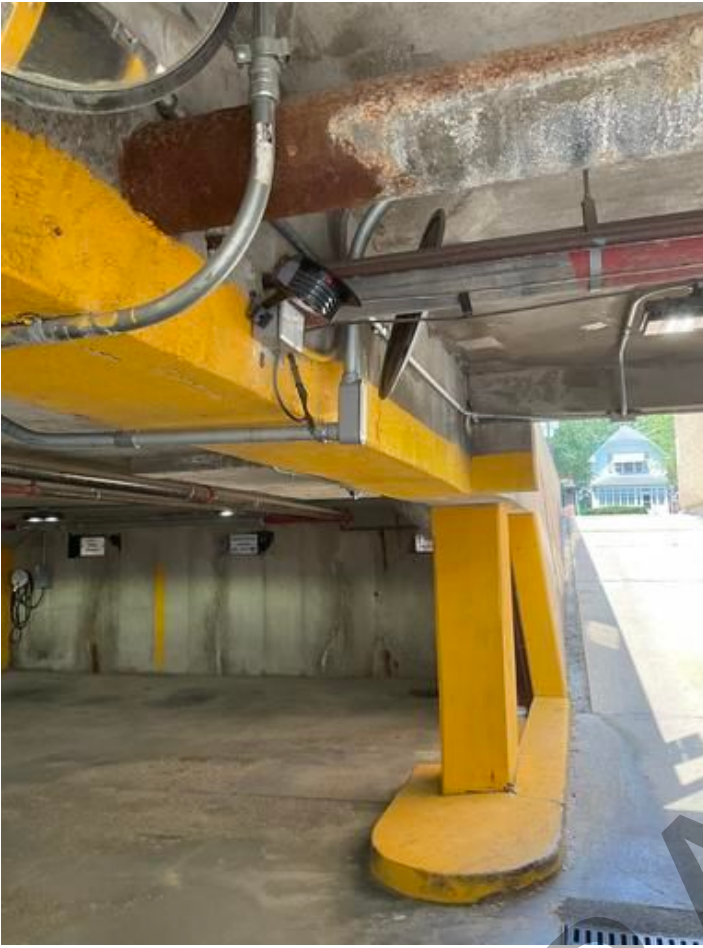
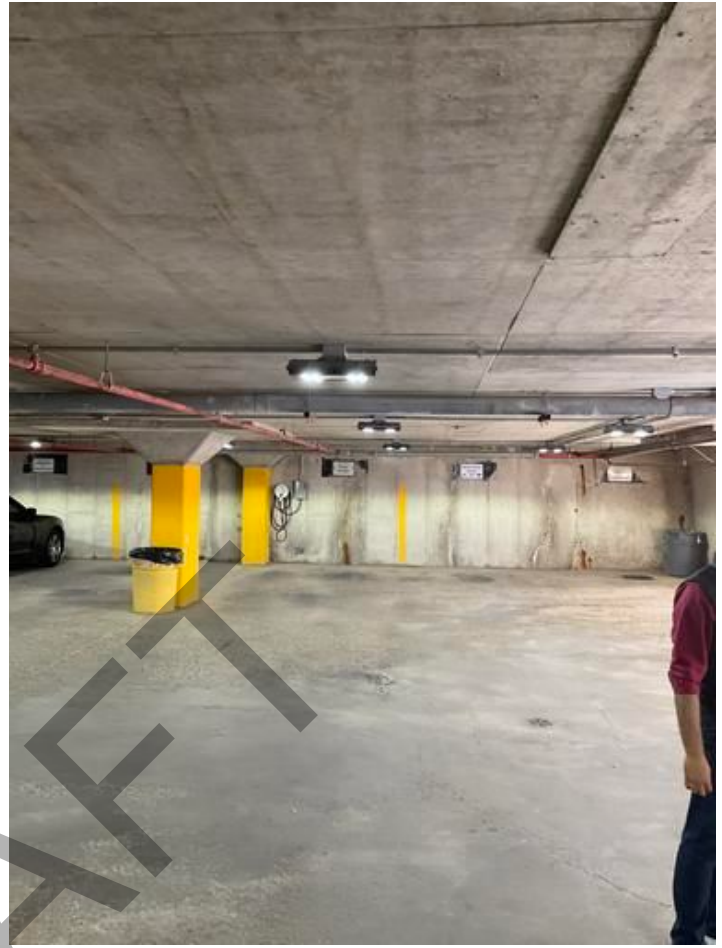
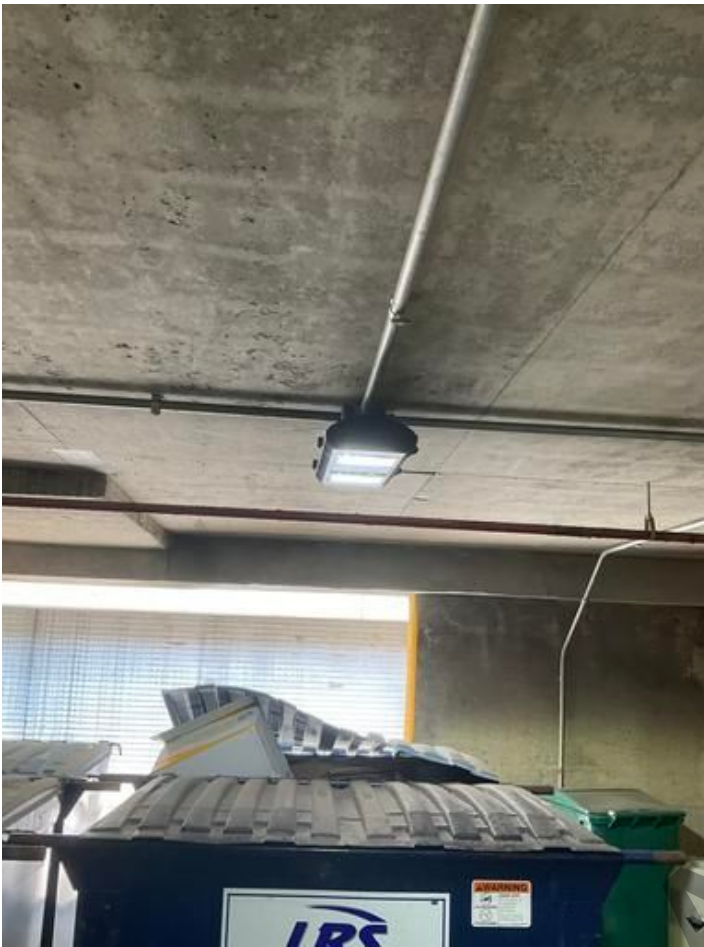
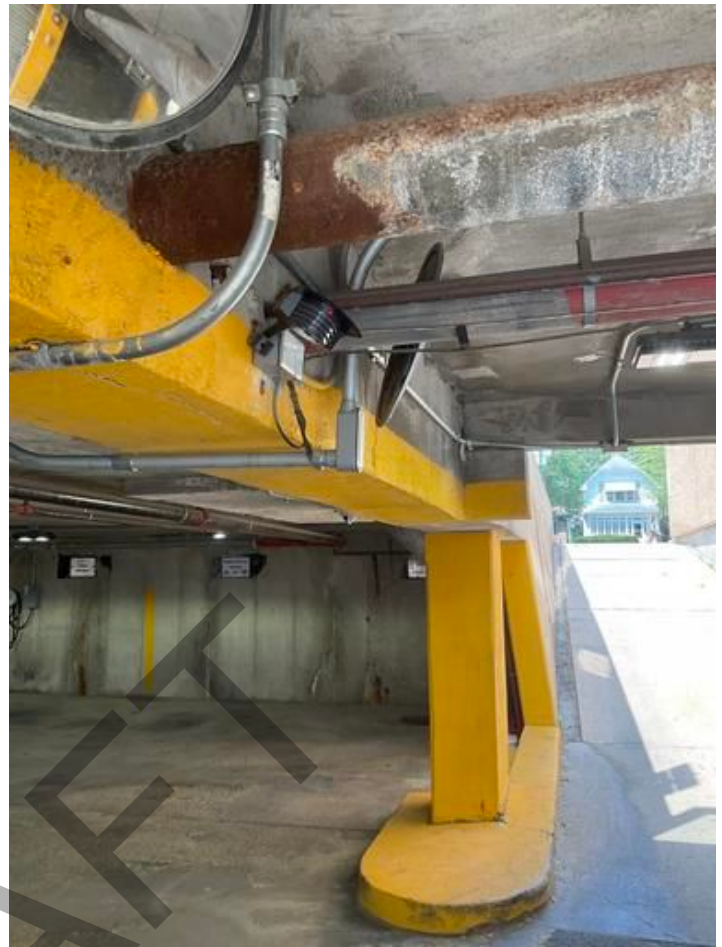
Description	Overall images of Underground Parking lighting, and devices.
Assigned to	—
Created by	Gabriel David (Cordogan Clark)
Created on	Jun 30, 2023
Location	Village Hall - Lower Level
Location details	—
Due date	—
Start date	—
Placement	04 (Village Hall - Lower Level Plan)
Root cause	—

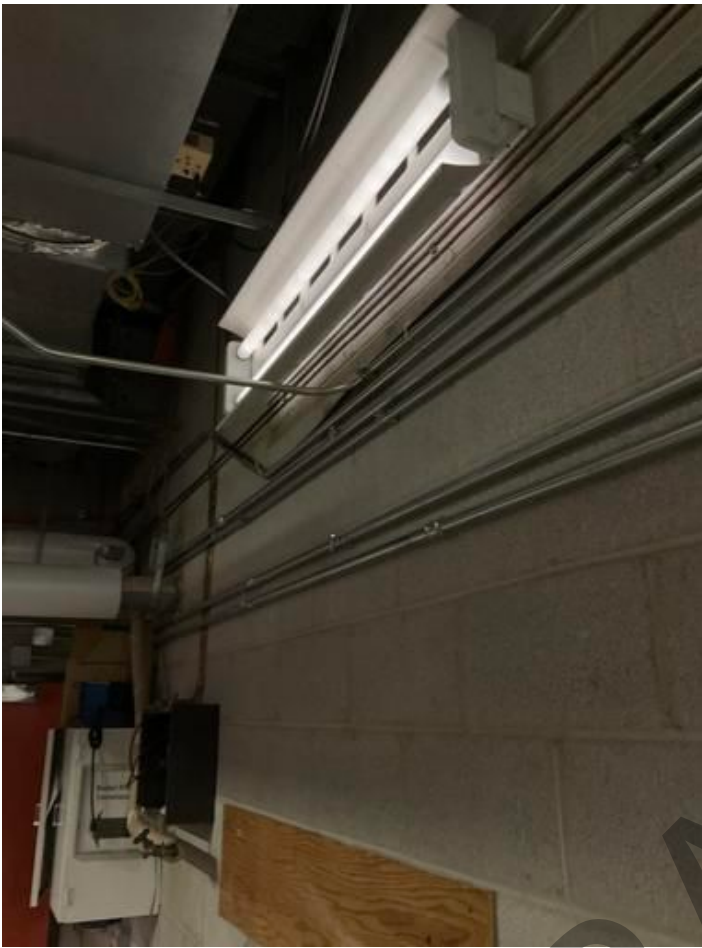
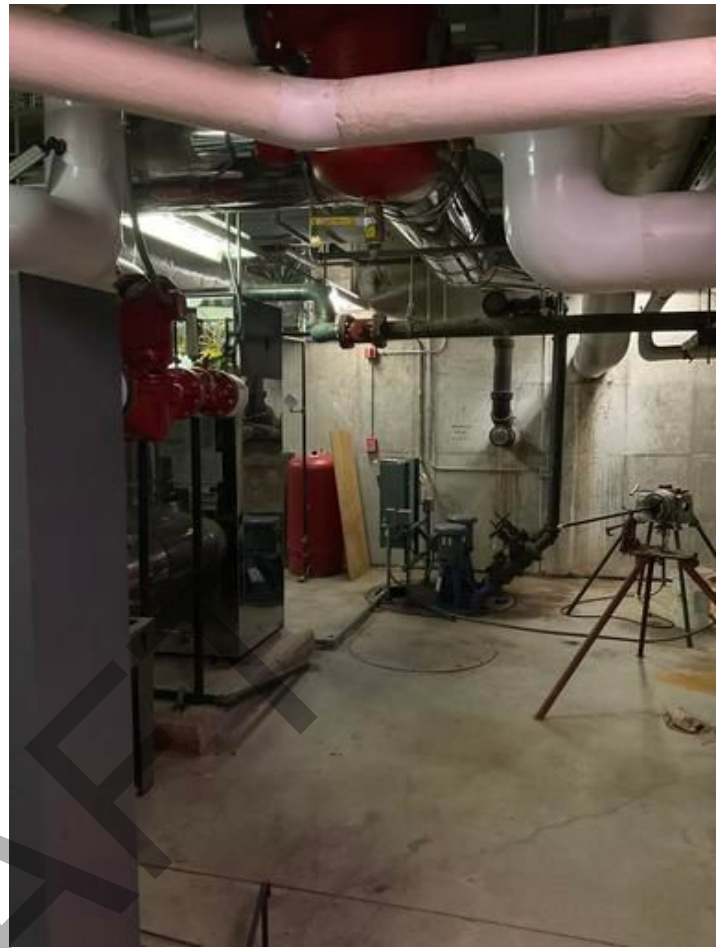
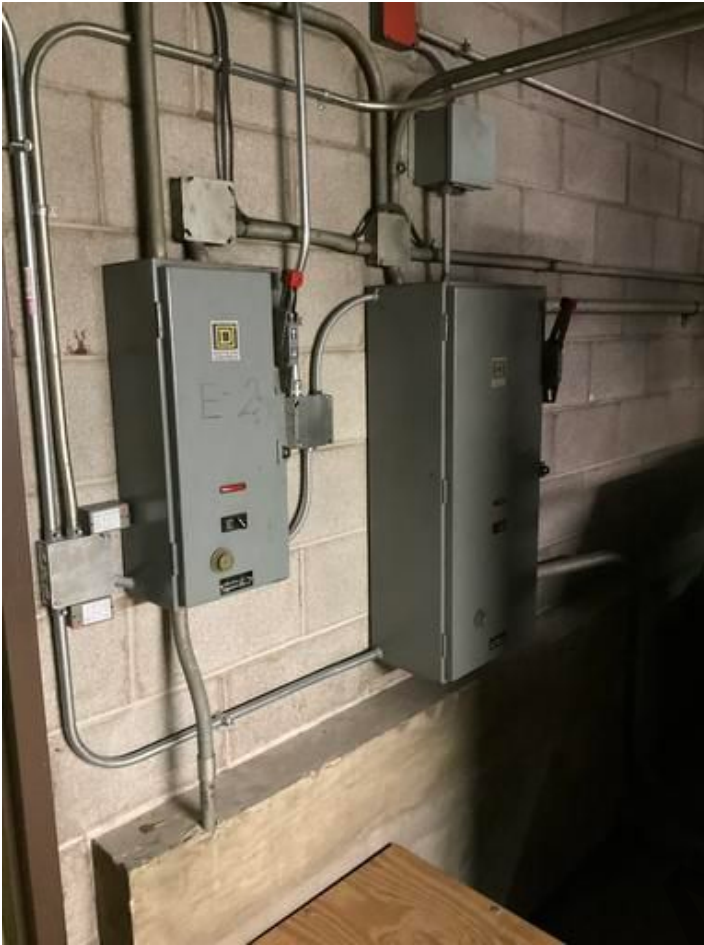
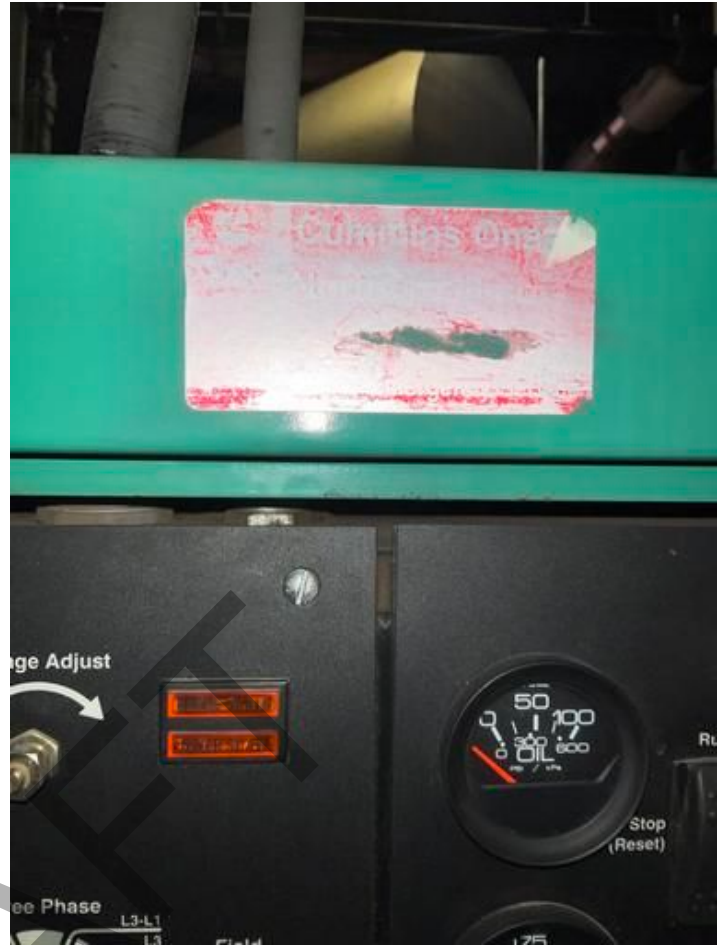
ID	#363
Pin	38
Status	<div><div></div>Open</div>
Type	<div><div>EG</div>Electrical General > Electrical General</div>

Description	Overall images of electrical systems, boxes, lights, and lines.
Assigned to	—
Created by	Gabriel David (Cordogan Clark)
Created on	Jun 30, 2023
Location	Village Hall - Lower Level
Location details	—
Due date	—
Start date	—
Placement	04 (Village Hall - Lower Level Plan)
Root cause	—

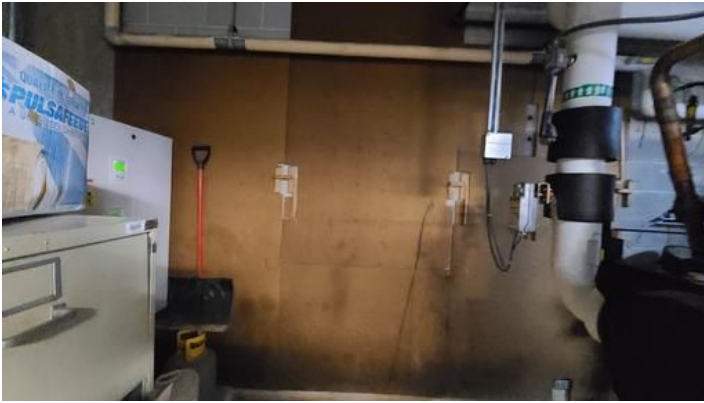
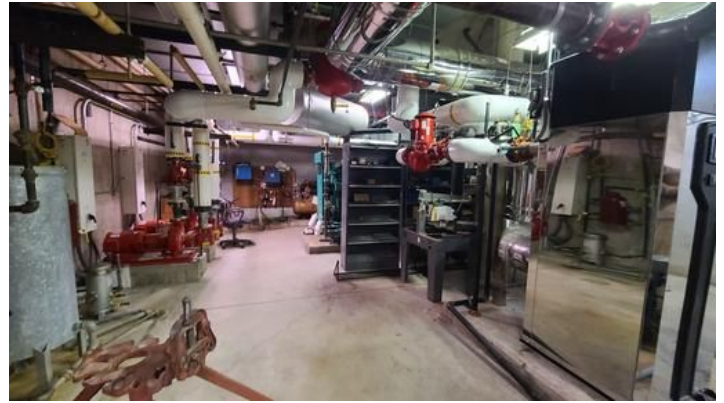
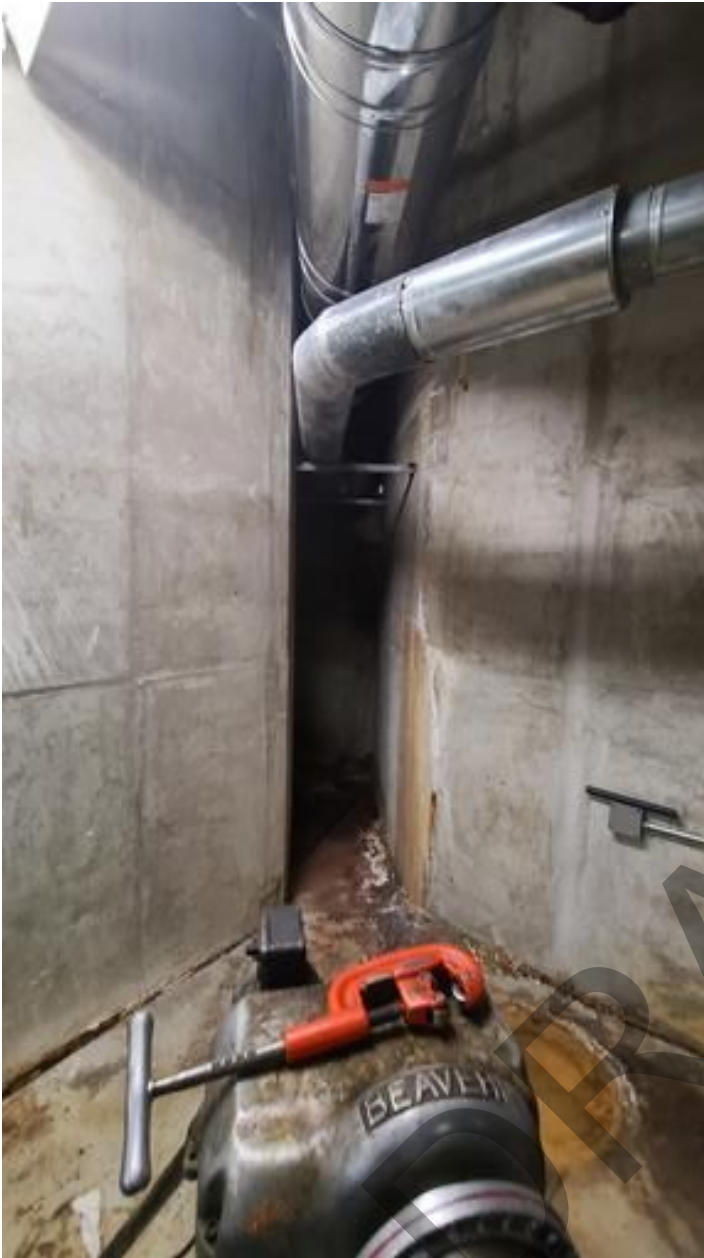
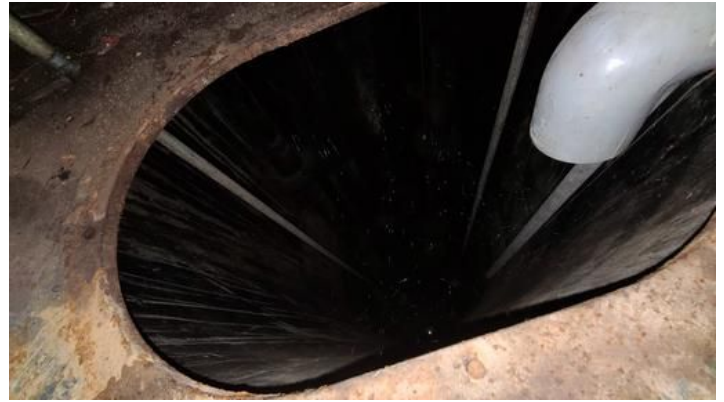
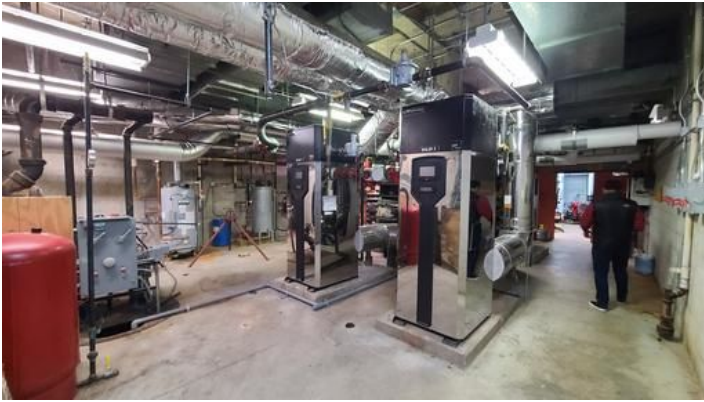
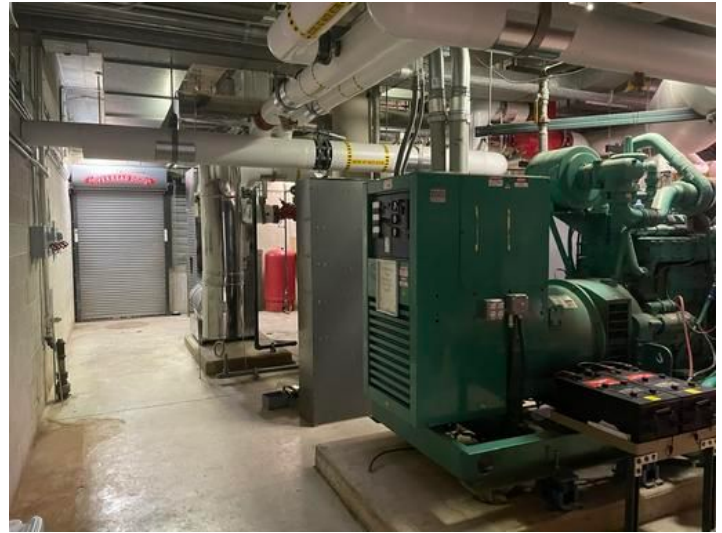
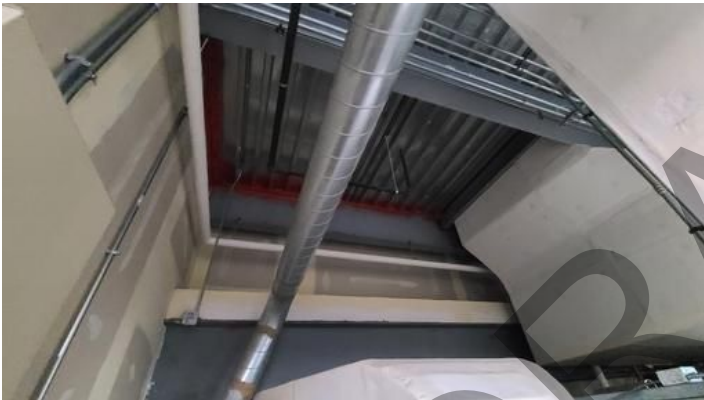
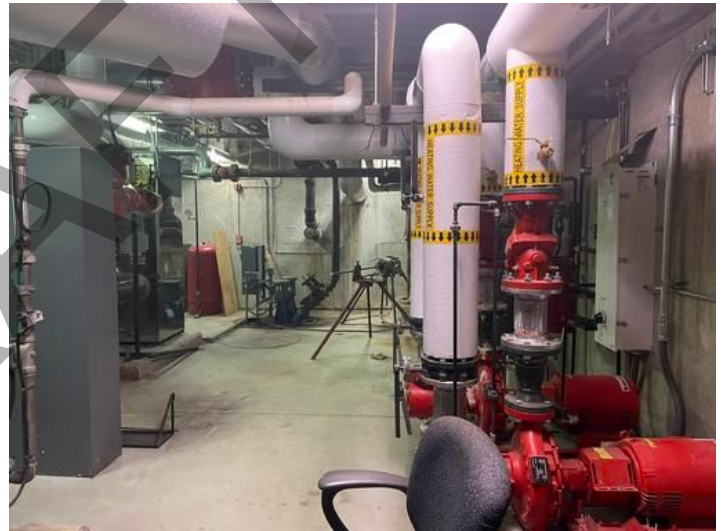
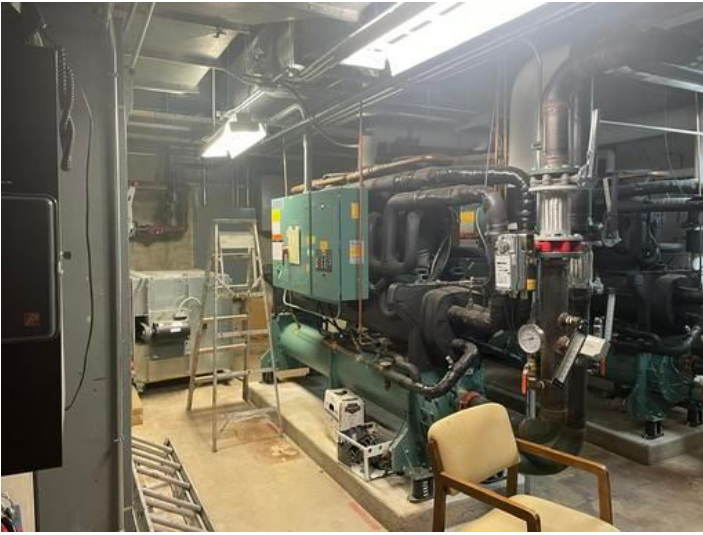
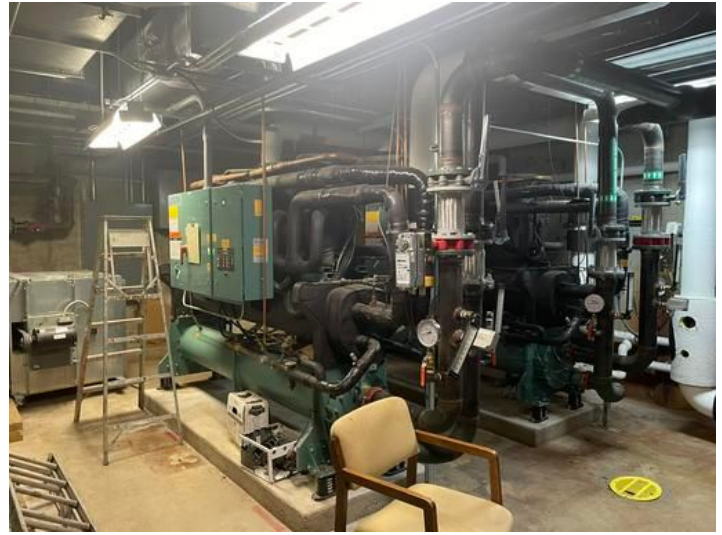
ID	#240
Pin	39
Status	Open
Type	AG Architectural General > Architectural General

Description	Overall photos of Generator Room.
Assigned to	—
Created by	Gabriel David (Cordogan Clark)
Created on	Jun 23, 2023
Location	Village Hall - Lower Level
Location details	—
Due date	—
Start date	—
Placement	04 (Village Hall - Lower Level Plan)
Root cause	—
