**OAK PARK VILLAGE HALL
123 Madison Street, Oak Park IL. 60302**

**PROPERTY CONDITION ASSESSMENT REPORT
07.08.23**

Property Condition Assessment Report

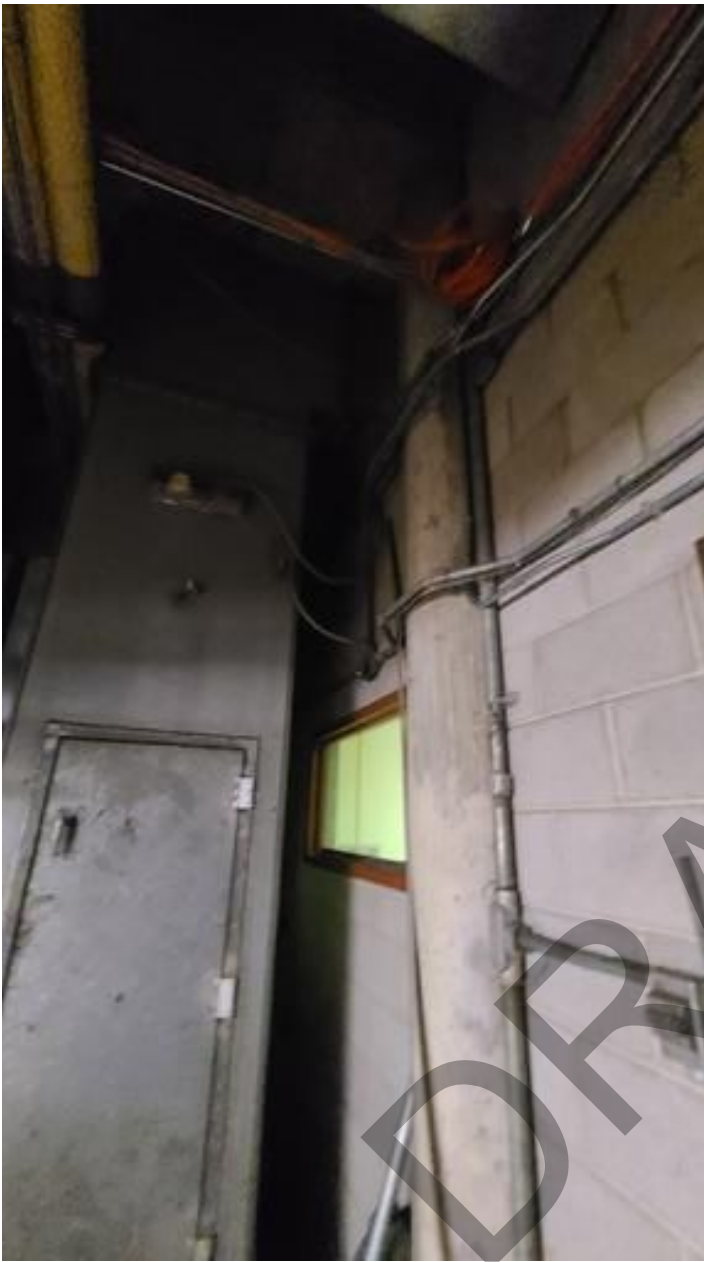
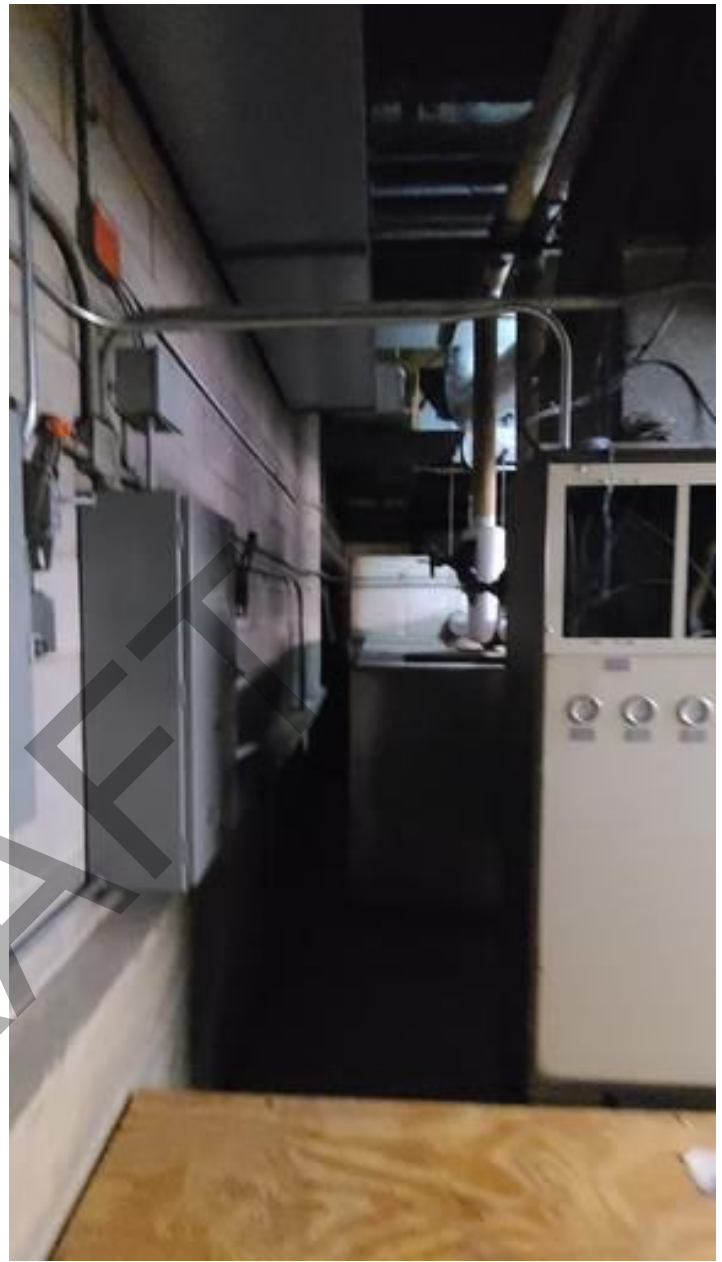
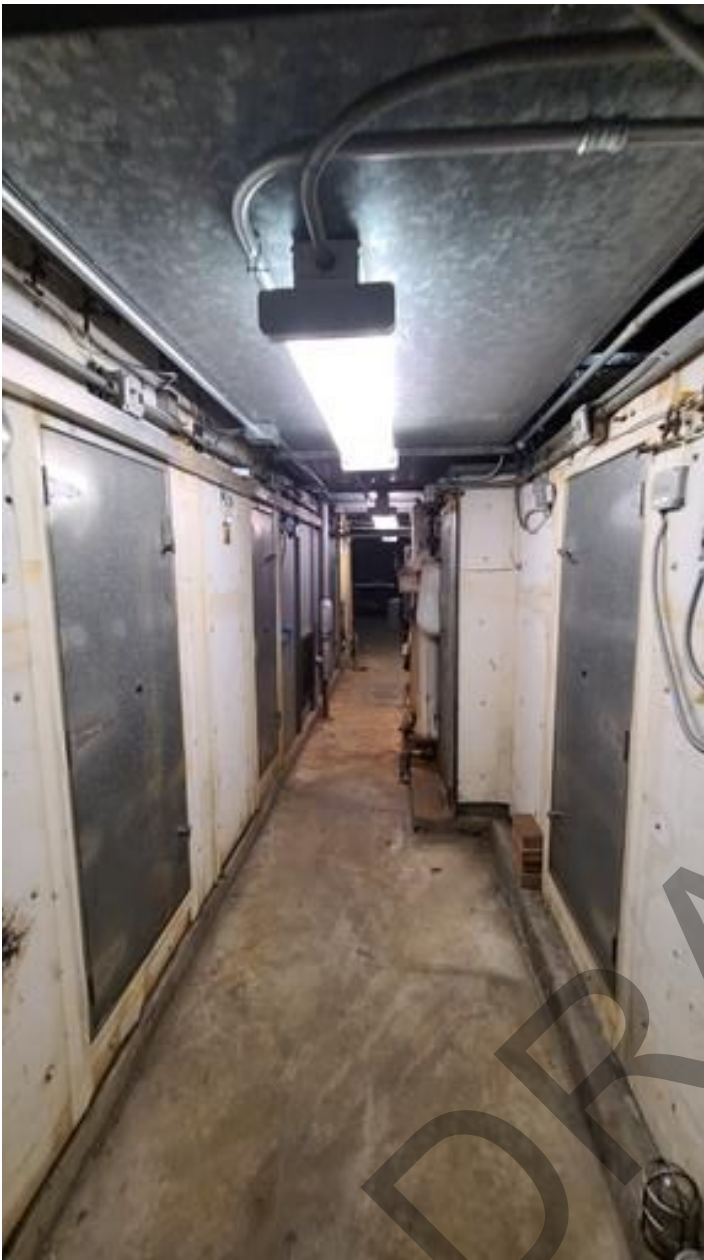
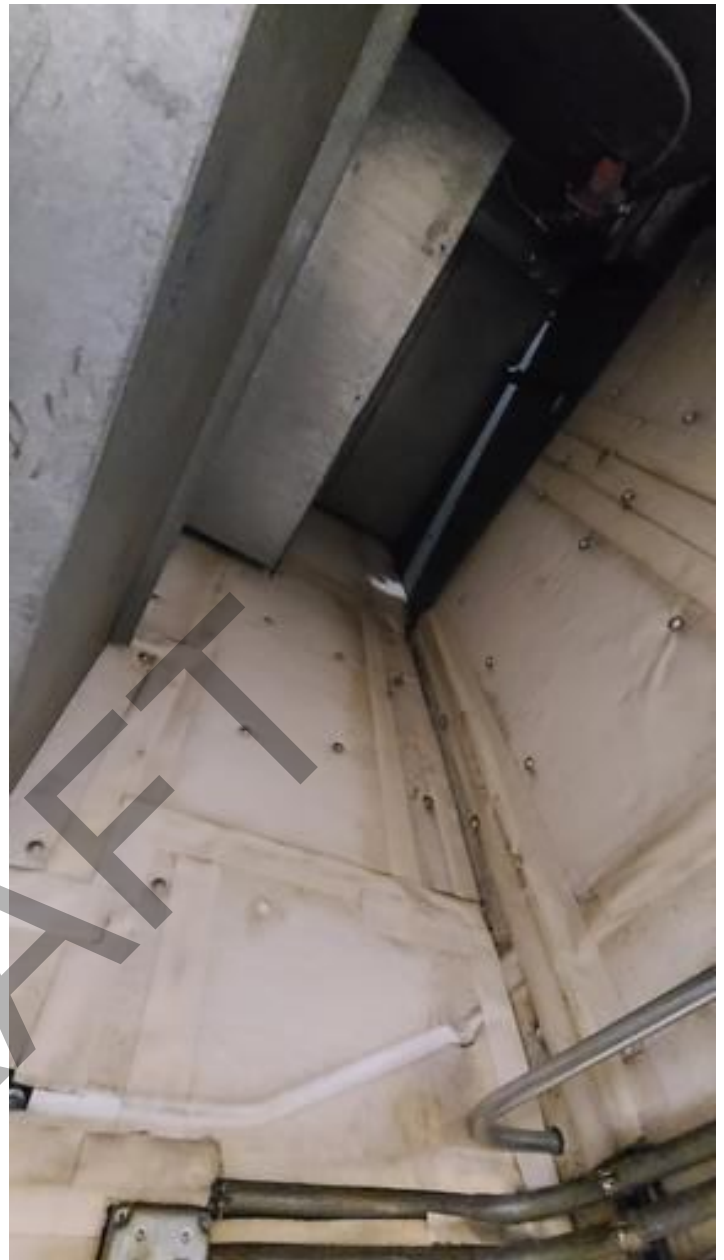
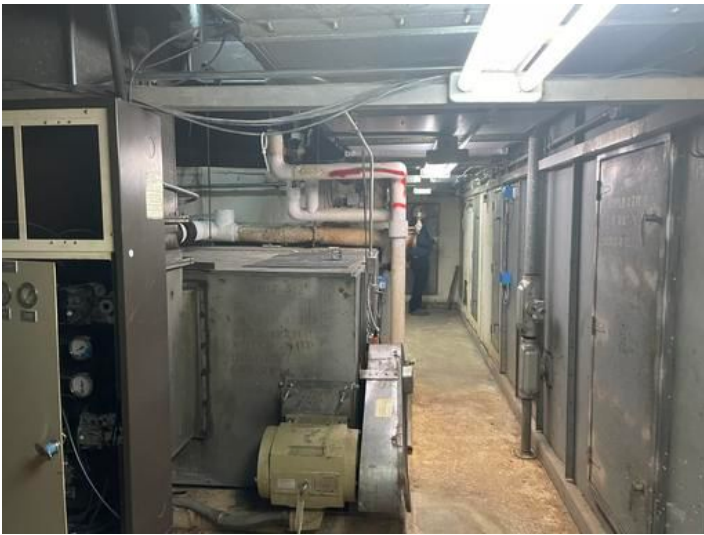
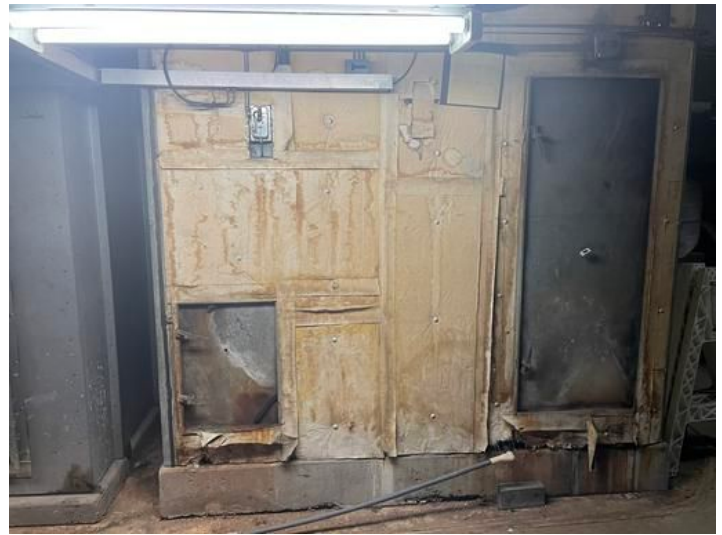
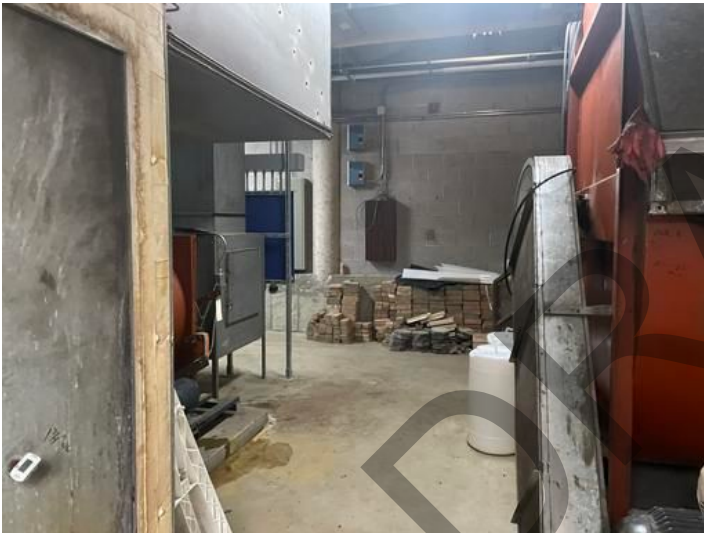
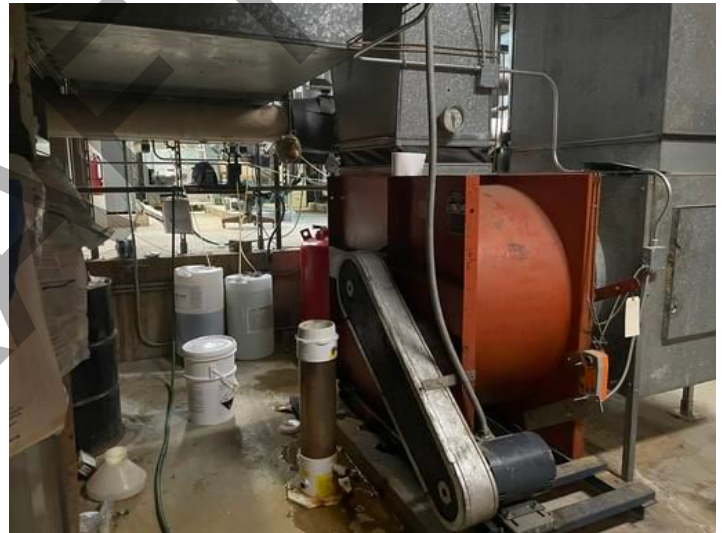
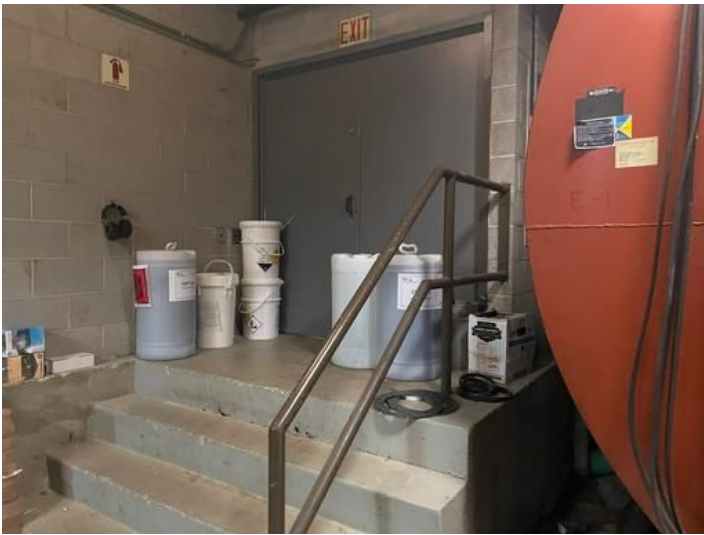
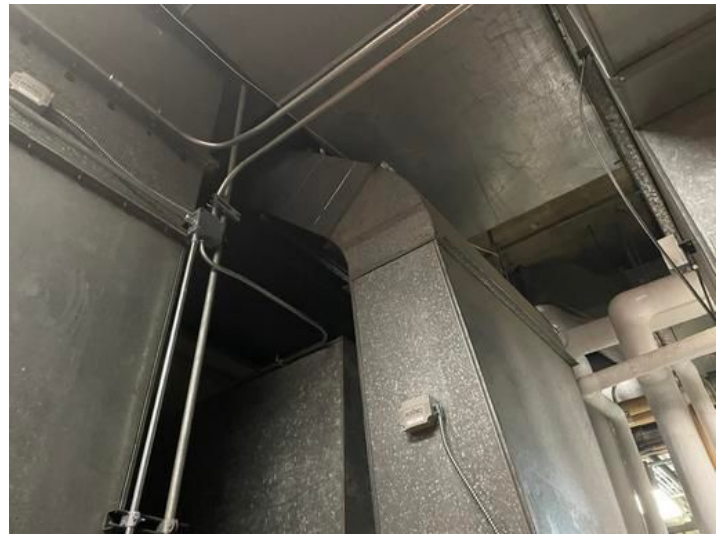
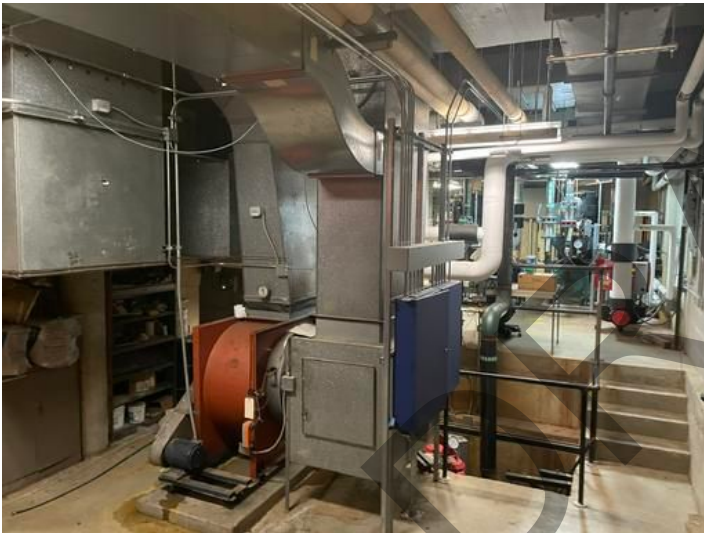
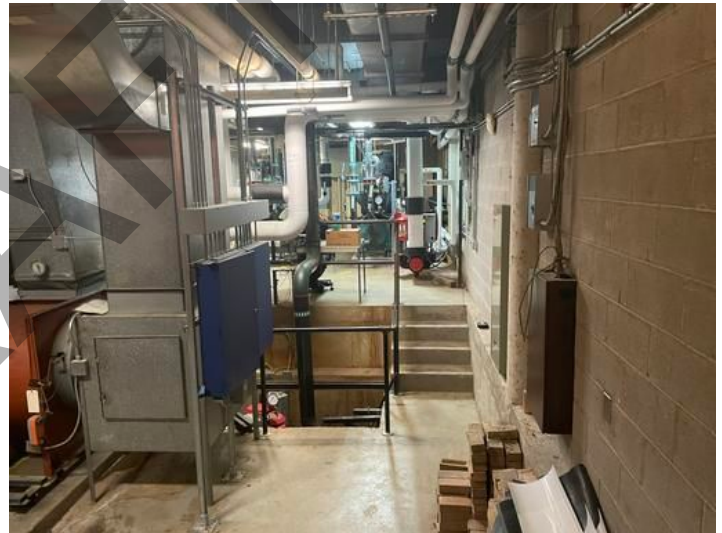
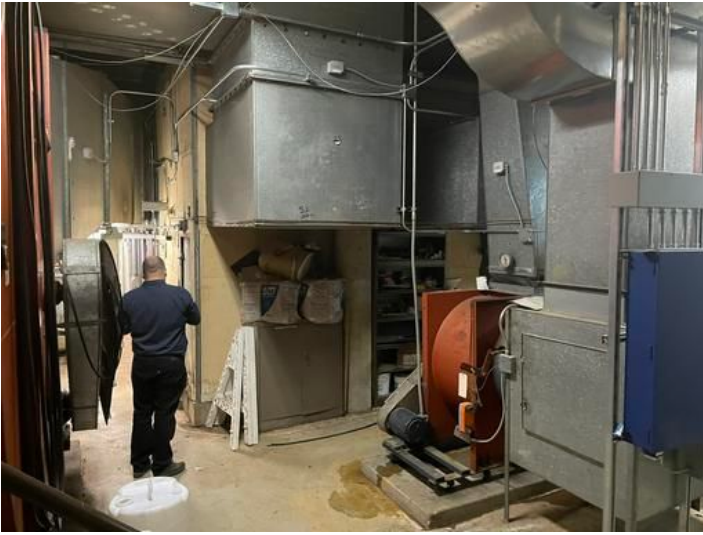
ID	#241
Pin	40
Status	 Open
Type	AG Architectural General > Architectural General

Description	Overall images of mechanical and HVAC equipment in larger area.
Assigned to	—
Created by	Gabriel David (Cordogan Clark)
Created on	Jun 23, 2023
Location	Village Hall - Lower Level
Location details	—
Due date	—
Start date	—
Placement	04 (Village Hall - Lower Level Plan)
Root cause	—

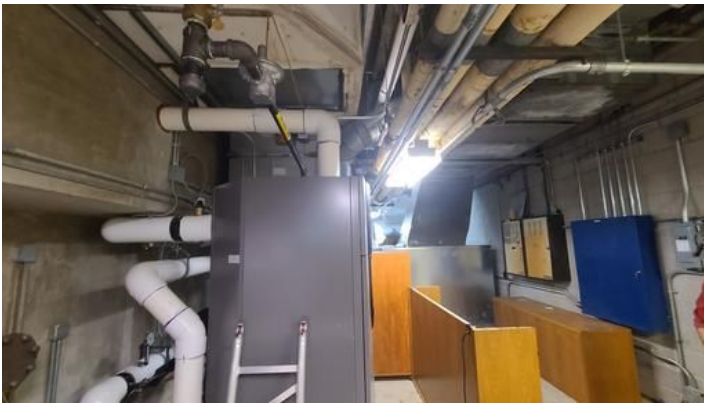
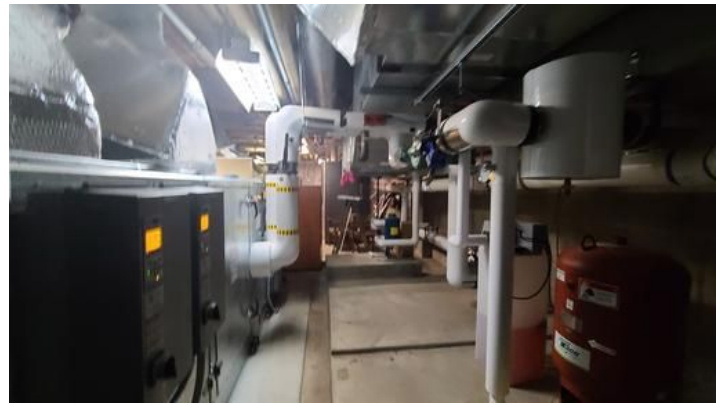
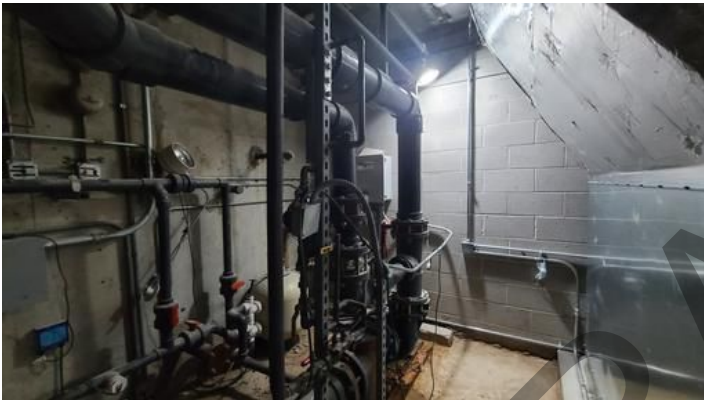
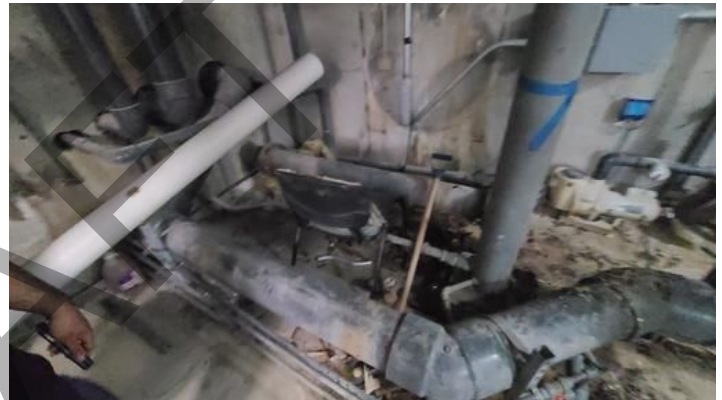
ID	#242
Pin	41
Status	<div></div> Open
Type	<div>AG</div> Architectural General > Architectural General

Description	Overall images of Mechanical Room.
Assigned to	—
Created by	Gabriel David (Cordogan Clark)
Created on	Jun 23, 2023
Location	Village Hall - Lower Level
Location details	—
Due date	—
Start date	—
Placement	04 (Village Hall - Lower Level Plan)
Root cause	—

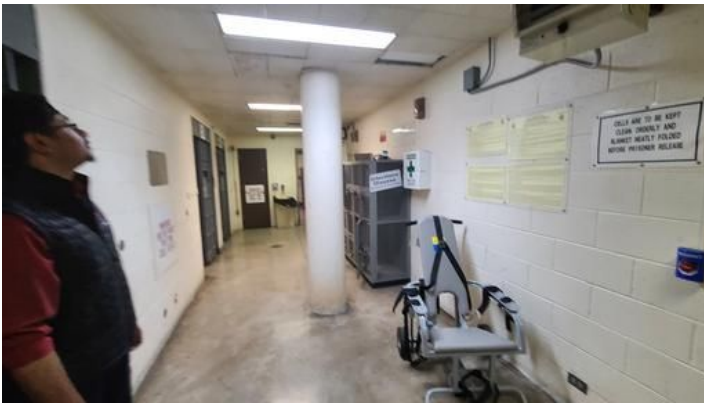
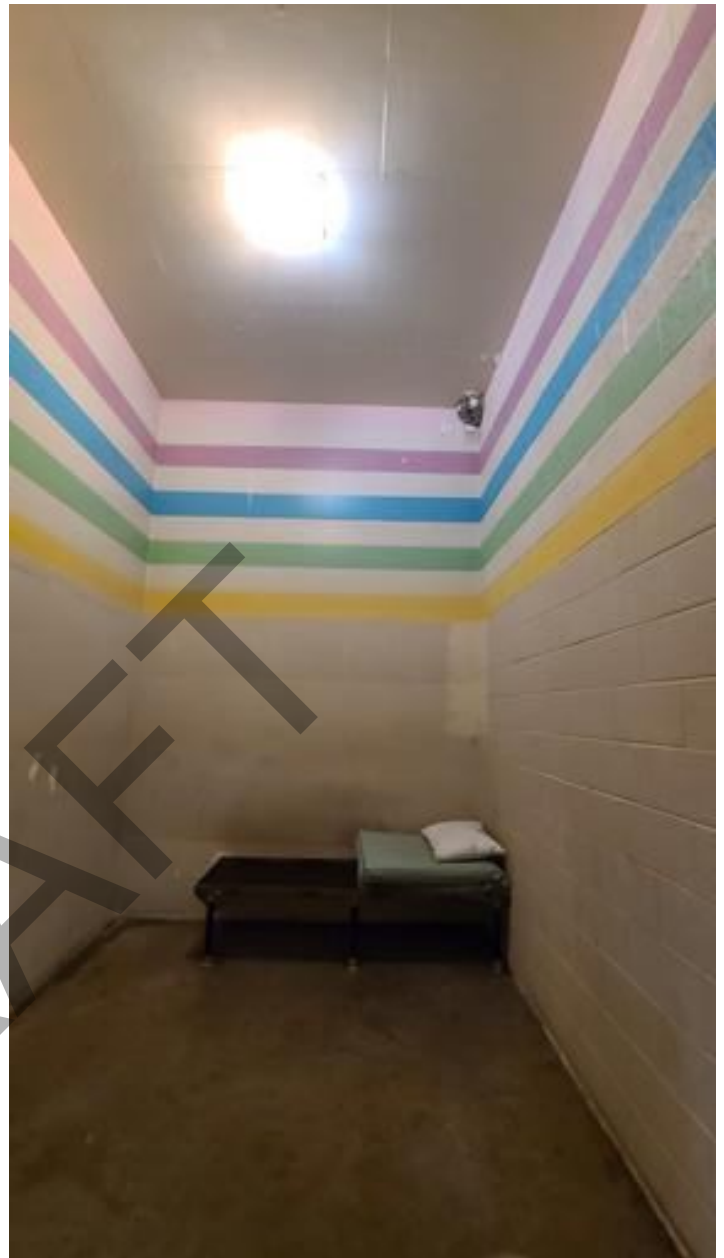
ID	#245
Pin	43
Status	<div>Open</div>
Type	<div>AG</div> Architectural General > Architectural General

Description	Overall general photos of typical lockup and hallway.
Assigned to	—
Created by	Gabriel David (Cordogan Clark)
Created on	Jun 23, 2023
Location	Village Hall - Lower Level
Location details	—
Due date	—
Start date	—
Placement	04 (Village Hall - Lower Level Plan)
Root cause	—

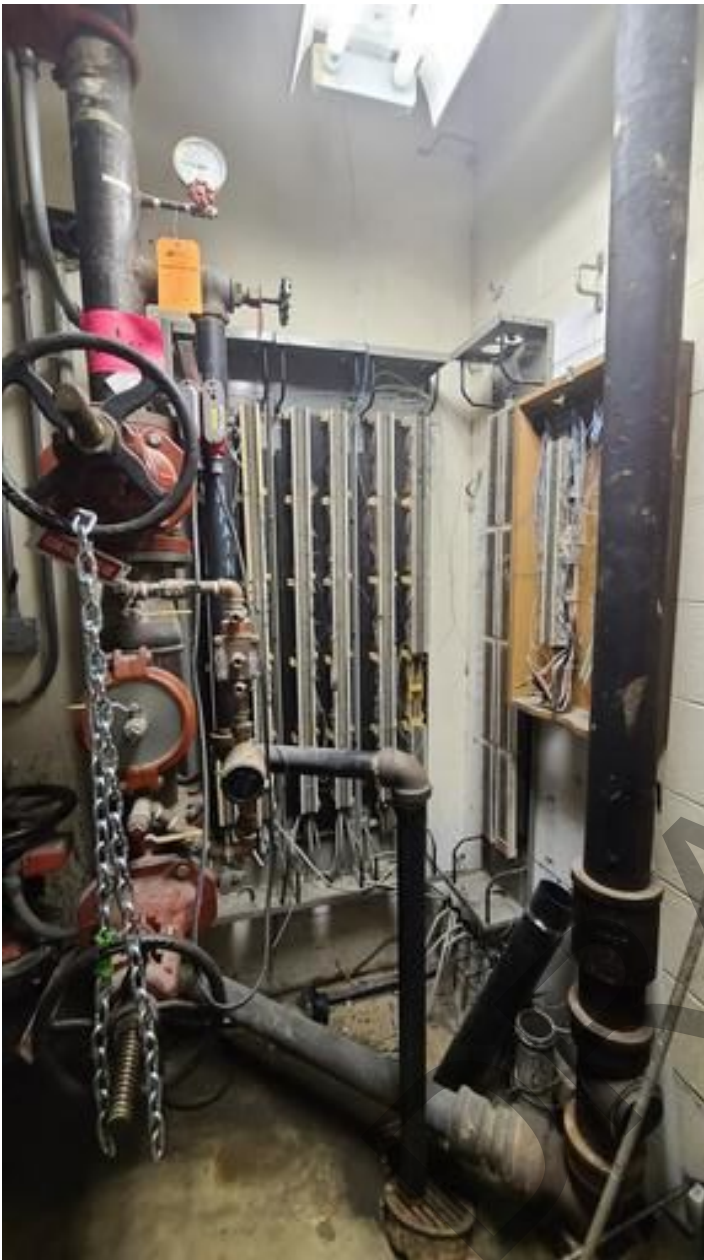
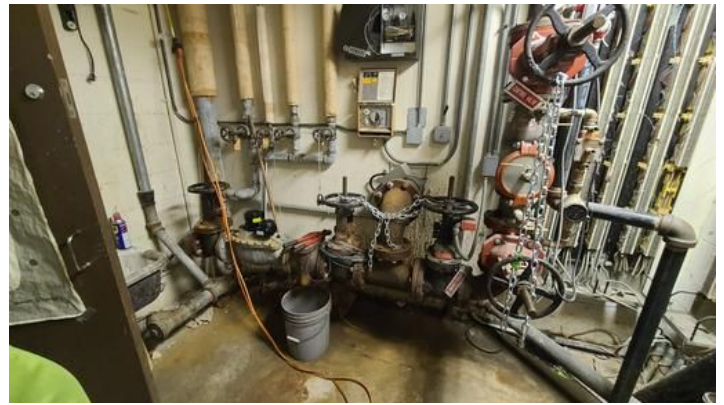
ID	#246
Pin	44
Status	<div><div></div>Open</div>
Type	<div><div>AG</div>Architectural General > Architectural General</div>

Description	Overall photos MEP equipment.
Assigned to	—
Created by	Gabriel David (Cordogan Clark)
Created on	Jun 23, 2023
Location	Village Hall - Lower Level
Location details	—
Due date	—
Start date	—
Placement	04 (Village Hall - Lower Level Plan)
Root cause	—

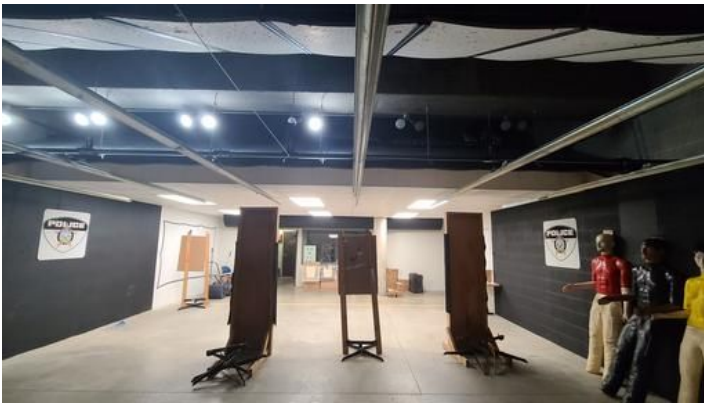
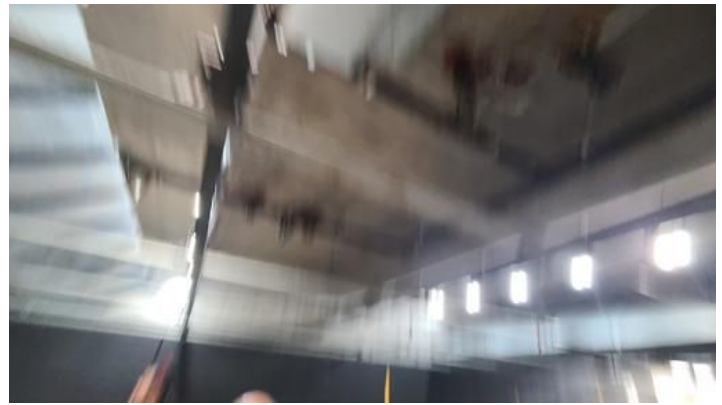
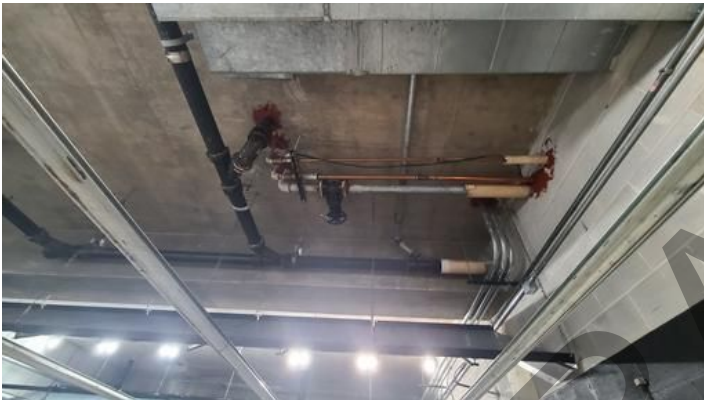
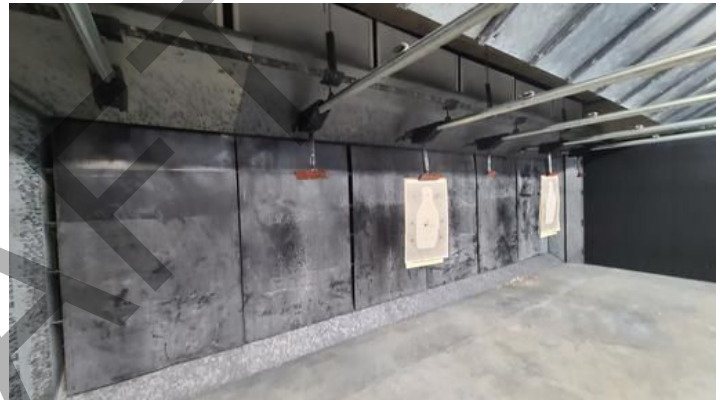
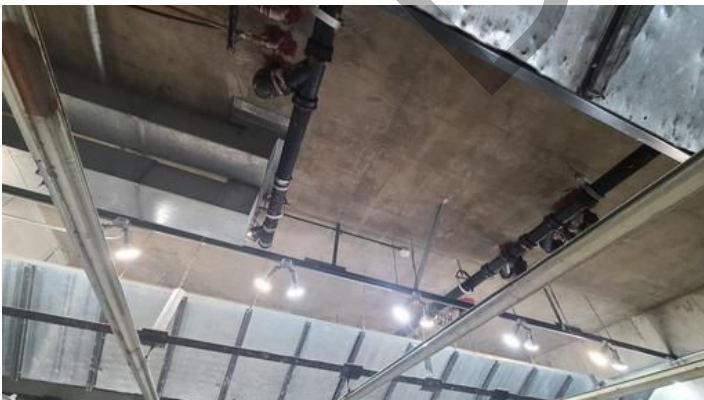
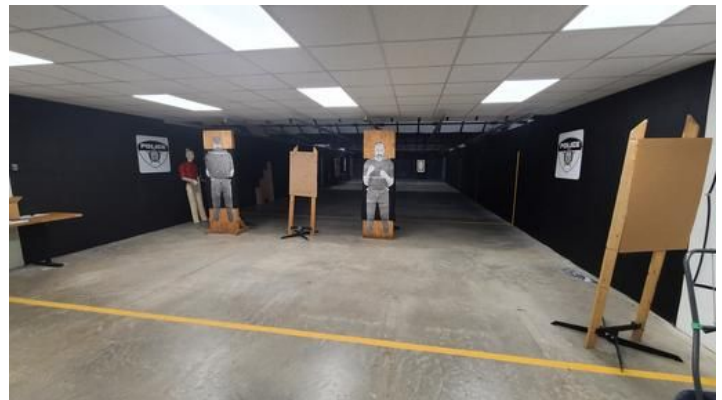
ID	#247
Pin	45
Status	■ Open
Type	AG Architectural General > Architectural General

Description	Overall images of Firing Range.
Assigned to	—
Created by	Gabriel David (Cordogan Clark)
Created on	Jun 23, 2023
Location	Village Hall - Lower Level
Location details	—
Due date	—
Start date	—
Placement	04 (Village Hall - Lower Level Plan)
Root cause	—

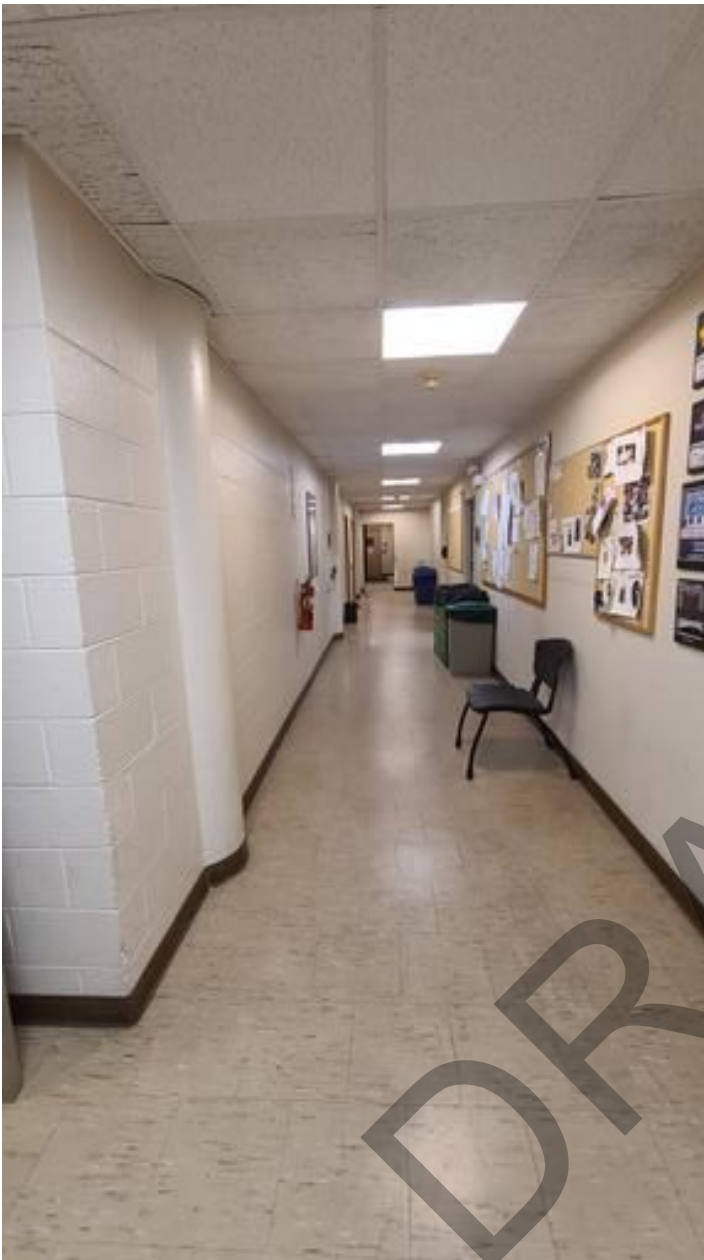
ID	#248
Pin	46
Status	■ Open
Type	AG Architectural General > Architectural General

Description	Overall photo of hallway.
Assigned to	—
Created by	Gabriel David (Cordogan Clark)
Created on	Jun 26, 2023
Location	Village Hall - Lower Level
Location details	—
Due date	—
Start date	—
Placement	04 (Village Hall - Lower Level Plan)
Root cause	—

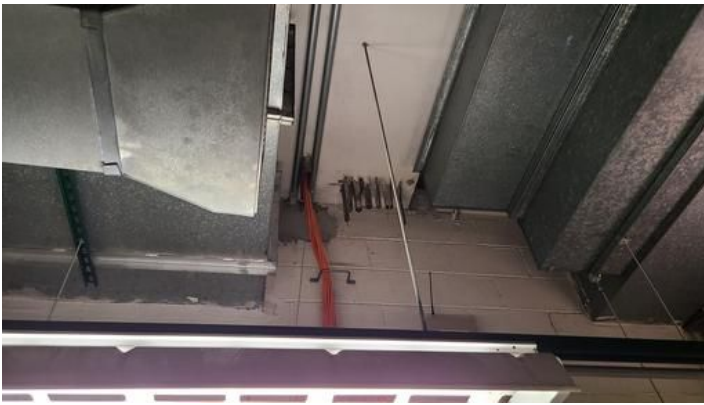
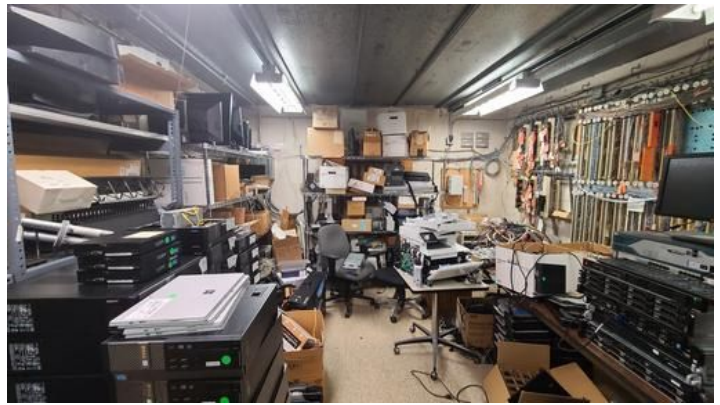
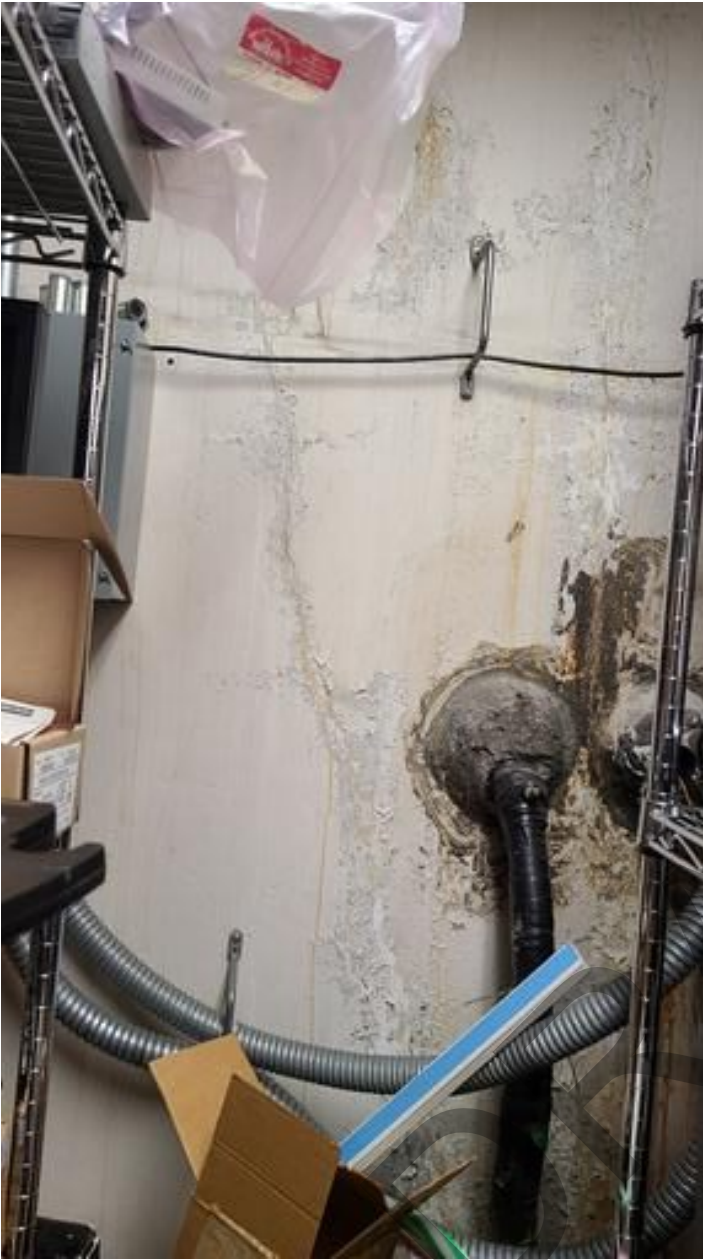
ID	#249
Pin	47
Status	■ Open
Type	AG Architectural General > Architectural General

Description	Overall photos of Telecom DMARC area.
Assigned to	—
Created by	Gabriel David (Cordogan Clark)
Created on	Jun 26, 2023
Location	Village Hall - Lower Level
Location details	—
Due date	—
Start date	—
Placement	04 (Village Hall - Lower Level Plan)
Root cause	—

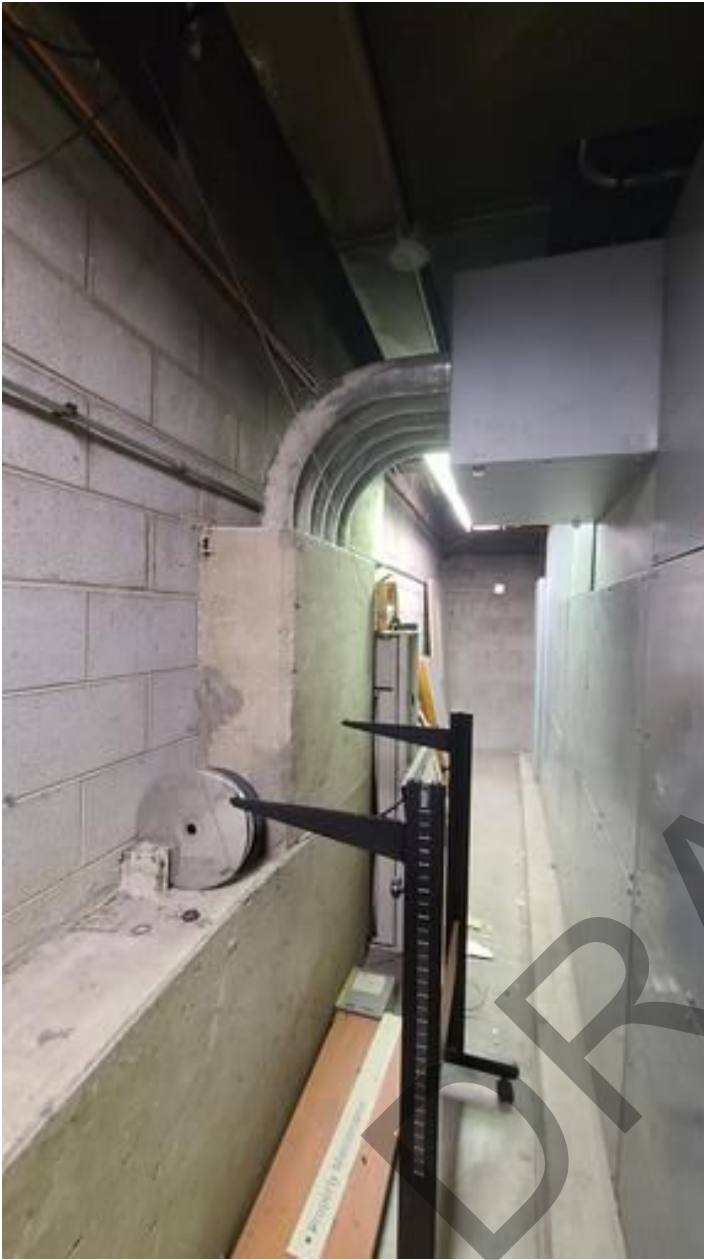
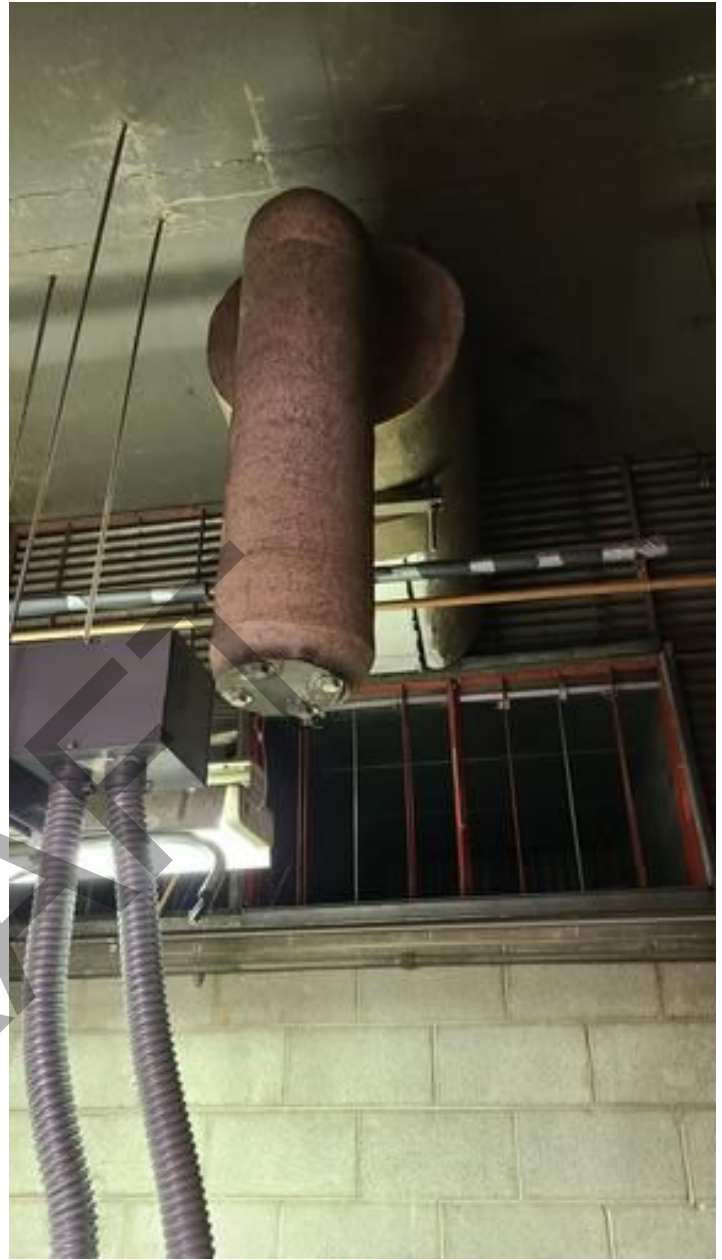
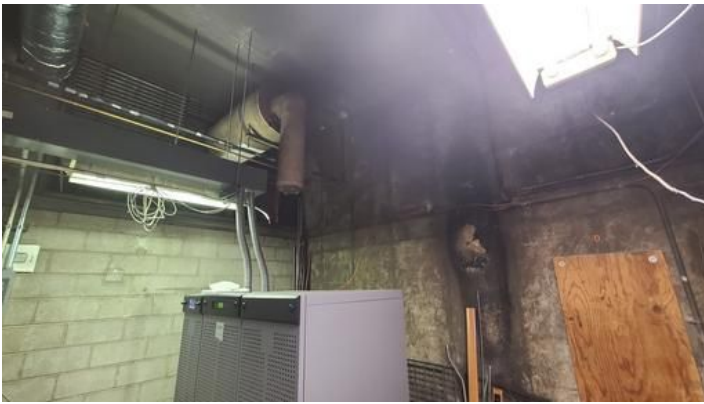
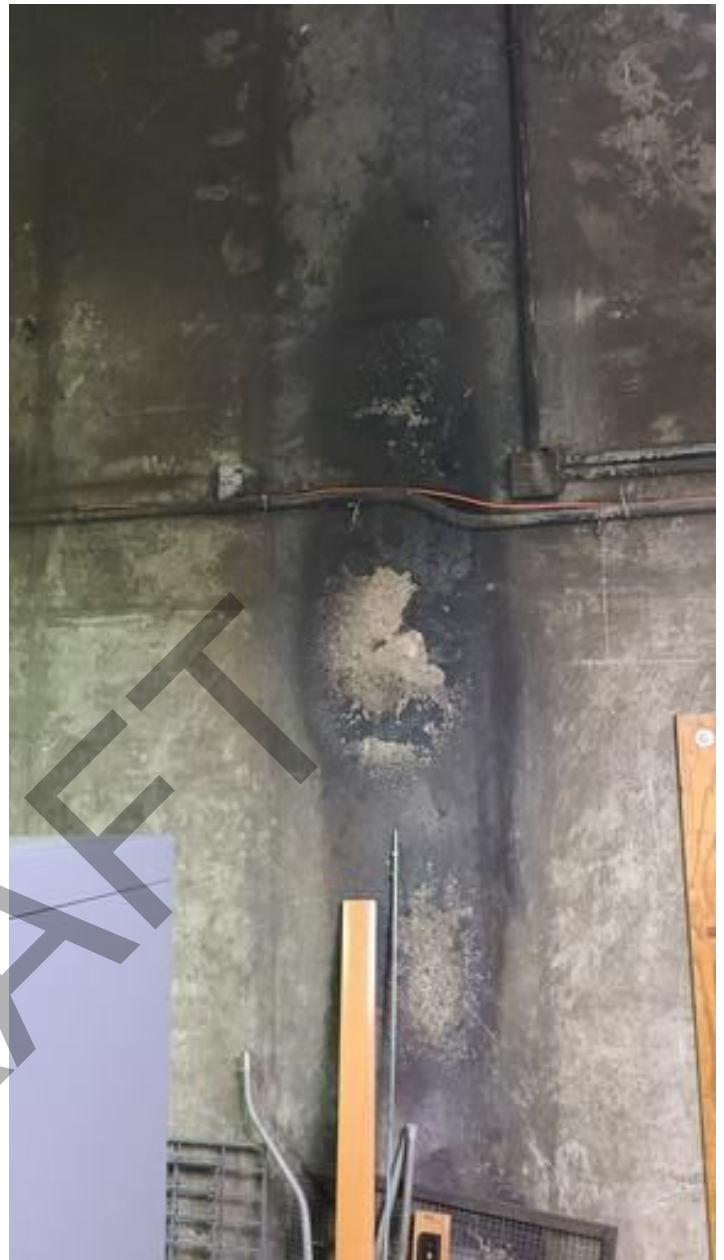
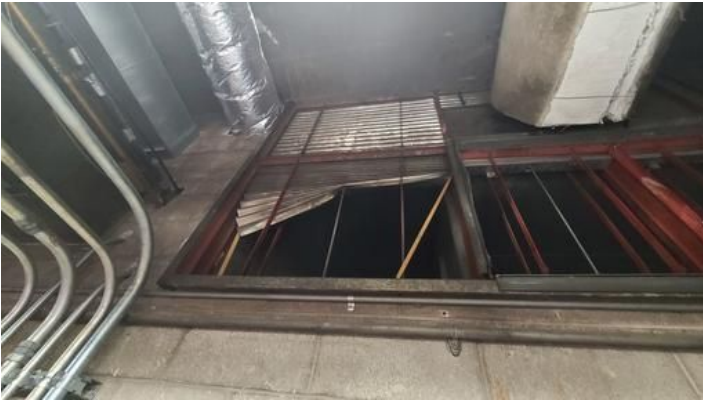
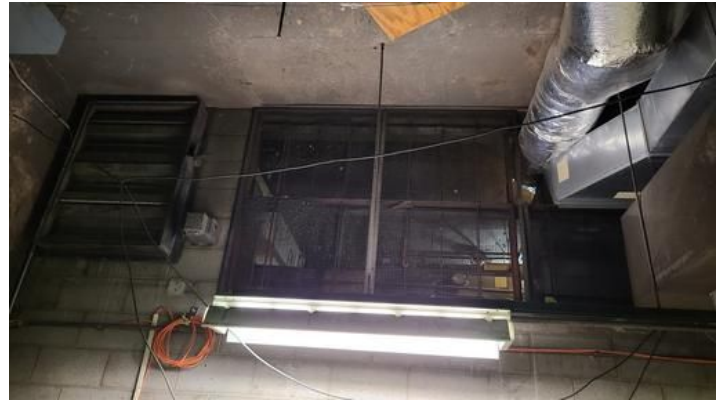
ID	#251
Pin	48
Status	 Open
Type	AG Architectural General > Architectural General

Description	Overall images on UPS area.
Assigned to	—
Created by	Gabriel David (Cordogan Clark)
Created on	Jun 26, 2023
Location	Village Hall - Lower Level
Location details	—
Due date	—
Start date	—
Placement	04 (Village Hall - Lower Level Plan)
Root cause	—

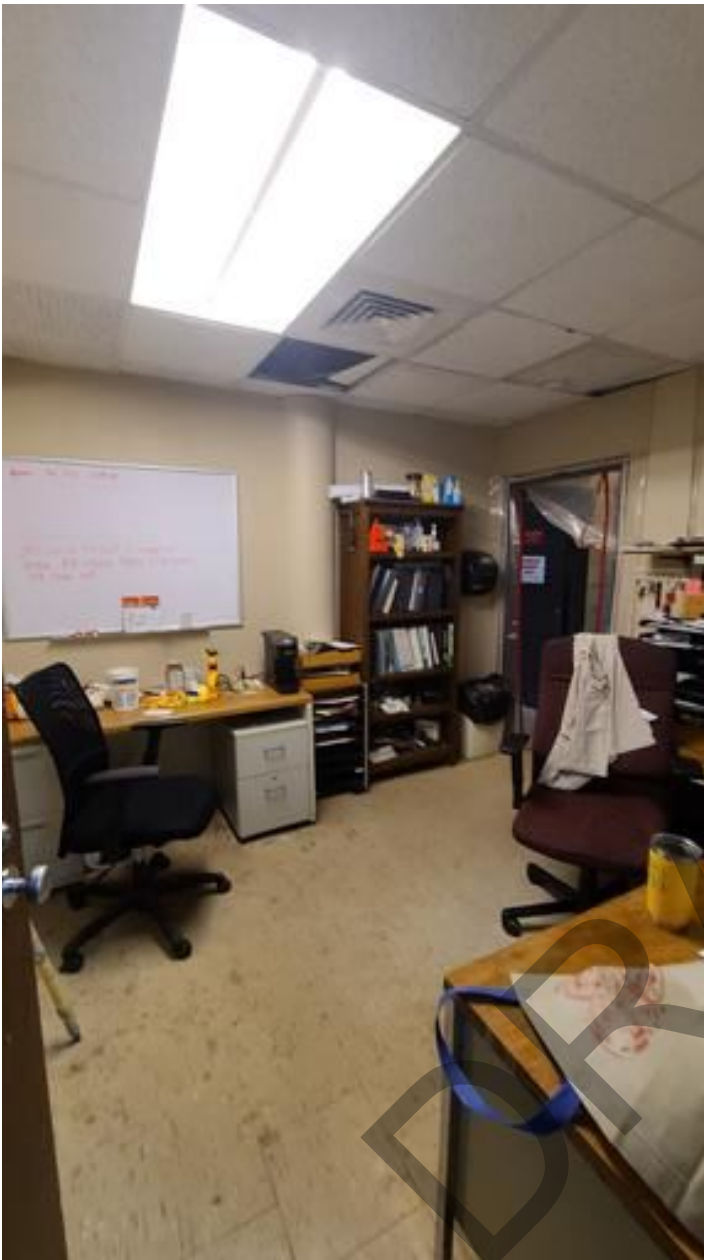
ID	#252
Pin	49
Status	<div></div> Open
Type	<div>AG</div> Architectural General > Architectural General

Description	Overall photo of Building Maintenance Office.
Assigned to	—
Created by	Gabriel David (Cordogan Clark)
Created on	Jun 26, 2023
Location	Village Hall - Lower Level
Location details	—
Due date	—
Start date	—
Placement	04 (Village Hall - Lower Level Plan)
Root cause	—

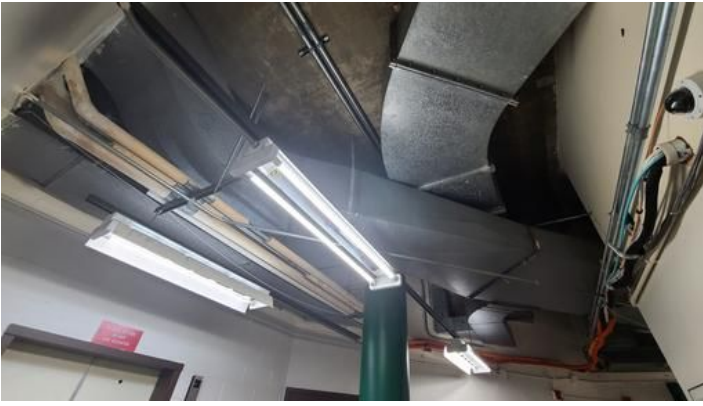
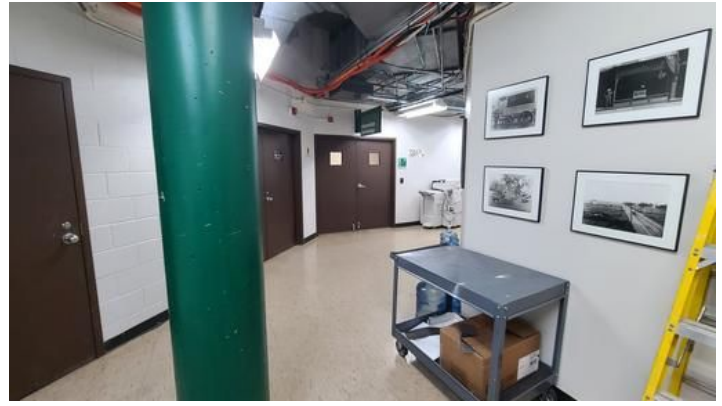
ID	#320
Pin	50
Status	 Open
Type	AG Architectural General > Architectural General

Description	Overall photos of ceiling and hallway.
Assigned to	—
Created by	Gabriel David (Cordogan Clark)
Created on	Jun 26, 2023
Location	Village Hall - Lower Level
Location details	—
Due date	—
Start date	—
Placement	04 (Village Hall - Lower Level Plan)
Root cause	—

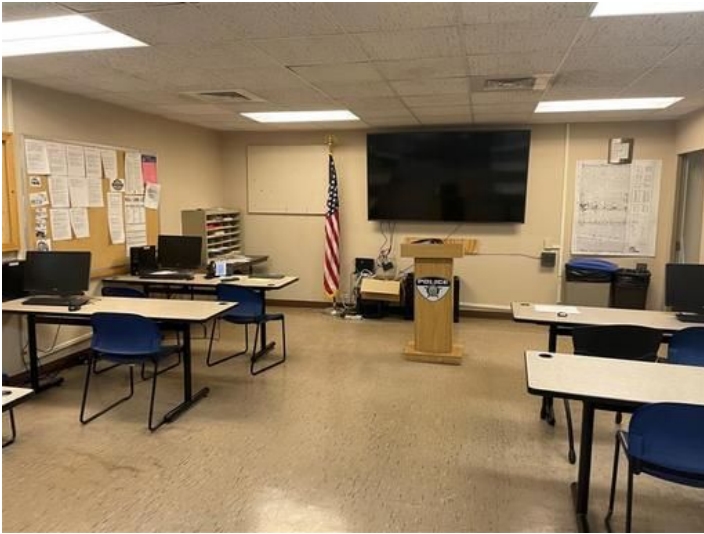
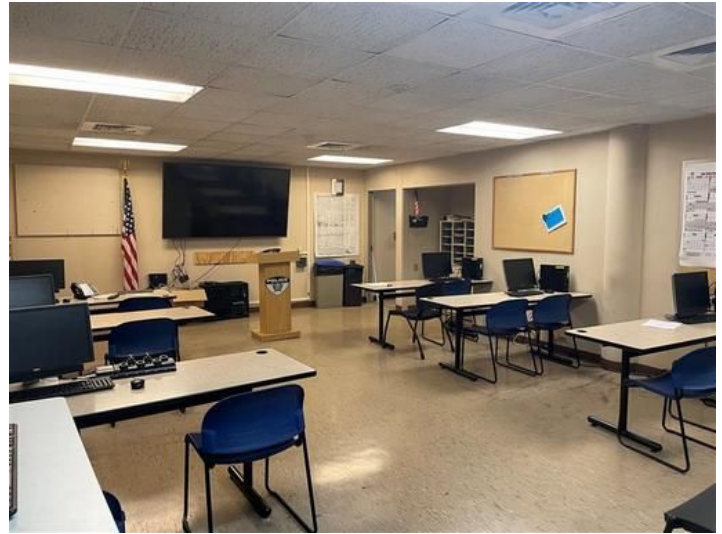
ID	#321
Pin	51
Status	 Open
Type	AG Architectural General > Architectural General

Description	Overall images of Roll Call area.
Assigned to	—
Created by	Gabriel David (Cordogan Clark)
Created on	Jun 26, 2023
Location	Village Hall - Lower Level
Location details	—
Due date	—
Start date	—
Placement	04 (Village Hall - Lower Level Plan)
Root cause	—

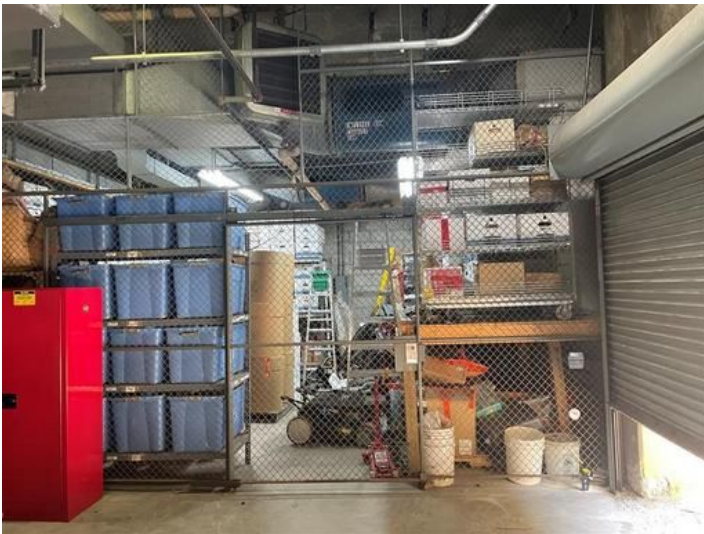
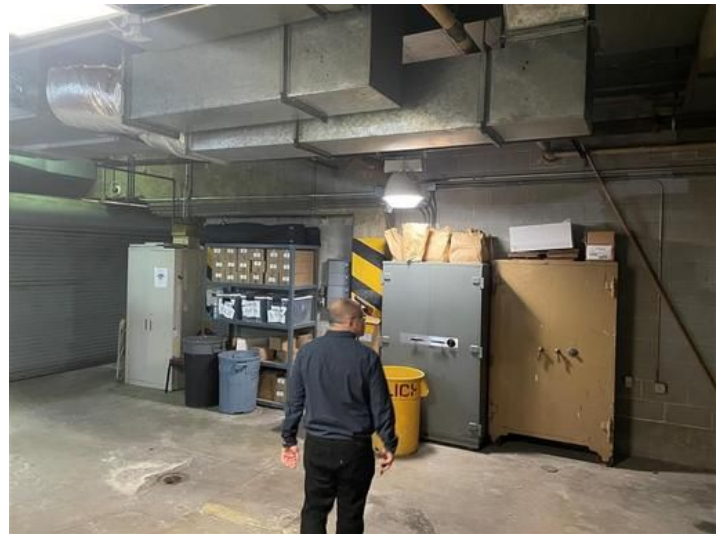
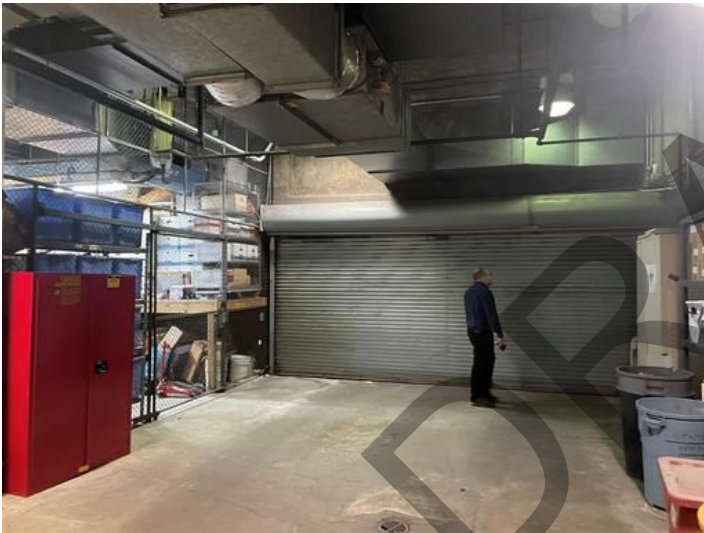
ID	#322
Pin	52
Status	■ Open
Type	AG Architectural General > Architectural General

Description	Overall photos of Sally Port area and garage door.
Assigned to	—
Created by	Gabriel David (Cordogan Clark)
Created on	Jun 26, 2023
Location	Village Hall - Lower Level
Location details	—
Due date	—
Start date	—
Placement	04 (Village Hall - Lower Level Plan)
Root cause	—
