**OAK PARK VILLAGE HALL
123 Madison Street, Oak Park IL. 60302**

**PROPERTY CONDITION ASSESSMENT REPORT
07.08.23**

Property Condition Assessment Report

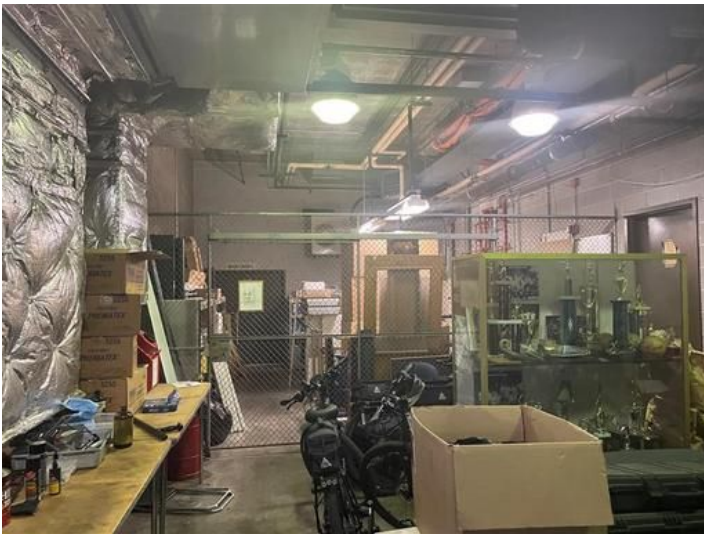
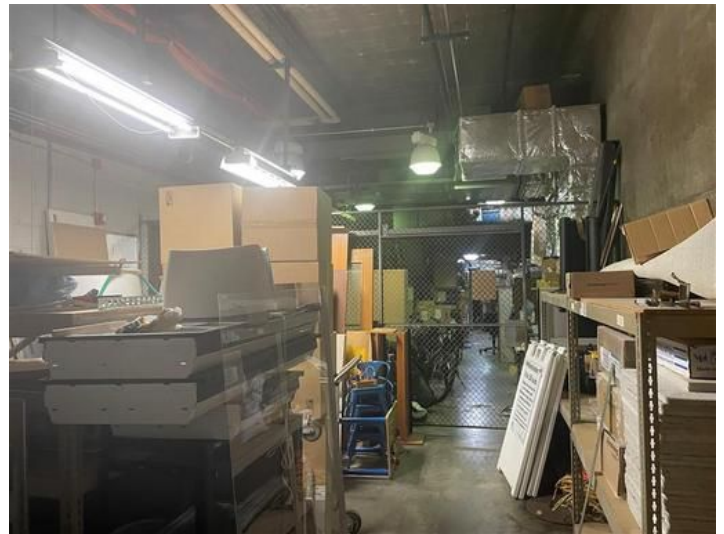
Description	Overall photos of Sall Port storage areas.
Assigned to	—
Created by	Gabriel David (Cordogan Clark)
Created on	Jun 26, 2023
Location	Village Hall - Lower Level
Location details	—
Due date	—
Start date	—
Placement	04 (Village Hall - Lower Level Plan)
Root cause	—

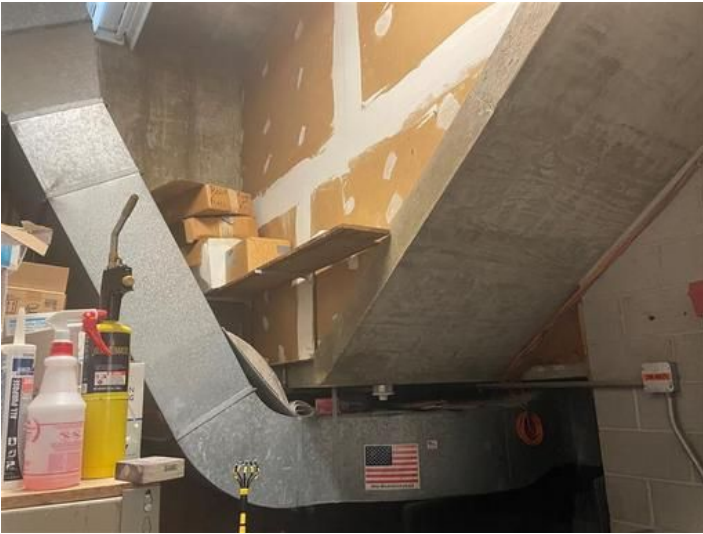
ID	#323
Pin	53
Status	■ Open
Type	AG Architectural General > Architectural General

Description	Overall photo of duct work and storage beneath stairs.
Assigned to	—
Created by	Gabriel David (Cordogan Clark)
Created on	Jun 26, 2023
Location	Village Hall - Lower Level
Location details	—
Due date	—
Start date	—
Placement	04 (Village Hall - Lower Level Plan)
Root cause	—

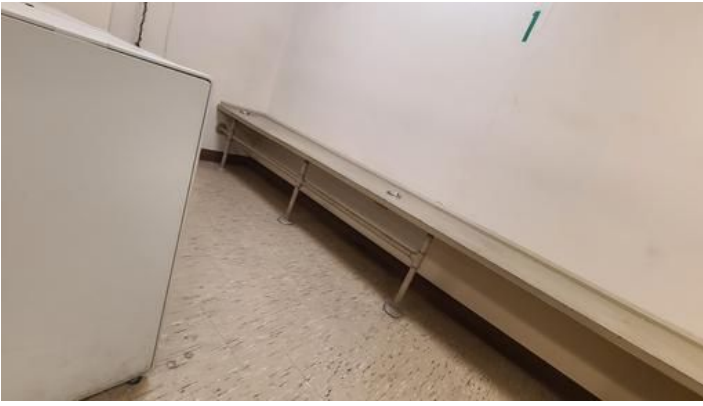
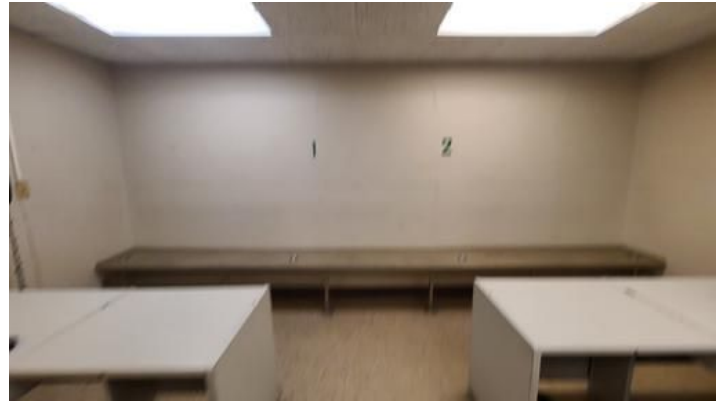
ID	#324
Pin	54
Status	<div>Open</div>
Type	<div>AG</div> Architectural General > Architectural General

Description	Overall images of Report Room.
Assigned to	—
Created by	Gabriel David (Cordogan Clark)
Created on	Jun 26, 2023
Location	Village Hall - Lower Level
Location details	—
Due date	—
Start date	—
Placement	04 (Village Hall - Lower Level Plan)
Root cause	—

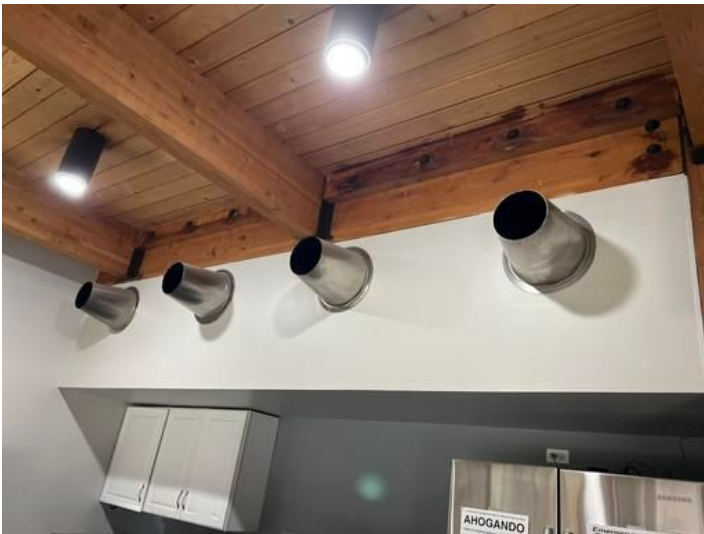
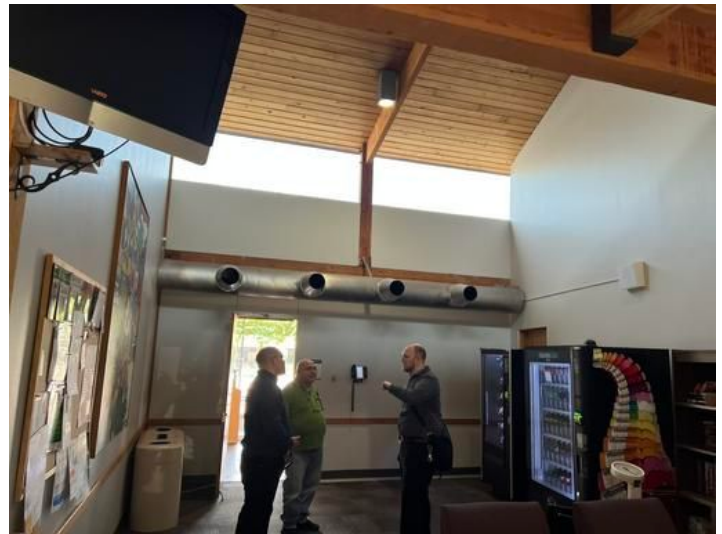
ID	#157
Pin	55
Status	<div>Open</div>
Type	<div>MG</div> Mechanical General > Mechanical General

Description	Overall images of ducts.
Assigned to	—
Created by	Gabriel David (Cordogan Clark)
Created on	Jun 21, 2023
Location	Village Hall - First Floor
Location details	—
Due date	—
Start date	—
Placement	05 (Village Hall - First Floor Plan)
Root cause	—

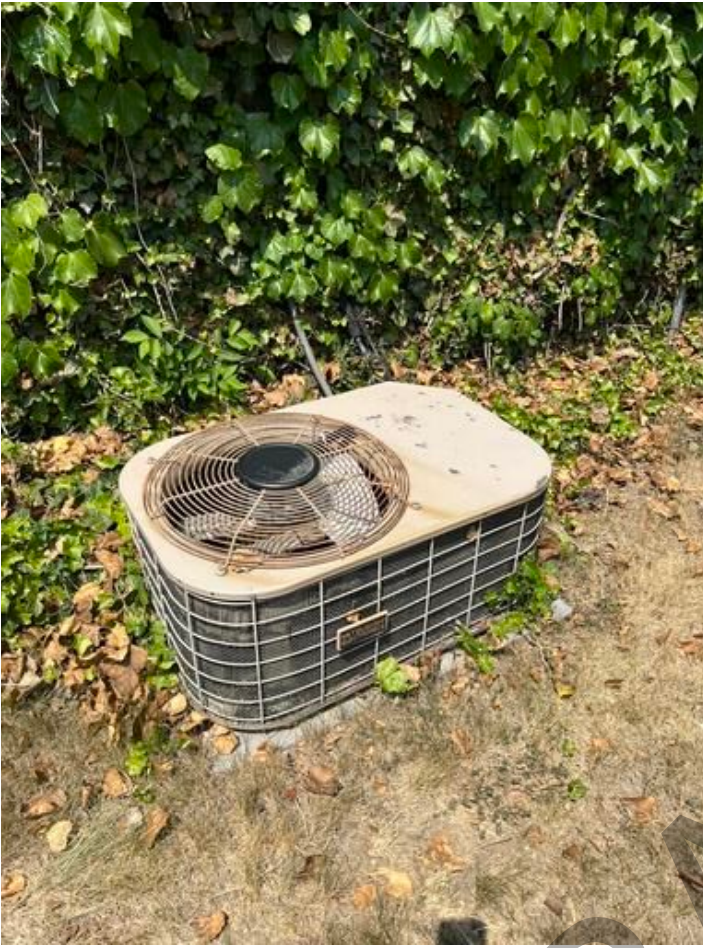
ID	#163
Pin	56
Status	<div></div> Open
Type	<div>EG</div> Electrical General > Electrical General

Description	Overall image of HVAC unit.
Assigned to	—
Created by	Gabriel David (Cordogan Clark)
Created on	Jun 21, 2023
Location	Village Hall - First Floor
Location details	—
Due date	—
Start date	—
Placement	05 (Village Hall - First Floor Plan)
Root cause	—

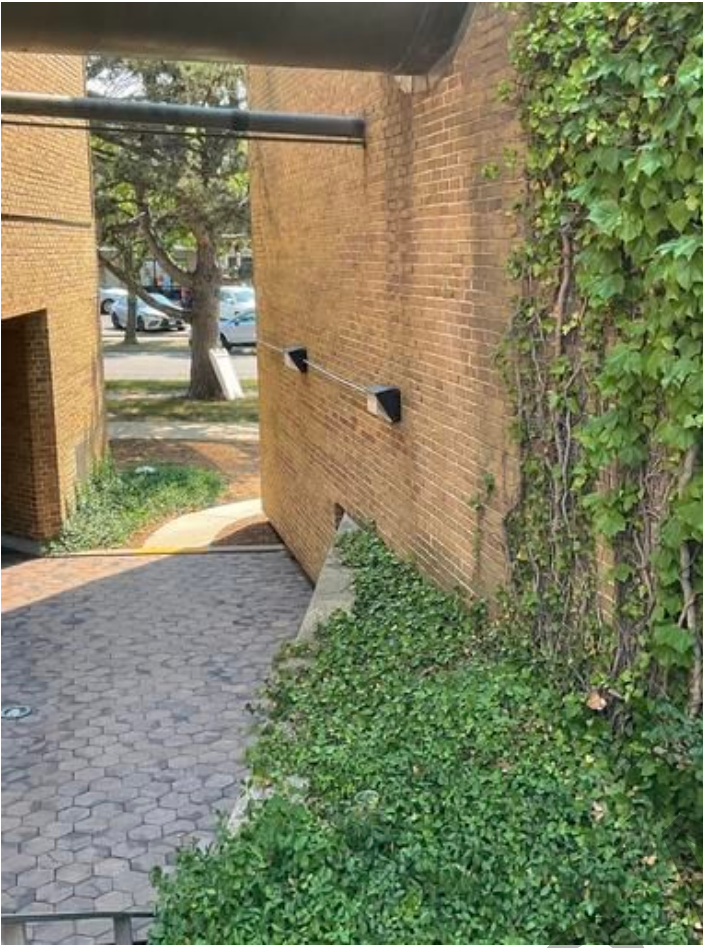
ID	#359
Pin	57
Status	<div></div> Open
Type	<div>EG</div> Electrical General > Electrical General

Description	Overall photo of exterior lighting.
Assigned to	—
Created by	Gabriel David (Cordogan Clark)
Created on	Jun 30, 2023
Location	Village Hall - First Floor
Location details	—
Due date	—
Start date	—
Placement	05 (Village Hall - First Floor Plan)
Root cause	—

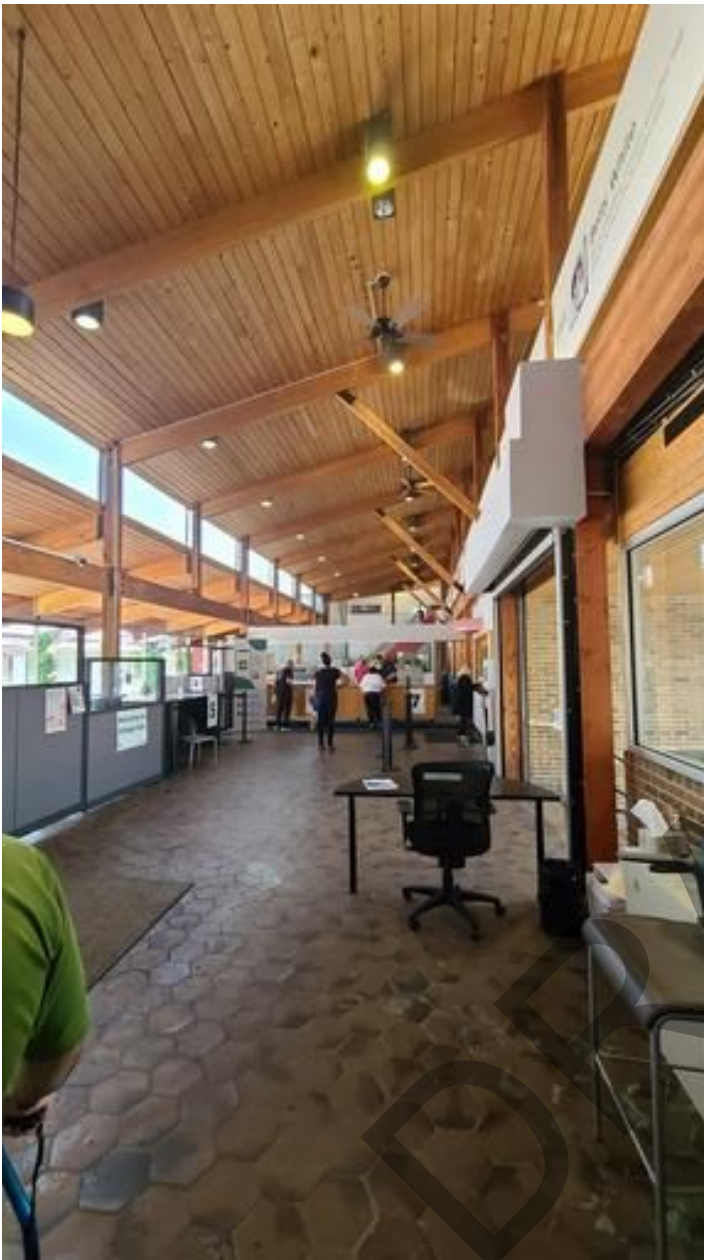
ID	#254
Pin	58
Status	 Open
Type	AG Architectural General > Architectural General

Description	Overall image of main lobby.
Assigned to	—
Created by	Gabriel David (Cordogan Clark)
Created on	Jun 26, 2023
Location	Village Hall - First Floor
Location details	—
Due date	—
Start date	—
Placement	05 (Village Hall - First Floor Plan)
Root cause	—

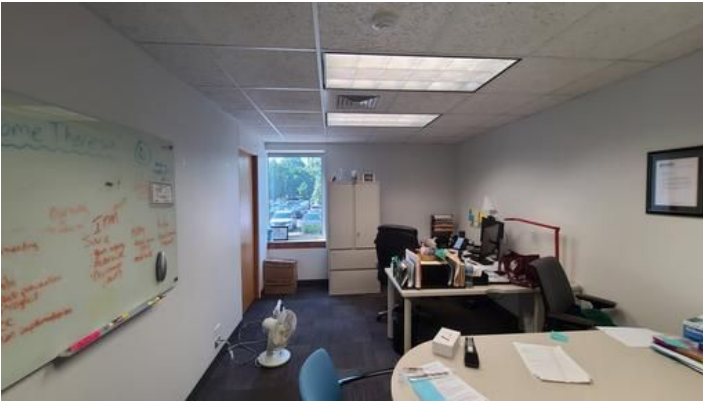
ID	#256
Pin	59
Status	<div></div> Open
Type	<div>AG</div> Architectural General > Architectural General

Description	Overall photo of office.
Assigned to	—
Created by	Gabriel David (Cordogan Clark)
Created on	Jun 26, 2023
Location	Village Hall - First Floor
Location details	—
Due date	—
Start date	—
Placement	05 (Village Hall - First Floor Plan)
Root cause	—

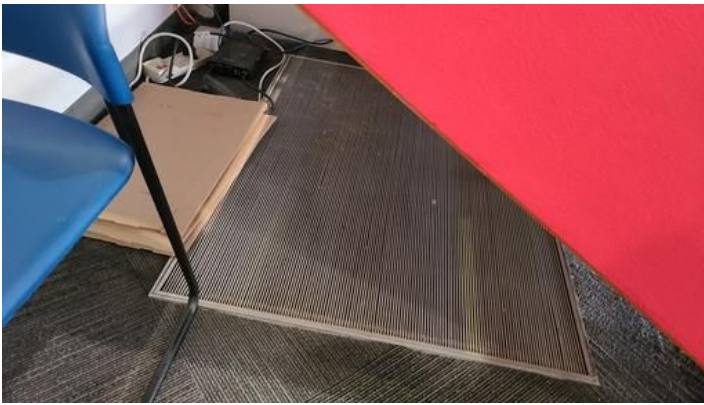
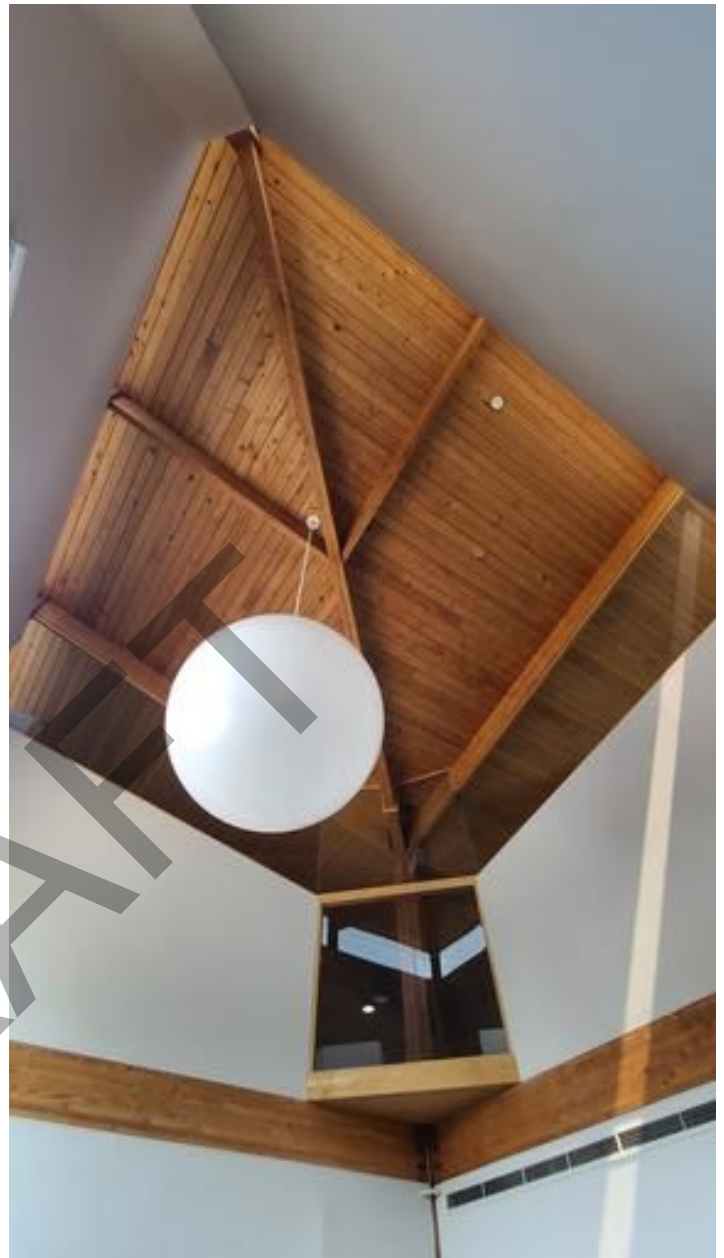
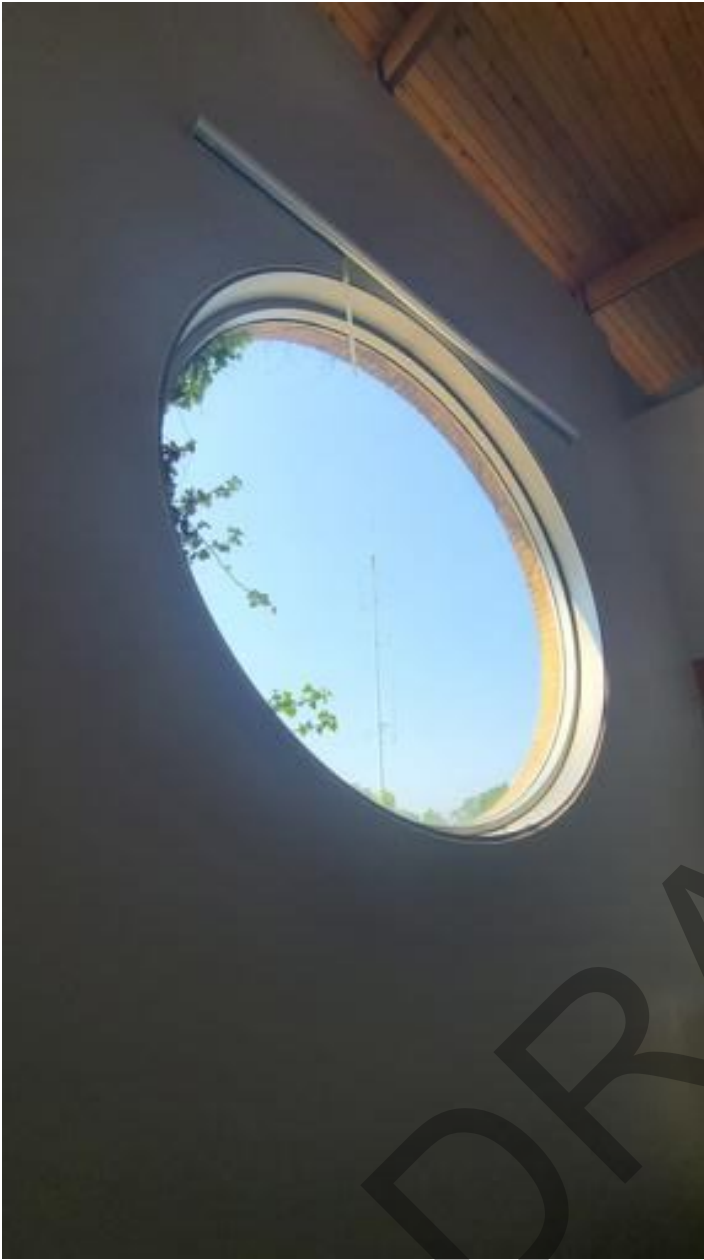
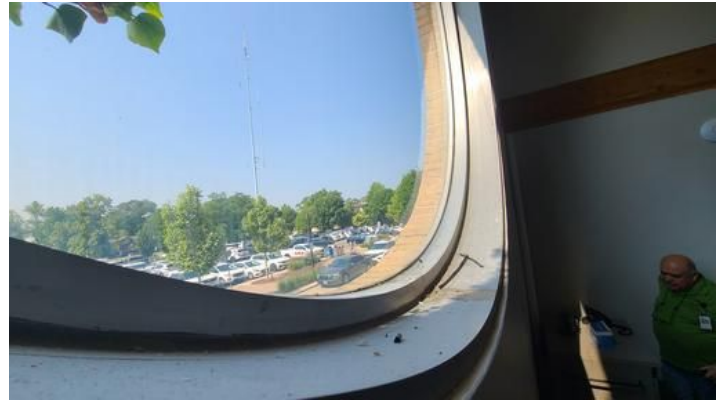
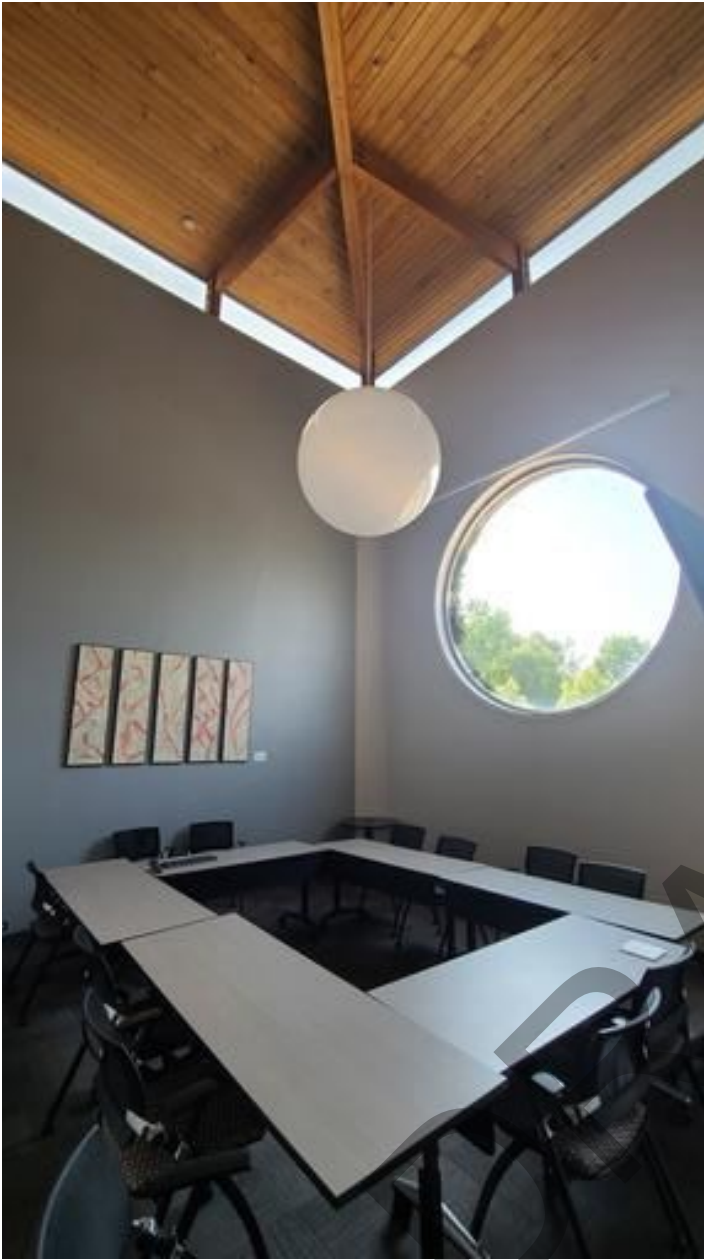
ID	#257
Pin	60
Status	 Open
Type	AG Architectural General > Architectural General

Description	Overall images of Parking Conference Room.
Assigned to	—
Created by	Gabriel David (Cordogan Clark)
Created on	Jun 26, 2023
Location	Village Hall - First Floor
Location details	—
Due date	—
Start date	—
Placement	05 (Village Hall - First Floor Plan)
Root cause	—

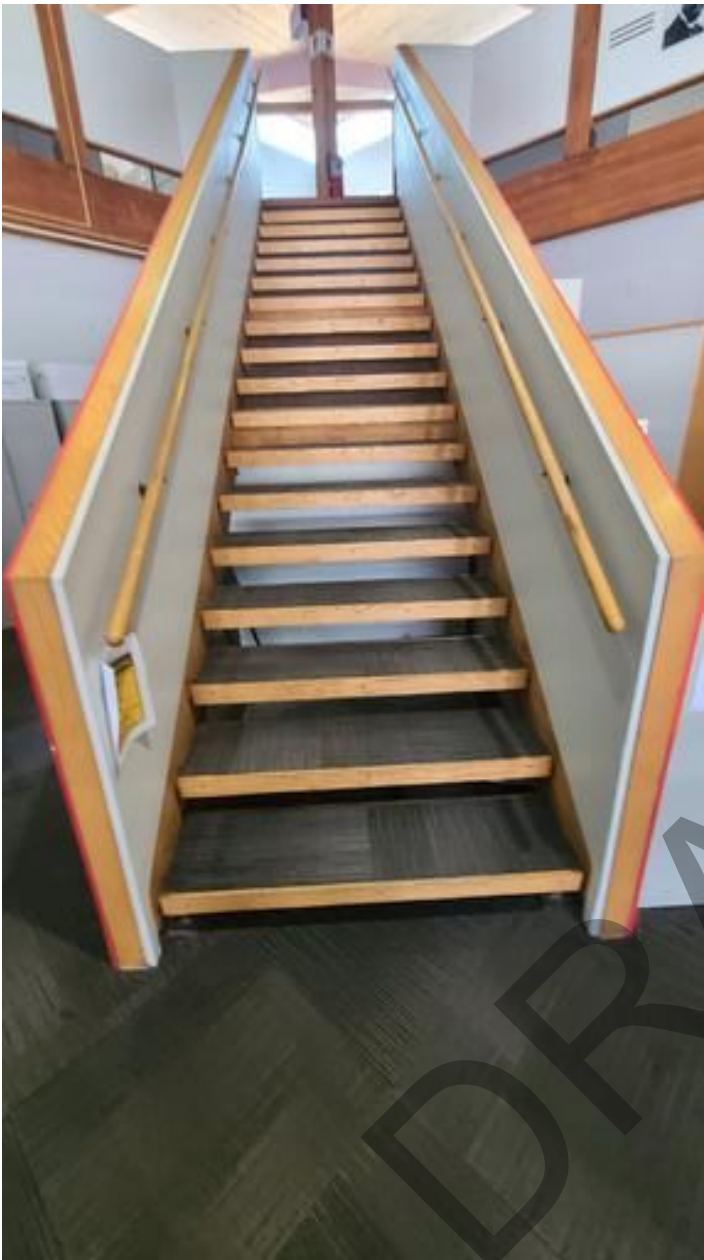
ID	#258
Pin	61
Status	 Open
Type	AG Architectural General > Architectural General

Description	Overall image of typical unenclosed stair up to the mezzanine level.
Assigned to	—
Created by	Gabriel David (Cordogan Clark)
Created on	Jun 26, 2023
Location	Village Hall - First Floor
Location details	—
Due date	—
Start date	—
Placement	05 (Village Hall - First Floor Plan)
Root cause	—

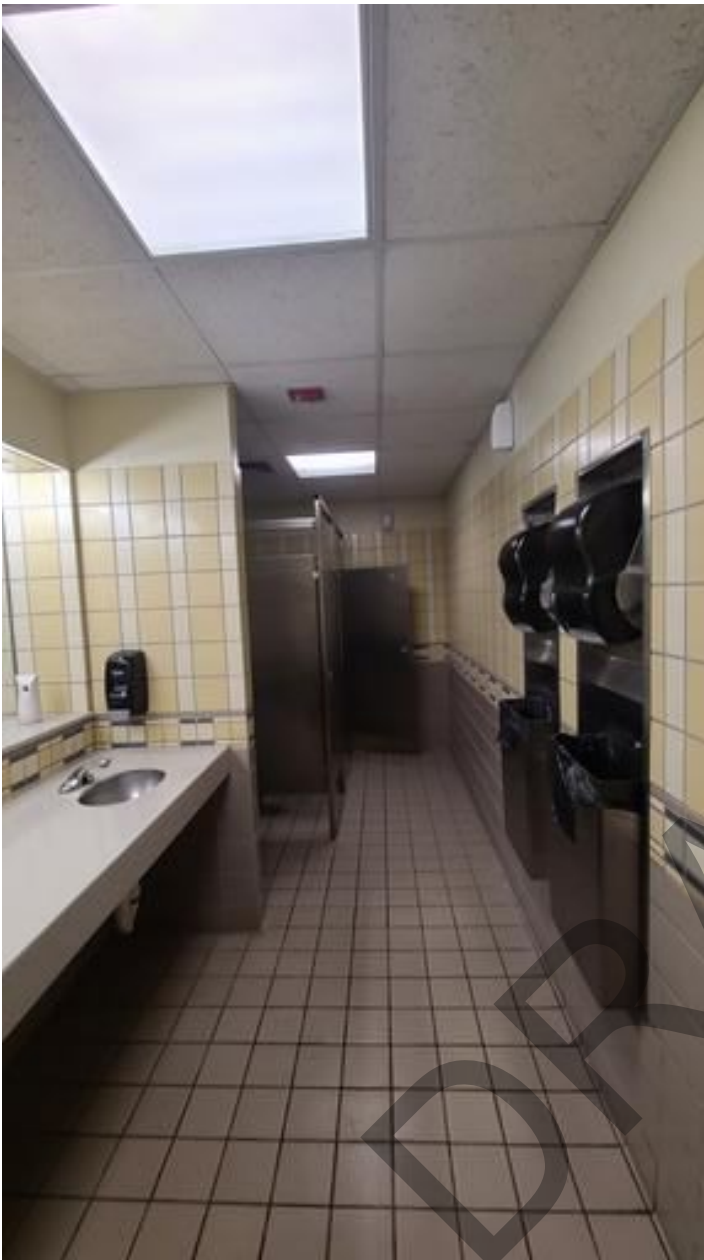
ID	#259
Pin	62
Status	 Open
Type	AG Architectural General > Architectural General

Description	Overall image of Men's Toilet.
Assigned to	—
Created by	Gabriel David (Cordogan Clark)
Created on	Jun 26, 2023
Location	Village Hall - First Floor
Location details	—
Due date	—
Start date	—
Placement	05 (Village Hall - First Floor Plan)
Root cause	—

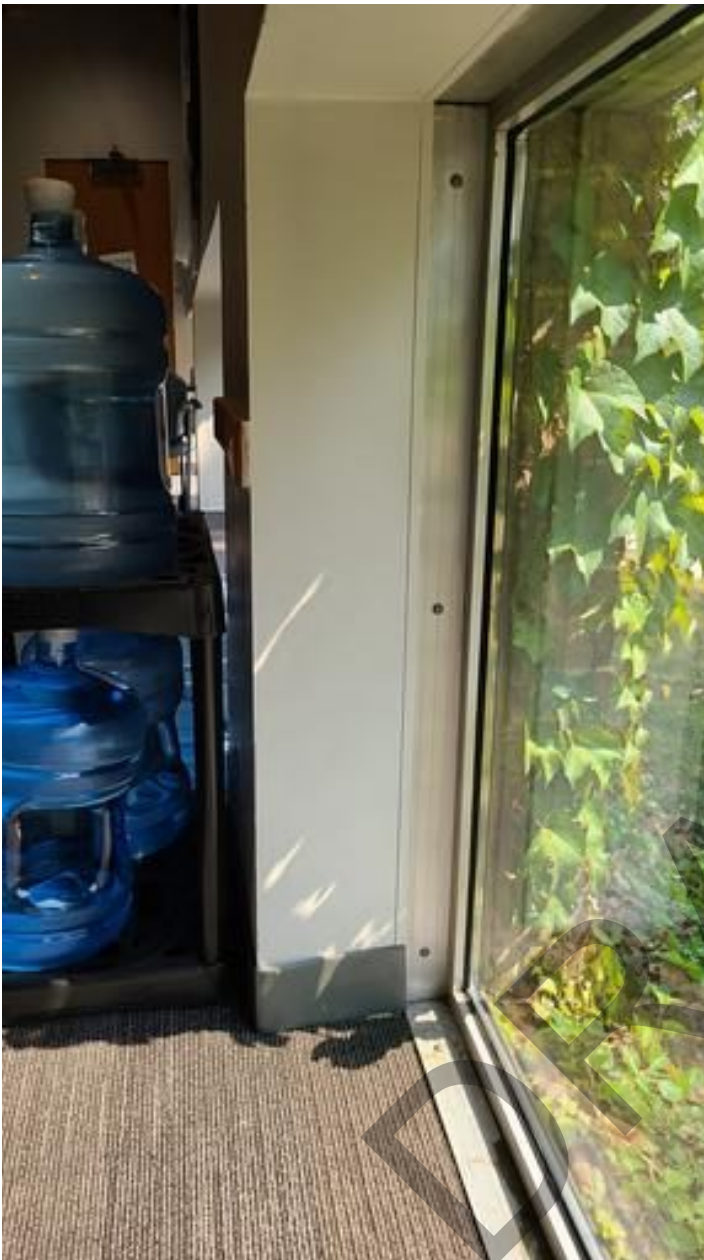
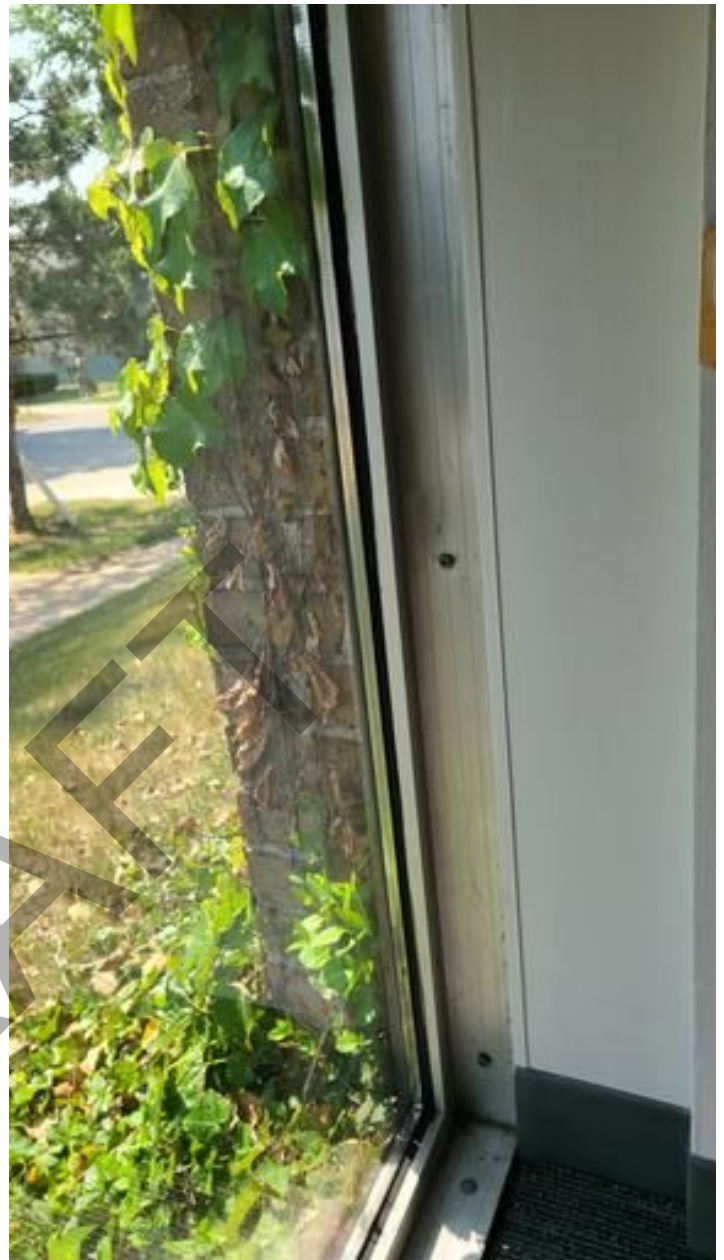
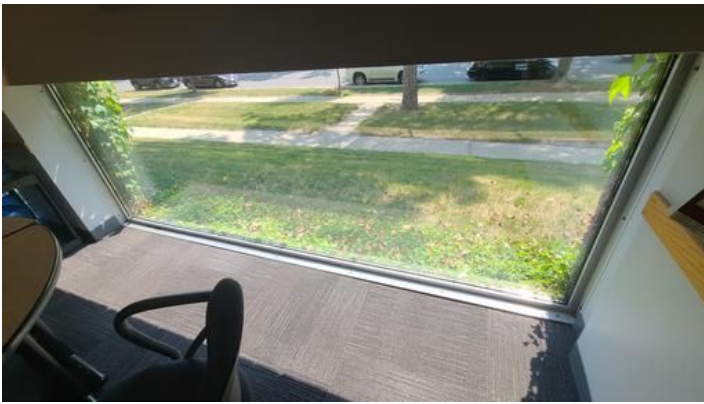
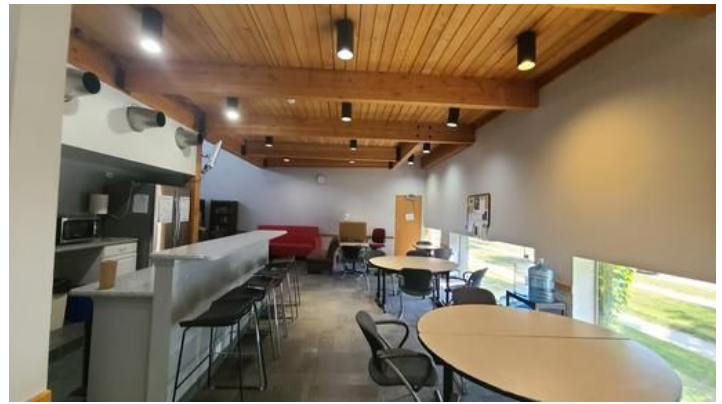
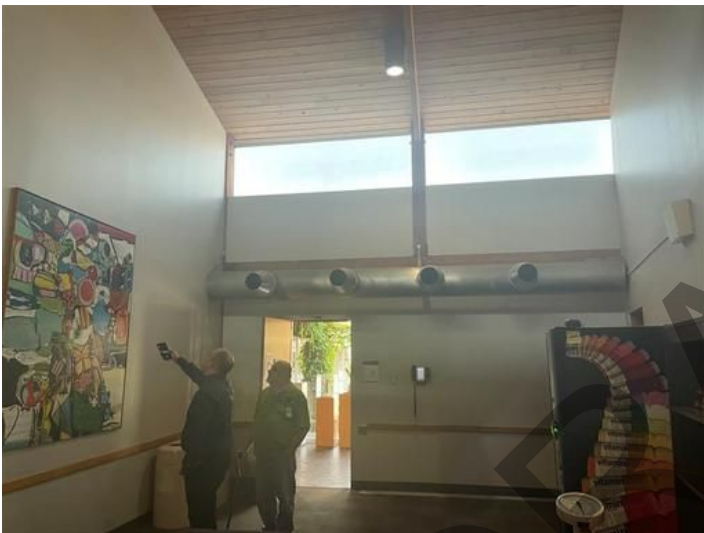
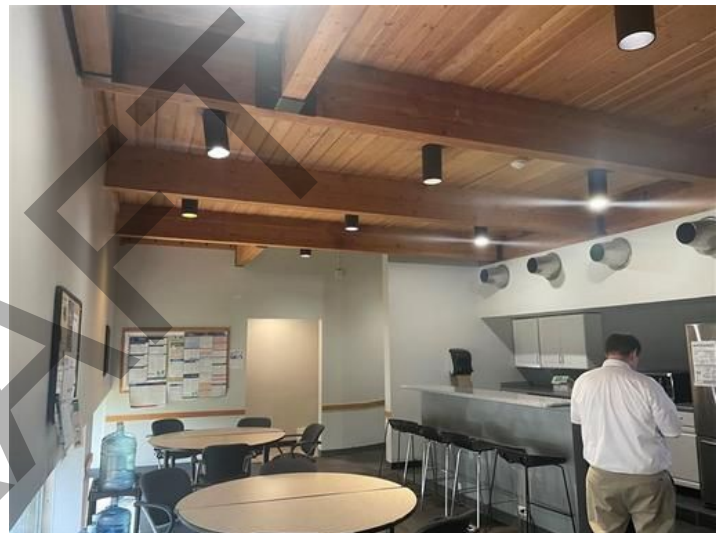
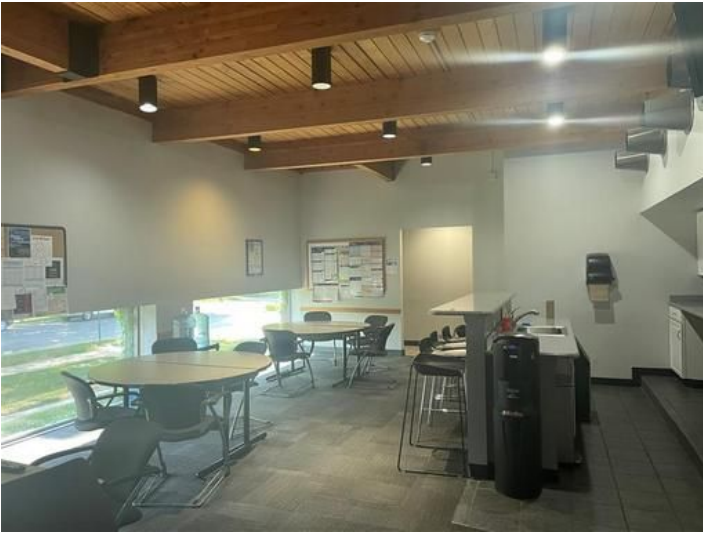
ID	#260
Pin	63
Status	 Open
Type	AG Architectural General > Architectural General

Description	Overall images of Employee Break Room.
Assigned to	—
Created by	Gabriel David (Cordogan Clark)
Created on	Jun 26, 2023
Location	Village Hall - First Floor
Location details	—
Due date	—
Start date	—
Placement	05 (Village Hall - First Floor Plan)
Root cause	—

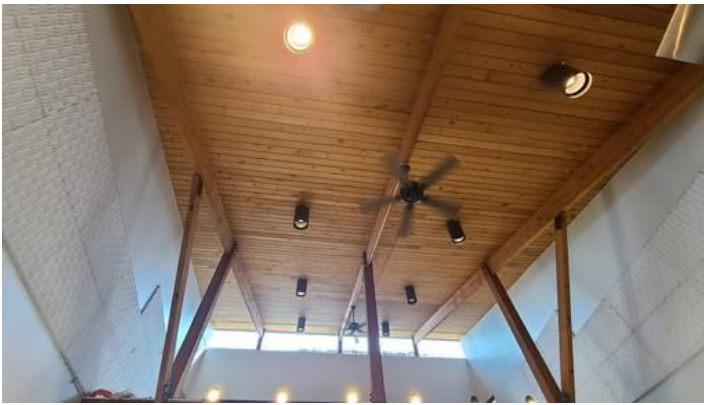
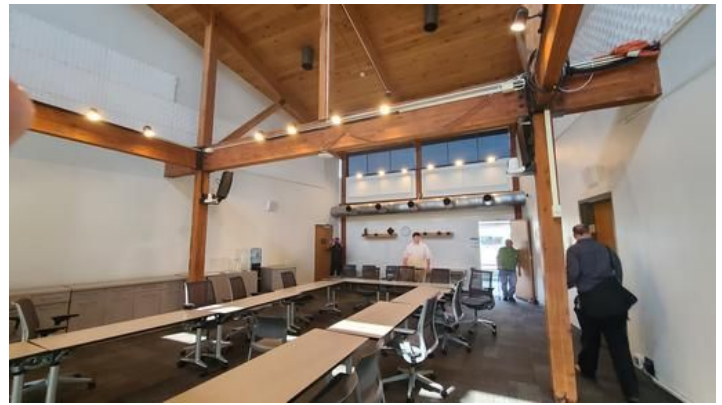
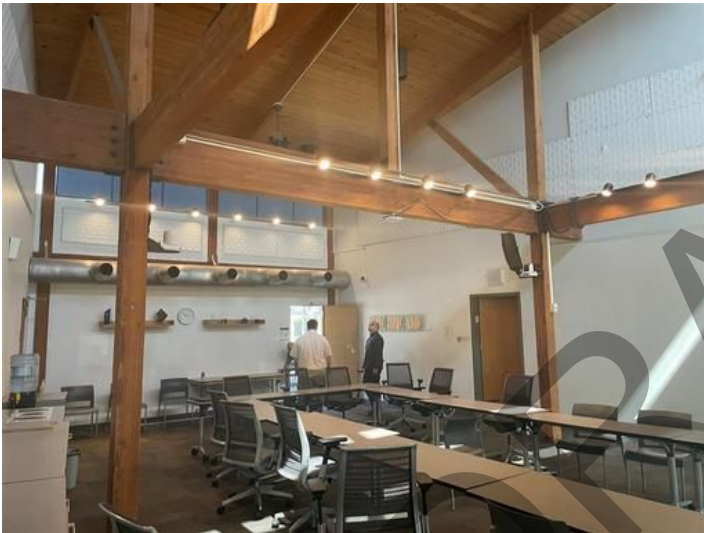
ID	#261
Pin	64
Status	 Open
Type	AG Architectural General > Architectural General

Description	Overall images of Conference Room.
Assigned to	—
Created by	Gabriel David (Cordogan Clark)
Created on	Jun 26, 2023
Location	Village Hall - First Floor
Location details	—
Due date	—
Start date	—
Placement	05 (Village Hall - First Floor Plan)
Root cause	—

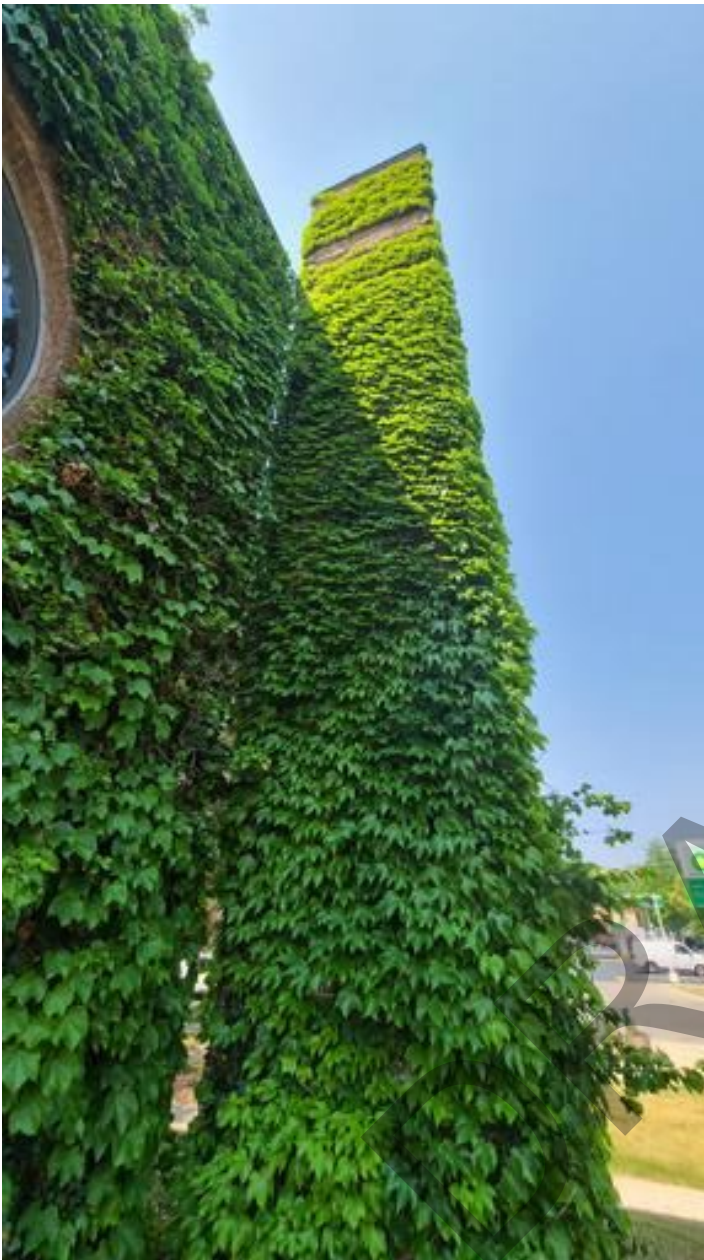
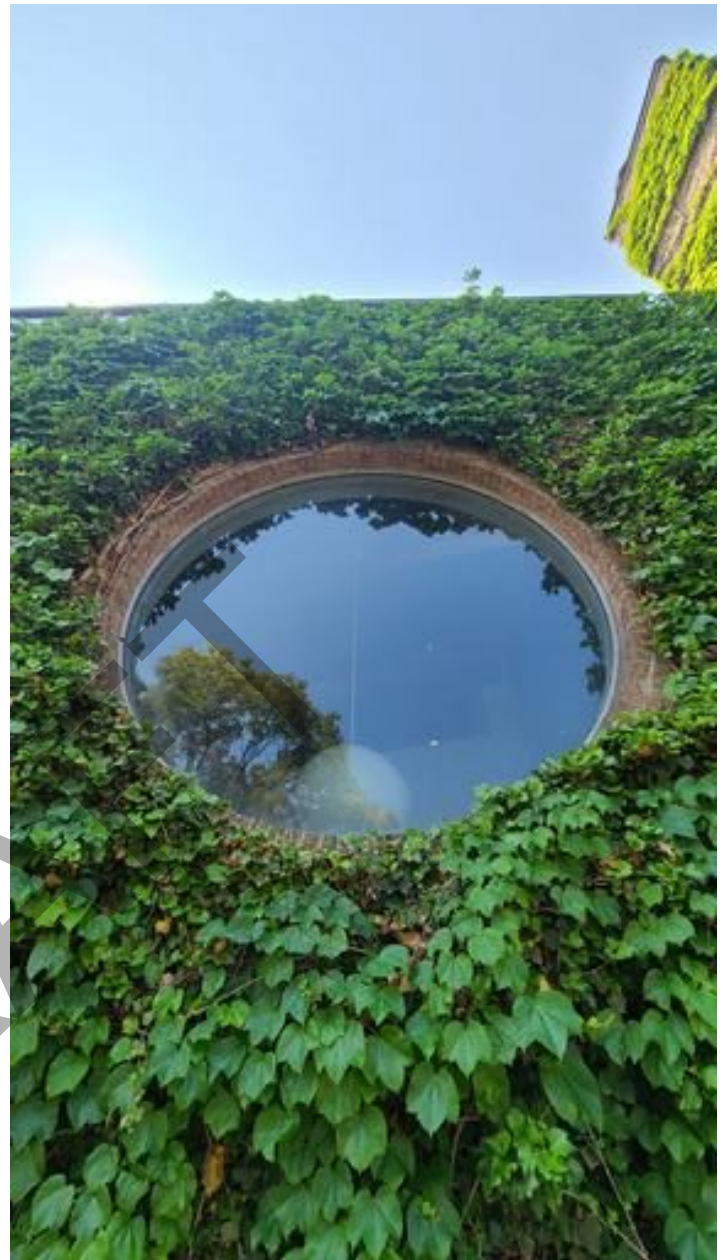
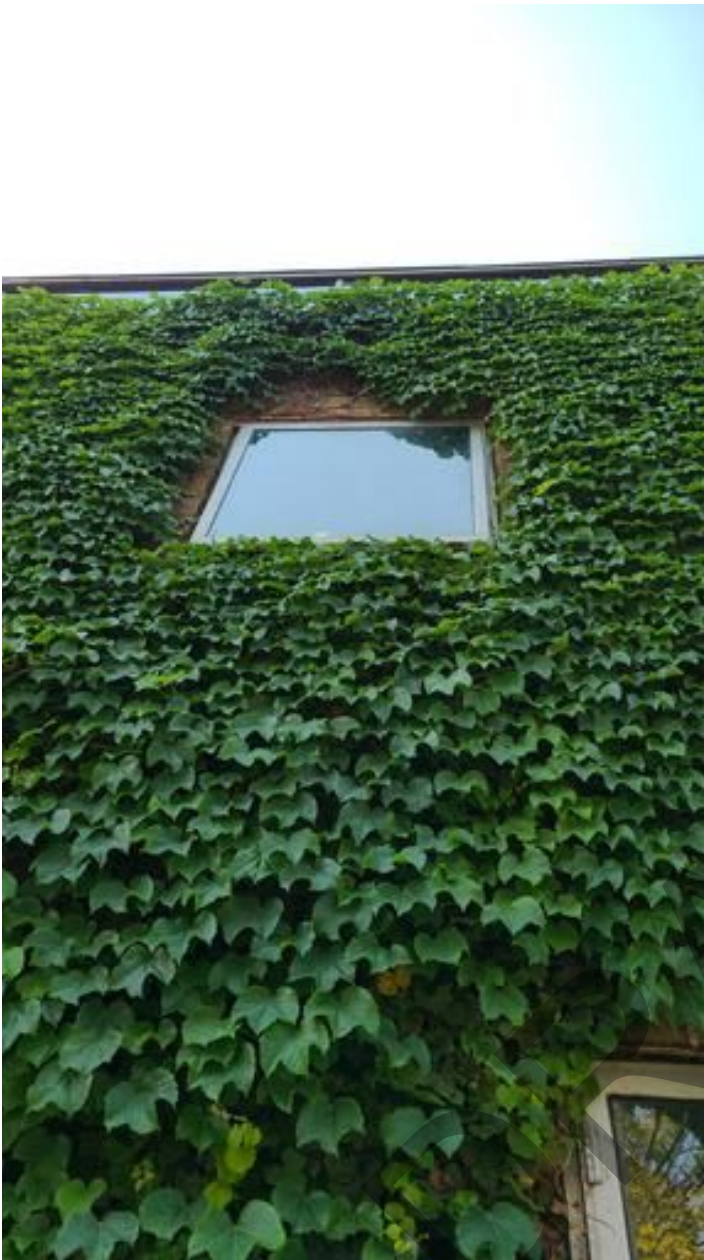
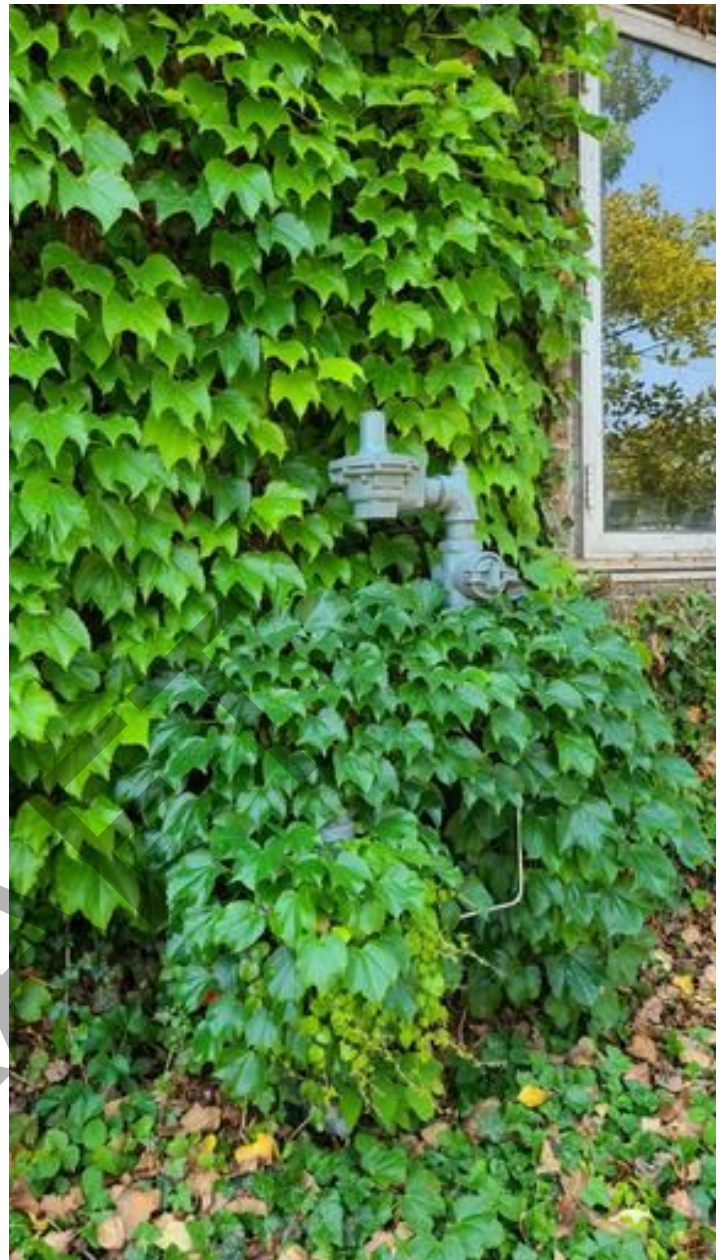
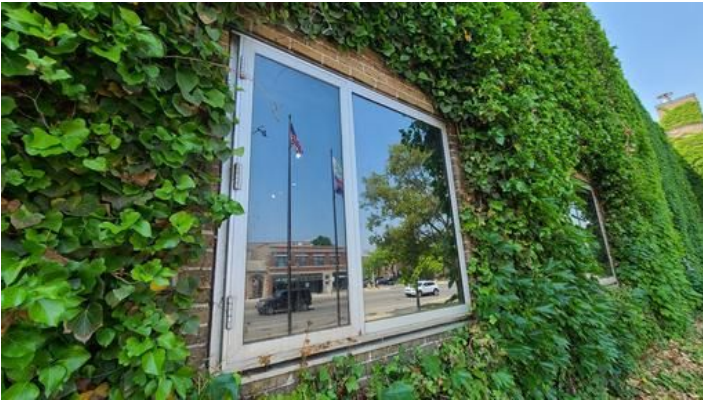
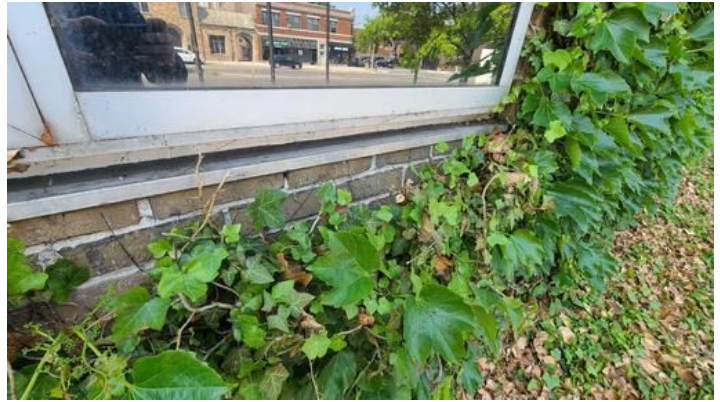
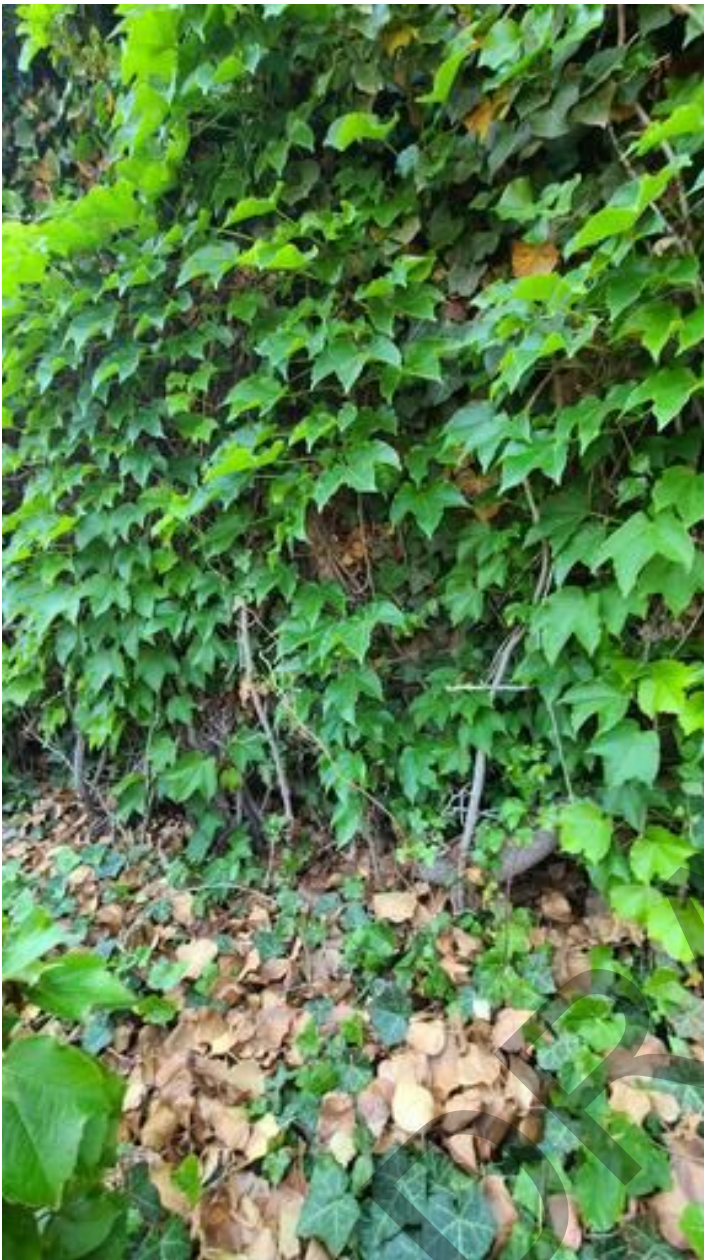
Description	Overall North facade view. Note the overgrowth of ivy, covering over pipe access.
Assigned to	—
Created by	Gabriel David (Cordogan Clark)
Created on	Jun 26, 2023
Location	Village Hall - First Floor
Location details	—
Due date	—
Start date	—
Placement	05 (Village Hall - First Floor Plan)
Root cause	—

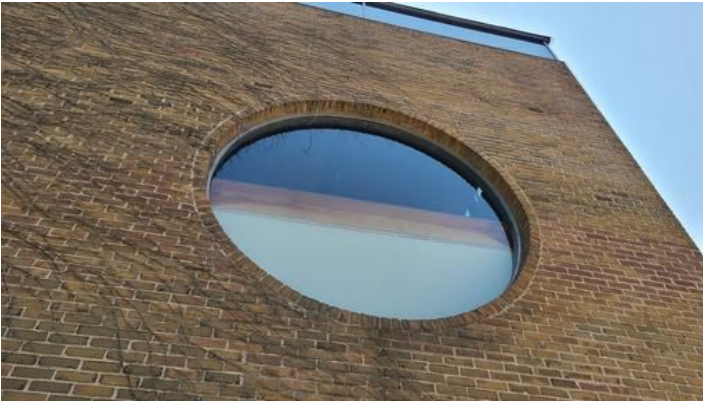
ID	#300
Pin	73
Status	■ Open
Type	AG Architectural General > Architectural General

Description	Overall photo of circular window on the corner of the West facade.
Assigned to	—
Created by	Gabriel David (Cordogan Clark)
Created on	Jun 26, 2023
Location	Village Hall - First Floor
Location details	—
Due date	—
Start date	—
Placement	05 (Village Hall - First Floor Plan)
Root cause	—

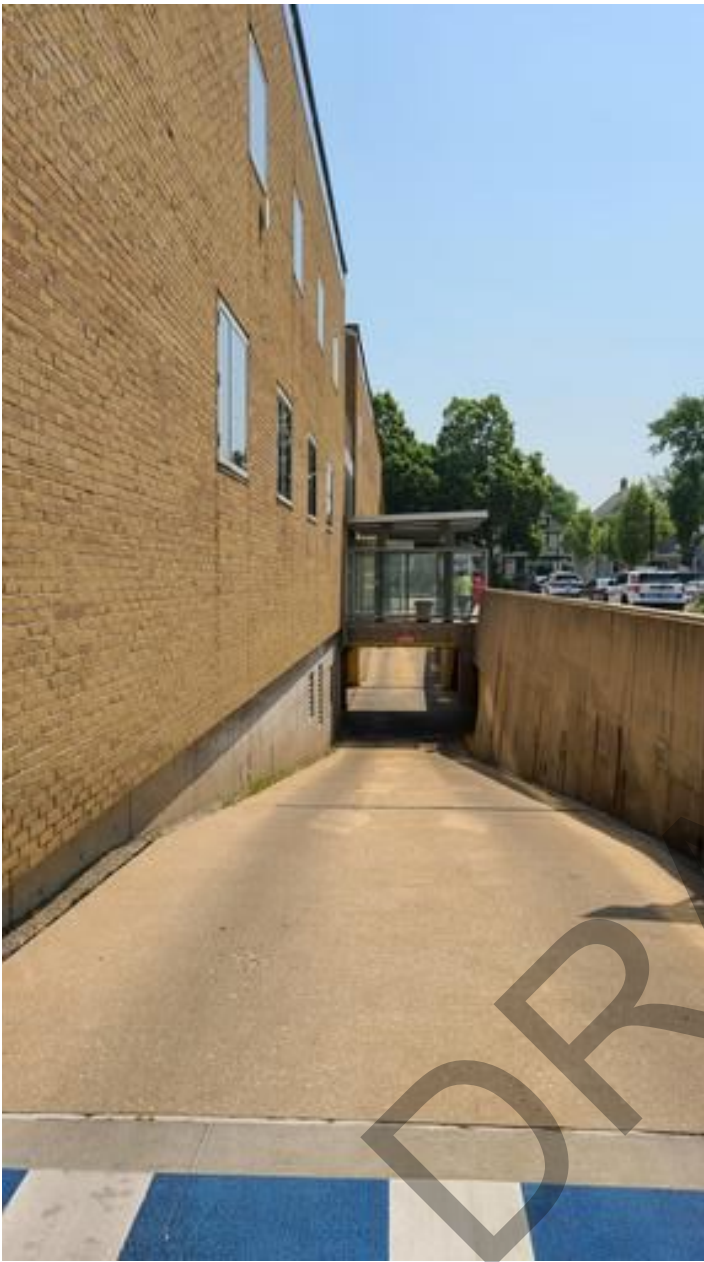
Description	Overall view of elevated entrance platform with canopy, on the Southern facade.
Assigned to	—
Created by	Gabriel David (Cordogan Clark)
Created on	Jun 26, 2023
Location	Village Hall - First Floor
Location details	—
Due date	—
Start date	—
Placement	05 (Village Hall - First Floor Plan)
Root cause	—

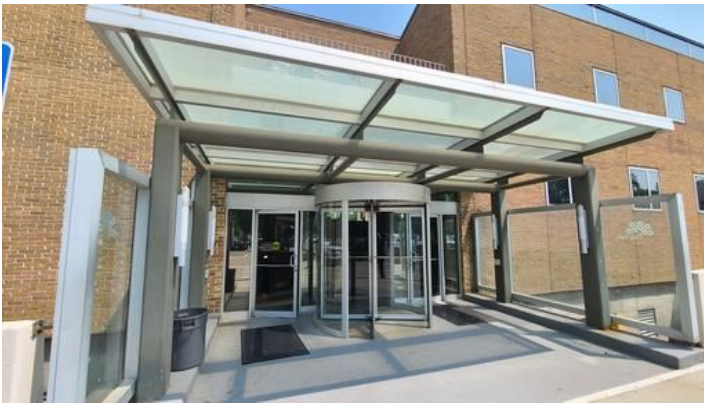
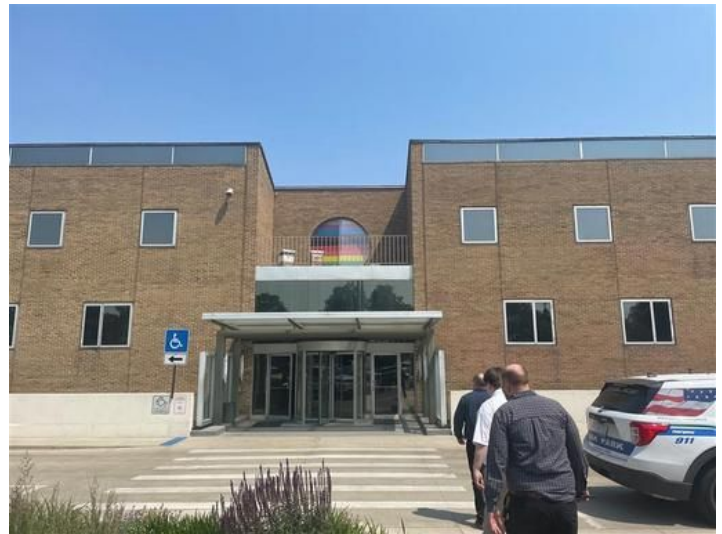
Description	Overall view of South facade with canopy entrance.
Assigned to	—
Created by	Gabriel David (Cordogan Clark)
Created on	Jun 26, 2023
Location	Village Hall - First Floor
Location details	—
Due date	—
Start date	—
Placement	05 (Village Hall - First Floor Plan)
Root cause	—
