**OAK PARK VILLAGE HALL
123 Madison Street, Oak Park IL. 60302**

**PROPERTY CONDITION ASSESSMENT REPORT
07.08.23**

Property Condition Assessment Report

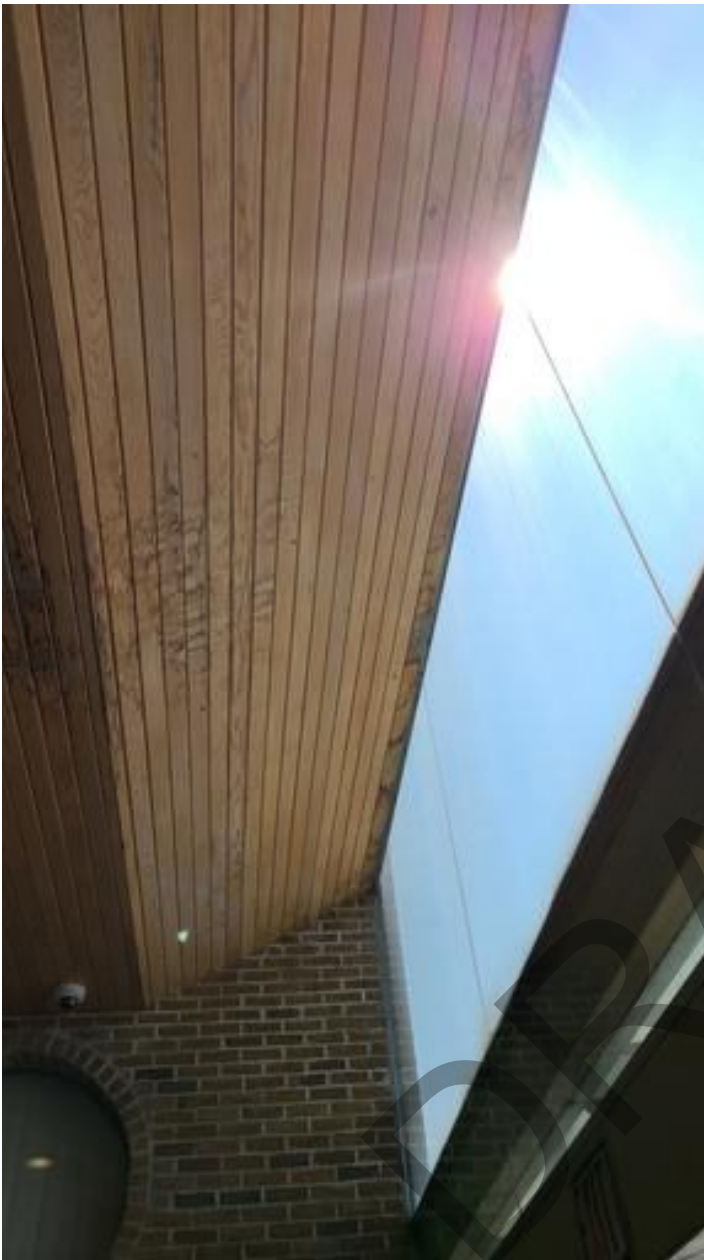
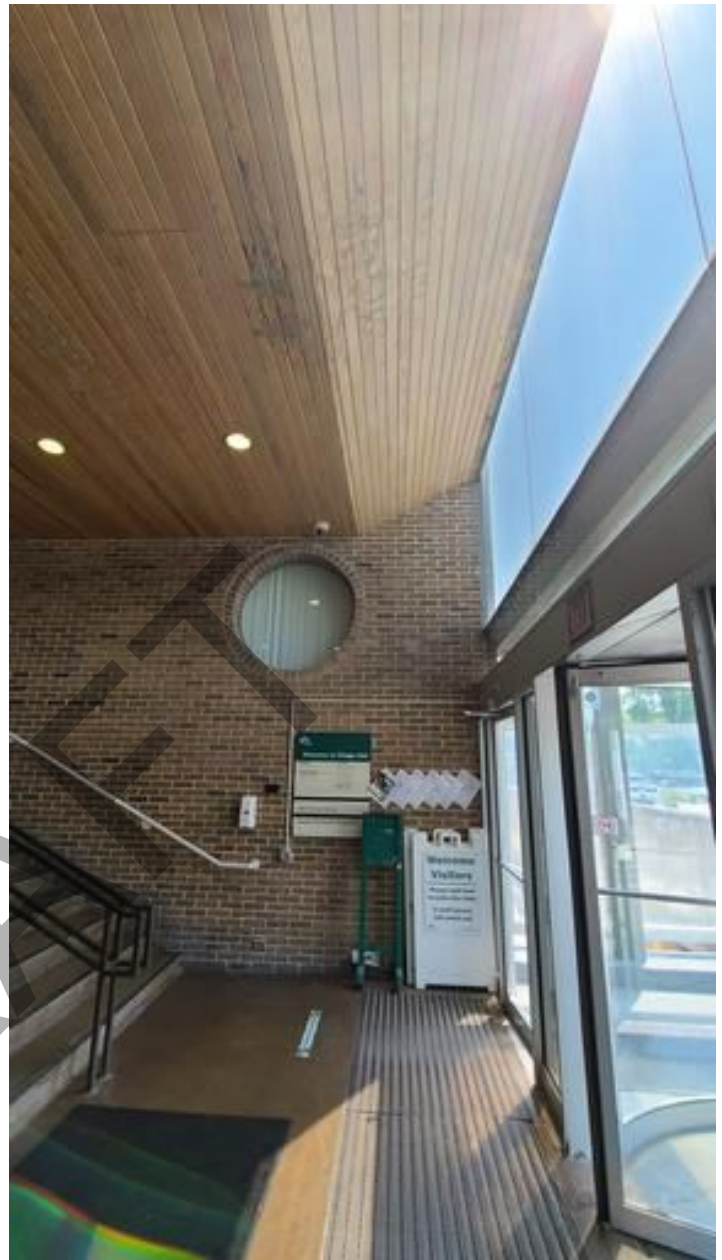
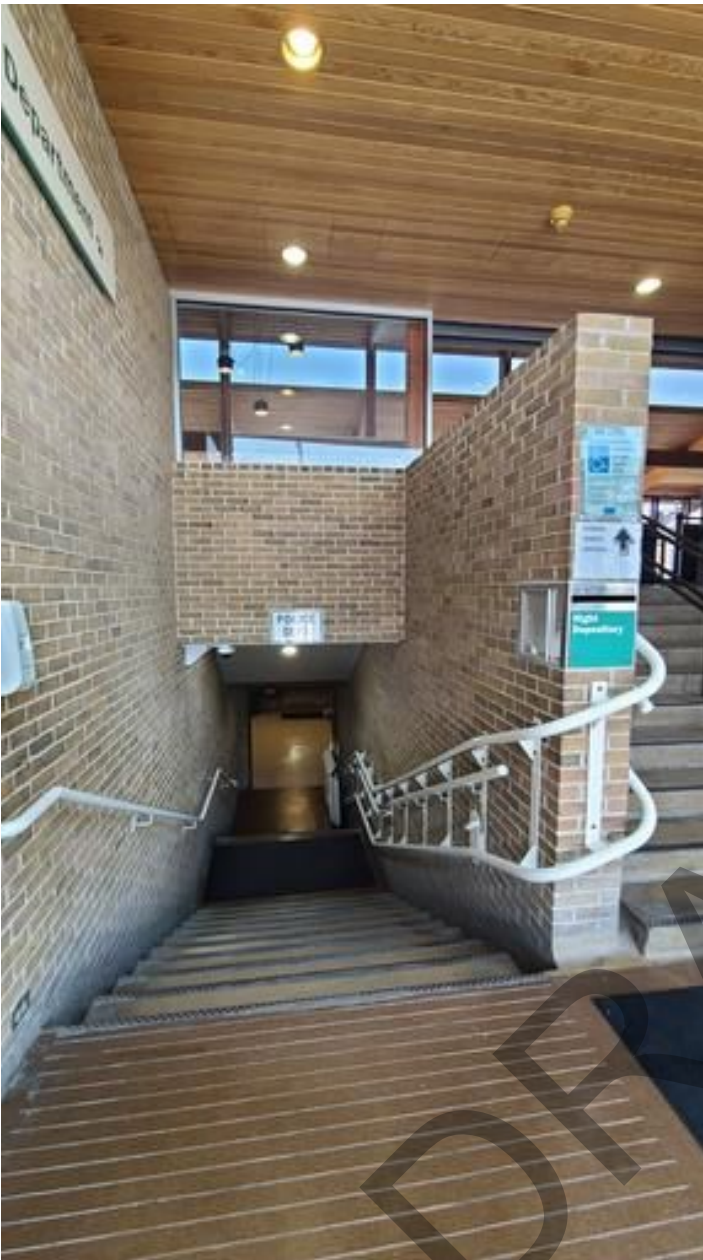
Description	Overall photos of South entrance stairs and vestibule.
Assigned to	—
Created by	Gabriel David (Cordogan Clark)
Created on	Jun 26, 2023
Location	Village Hall - First Floor
Location details	—
Due date	—
Start date	—
Placement	05 (Village Hall - First Floor Plan)
Root cause	—

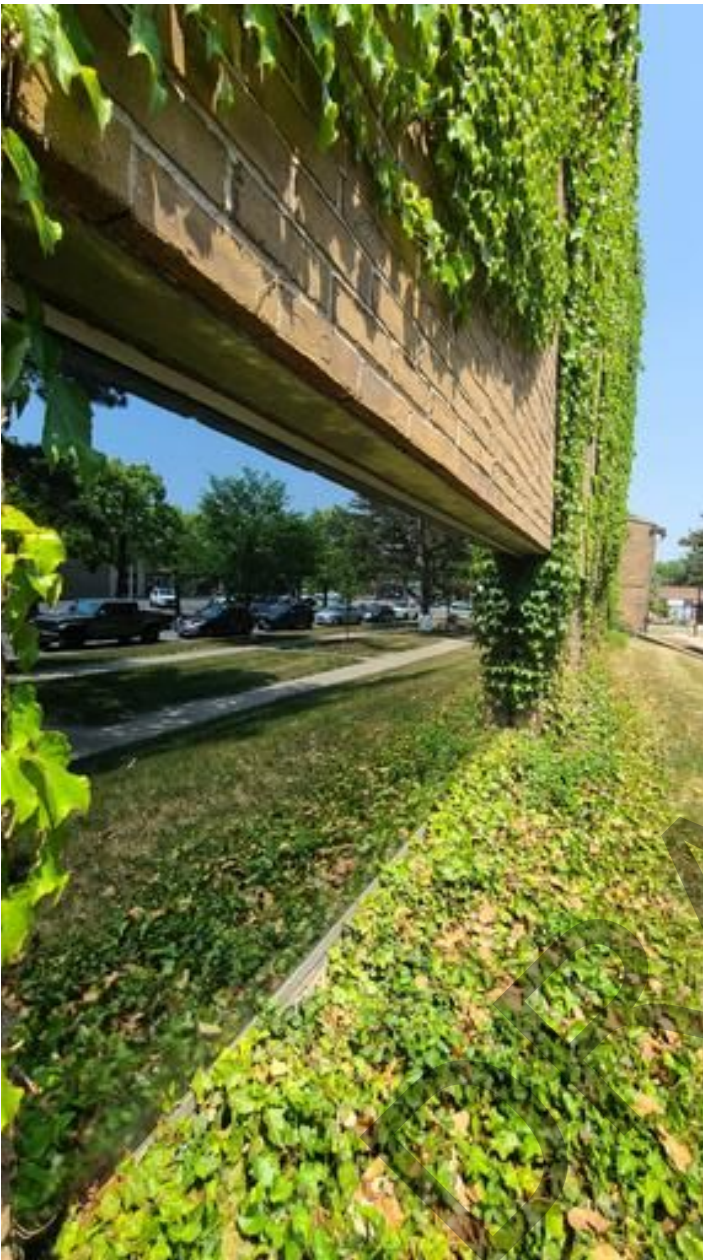
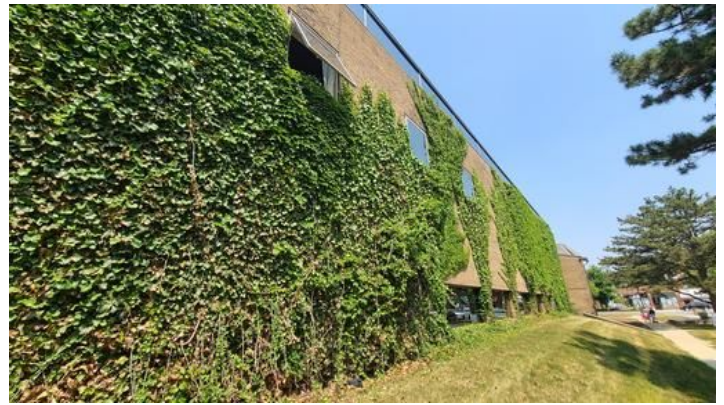
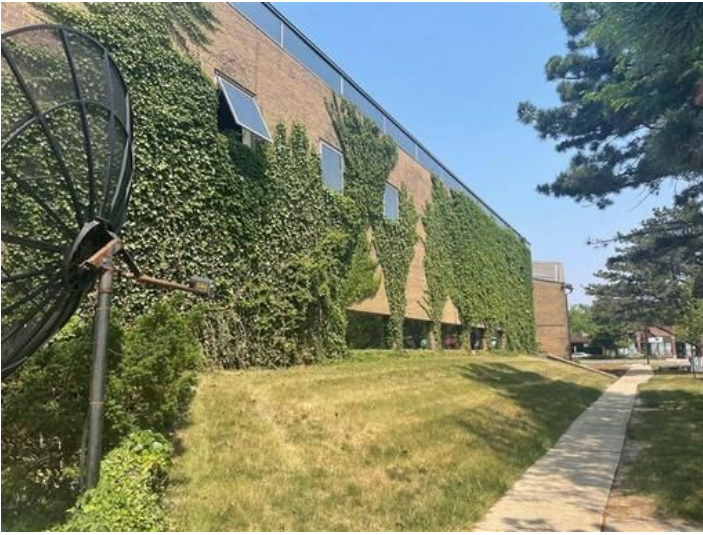
Standard fields	
Description	Overall photo of East facade.
Assigned to	—
Created by	Gabriel David (Cordogan Clark)
Created on	Jun 26, 2023
Location	Village Hall - First Floor
Location details	—
Due date	—
Start date	—
Placement	05 (Village Hall - First Floor Plan)
Root cause	—

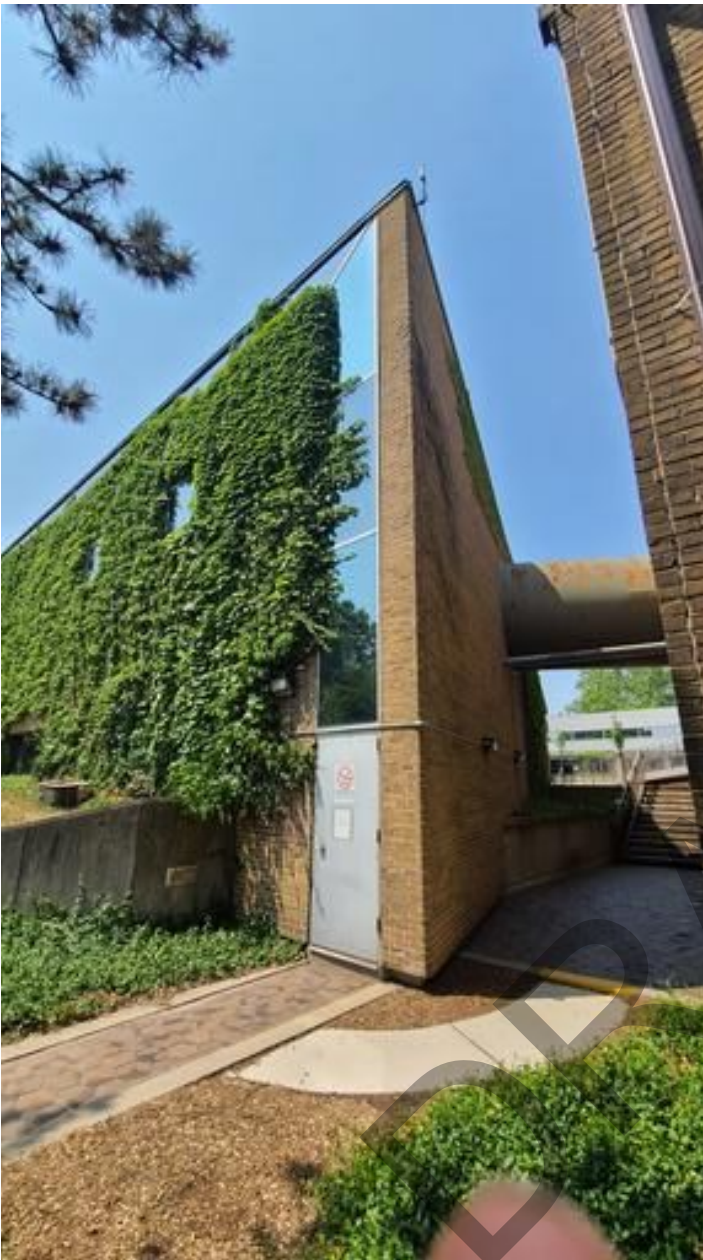
Description	Overall image of emergency exit door. Northeast corner of building.
Assigned to	—
Created by	Gabriel David (Cordogan Clark)
Created on	Jun 26, 2023
Location	Village Hall - First Floor
Location details	—
Due date	—
Start date	—
Placement	05 (Village Hall - First Floor Plan)
Root cause	—

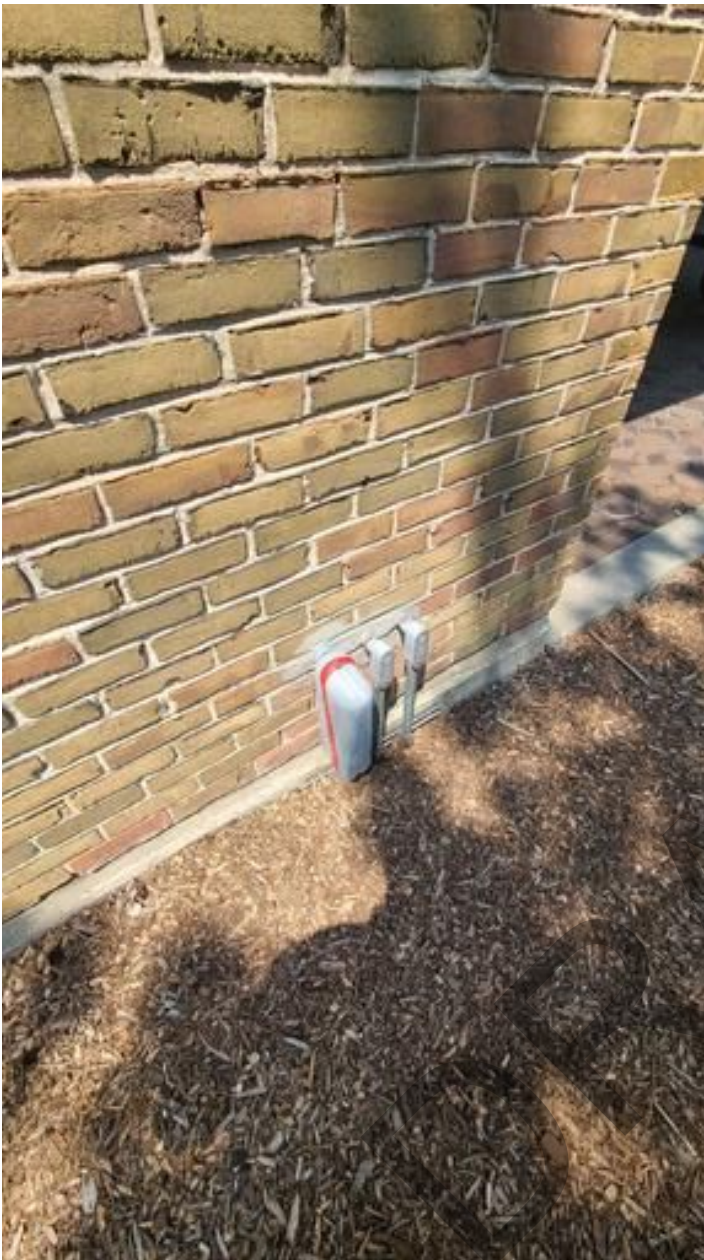
Pin	78	
Status	<div><div></div>Open</div>	
Type	<div><div>AG</div>Architectural General > Architectural General</div>	
Standard fields		
Description	Overall photo of MEP equipment.	
Assigned to	—	
Created by	Gabriel David (Cordogan Clark)	
Created on	Jun 26, 2023	
Location	Village Hall - First Floor	
Location details	—	
Due date	—	
Start date	—	
Placement	05 (Village Hall - First Floor Plan)	
Root cause	—

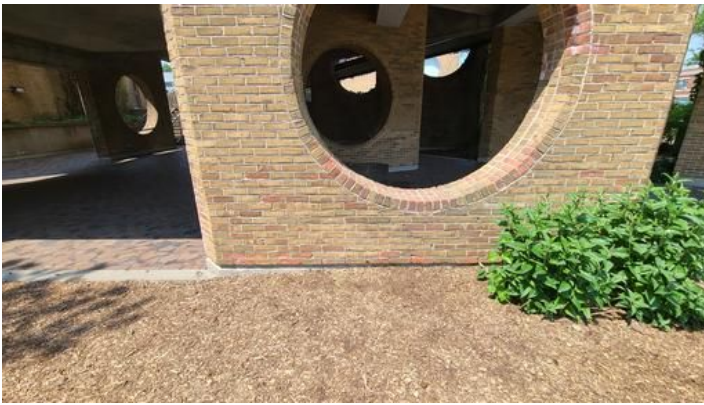
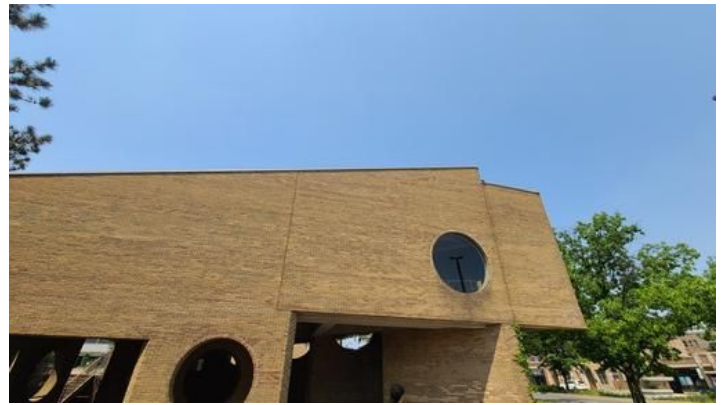
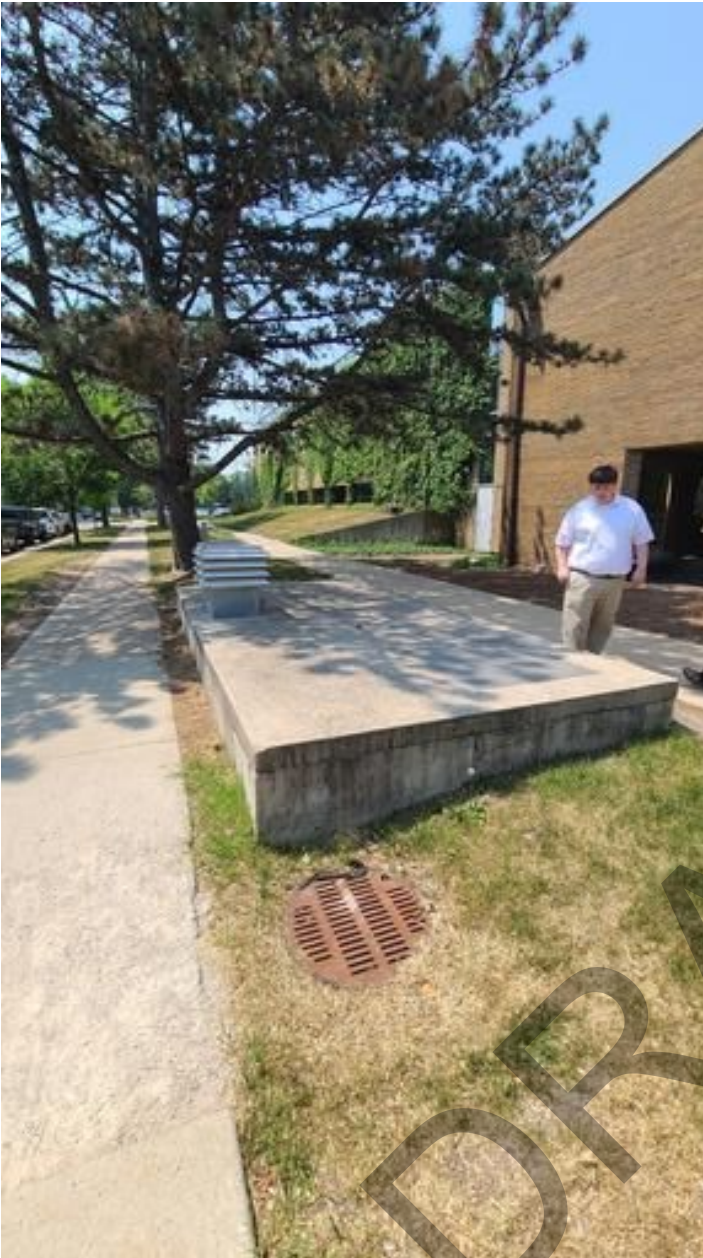
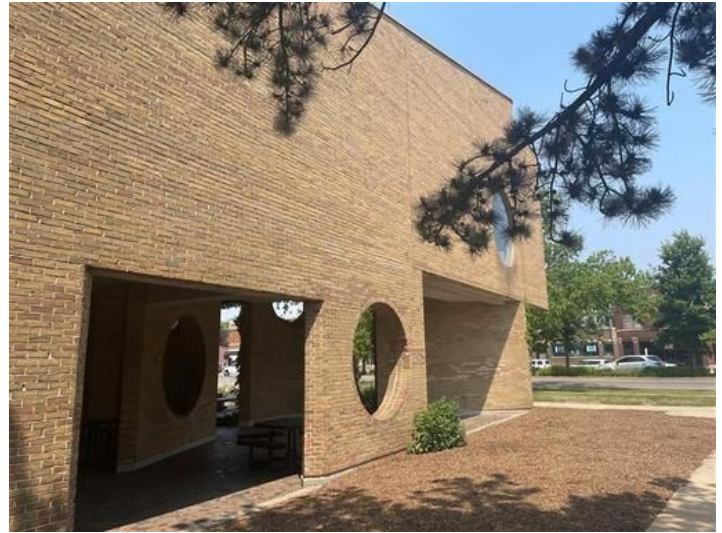
Description	Overall East facade view. S-6 geothermal vault mounted heat pump included.
Assigned to	—
Created by	Gabriel David (Cordogan Clark)
Created on	Jun 26, 2023
Location	Village Hall - First Floor
Location details	—
Due date	—
Start date	—
Placement	05 (Village Hall - First Floor Plan)
Root cause	—

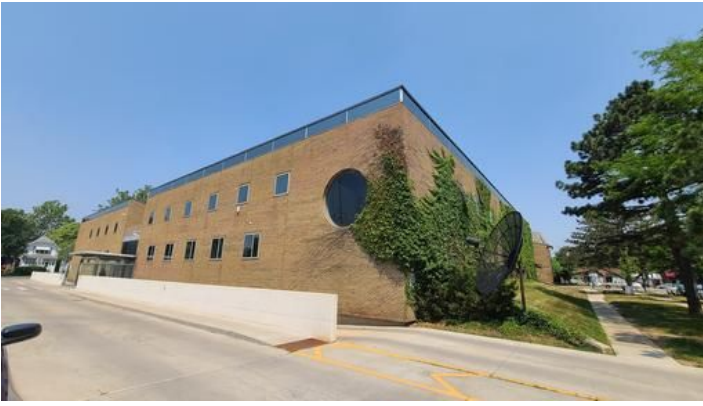
Description	Overall South facade view.
Assigned to	—
Created by	Gabriel David (Cordogan Clark)
Created on	Jun 26, 2023
Location	Village Hall - First Floor
Location details	—
Due date	—
Start date	—
Placement	05 (Village Hall - First Floor Plan)
Root cause	—

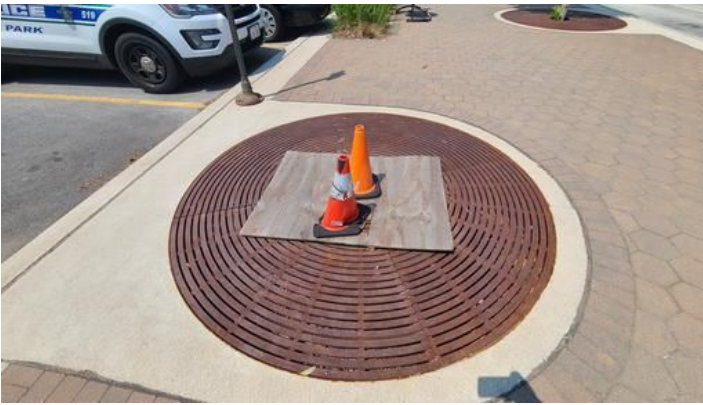
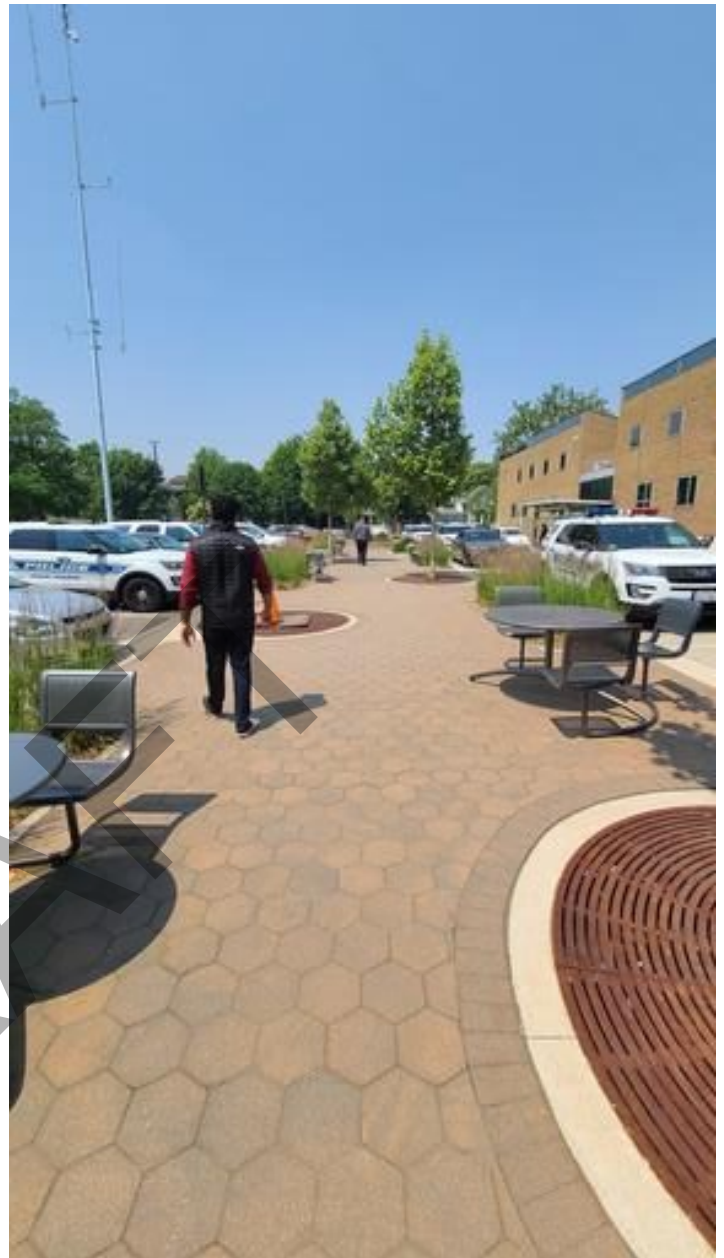
Description	Tree no longer present.
Assigned to	—
Created by	Gabriel David (Cordogan Clark)
Created on	Jun 26, 2023
Location	Village Hall - First Floor
Location details	—
Due date	—
Start date	—
Placement	05 (Village Hall - First Floor Plan)
Root cause	—

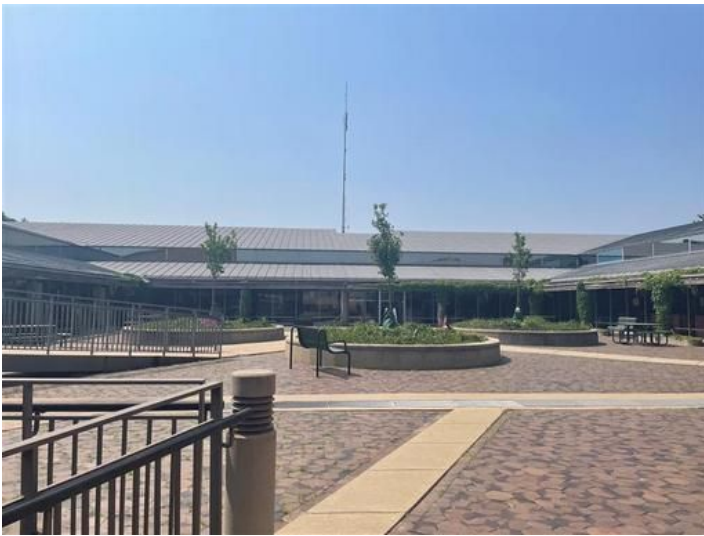
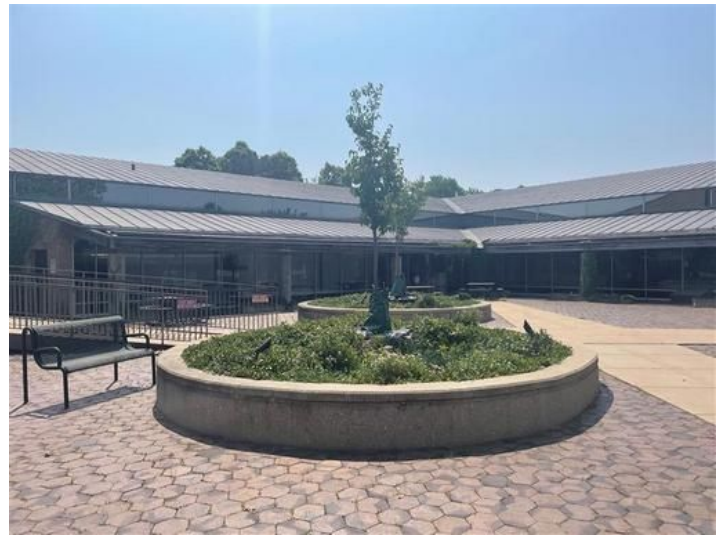
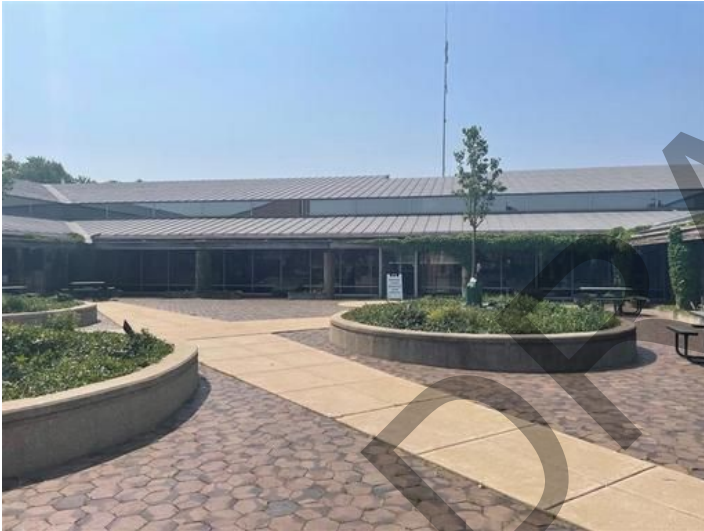
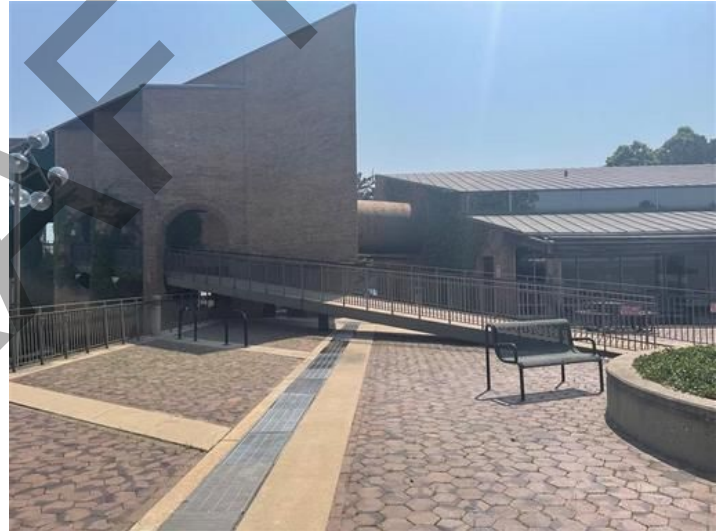
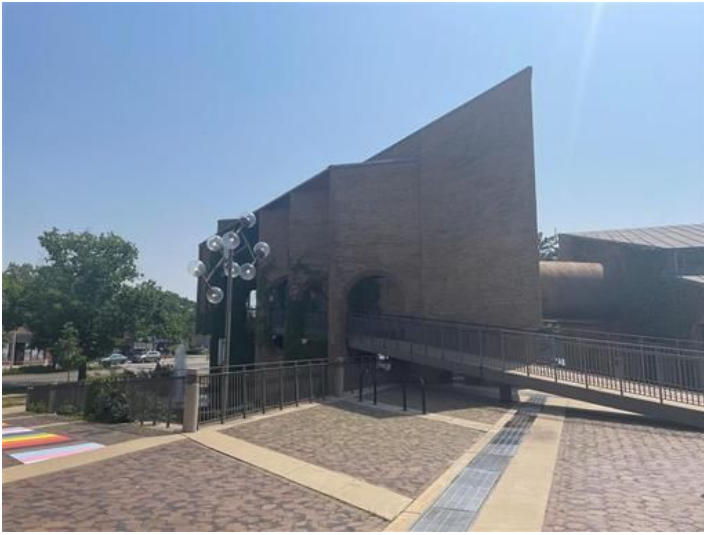
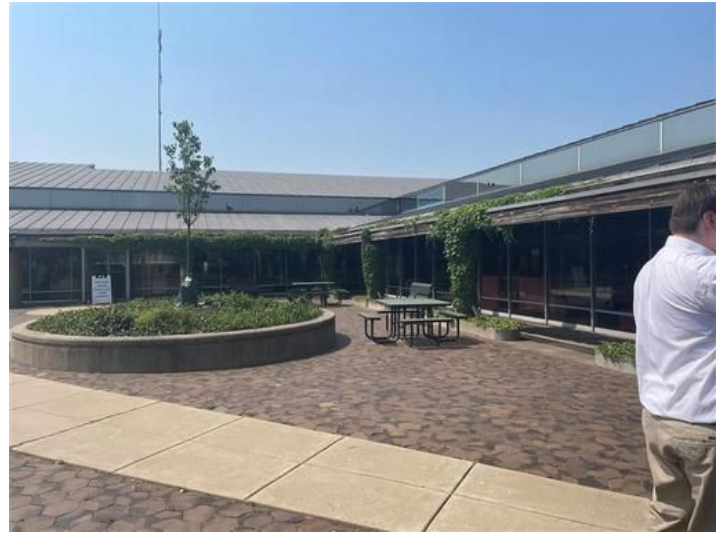
Description	Overall views of clerestory windows, courtyard plaza, with wood framed sunshade over window wall on ground level.
Assigned to	—
Created by	Gabriel David (Cordogan Clark)
Created on	Jun 26, 2023
Location	Village Hall - First Floor
Location details	—
Due date	—
Start date	—
Placement	05 (Village Hall - First Floor Plan)
Root cause	—

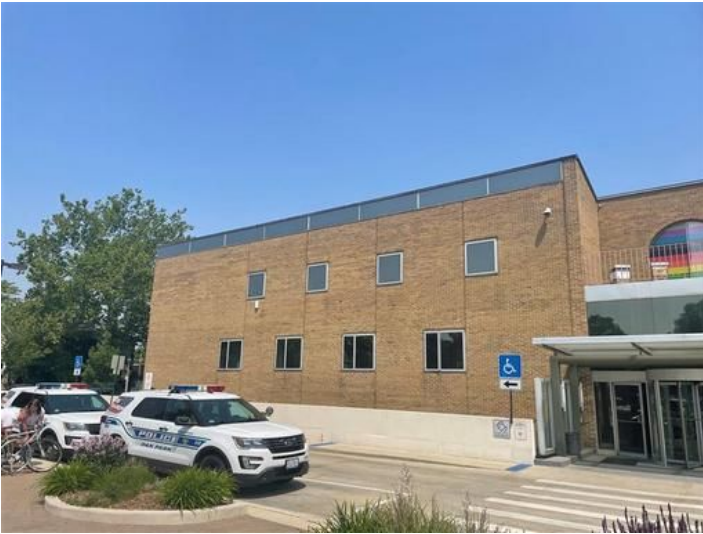
48

Description	Overall view of western half of South facade.
Assigned to	—
Created by	Gabriel David (Cordogan Clark)
Created on	Jun 26, 2023
Location	Village Hall - First Floor
Location details	—
Due date	—
Start date	—
Placement	05 (Village Hall - First Floor Plan)
Root cause	—

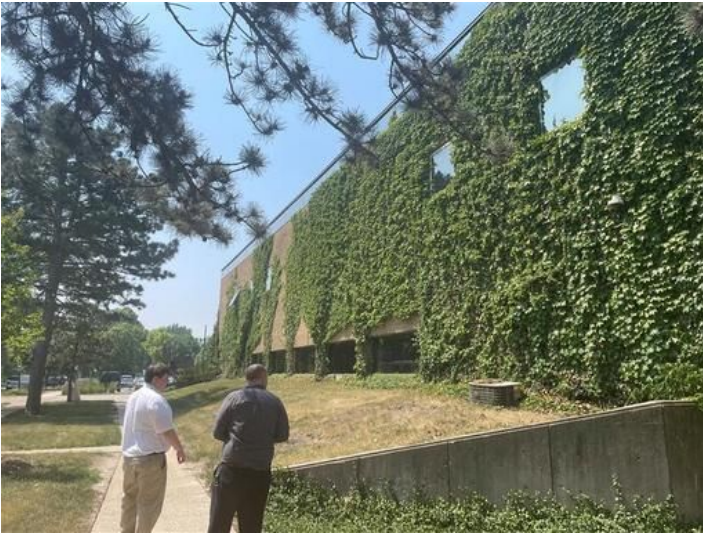
55

Pin	84	
Status	<div><div></div>Open</div>	
Type	<div><div>AG</div>Architectural General > Architectural General</div>	
Standard fields		
Description	Overall East facade.	
Assigned to	—	
Created by	Gabriel David (Cordogan Clark)	
Created on	Jun 26, 2023	
Location	Village Hall - First Floor	
Location details	—	
Due date	—	
Start date	—	
Placement	05 (Village Hall - First Floor Plan)	
Root cause	—

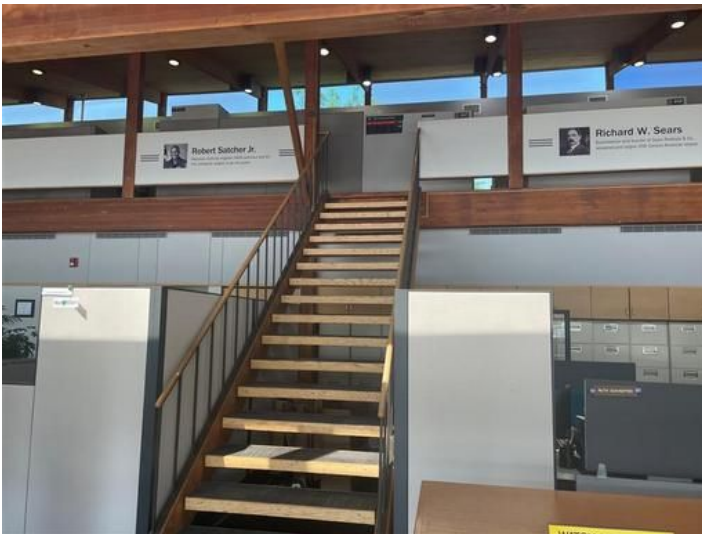
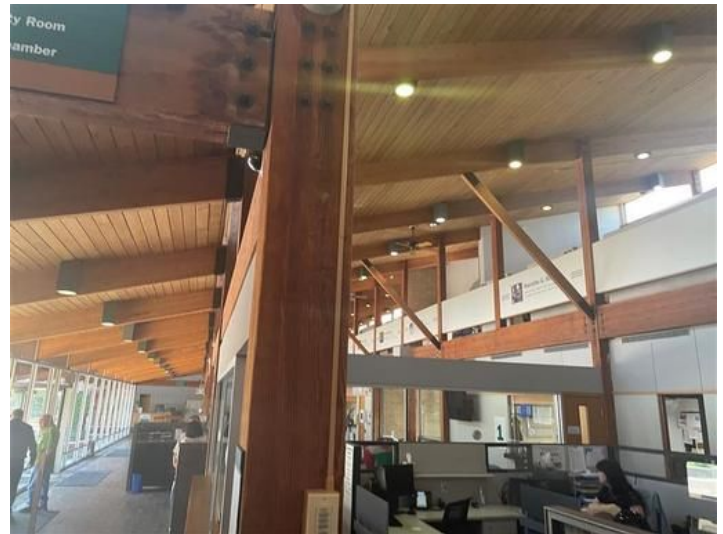
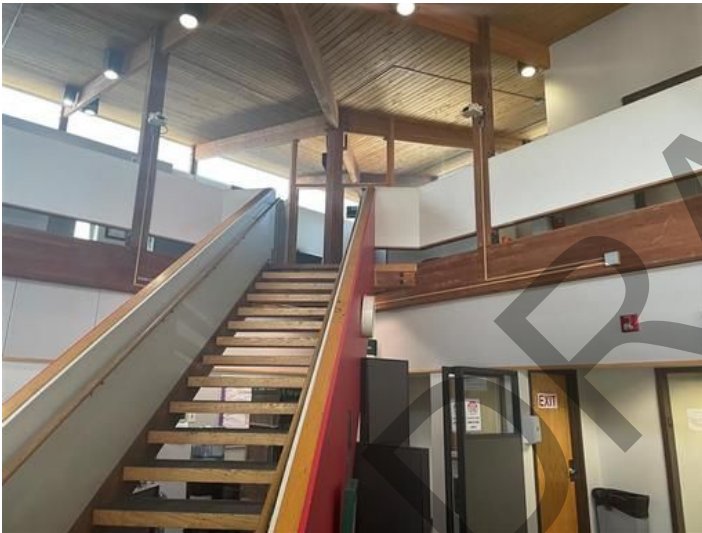
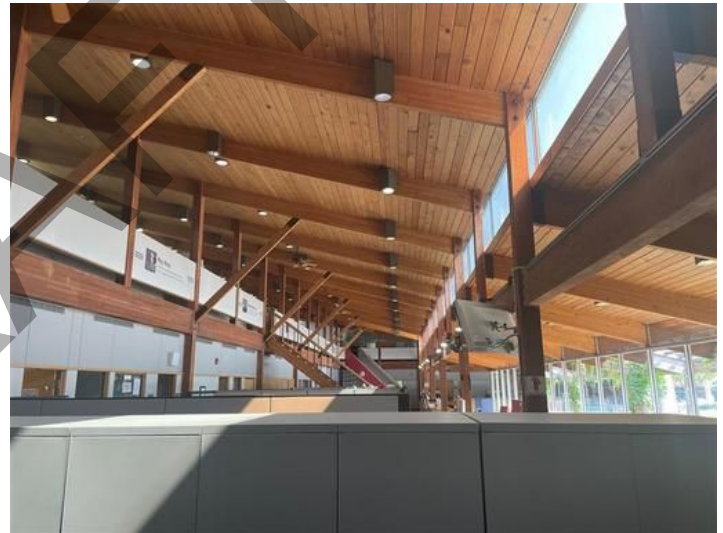
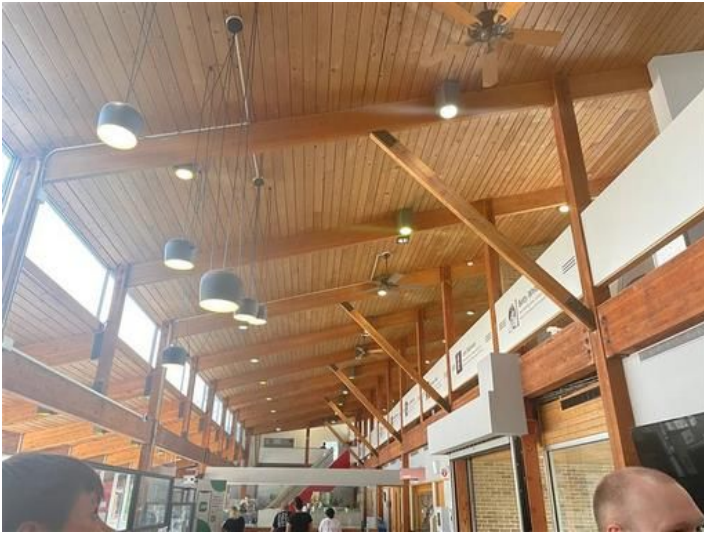
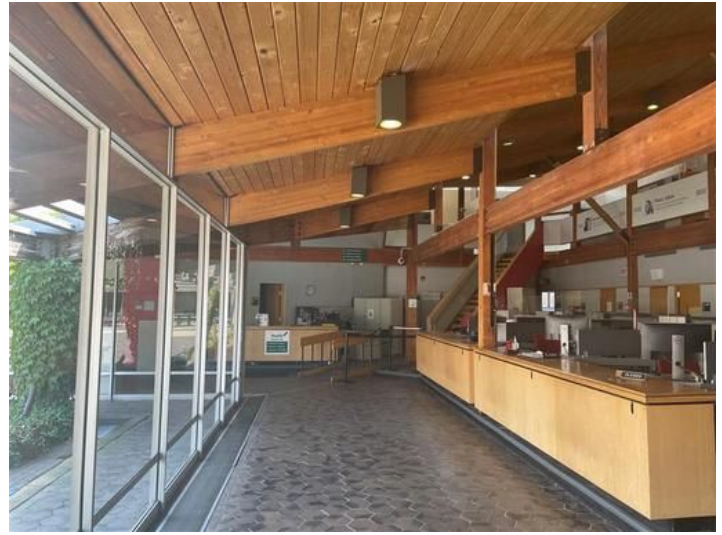
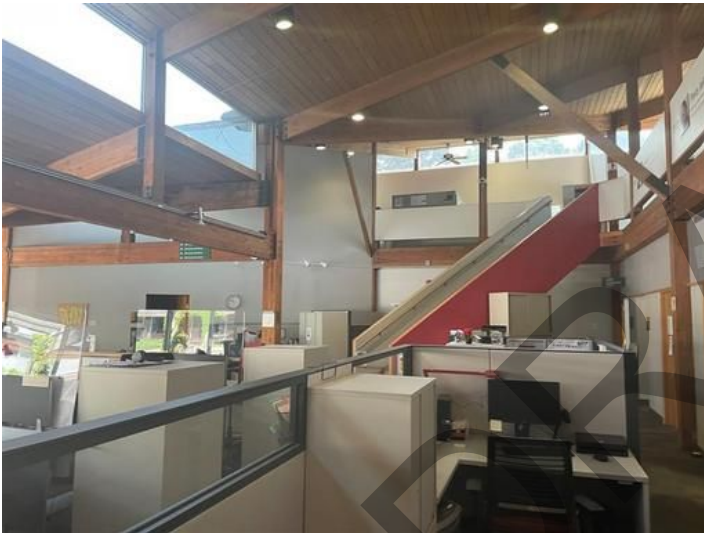
Description	Interior looking up to mezzanine level from ground level.
Assigned to	—
Created by	Gabriel David (Cordogan Clark)
Created on	Jun 26, 2023
Location	Village Hall - First Floor
Location details	—
Due date	—
Start date	—
Placement	05 (Village Hall - First Floor Plan)
Root cause	—

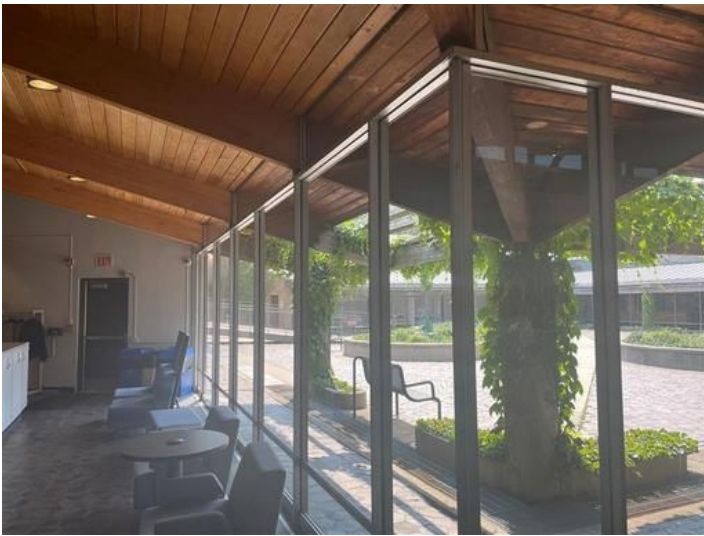
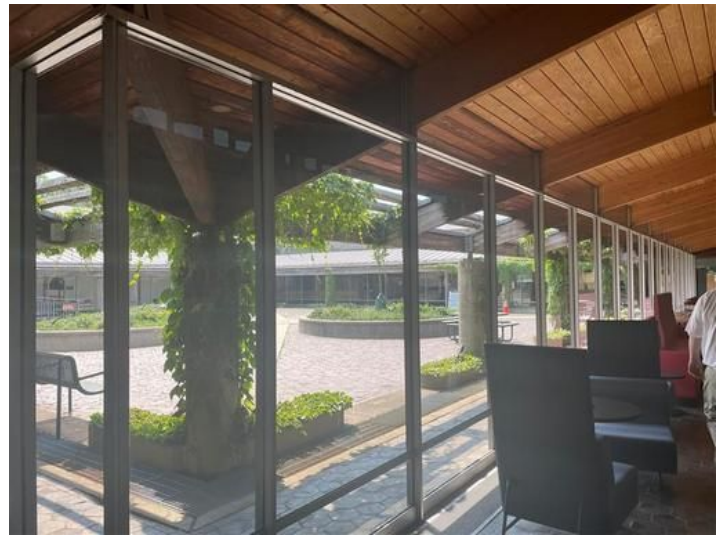
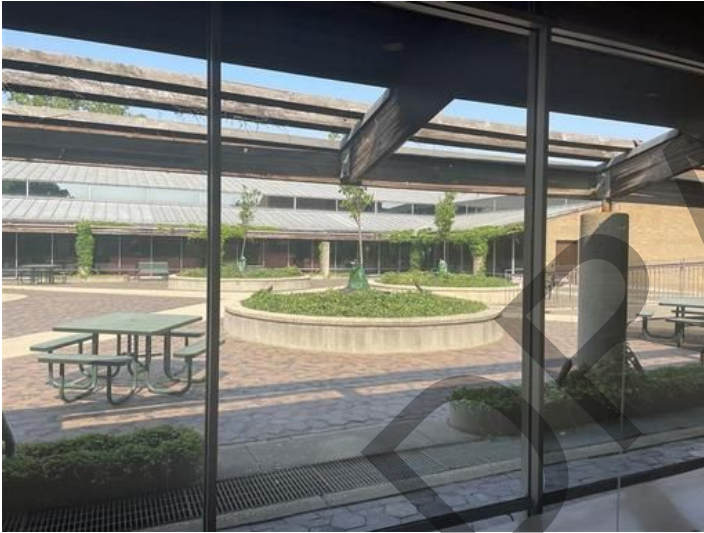
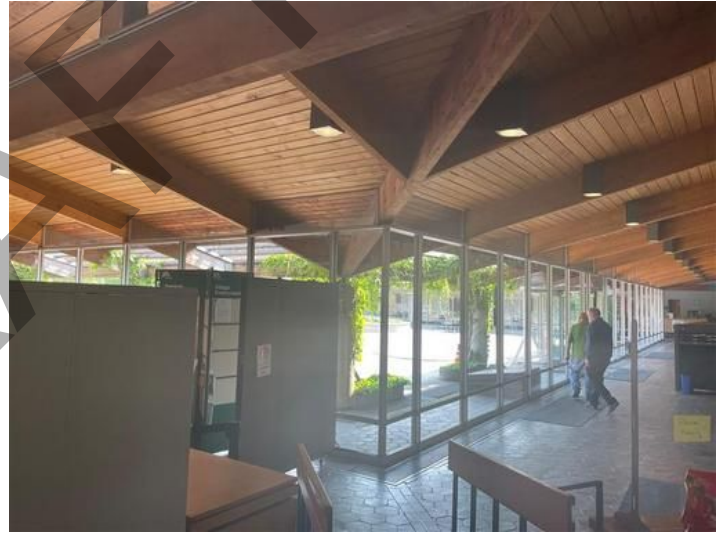
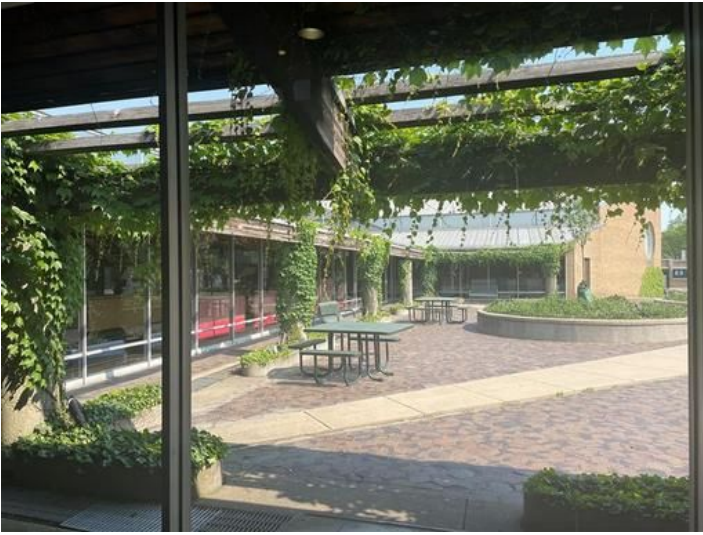
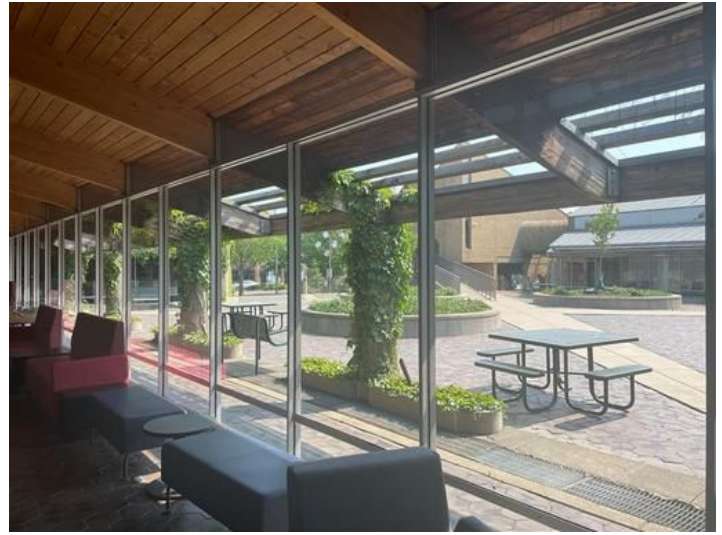
Description	Interior views of curtain wall at ground level. Note water staining on the underside of the wood deck and beams.
Assigned to	—
Created by	Gabriel David (Cordogan Clark)
Created on	Jun 26, 2023
Location	Village Hall - First Floor
Location details	—
Due date	—
Start date	—
Placement	05 (Village Hall - First Floor Plan)
Root cause	—
