OAK PARK VILLAGE HALL Property Condition Assessment

Oak Park, Illinois 60304

Final Report

November 9, 2015

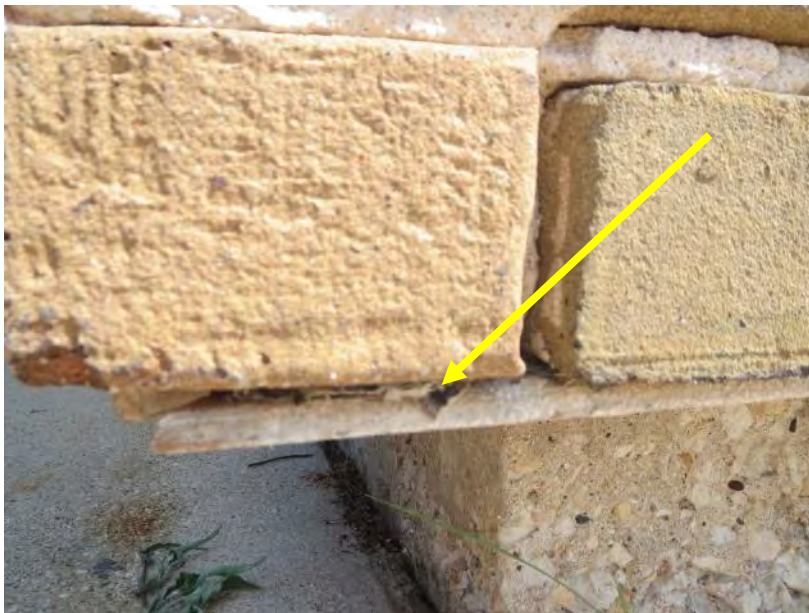
1. The brick veneer is supported by a continuous steel shelf angle at the base of the wall. Flashing is evident at multiple locations (Figure 21).
2. There is significant ivy growth on the brick masonry walls on the north, west, and east facades (Figure 22 through Figure 24).

Figure 21. Close up view of brick at steel shelf angle. Note the flashing on the shelf angle.

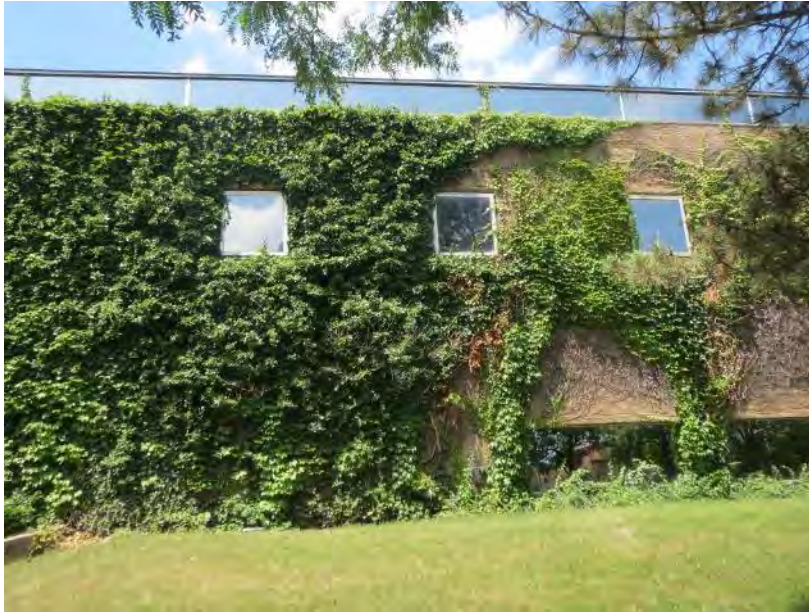
Figure 22. View of ivy on east facade

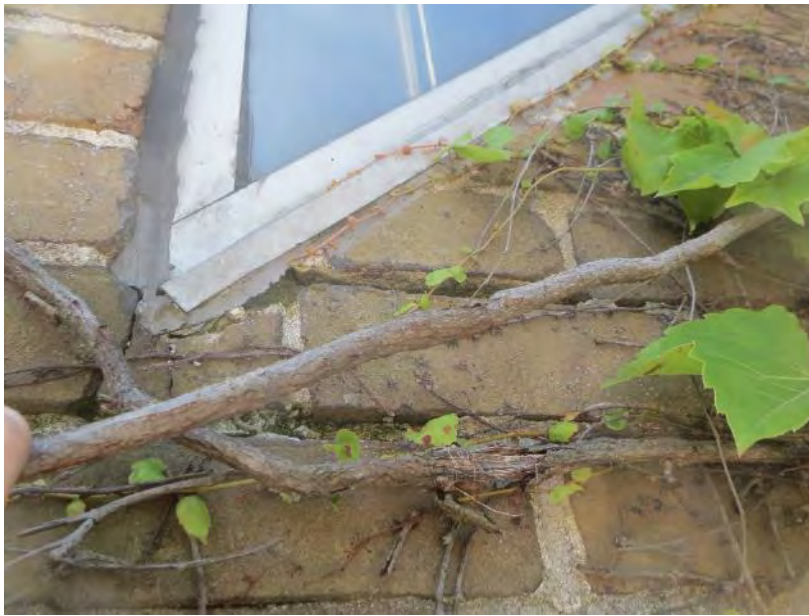
Figure 23. Close up view of ivy at north facade

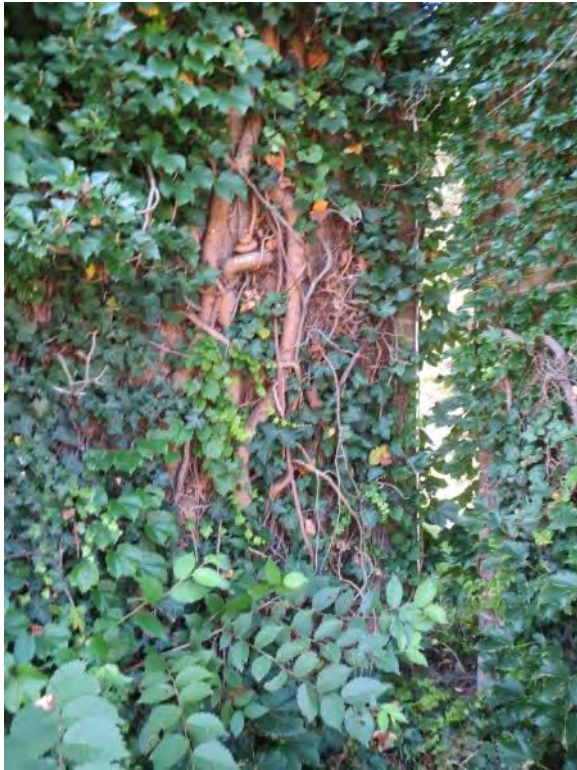
Figure 24. View of extensive ivy growth at west facade

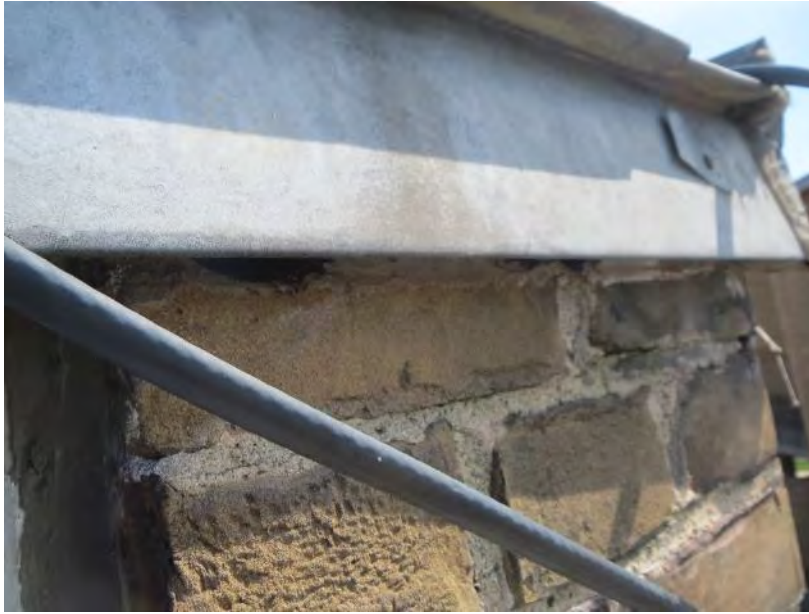
4. The top of the brick cavity wall at the return ends of the north and east facades is open under the roof edge condition (Figure 27 and Figure 28).
5. Isolated cracked and debonded mortar and open joints exist throughout the brick masonry (Figure 29 through Figure 31).

Figure 28. Voids exist between the top of the masonry pier and the roofing termination

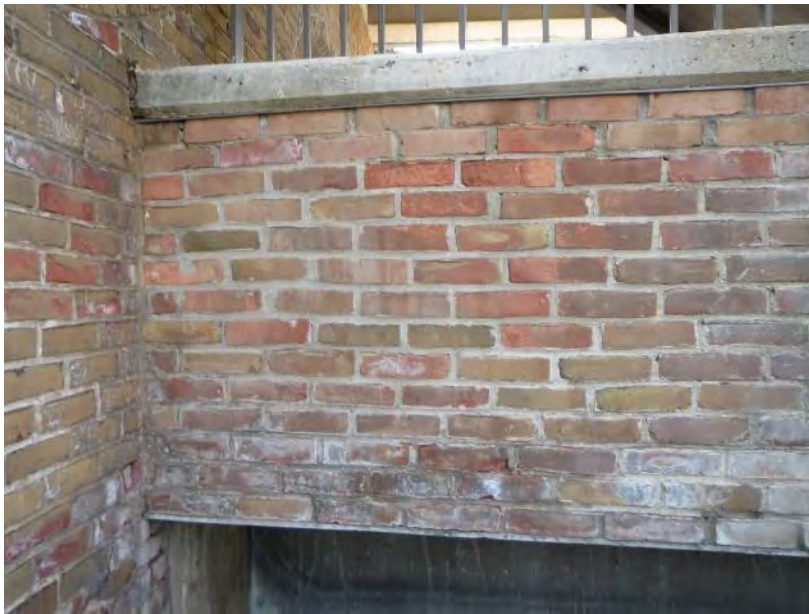
8. Significant efflorescence and water staining were visible on brick and concrete at the north wall of the elevated plaza. The brick is supported on a galvanized steel shelf angle (Figure 36 and Figure 37).

Figure 37. View of efflorescence at the brick cladding at the edge of the elevated plaza level

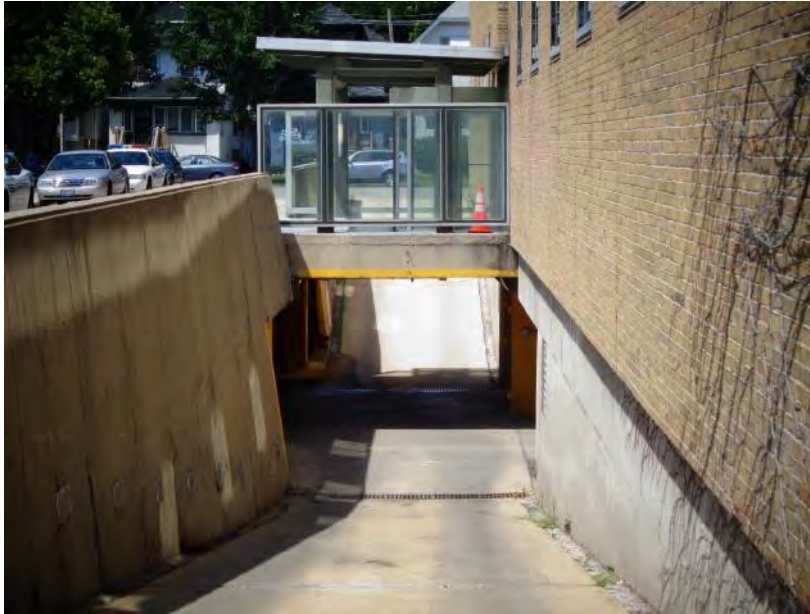
19. Cracking, spalling, corrosion staining, and visible corroded reinforcing bars were noted at the underside of the concrete elevated walkway at the south entrance above the garage ramp entrance (Figure 42 and Figure 43). Additionally, the traffic coating on the top side of the slab at the elevated walkway is bubbling, peeling, and delaminated (Figure 44).

Figure 42. Overall view of elevated entrance platform at south facade

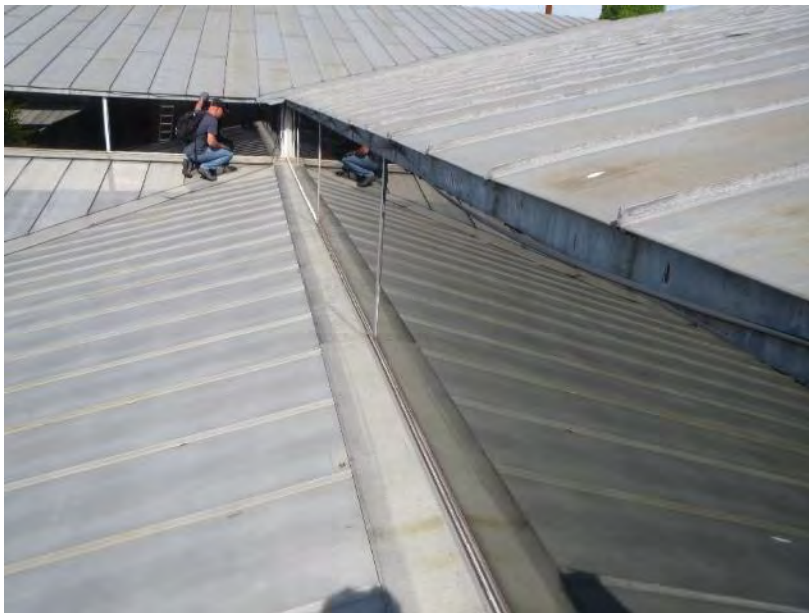
3. There is significant crazeing and debonding of the perimeter sealant at the clerestory windows. Many of the window gaskets at the clerestory windows are brittle and/or crazed. Additionally, some of the gaskets have been previously cap sealed and the sealant is crazed and debonded (Figure 49 through Figure 53).

Figure 49. View of clerestory windows

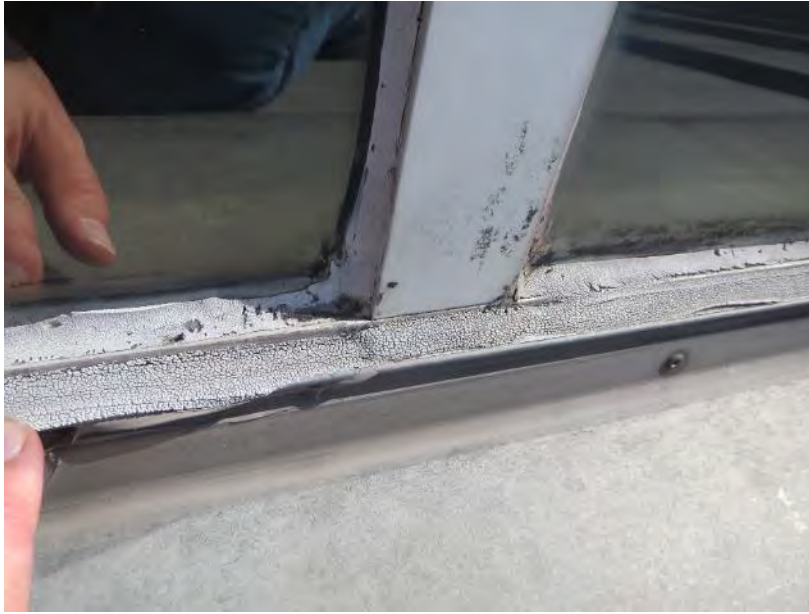
Figure 50. Significantly crazed sealant at the base of the clerestory windows

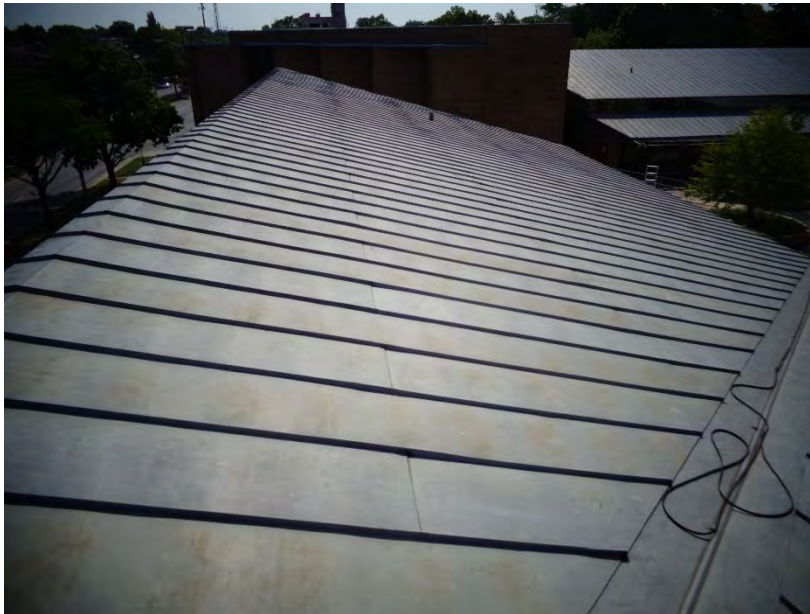
2. Both the upper and lower roof levels allow water runoff to freely fall off the roof.
3. The standing seam roofing is in serviceable condition.
4. The standing seam panels have a gray patina. The panels include bands of red discoloration that typically appear to align with isolated low areas in the panels (Figure 73). On the Council Chamber annex and the roofing over the north end of the east wing, the discoloration is consistent across the full length of the panels (Figure 74).

Figure 73. Bands of red discoloration on the surface of the standing seam panels on the upper roof on the east side of the building

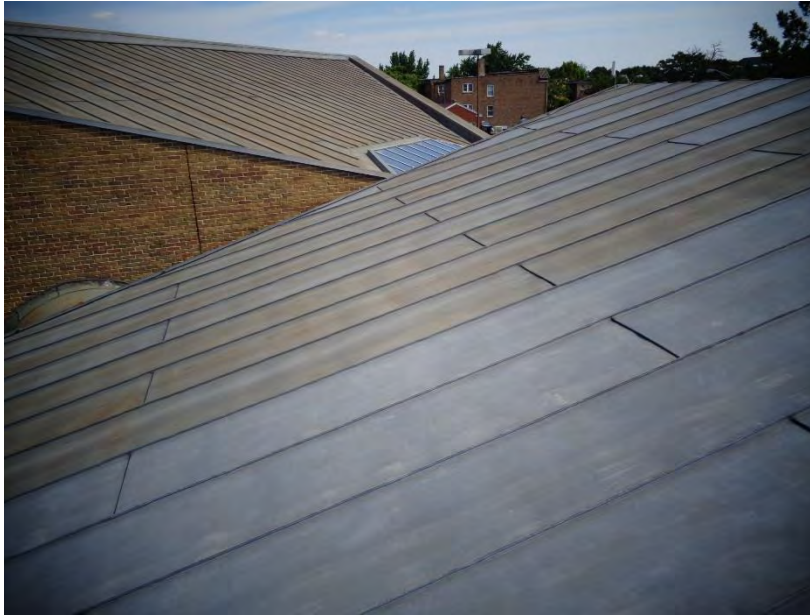
Figure 74. Consistently discolored panels at the north end of the upper roof on the east side of the building and on the Council Chamber annex (background)

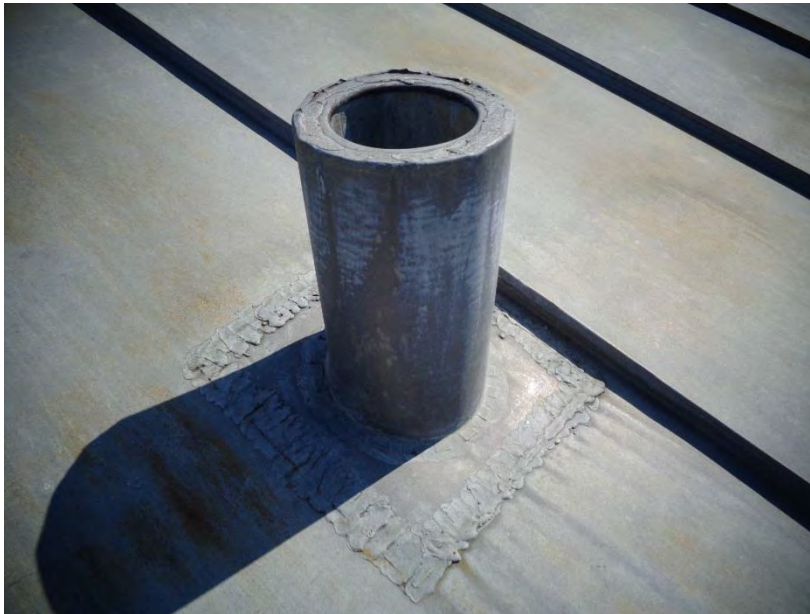
5. The panels include a few isolated, small diameter punctures and dents (Figure 75 and Figure 76).
6. Vent stack penetrations are flashed with lead coated copper sleeves that are soldered to the standing seam panels (Figure 77).

Figure 77. Vent stack flashing

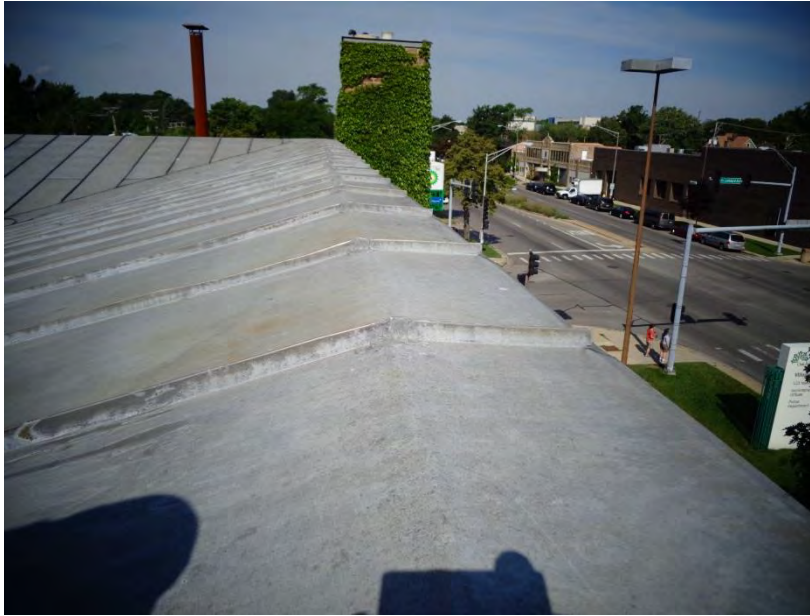
7. At the top of the upper roof level, the roof is flat above the exterior walls. At the slope transition in the standing seams, the seams were cut, patched, and soldered (Figure 78). Isolated solder joints around these patches are cracked (Figure 79). The top edges of the panels lock into a metal edge above the windows in the exterior wall. At the top ends of the panels, the standing seams were cut and folded back to close the ends of the standing seams. Where the panels engage the edge metal, the joint between the panels is a lap (Figure 80).

Figure 78. Flat portion of upper standing seam roofing over the exterior walls

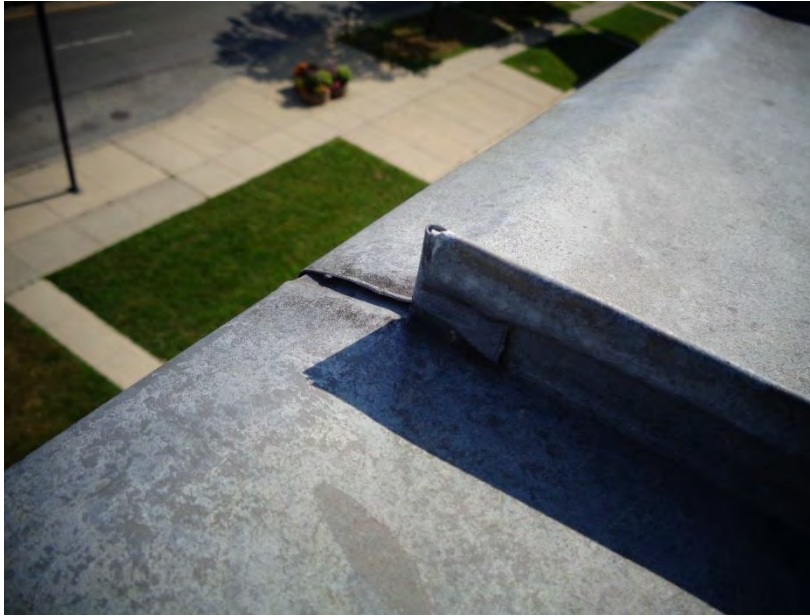
Figure 80. Close-up of cut and folded standing seam at the top of the upper roof level

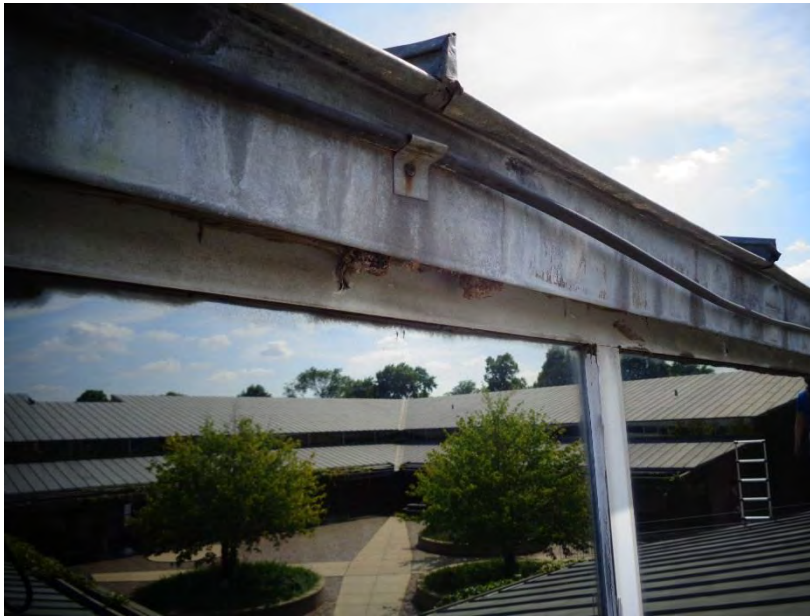
Figure 81. Close up of edge metal above top of clerestory windows

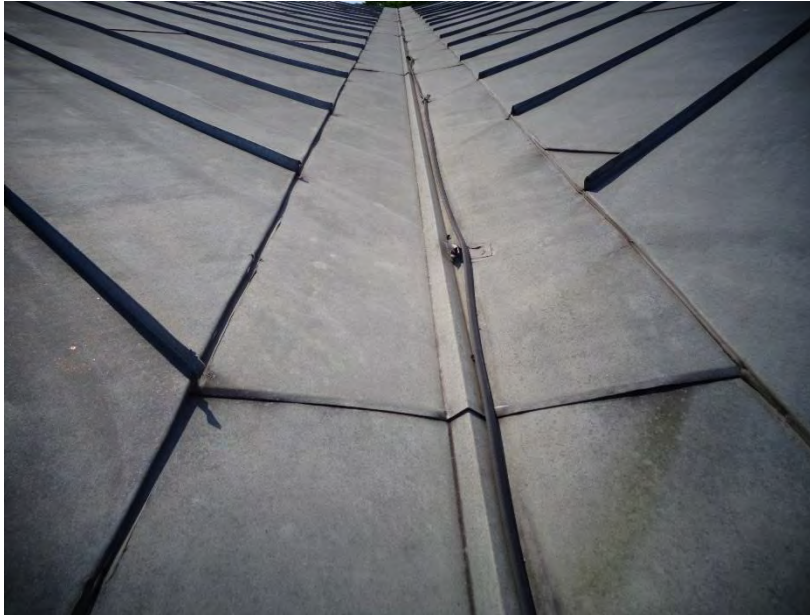
Figure 82. Close-up of sheet metal valley

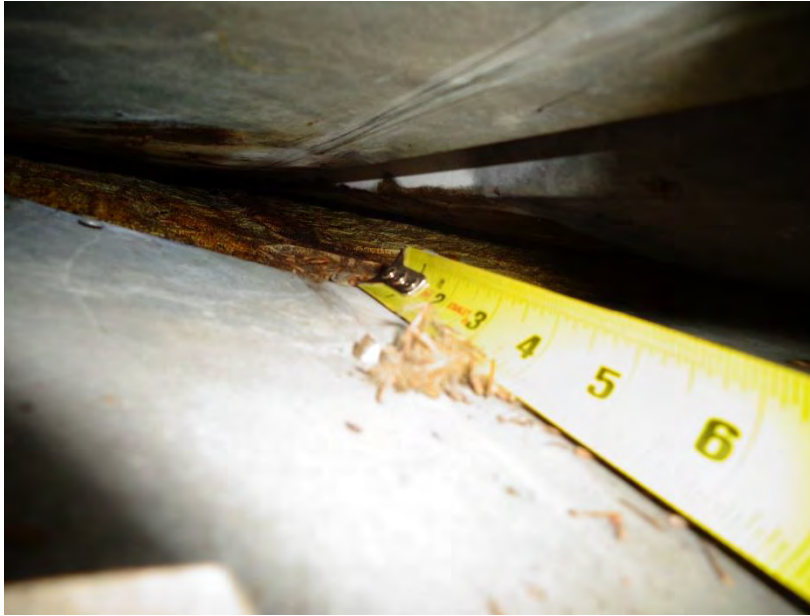
Figure 84. Measuring tape inserted into 8 inch transvers seam in the valley metal

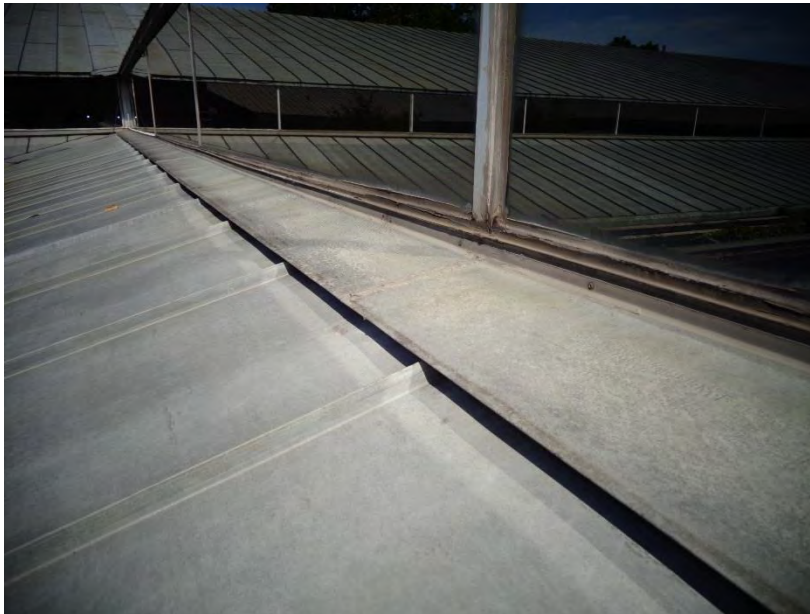
Figure 85. Roof-to-wall sheet metal flashing at the base of the clerestory

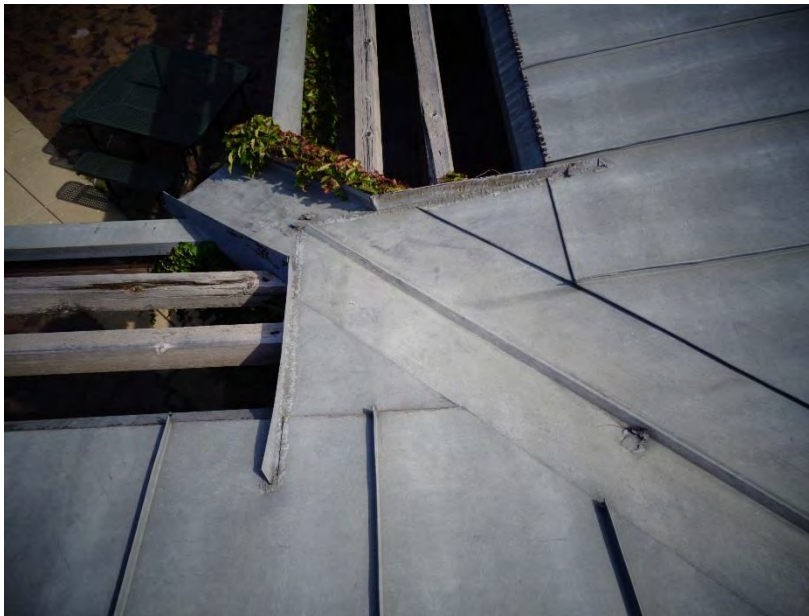
Figure 89. The valleys extend into sheet metal pans to carry the runoff water past the wood trellis

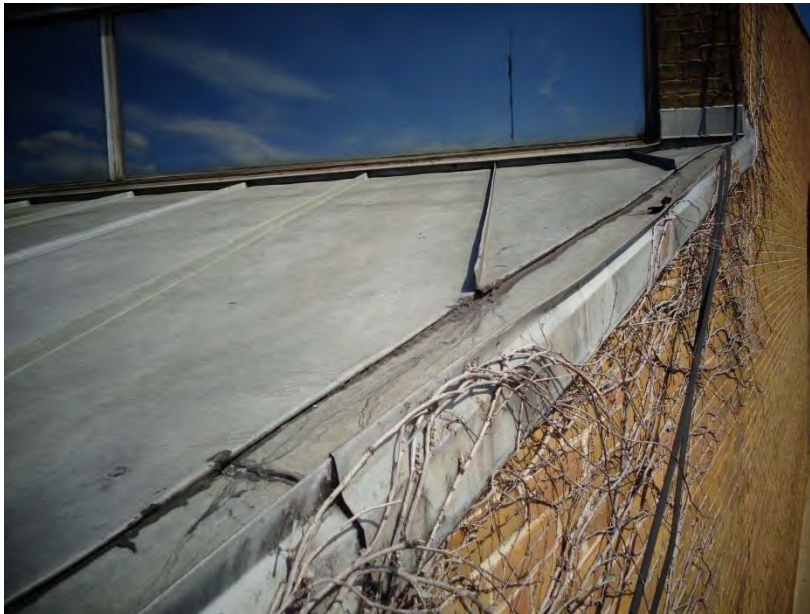
Figure 91. Rake-style edge metal at end wall

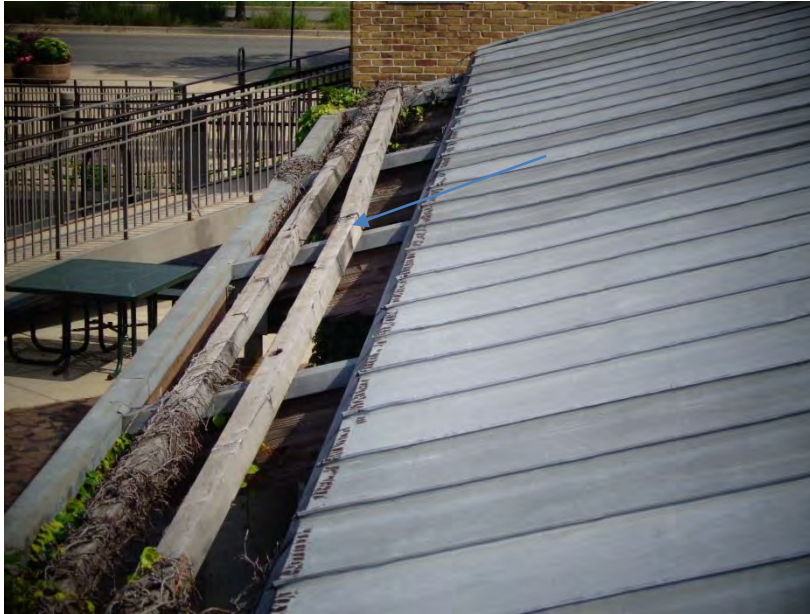
Figure 92. The end rafter of the wood sunshade is not adequately fastened and has displaced.

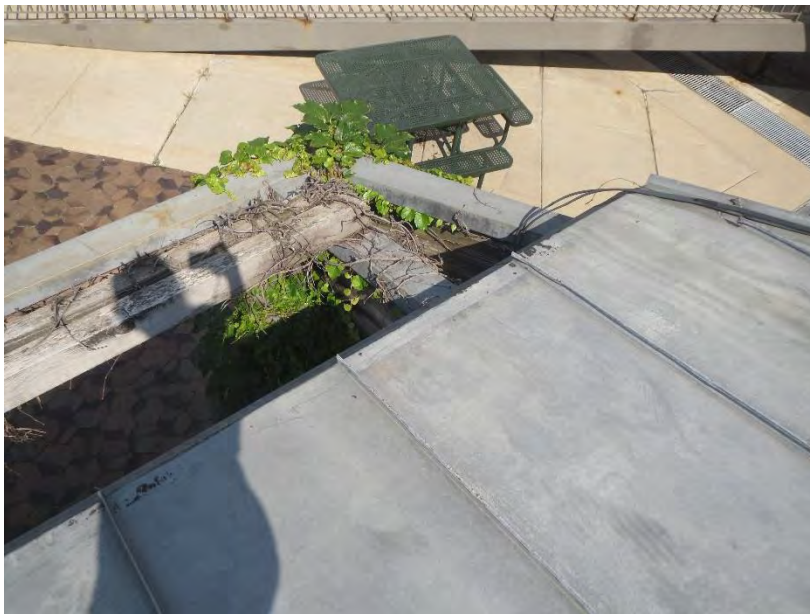
Figure 93. View of low slop roof edge and wood framed sunshade. Note how some of the wood framing is clad with sheet metal and significant vine growth.

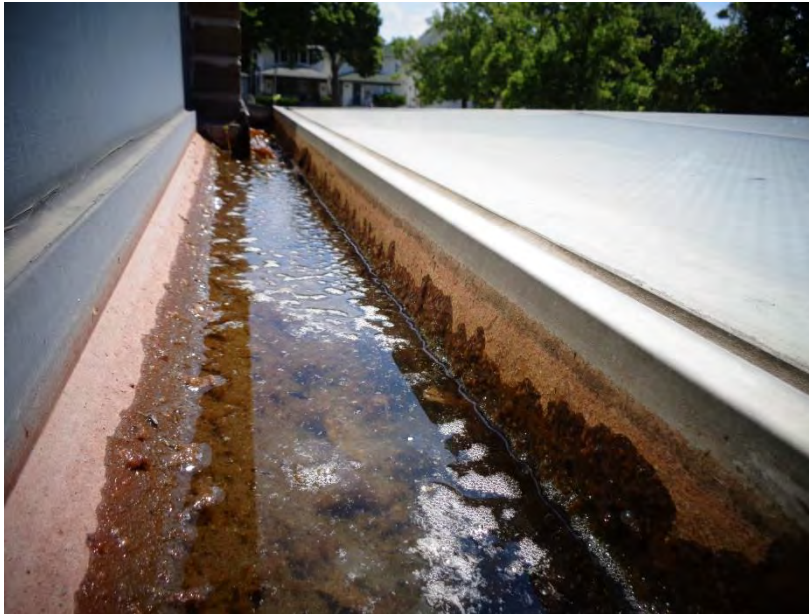
Figure 95. Standing water at gutter between the building wall at the glass canopy above the south entrance walkway

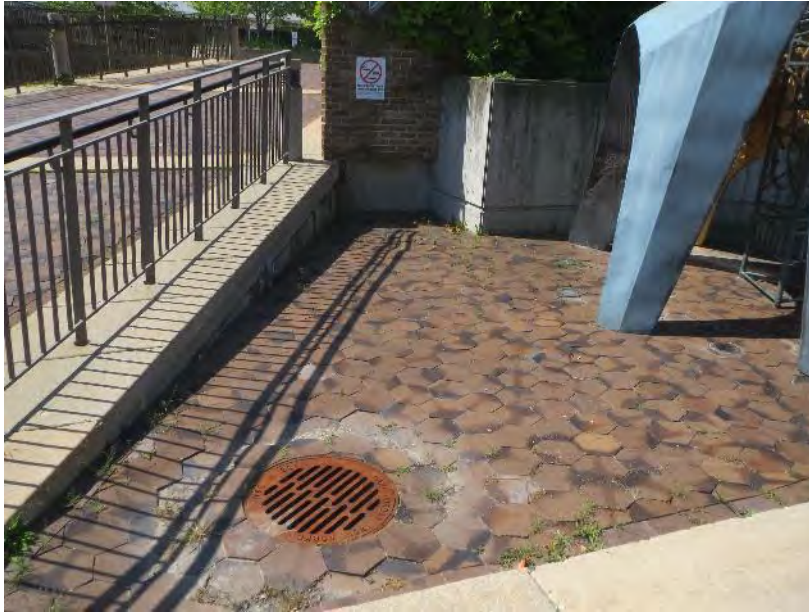
Figure 96. View displaced pavers at area drain

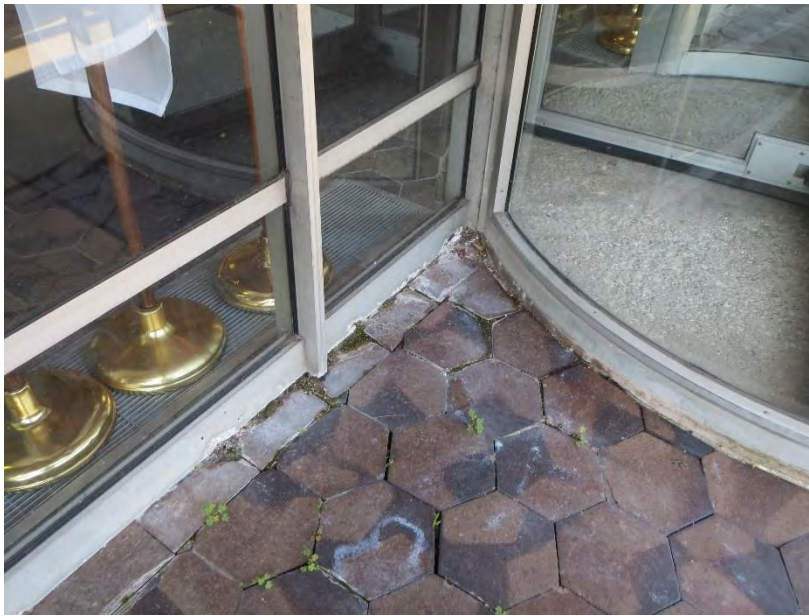
Figure 97. Displaced pavers and organic growth at joints between pavers near revolving door at south portion of plaza

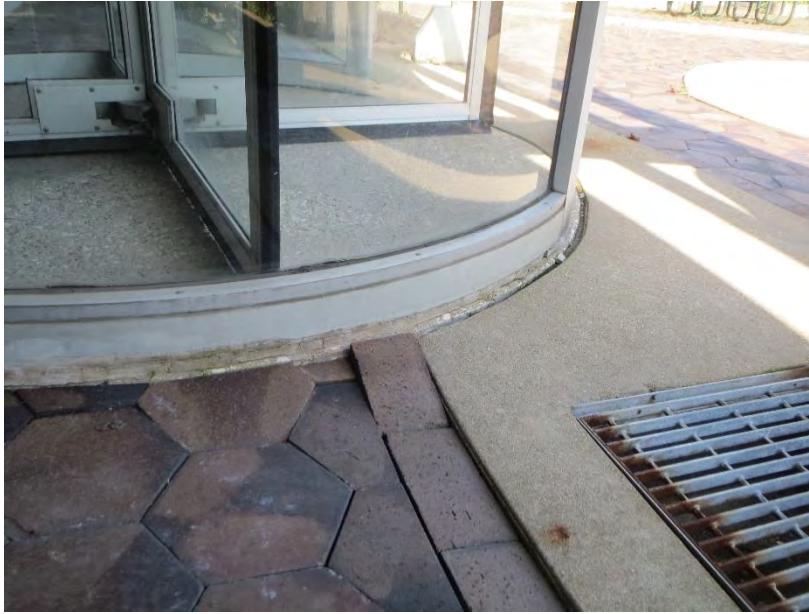
Figure 98. Displacement of pavers at concrete curb at revolving door at south side of plaza

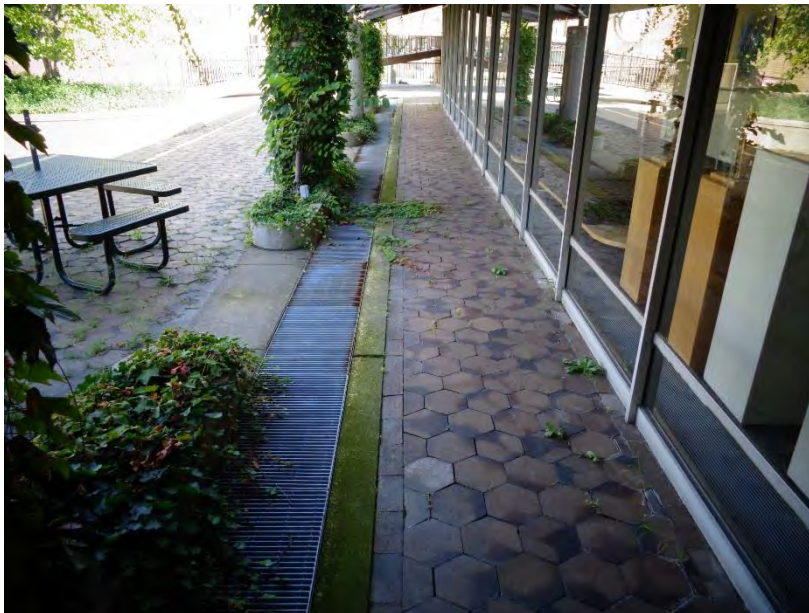
6. Standing water and significant biological growth were observed at the built-in trench drain at the perimeter at the elevated plaza (Figure 99 through Figure 101).

Figure 99. Overall view perimeter gutter at plaza. Note the organic growth at the concrete gutter structure and ivy at the sunshade support structure.

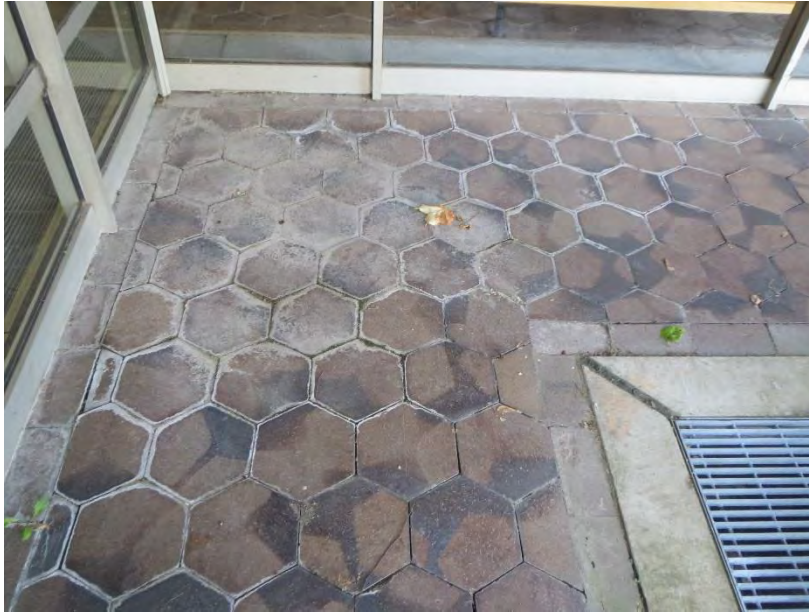
Figure 100. Efflorescence at joints between pavers at the window wall side of the gutter

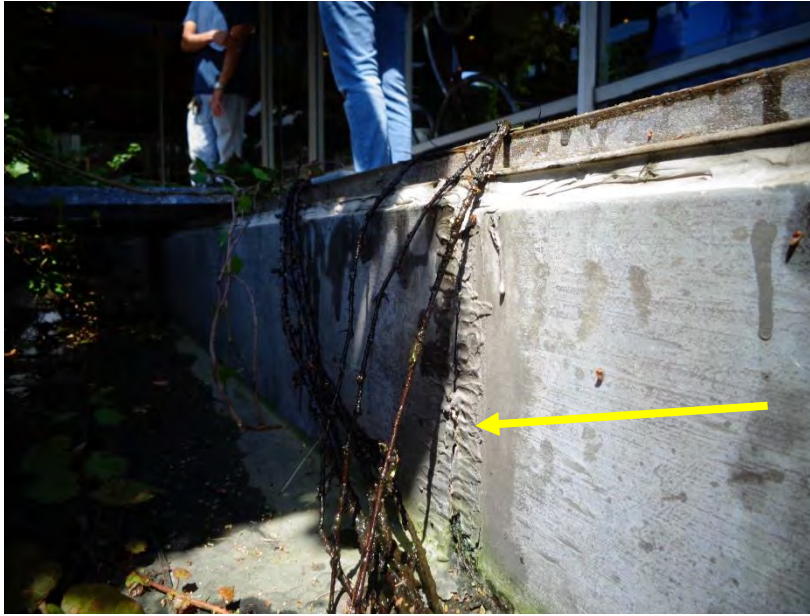
7. Many of the solder seams at the lead coated copper liner of the built-in are cracked (Figure 102 and Figure 103).

Figure 102. Close up view of open vertical solder seam in gutter liner. Note the plant growth and significant debris.

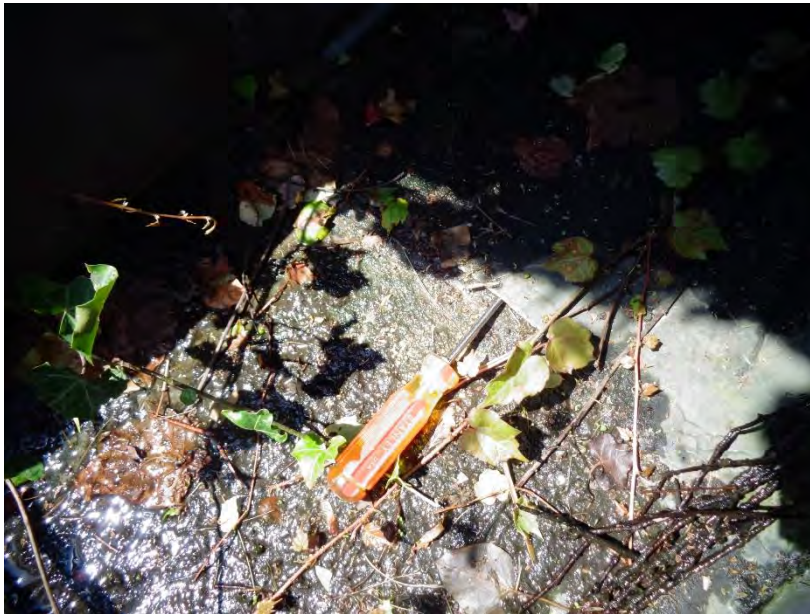
Figure 103. Close up view of open horizontal lap seam in gutter liner. Note the plant growth and significant debris.

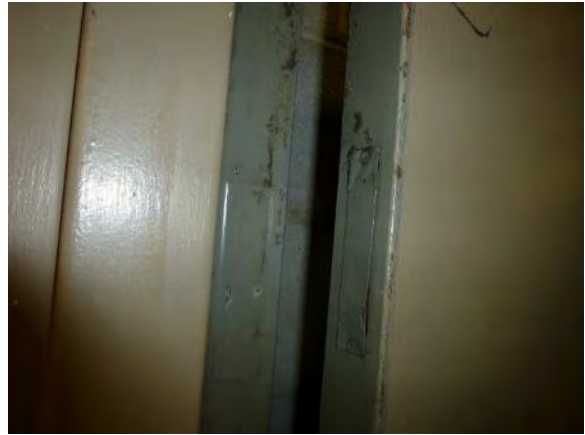
Figure 108. Painted door label in secure police area fire-rated enclosure

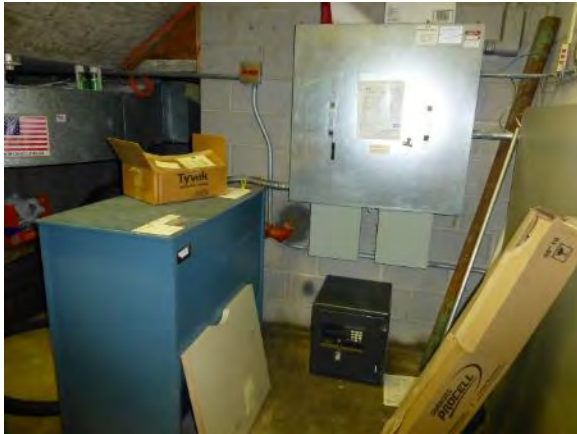
Figure 109. Storage in elevator machine room

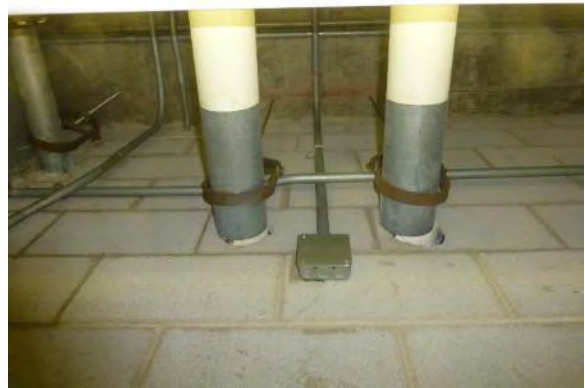
5. Vertical duct shafts appeared to be enclosed in 1-hour fire-rated construction.
6. Mechanical rooms and storage rooms were separated from other areas by 2-hour fire-rated construction with 1-1/2-hour rated, self-closing fire doors. Several door labels were painted and the doors were improperly held open. Unsealed conduit penetrations and small holes were observed in several of the rooms (Figure 110).

Figure 110. Unsealed penetration in mechanical room

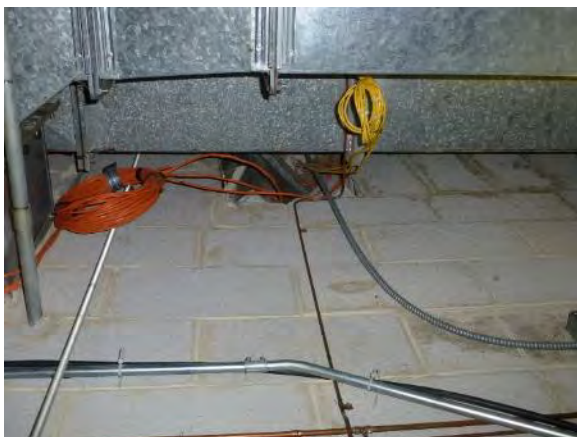
7. The generator room and main electrical room were separated from other areas by 2-hour fire-rated construction with 1-1/2-hour rated, self-closing fire doors. Unsealed conduit penetrations and other openings were observed in the walls (Figure 111), and door labels to the main electrical room were painted.

Figure 111. Unsealed penetrations in generator room

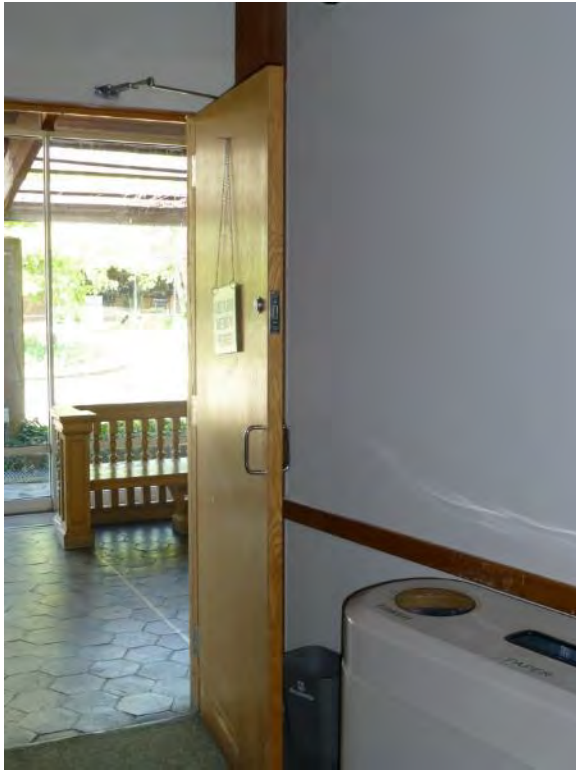
5. The first floor east training room has a posted occupant load of eighty-five, but the room only has one exit door, which swings into the room and has a deadbolt lock, and exit signs are not provided (Figure 113). There are other doors from the space, but they exit into other rooms and not to a corridor.

Figure 113. First floor training room exit door

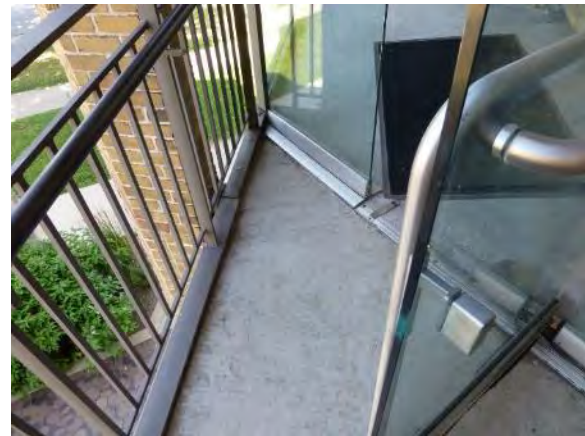
2. In addition to the stairs that exit at grade, the first floor has two exit doors that discharge to the exterior. The basement has one access-controlled door from the sally port that discharges to the exterior and goes up a vehicle ramp to grade. The annex has one exterior door that discharges to an exterior ramp to grade, but the exterior door to the ramp opens 90 degrees, which restricts egress based on the angle of the door to the ramp (Figure 115 and Figure 116).

Figure 115. North stair door from annex area

Figure 116. North stair door from annex in fully opened position

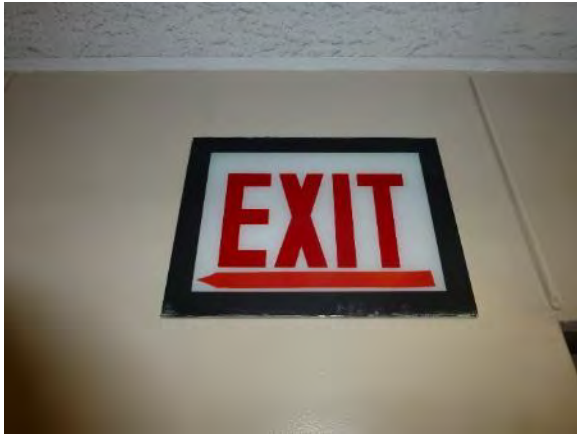
1. Exit signs directing occupants to exits are provided, but not all signs were illuminated (Figure 117).
2. Exit signs were blocked by storage in corridors in several areas of the basement (Figure 118).

Figure 117. Non-illuminated exit sign

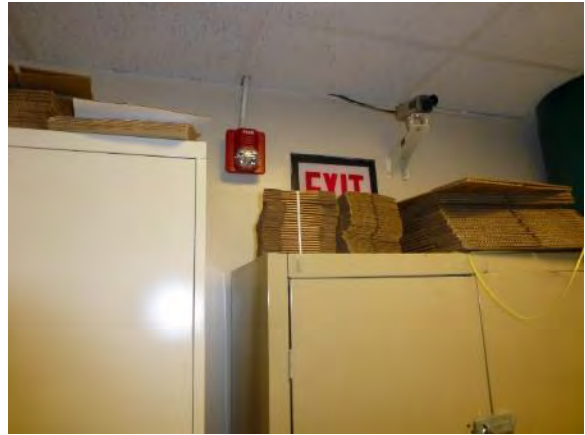
Figure 118. Exit sign obstructed by storage

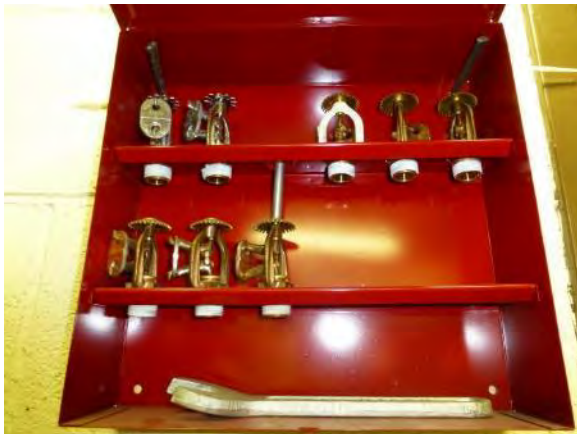
sprinklers appeared to be dirty or corroded. It is assumed that most sprinklers were installed at the time of initial construction, so the observed sprinklers are approximately forty years old. A spare sprinkler cabinet was installed in the incoming water room, but sprinklers of each type installed in the system were not observed in the sprinkler cabinet (Figure 126). Several concealed sprinkler cover plates were missing (Figure 127).

Figure 126. Spare sprinkler cabinet

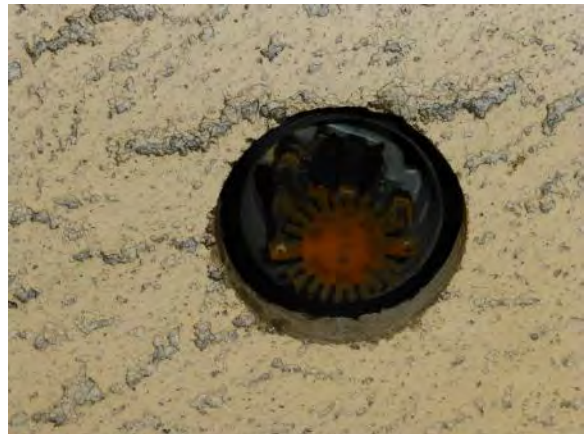
Figure 127. Concealed sprinkler without concealed cover plate

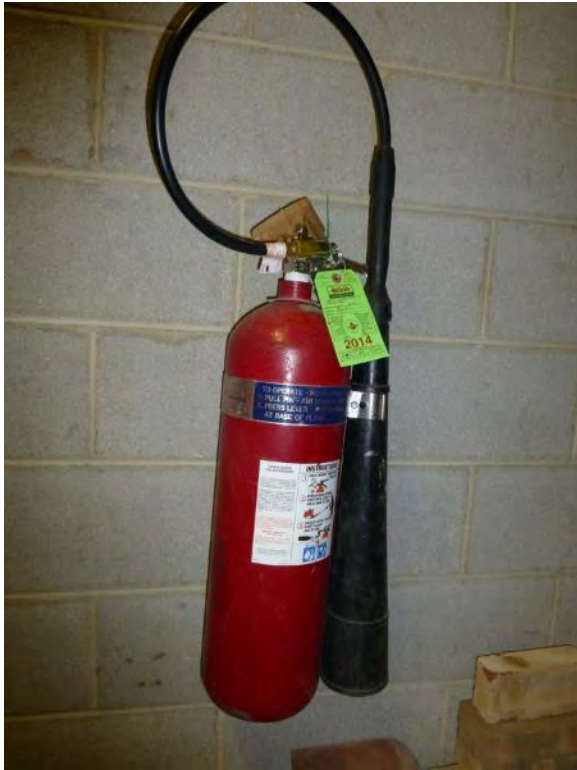
Manual fire extinguishers are distributed throughout the building, and their spacing is generally in compliance with the IBC and NFPA 10. Fire extinguishers were last inspected in October 2014 (Figure 128). A fire extinguisher outside the generator room was sitting on the floor (Figure 129) and a fire extinguisher on the south wall of the basement south storage area was obstructed.

Figure 128. Fire extinguisher with current inspection tag

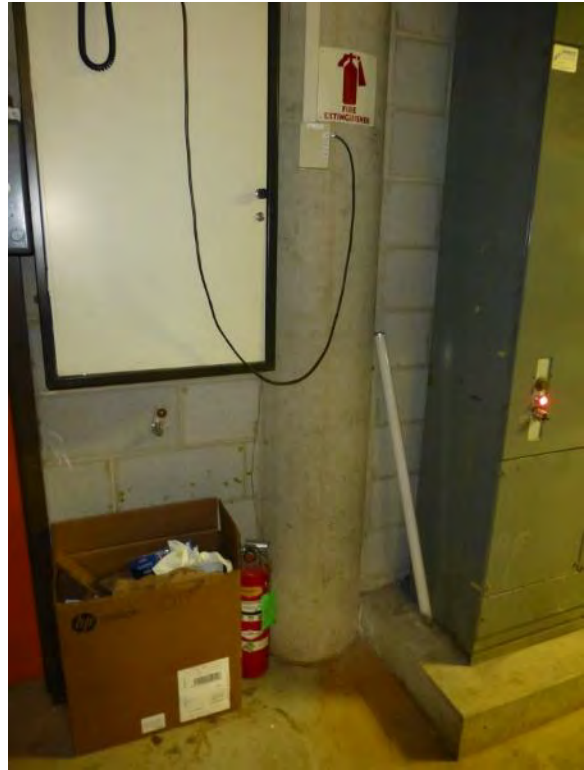
Figure 129. Fire extinguisher on floor outside generator room

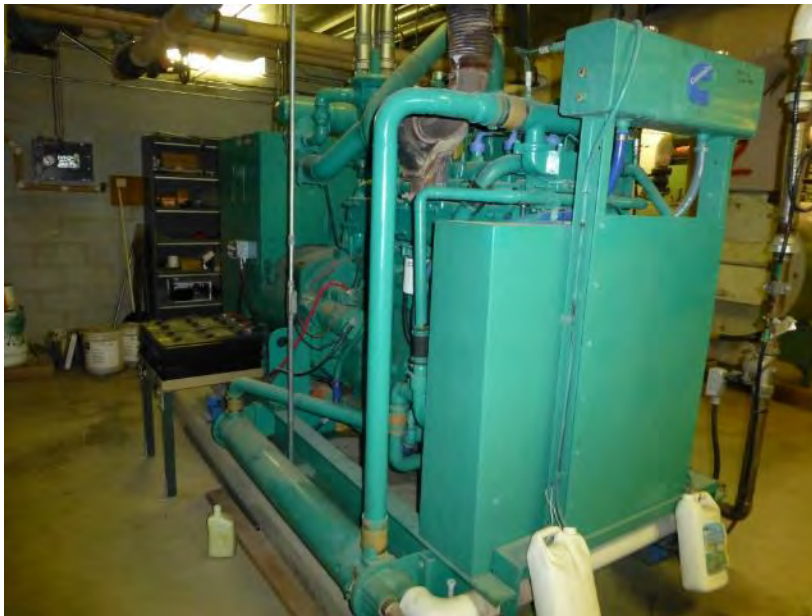
The building has a 475 HP Cummins natural gas emergency generator (Figure 130). The generator reportedly had a major overhaul in 2014. A test report was not available for the most recent test, but a tag on the generator indicated it was inspected in April 2014. The generator reportedly provides power for the entire building except for the chillers.

Figure 130. Emergency generator

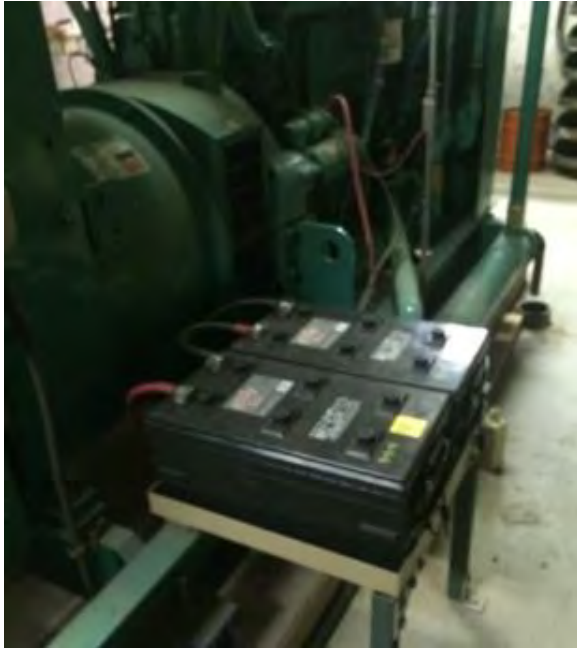
1. The generator batteries are reaching their serviceable life (Figure 131).
2. Back of house lighting fixtures are older and typically linear fluorescent fixtures, which do not provide adequate lighting (Figure 132 through Figure 134).
3. In many areas, exit sign bulbs are incandescent and not LEDs (Figure 135).
4. Branch and distribution panel boards are deteriorating and reaching their useful life expectancy. All electrical panels which have not been replaced within the last fifteen years are beginning to show signs of deterioration (Figure 136).
5. UPS system batteries are nearing their serviceable lifetime expectancy (Figure 137).
6. Panel board schedules are missing for many of the panels (Figure 138).

Figure 131. Close up view of generator batteries

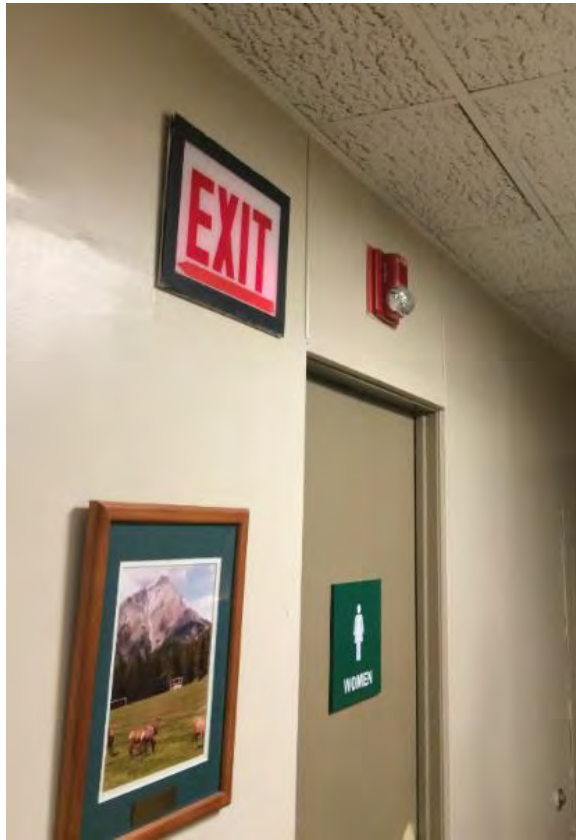
Figure 135. Exit signs and fire alarm notifiers (typical)
