OAK PARK VILLAGE HALL Property Condition Assessment

Oak Park, Illinois 60304

Final Report

November 9, 2015

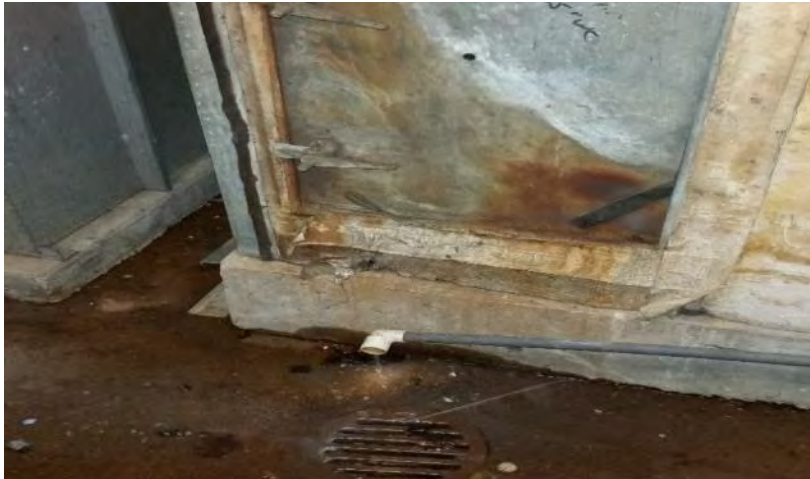
2. The S-2 chilled water cooling coil condensate drain pipe is properly trapped, yet condensate pipe spills water on the concrete floor (Figure 140).
3. Internal AHU S-1 and S-2 components are typical (Figure 141 through Figure 143).
4. All supply and return/exhaust fans are controlled by pneumatic actuated inlet guide vanes (Figure 144).
5. S-5 is currently being renovated, adding outdoor air and MERV 13 filtration for the removal of lead particles from the return airstream.
6. The new S-6 heat pump is remote mounted in a concrete vault below grade (Figure 145).

Figure 140. S-2 chilled water coil section and condensate drain

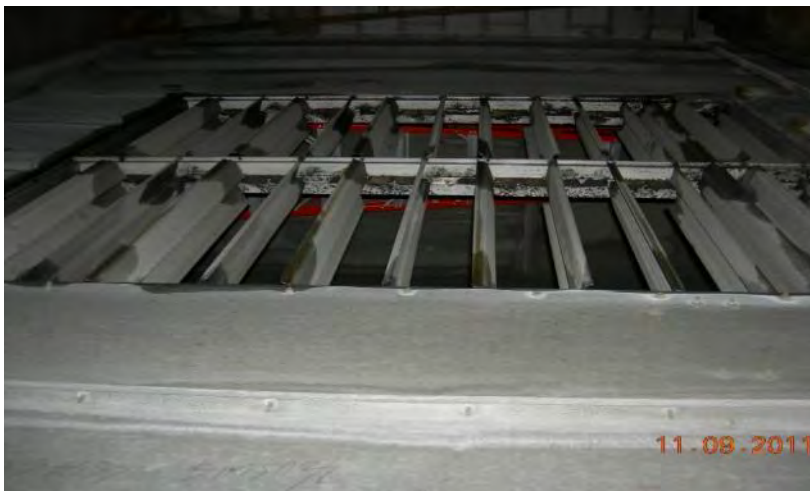
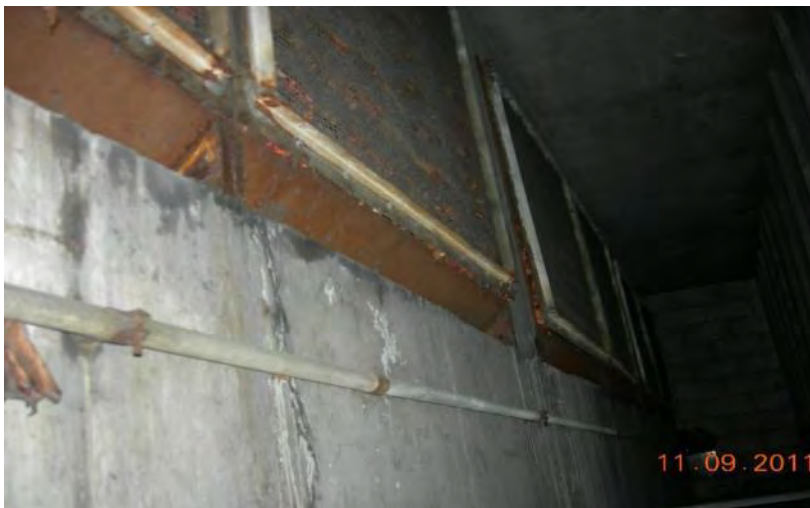
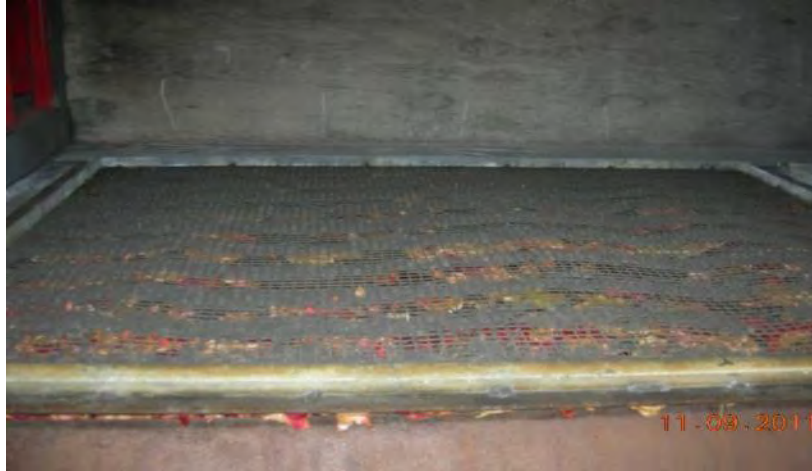
Figure 141. View of air handling units

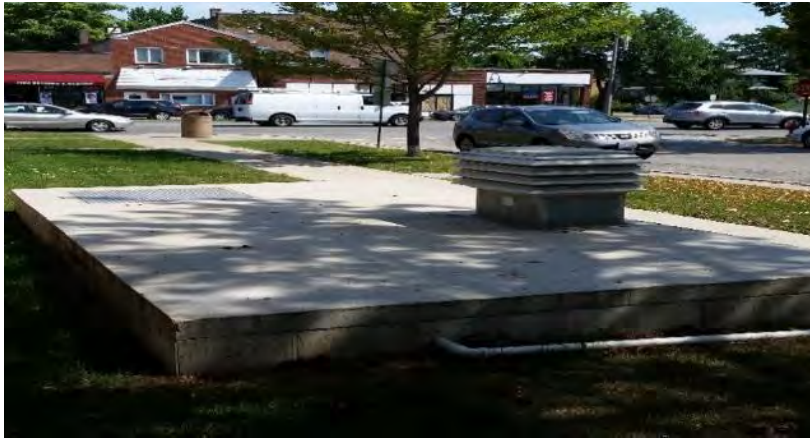
Figure 145. S-6 geothermal vault mounted heat pump

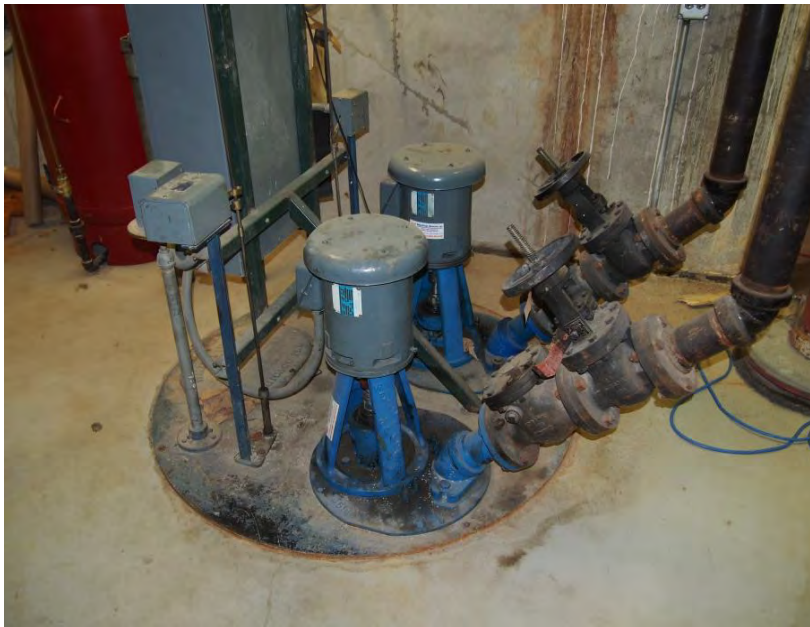
1. The building plumbing systems are generally in working order (Figure 146 and Figure 147).
2. Isolated portions (typically at connections) of the existing piping are corroded (Figure 148 through Figure 151).
3. The water heaters were repaired in 2007 but isolated damage to the metal jacketing was observed near the base of the units. They are exceeding their life expectancy (Figure 152).
4. Plumbing fixtures do not fully comply with ADA (Figure 153 and Figure 154).

Figure 146. Existing sump pump system

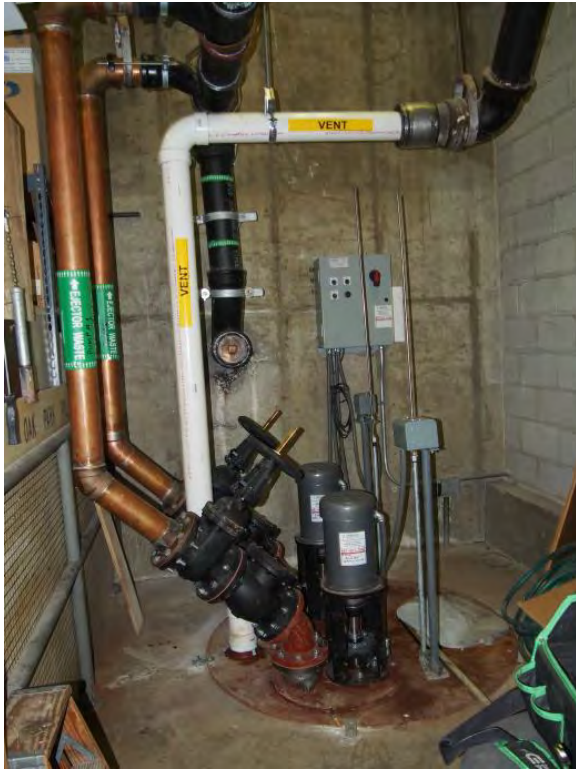
Figure 147. Sewage ejector pumps

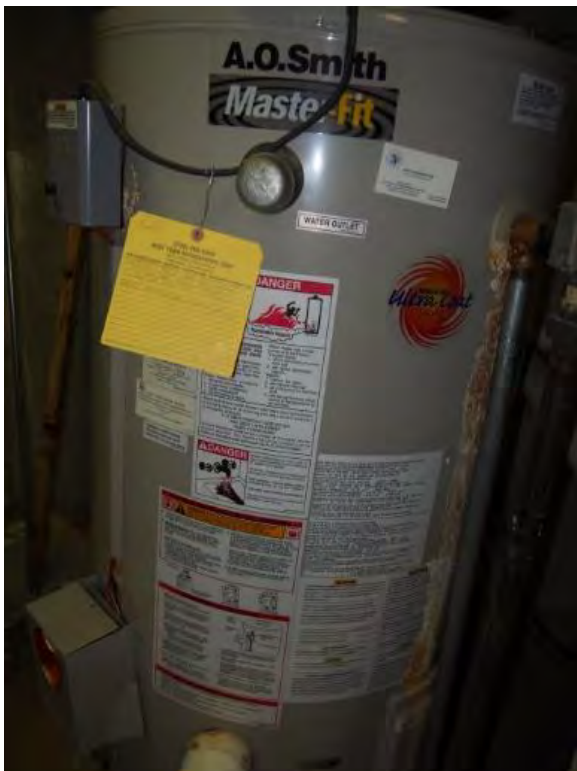
Figure 152. Close up view of existing water heaters

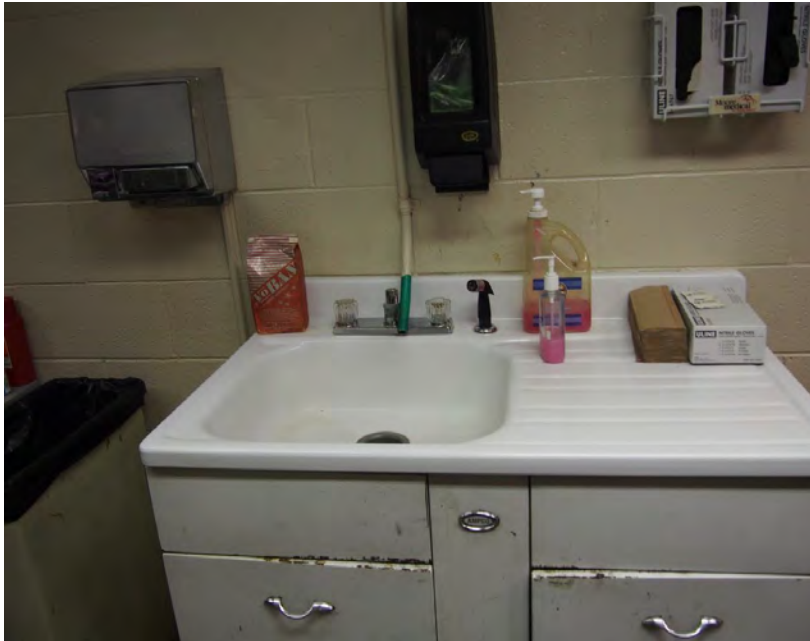
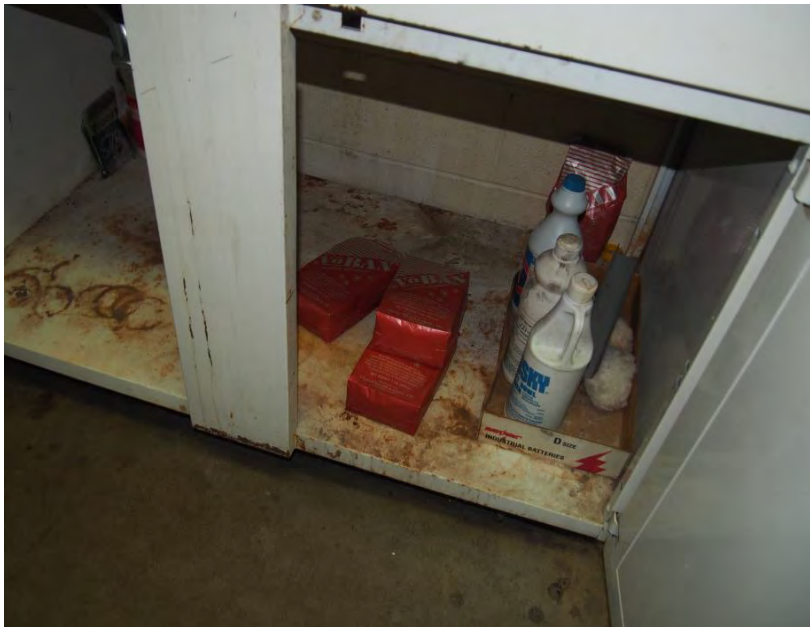
Figure 153. Existing sink at finger printing
