## OAK PARK POLICE DEPARTMENT

SPACE NEEDS ASSESSMENT

August 30, 2019  
FGM # 19-2639.01

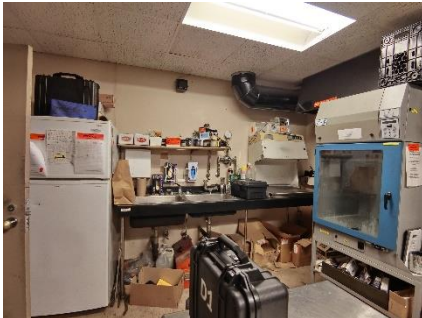
*Evidence Processing Room*

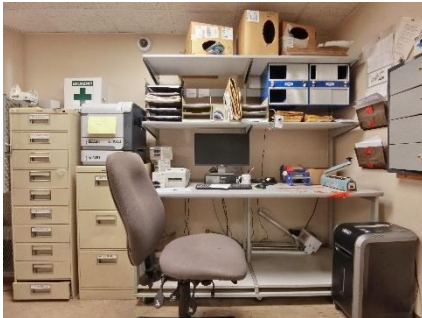
*Evidence packaging area*

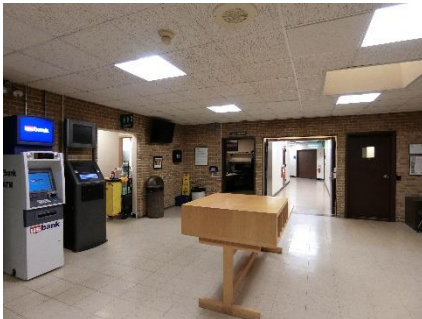
*Views from front desk are limited*

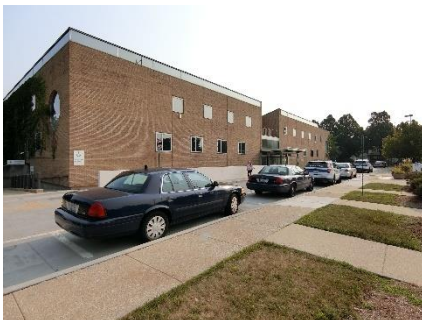
*Unsecured parking for squad cars*

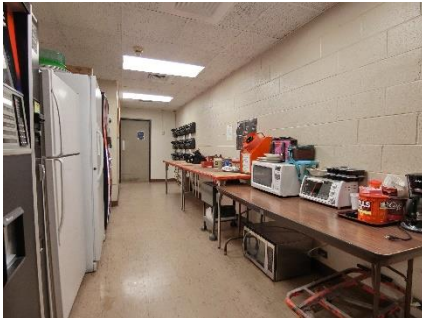
Staff Break area  
shared with gun cleaning

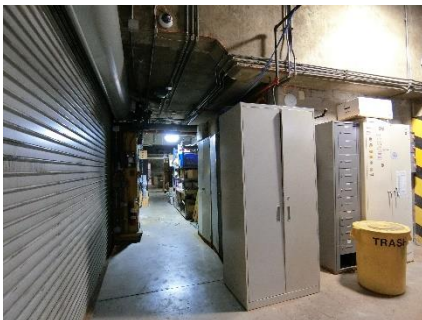
Sally Port

- It is necessary to use steps to access Lockup Areas, which is dangerous when moving prisoners.
  - There are many items stored in the Sally Port which reduces the space available for defensive tactics if a detainee struggles. This poses a liability risk to the Village as it is the Police Department's responsibility for the well-being and safety of detainees.
- **Booking Room:** This space was designed at a time when ink fingerprints and Polaroid Cameras for mugshots were the norm. Now, the Police Department uses electronic fingerprinting (Live Scan) and digital photography for mugshots, which are

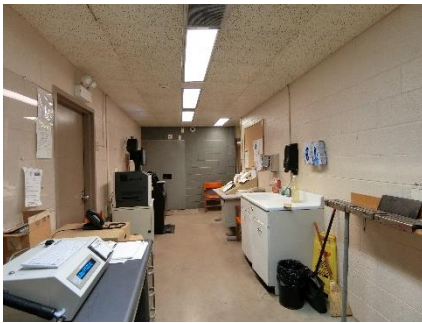
Booking Room

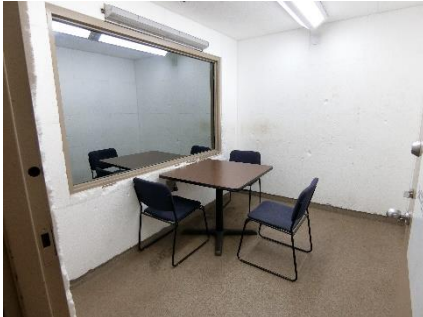
- A soft interview room should be provided. There are many studies that show interrogations within a soft interview room can be more effective than interviews in "hard" or traditional interview rooms. This type of interview room can also be used as a "victim room," where the Department can work with a victim without making him/her feel like a criminal.

Investigations Interview Room

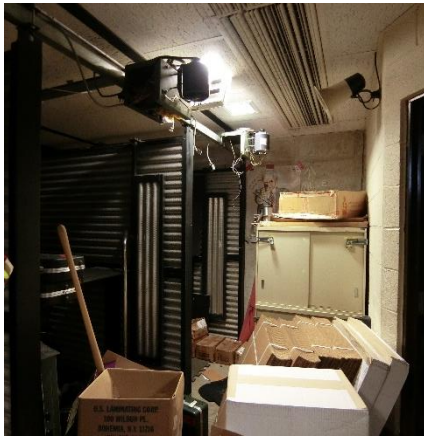
- The Firing Range is currently not in use due to HVAC issues.
- If this Firing Range were converted to a tactical range a new bullet trap capable of accommodating rifles will be required. Modern bullet traps are larger than the current one, so the shooting distance would be less than 25 yards, which is the longest qualifying distance required.
- A dangerous aspect of the Firing Range is that a person enters directly onto the range. Typically, there is a preparation room or man trap prior to entering a range.
- There is no storage for range props, targets, and cleaning equipment.
- The location of the Firing Range causes noise issues to the Village Offices above it, so there are restrictions on when it can be used.

Firing Range

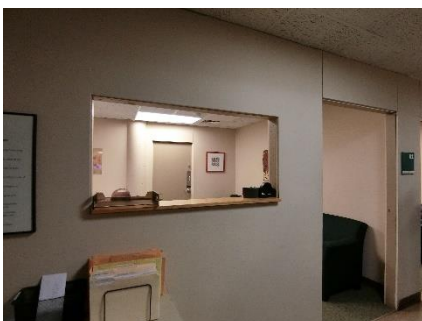
*Non-ADA compliant service window*

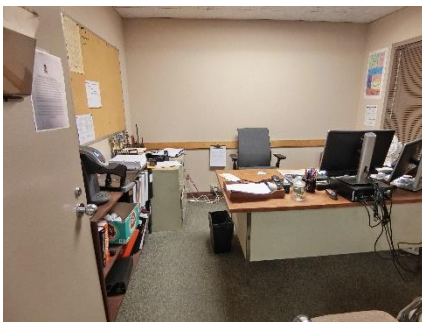
*Extension cords laying on floor due to insufficient electrical outlets*

- Due to age of building there is a lack of electrical and data outlets, cords are draped over furniture and across cabinets throughout the building.
- Within the Administration Department extension cords are lying across walkways creating a tripping hazard.
- Within the lobby conference room, temporary partition walls have been added to the west and south walls creating mechanical and electrical closets. These closets lack the required signage and fire ratings.
- A mechanical closet is located within the Crime Analyst's Office. This equipment should be accessible from the main corridor and not require access through a private office.
- Files and boxes being stored within 24" of ceiling
- Lighting levels within the Building Maintenance Department are too low.
- There is no free exit from the Mechanical Room. This door requires free egress.

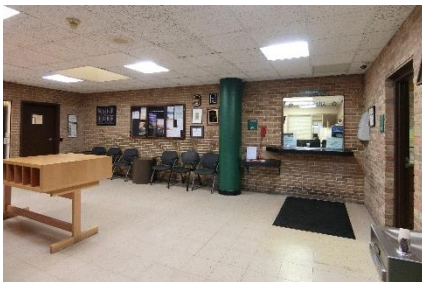
Poor sight lines from the Front Desk

- There is water damage located at the skylight within the public lobby.
- The door finishes are showing their age with chipping paint and damaged jambs.
- The flooring within the lockup area at the front desk is damaged.
- Due to the layout of the space, sight lines to lobby and the lockup cell are difficult.

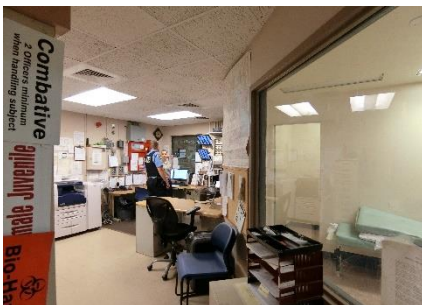
Poor sight lines from Front Desk to  
Observation Room

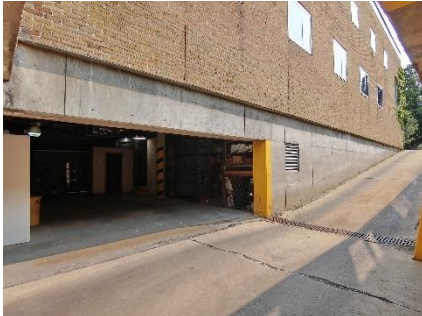
- Vehicular access to the sally port and parking garage is difficult with the current turning radii. The ramp is steep and creates issues with access for larger vehicles. The low headroom at the overhead doors leading into the sally port and garage limits the size of vehicles that can enter the area.

*Difficult vehicular access to Sally Port*

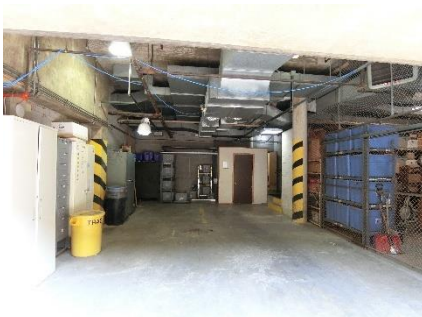
*Walls within Sally Port lined with storage*

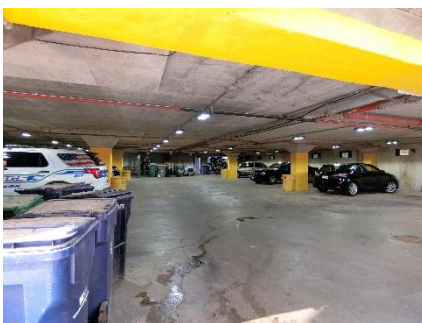
*Steep slope and low head clearance at parking garage*

- Snowplows and garbage trucks cannot access the bottom of the ramp and garage due to the steep slope and low headroom clearance.
- The floors and ceiling are showing signs of damage. The concrete around the trench drains is spalling and cracking. The concrete roof deck is spalling, exposing rebar which is rusting and corroding due to exposure to the elements.
- There is seepage in the garage which is likely caused by blocked or collapsed drain tile within the garage.
- The conduit surrounding the main data line connecting the communications tower to the building appears to be severely damaged and is exposing the cabling to water.

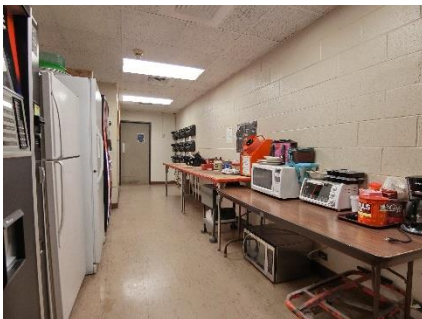
*Staff break area shared with gun cleaning*

- The staff break area is currently being shared with the gun cleaning area. This is not a safe situation. Gun cleaning should be in a dedicated area to prevent an accidental discharge from injuring others. Furthermore, having these functions together creates an unsanitary, hazardous environment with chemicals for cleaning guns comingling with food.
- Overall, the space is inadequate for either function. There is a lack of counterspace for gun cleaning, folding tables have been covered with cardboard to soak up the spills from the chemicals and solvents. There is no seating area or place for staff to gather during break times. The lack of natural light contributes to the overall gloomy feel of the space.

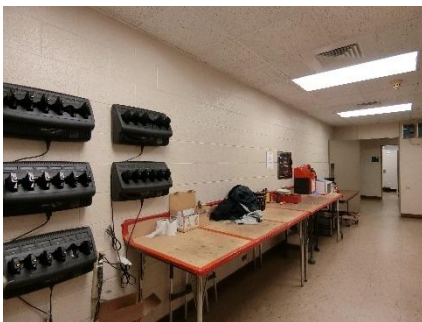
*Lack of seating and natural daylight at staff break area*

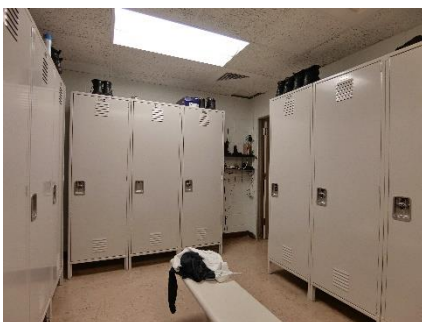
*Lack of storage within sergeant's locker room*

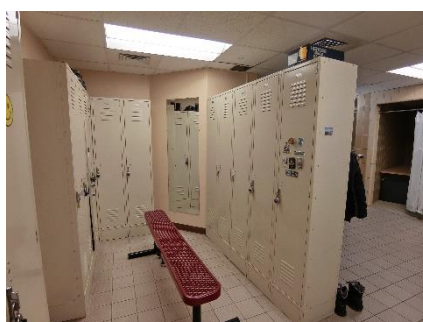
*Insufficient space for storage and circulation*

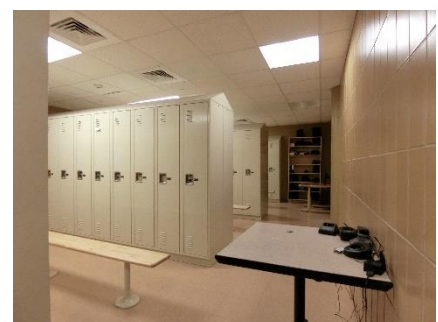
*Lockers size is insufficient*

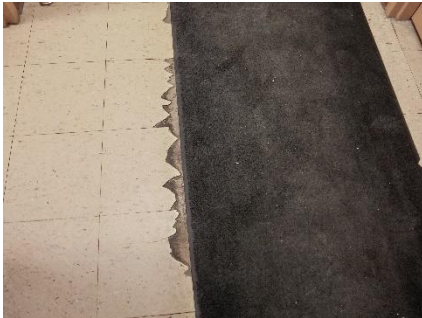
*Chipped flooring outside conference room*

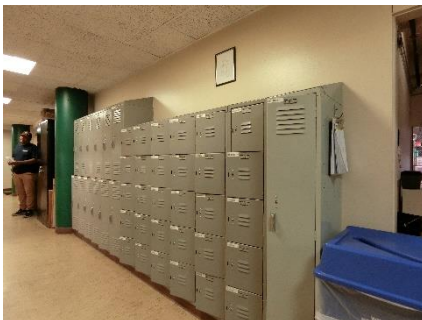
*Evidence lockers located in the main corridor*

- Due to overcrowding, the evidence lockers cannot be located near the bag and tag area and have been put in the main corridor. This location is not recommended as it requires moving evidence through the main circulation corridor.
- The bag and tag area is currently being shared with the evidence processing lab. The space is too small and does not allow for proper layout, circulation or processing space. There is insufficient space for storage and an overcrowding of equipment. In order to perform a task several items need to be relocated in order to access the required equipment.

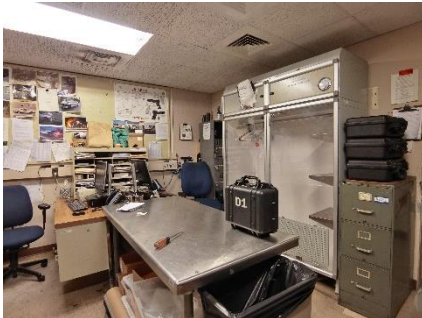
*Evidence processing is overcrowded*

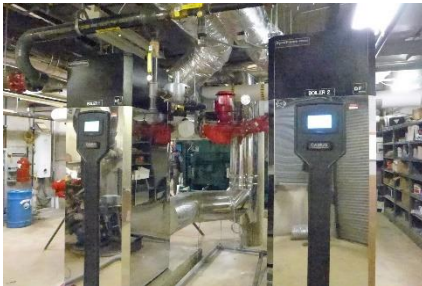
*Existing boilers recently replaced*

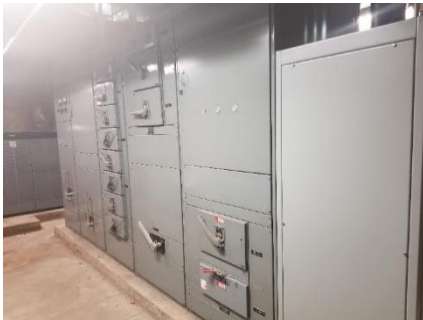
*Main electric service switchboard*

The main switchboard is original to the building and is a Square D manufactured assembly labeled with a rating of 2000 amps, 208 volts, three-phase, four-wire. There are two main disconnect switches provided, one 800 amp three-pole switch supplying the facility chiller equipment and one 1200 amp three-pole switch supplying the rest of the building power. Each additional vertical switchboard section is rated for 1200 amps which limits the largest feed the board can supply to 1200 amps. The switchboard is in fair condition. The switchboard, excluding the cooling load, has recently been re-worked to feed through a full building transfer switch at the end of the switchboard lineup.

recommended. Typical expected useful service life of electrical service gear is approximately forty to fifty years. The existing service gear is nearing the end of its expected service life in approximately five years.

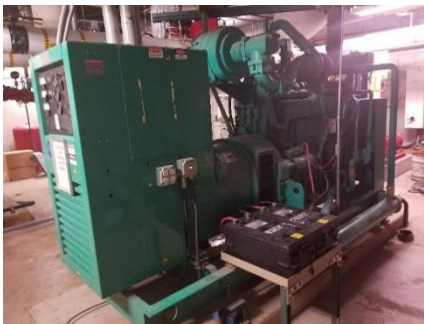
*Main gas-fired back-up generator set*

There is an 325kw/406kva natural gas fired Cummins Power Generation backup generator set installed in the basement northwest mechanical area. The generator has a start-up date of 11/99 listed on the control cabinet. The 1200 amp, 3-pole transfer switch in the main electrical room appears to be new and recently installed. The generator set is in fair condition at twenty years of age and has a typical expected service life of approximately thirty years. The back-up generator system appears to power the entire facility, excluding the chiller load. The output and loads supplied are adequate for a facility of this type and size.

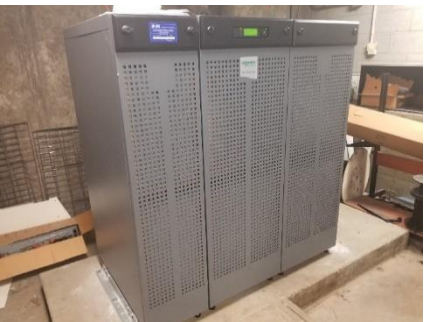
*UPS battery back-up system*

There is an MGE 3500 Schneider central UPS system located within the main electrical service room that provides battery back-up for the critical equipment. The UPS system is newer and in overall good condition. The output and loads supplied appear to be adequate for a facility of this type and size. Typical expected useful service life of electrical uninterrupted power supply systems is approximately 15 to 20 years.

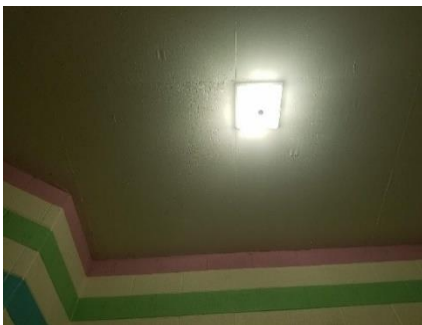
*Typical detention cell lighting fixtures*

The booking and detention areas of the police station do not have appropriately constructed vandal-proof detention rated light fixtures. The fixtures in the booking area are standard troffer fixtures and in the cells are exterior grade lights. The fixtures themselves are in fair condition.
